ARBORICULTURAL IMPACT ASSESSMENT

(INC. TREE SURVEY TO BS 5837:2012)

CLIENT - Heraeus Nobelight
PROJECT - Project Luma
DOC. REF - P2882-AIA01 V2
PLANNING REF - n/a
CREATION DATE - 11/06/2023

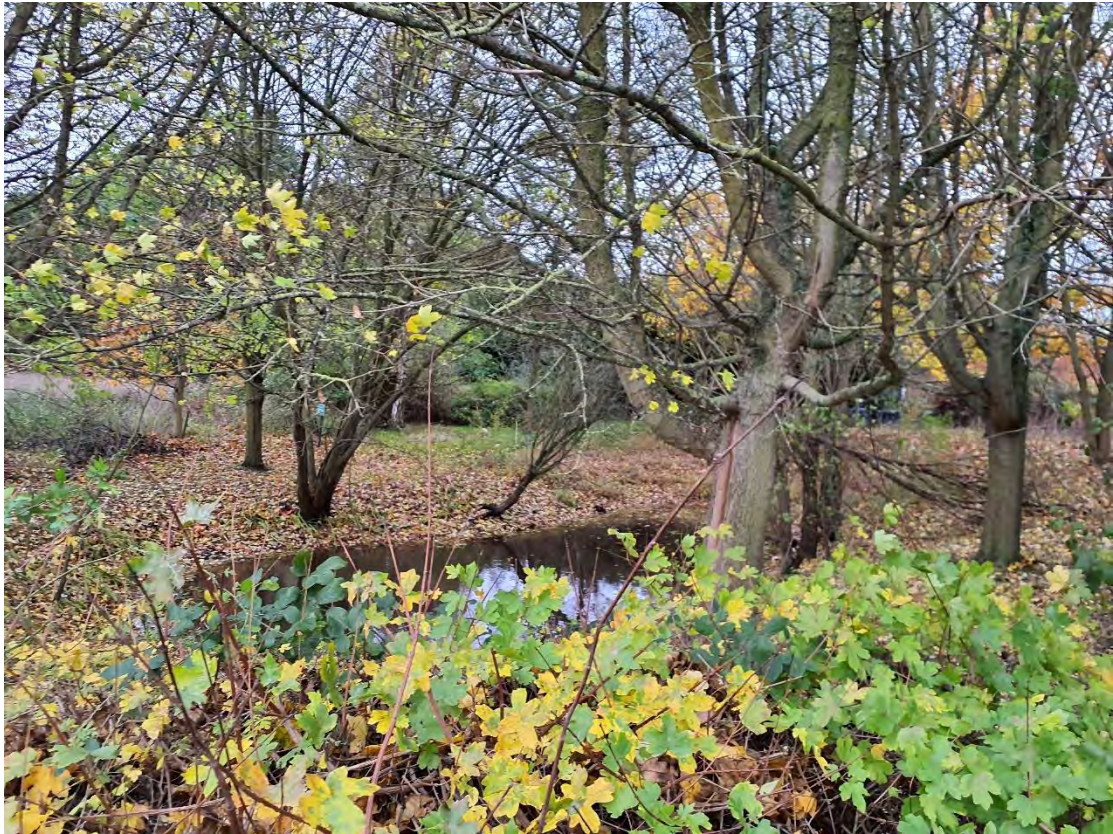
Figure 4 – Looking north in to G7.

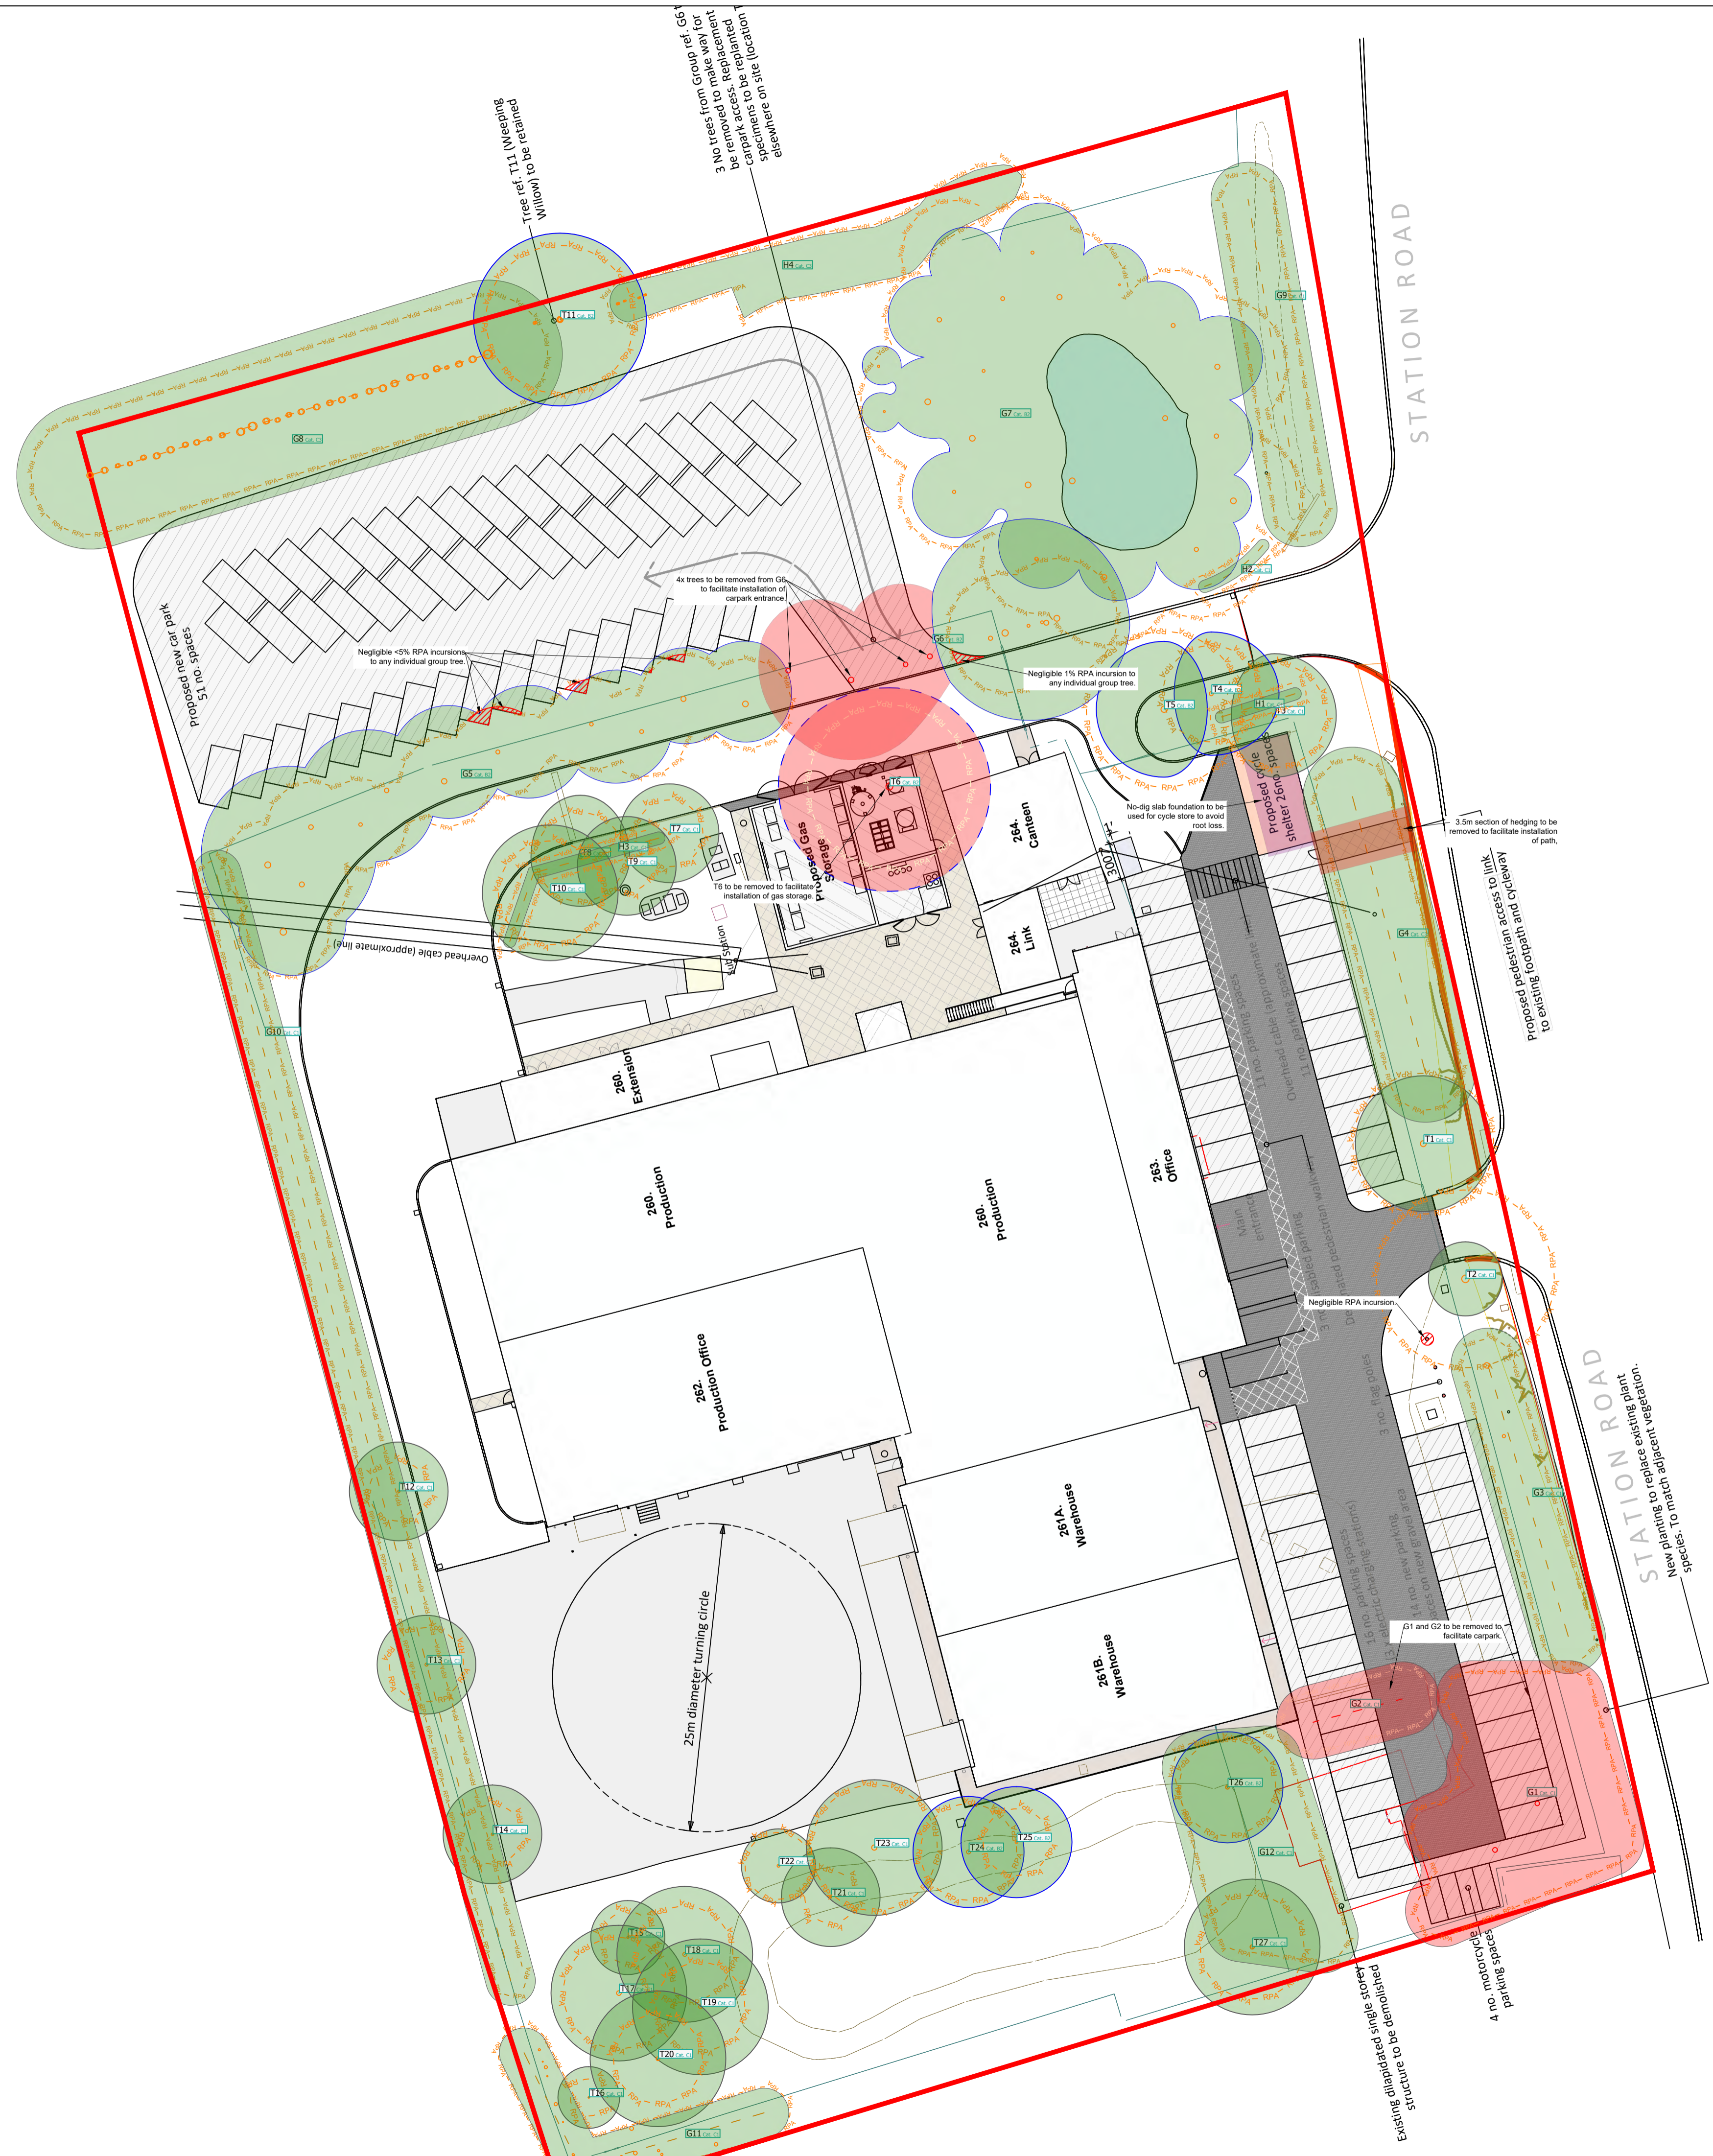
ARB. SITE PLAN (PROPOSED)

3.3 INSTALLATION OF SURFACING WITHIN RPAS

Affected Trees Cat. B: G5 (Mixed group), G6 (Mixed group)

Impact Appraisal & Mitigation	<p>The installation of the new carpark surfacing will result in negligible RPA incursions of any one group tree to <5% for G5 and ~1% for G6.</p> <p><i>Owing to the negligible size of the incursions, any lasting impact on the overall health and condition of the trees is believed to be well within tolerable limits.</i></p> <p>No direct mitigation is considered necessary during the excavation of the foundations.</p>
Significance (with mitigation)	Negligible

3.4 INSTALLATION OF CYCLE STORE WITHIN RPA

Affected Trees Cat. C: T3 (Acer campestre)

Impact Appraisal & Mitigation	<p>A new cycle store is proposed on virgin ground within the RPA of T3. To prevent the need for excavation within the rooting area, a no-dig foundation should be used.</p> <p><i>The foundation of the cycle store should consist of a no-dig concrete slab cast atop the existing ground level (this must be cast atop an impermeable membrane to prevent chemical damage to the surrounding tree roots).</i></p>
Significance (with mitigation)	Negligible

3.5 INSTALLATION OF FLAG POLES

Affected Trees Cat. C: T2 (Laburnum anagyroides)

Impact Appraisal & Mitigation	<p>A new flag pole is proposed within the RPA of T2. The installation of this will result in a <1% RPA incursion, and as such is not considered to result in any significant impact on the tree.</p>
Significance (with mitigation)	Negligible

1.5.1 It is recommended that at least 8x new tree plantings, and the planting of a new mixed native hedge along the site’s northern boundary are to be included within the landscaping of the site so as to mitigate against the proposed tree removals.

3.9.1.1 The foundation of the cycle store should consist of a no-dig concrete slab cast atop the existing ground level (this must be cast atop an impermeable membrane to prevent chemical damage to the surrounding tree roots).
