Heritage Statement

Home Farm House

Penton Mewsey

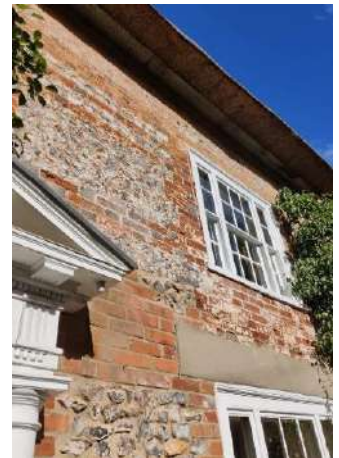
There are examples of large areas of later replacements/repairs with examples of standardised machine-cut brickwork and replacement flints amongst the historic brickwork. There are also large areas of cement mortar repairs that have led to the deterioration of the older areas of brickwork including blown faces.

Figure 73 Large areas of 20th century repairs and replacements.

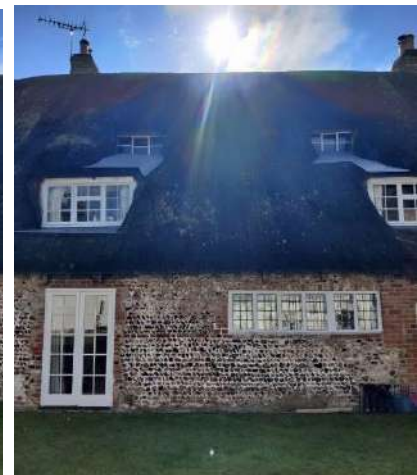
The next two bays form the early 18th-century core of the property. The flint walls differ from the flint work to the front elevation as do the details, it appears likely that this is an area of late 19th-century flintwork with large areas of 20th-century flint and brick replacements. The windows in this section are predominantly 20th-century additions/replacements except for the long timber window with smaller leaded lights which may date from the late 19th century and the Hampshire casement dormer windows which appear to be original. The door appears to be a 20th-century addition and the porch was built in 1997. There is no evidence of 18th-century fabric on this elevation at ground floor level.

Figure 86 Early 18th century core of the property. Flint walls with large areas of 20th century flint and brick replacements.

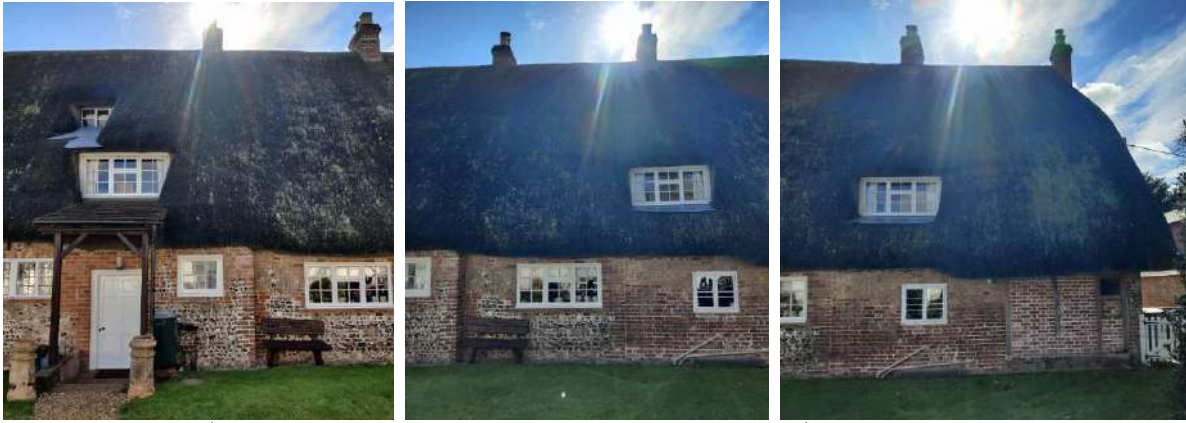
Figure 87 Early 18th century core of the property. Flint walls with large areas of 20th century flint and brick replacements.
 Figure 88 Early 19th century section of the property. The flintwork matches the majority of the north elevation suggesting a period of refacing assumed 19th century. This area has large areas of 20th century flint and brick replacements.
 Figure 89 Early 19th century section of the property. Complete refacing in 19th century Flemish Bond brickwork.
 Figure 90 Early 19th century extension of property. Timber framing with Flemish bond brick infill panel.

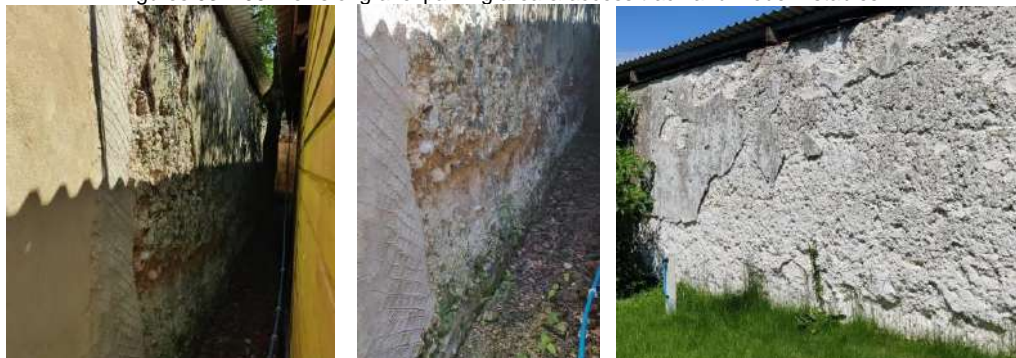
Figures 96 – 98 Views of poor historic wall condition

Beyond the parking area, there are gardens and planting beds which are divided from the parking area by modern fencing and brickwork. The north more areas of the garden have the same footprint as the historic walled garden and are bounded on the north, east, and areas of the west with the 19th-century cob, flint, and brick garden walls with some areas of render which is visible on early 19th century maps. The garden walls in this area are in very poor and even dangerous condition.

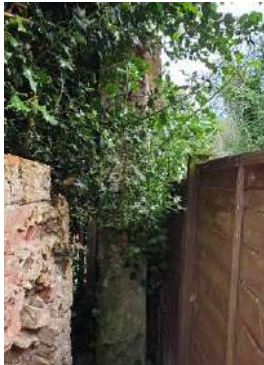
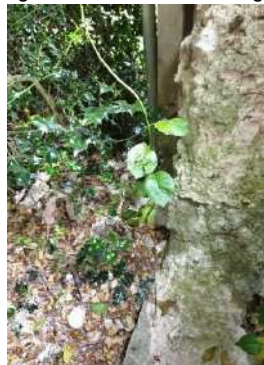
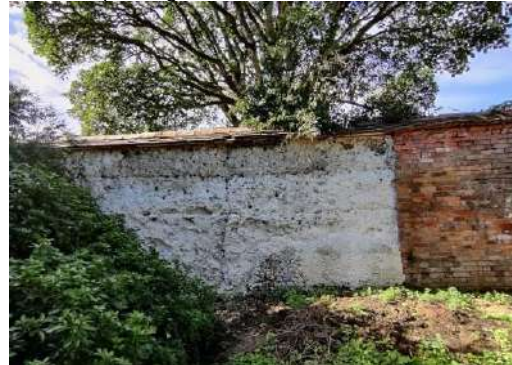
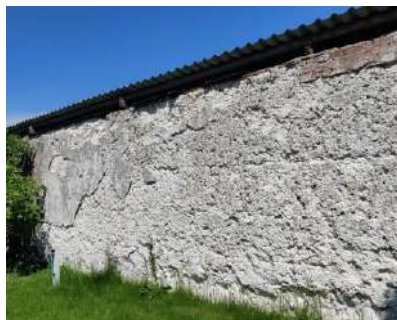
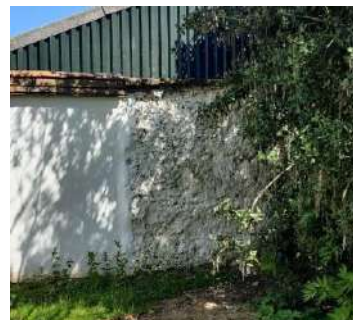
There are examples of inappropriate repairs causing ongoing deterioration to the historic fabric including blown faces, loss of mortar and lime rendering, and in some areas collapse. It is proposed as part of the proposals to complete sensitive internal and external repairs including to the historic garden walls.

Figures 102 – 106 Views of poor condition historic garden walls

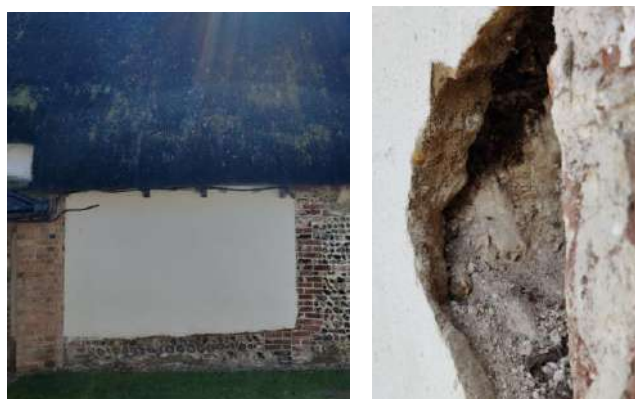
The render and the wall fabric are in very poor condition and there is water ingress and damage where water has entered above the render, through a crack in the render, and via holes created for modern cable runs. The water has become trapped behind the non-breathable render finish and internally the whole wall is saturated with damp. Internally areas of the internal finish are cracking and falling away. The damp has also tracked through to the games room wall which forms the historically external wall of the early 18th-century core and is causing deterioration to the fabric of the wall as well. High levels of damp and saturation were recorded with a damp meter on both walls. The proposals will involve the removal of the inappropriate render.

Figure 119 Image of area of wall for new fire door
 Figure 120 Scope survey of missing area of cement render showing poor condition fabric behind

An opening will be created through the wall which will result in the removal of 2m² of fabric which material evidence and the scope camera survey indicate has been at least partially repaired and replaced in the 20th century. The proposed door will be a traditional timber stable door style with areas of glazing to allow more light into the room. The remainder of the historic wall (approx. 5.2 m²), having been sensitively repaired, will then be retained, and exposed as a feature wall in the new extension.

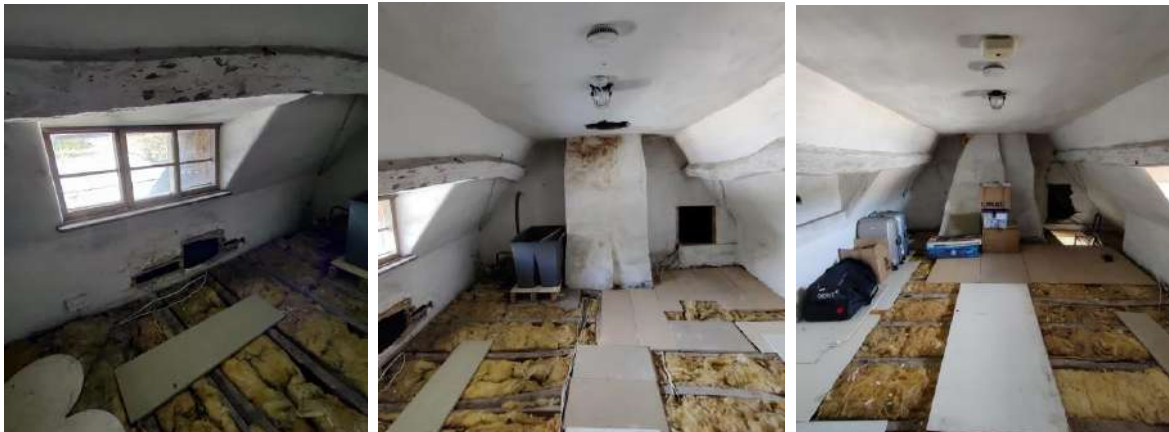
The fabric in these rooms is in fair condition with some large areas of fabric loss from the lath and plaster ceilings and walls and some areas of water ingress and damage, particularly on the chimneys. It is proposed to complete repairs throughout the attic rooms to protect the fabric from further deterioration and offset the impact of other areas of the proposals. It is hoped that the benefits of bringing these historic rooms back into use and carrying out essential repairs to the historic fabric will help to offset some of the impacts of the proposals. The existing Hampshire casement dormer windows will be retained as existing and sensitively repaired as part of the proposals.

Figures 127 – 129 Images of Attic including areas of lost and damaged fabric

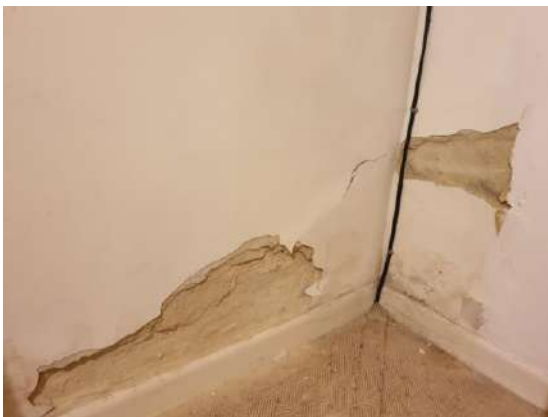
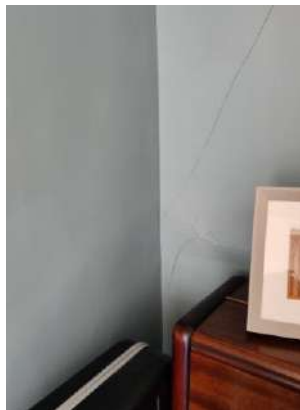
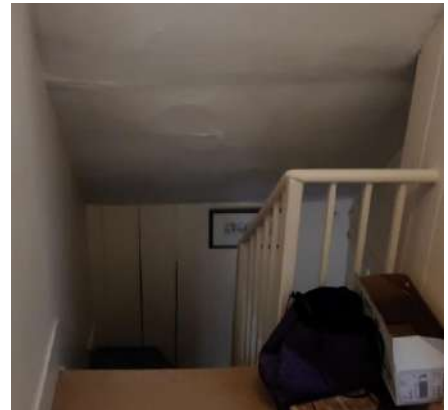
Figure 140 Damaged plaster in Games Room
Figure 141 Cracking in north wall of Dining Room
Figure 142 Crumbling and cracking of ceiling above staircase

In order to offset the less than substantial harm created by the proposals, it is proposed that sensitive repair works be completed both within the historic property and the site in order to combat and reverse the deterioration caused by modern interventions and protect the property for the future.

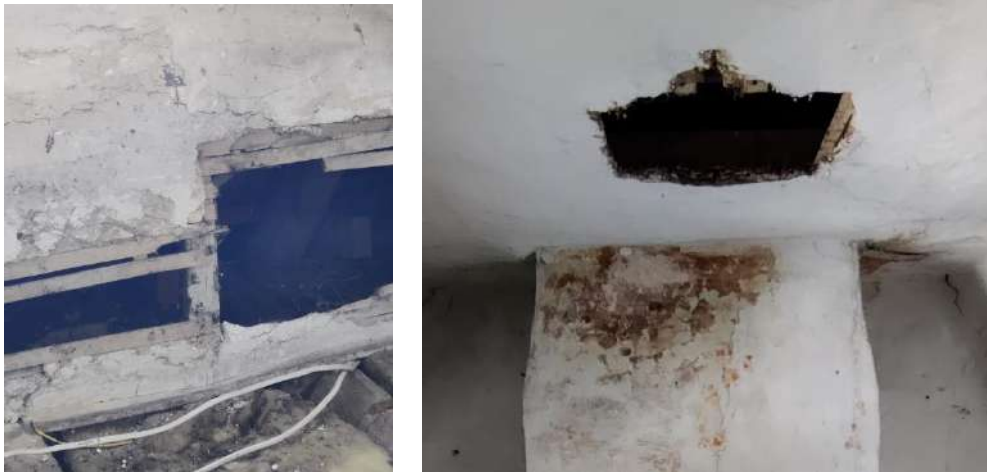
Figure 143 & 144 Missing areas of lath and plaster and water damage in Attic space

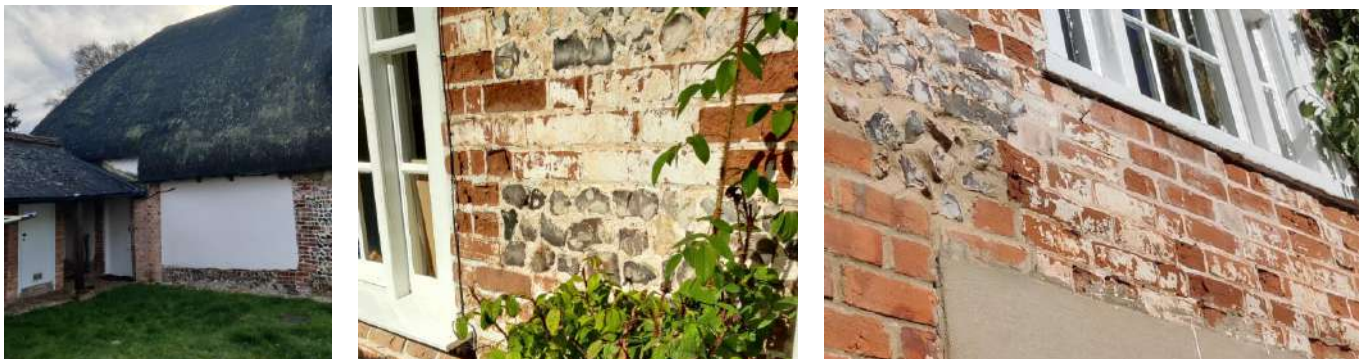
Figure 145 Cement rendered area on north elevation
Figure 146 & 147 Areas of blown faced brickwork
