Arboricultural Report

Proposed development at
Acre Wood
Tower Road
Aylmerton
Norfolk

21st April 2023

**Acre Wood, Tower Road
Aylmerton**

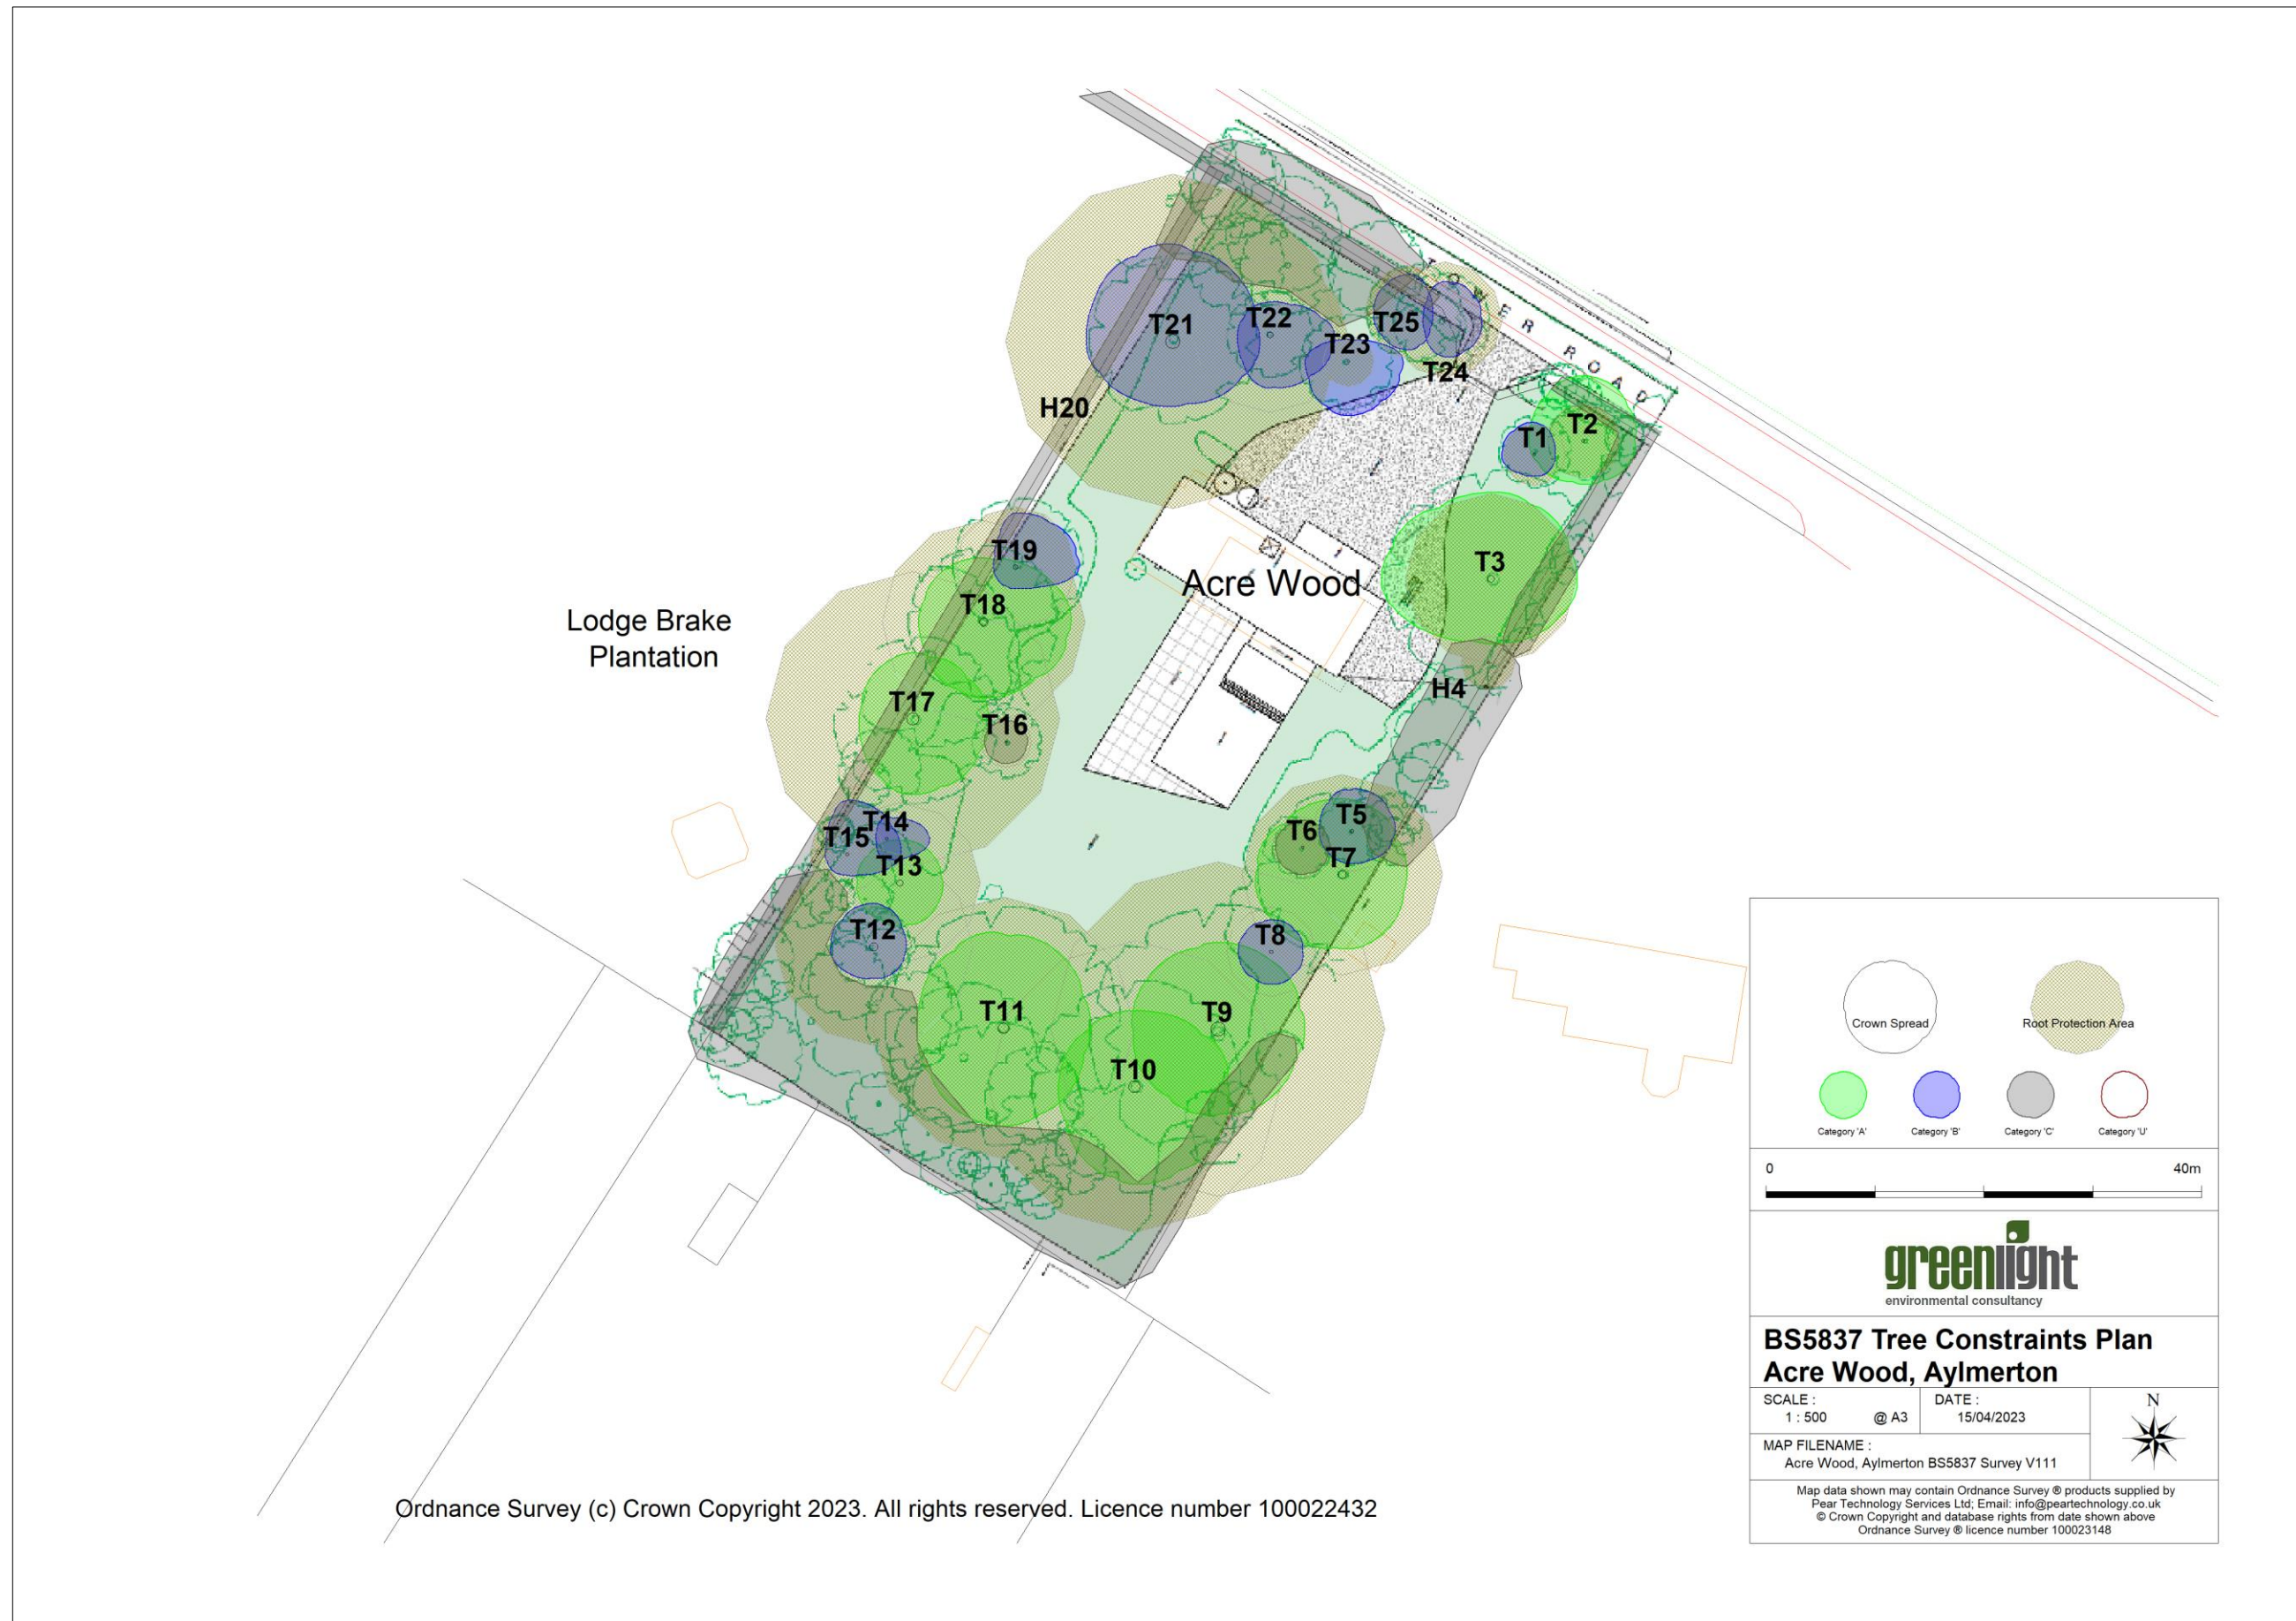
Figure 3: Tree Constraints Plan

- 5.10 The Tree Constraints Plan in Figure 3 shows the distance that construction should normally be kept away from retained trees to provide the Root Protection Area (RPA) recommended in BS 5837: 2012. Full protection of the RPAs should normally be reinforced by creating Construction Exclusion Zones through the erection of protective fencing constructed to at least a minimum standard as prescribed in BS 5837: 2012 and described in the Arboricultural Method Statement. This fencing should carry warning notices to prevent inadvertent encroachment. A suggested line for the erection of protective fencing is shown in the tree protection plan.
- 5.11 An arboricultural method statement in Appendix D and tree protection plan in Appendix E provide further guidance for protecting trees during construction. This guidance may be amended should the proposed design be altered.

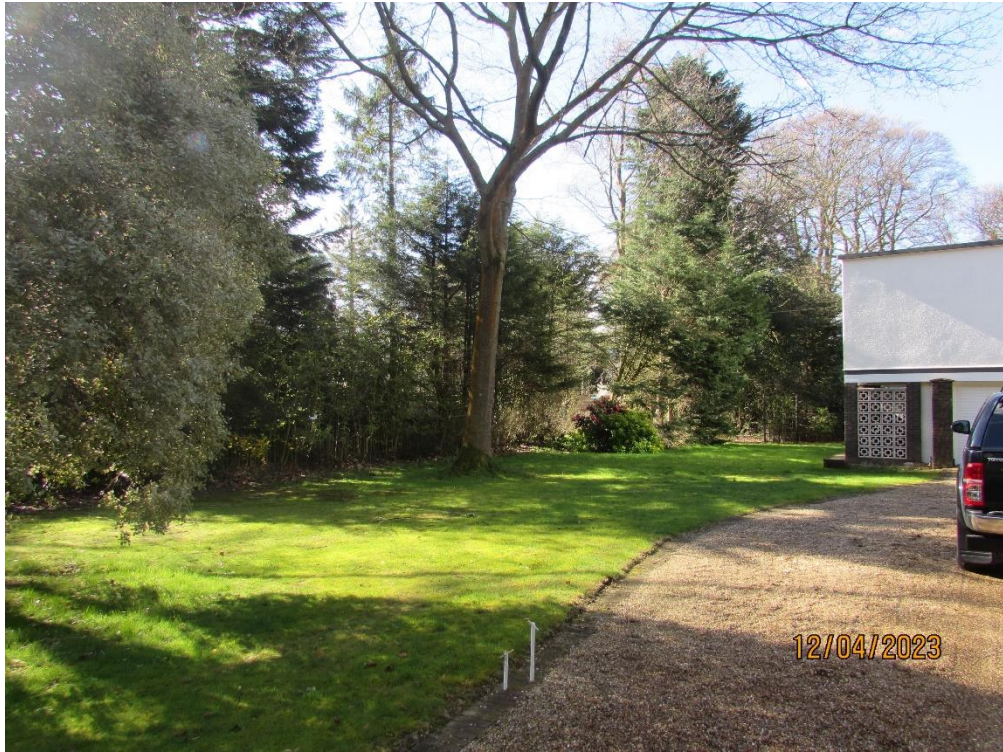
- 5.5 There is below ground encroachment into the Root Protection Area (RPA) of the retained tree T3, a category A red oak where the driveway is to be widened and extended. This driveway will adopt the use of No-Dig construction techniques with a cellular containment load bearing structure and a permeable surfacing layer. The encroachment extends to less than 17% of the RPA and remains within the tolerances of the British Standard. Impacts will be minimal.

Area where driveway is to be widened adjacent T3

9. No excavation is allowed in the areas shown cross hatched in orange on the Tree Protection Plan and a No-Dig method of construction for hard surfacing installation is required.

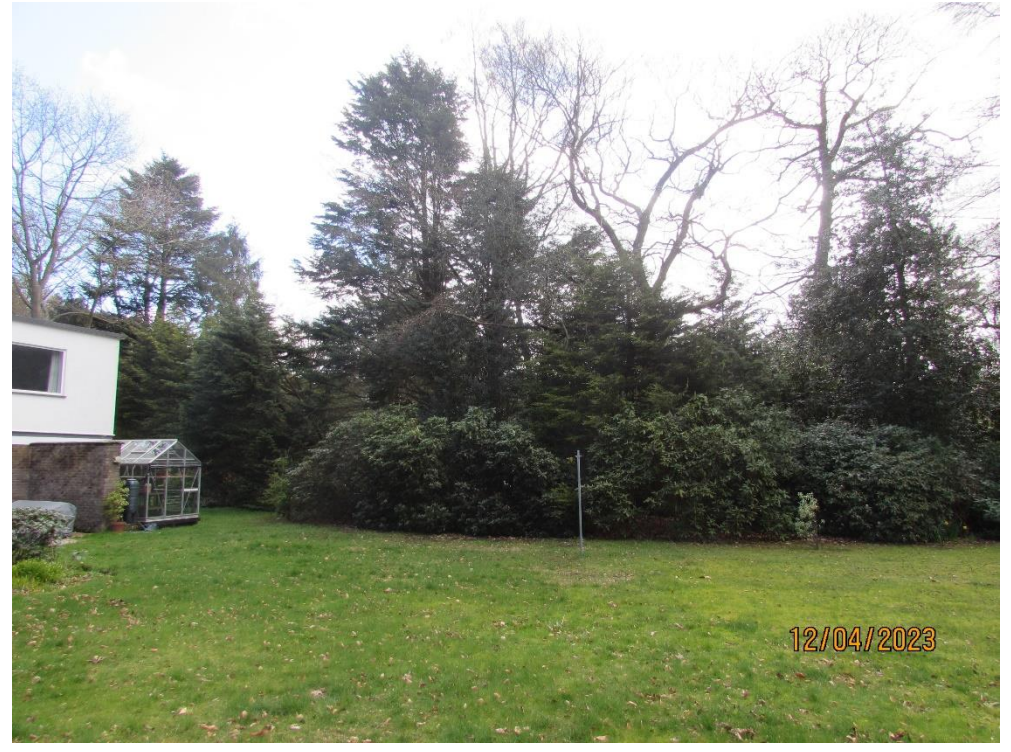
Trees T4-T6 over rhododendron border
