Job: Hill Farmhouse, Drinkstone, Bury St Edmunds
Job No: 7536
Client: Mr and Mrs Slattery
Date: 18/07/2023

Design and Access/Historic Statement

Proposed Soleplate Replacement

Hill Farmhouse

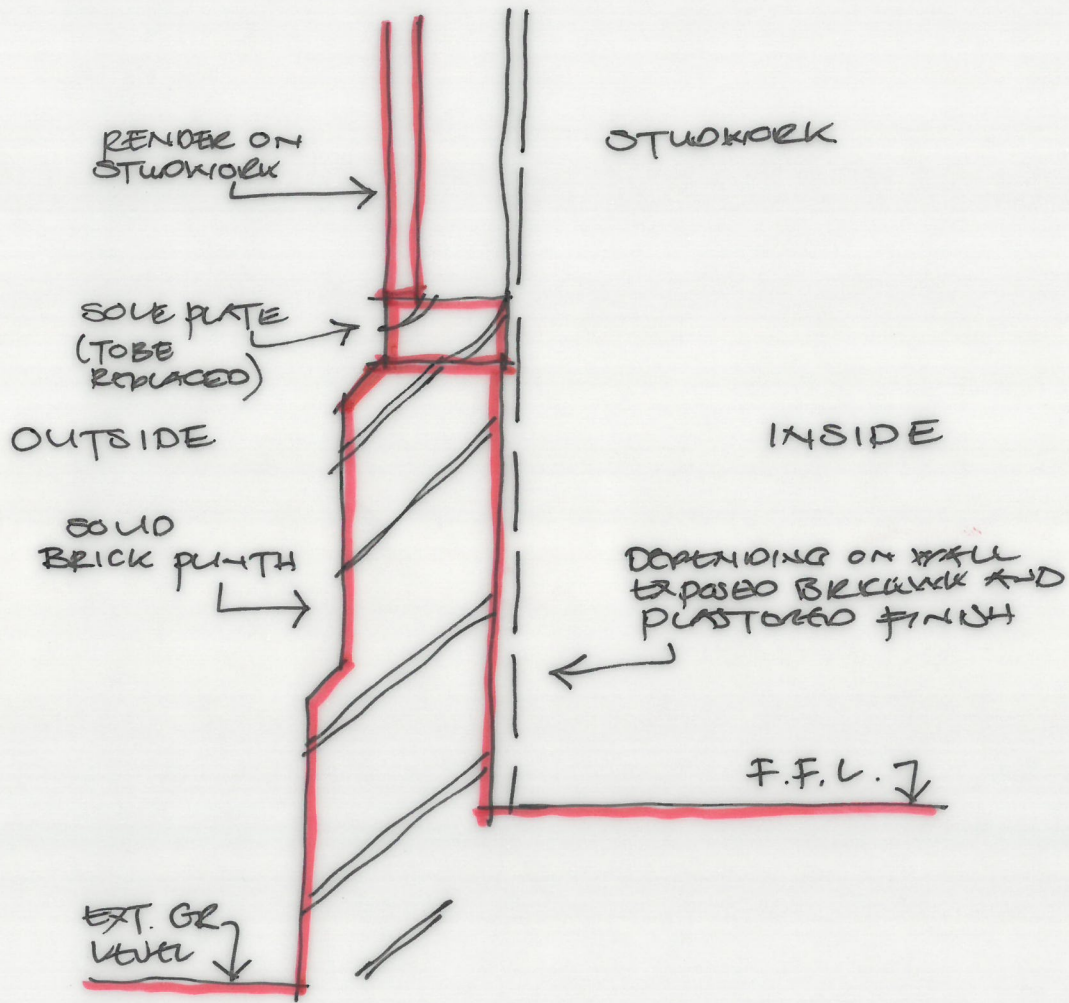
SOLE PLATE PROFILE
1:10 (ATAA)

We attach a photograph of the main front elevation from the south west view (1) which clearly indicates the soleplate (probably oak) is set on a double cant brick plinth – see sketch attached of profile. The plate is visible inside in some spaces and is painted black externally which appears to be bitumous paint. The plate has clear signs of rot and existing wood pegs have/are falling out (18,19) and rotting away. Attach photographs of full length of the exposed plate (2-11). The plate is in some locations filled with cement mortar (12-14). As indicated from inspections with a screwdriver the plate is severely rotten in many parts as shown in the photographs taken on site (15-17).

The soleplate would be replaced in oak in 4/5 metre sections. Render would be removed to allow the timber frame to be held in position with needles, probably at level just above the ground floor windows. Once stable, a row or two rows of bricks would be removed below the plate. These would be removed, cleaned down and stacked for re-use. This would allow the soleplate to be carefully removed, retaining studs and where condition allows their mortice connection into the sole plate. The new oak soleplate would be set into the wall with stud positions marked to allow the studs to be morticed into the new oak soleplate. Once these are formed the soleplate would be set into place and re-doweled with oak dowels where these originally existed. Once set into place, the top of the wall would be reformed with existing bricks or if not fully re-usable, bricks to match the existing. Between the soleplate and the brickwork is proposed a natural slate dpc bedded course to give some protection and longevity to the sole plate. All set in a lime mortar to match the existing.

The soleplate as indicated would be completed in 4/5 metre lengths with a 225mm lapping for a mortice joint at junctions of the construction with 2 no 1/2" dowels set into the jointing positions of the wall plate. Once the wall plate is located and completed the wall would be re-rendered and re-decorated with material and form to match the existing. Laths and plaster as the existing construction to be re-used or matched in material to the existing. Soleplate to remain undecorated unless otherwise agreed with the Historic Officer.

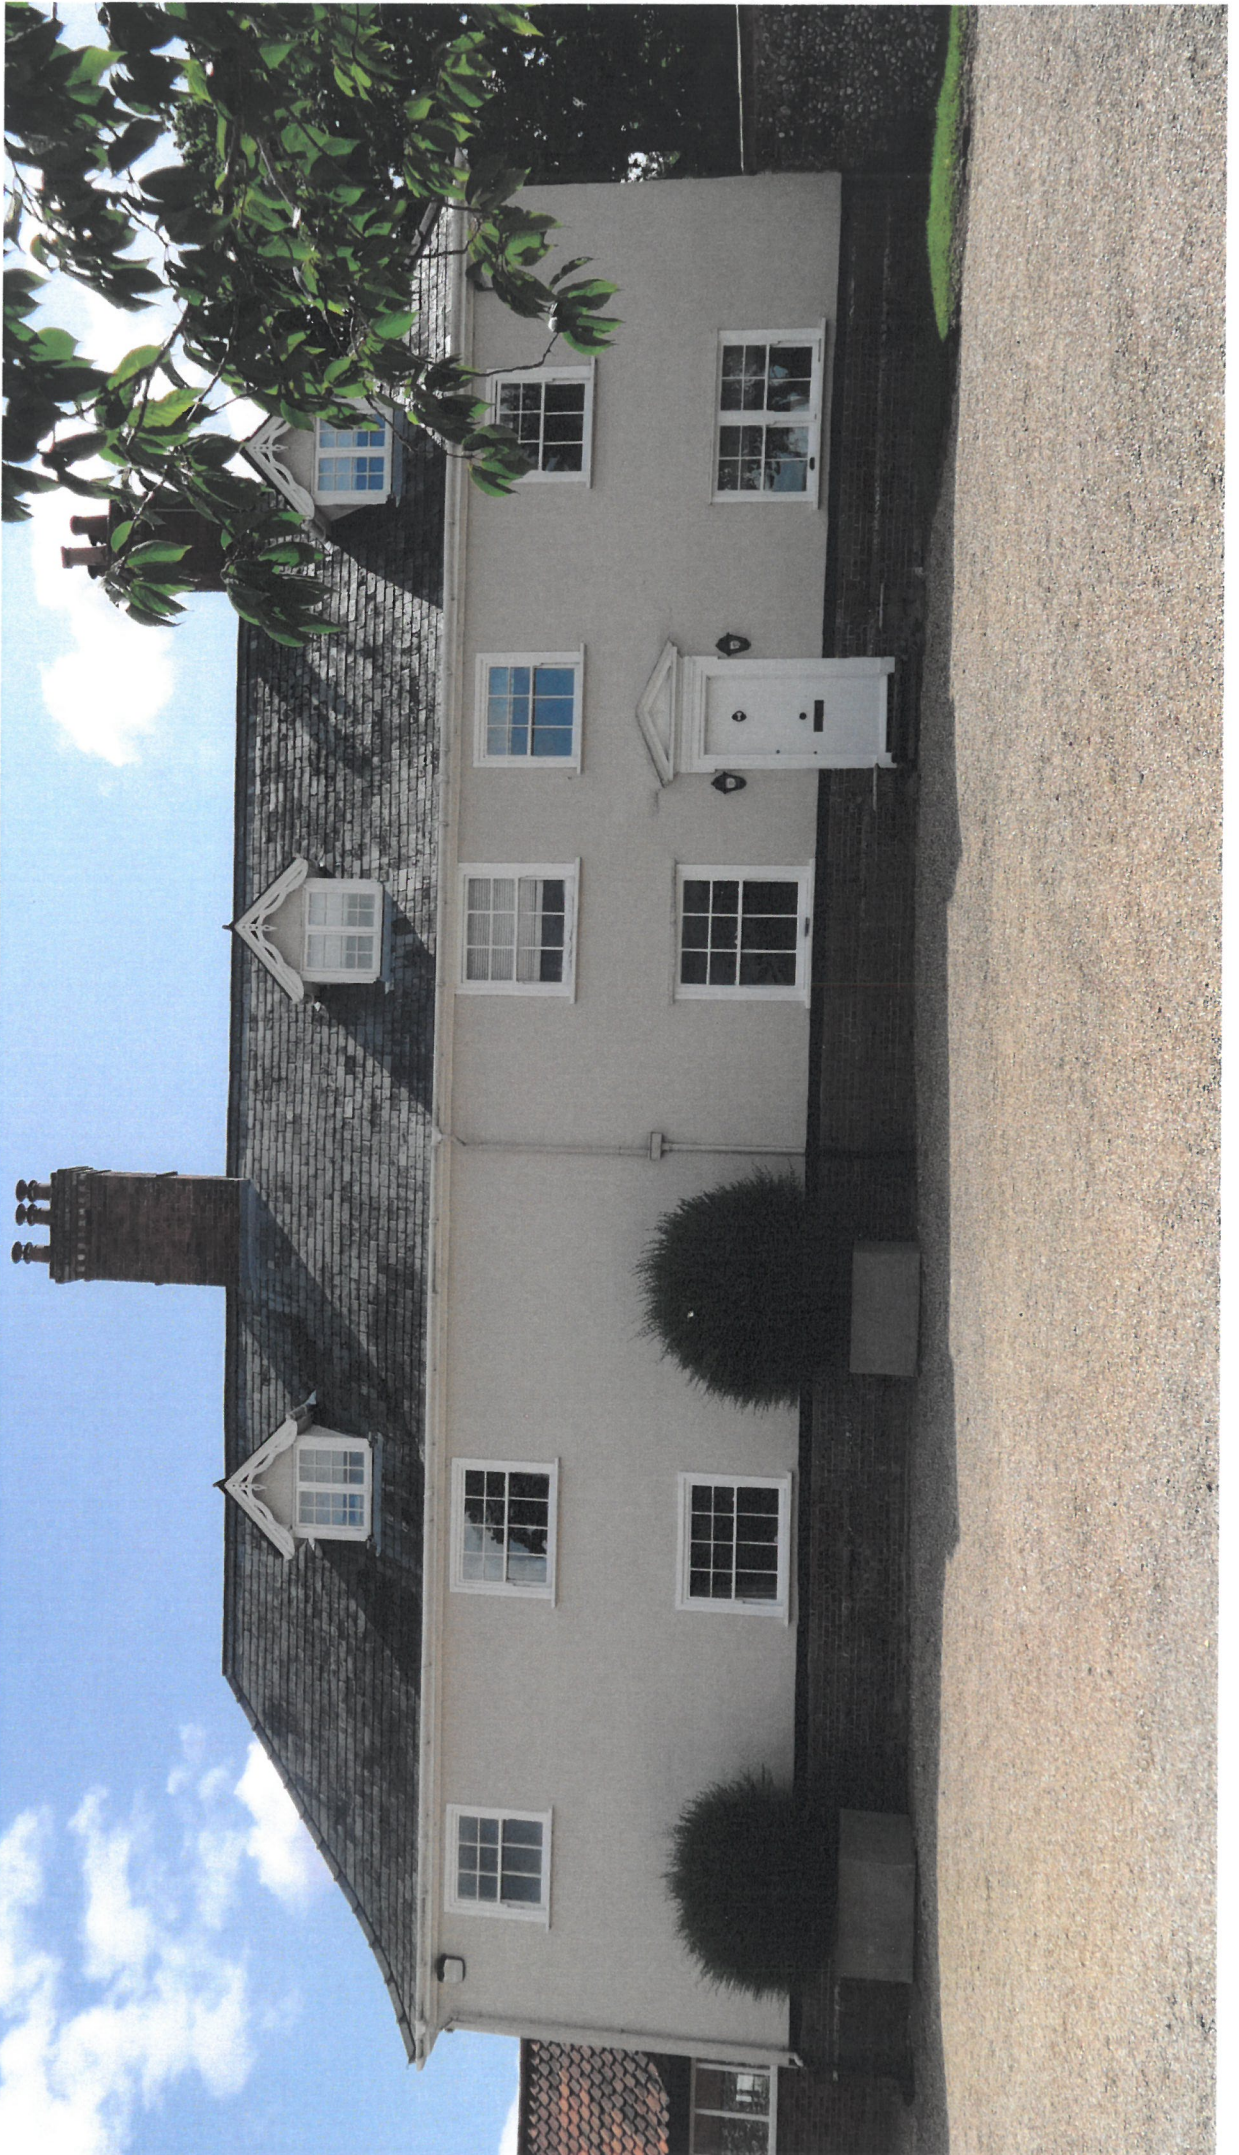
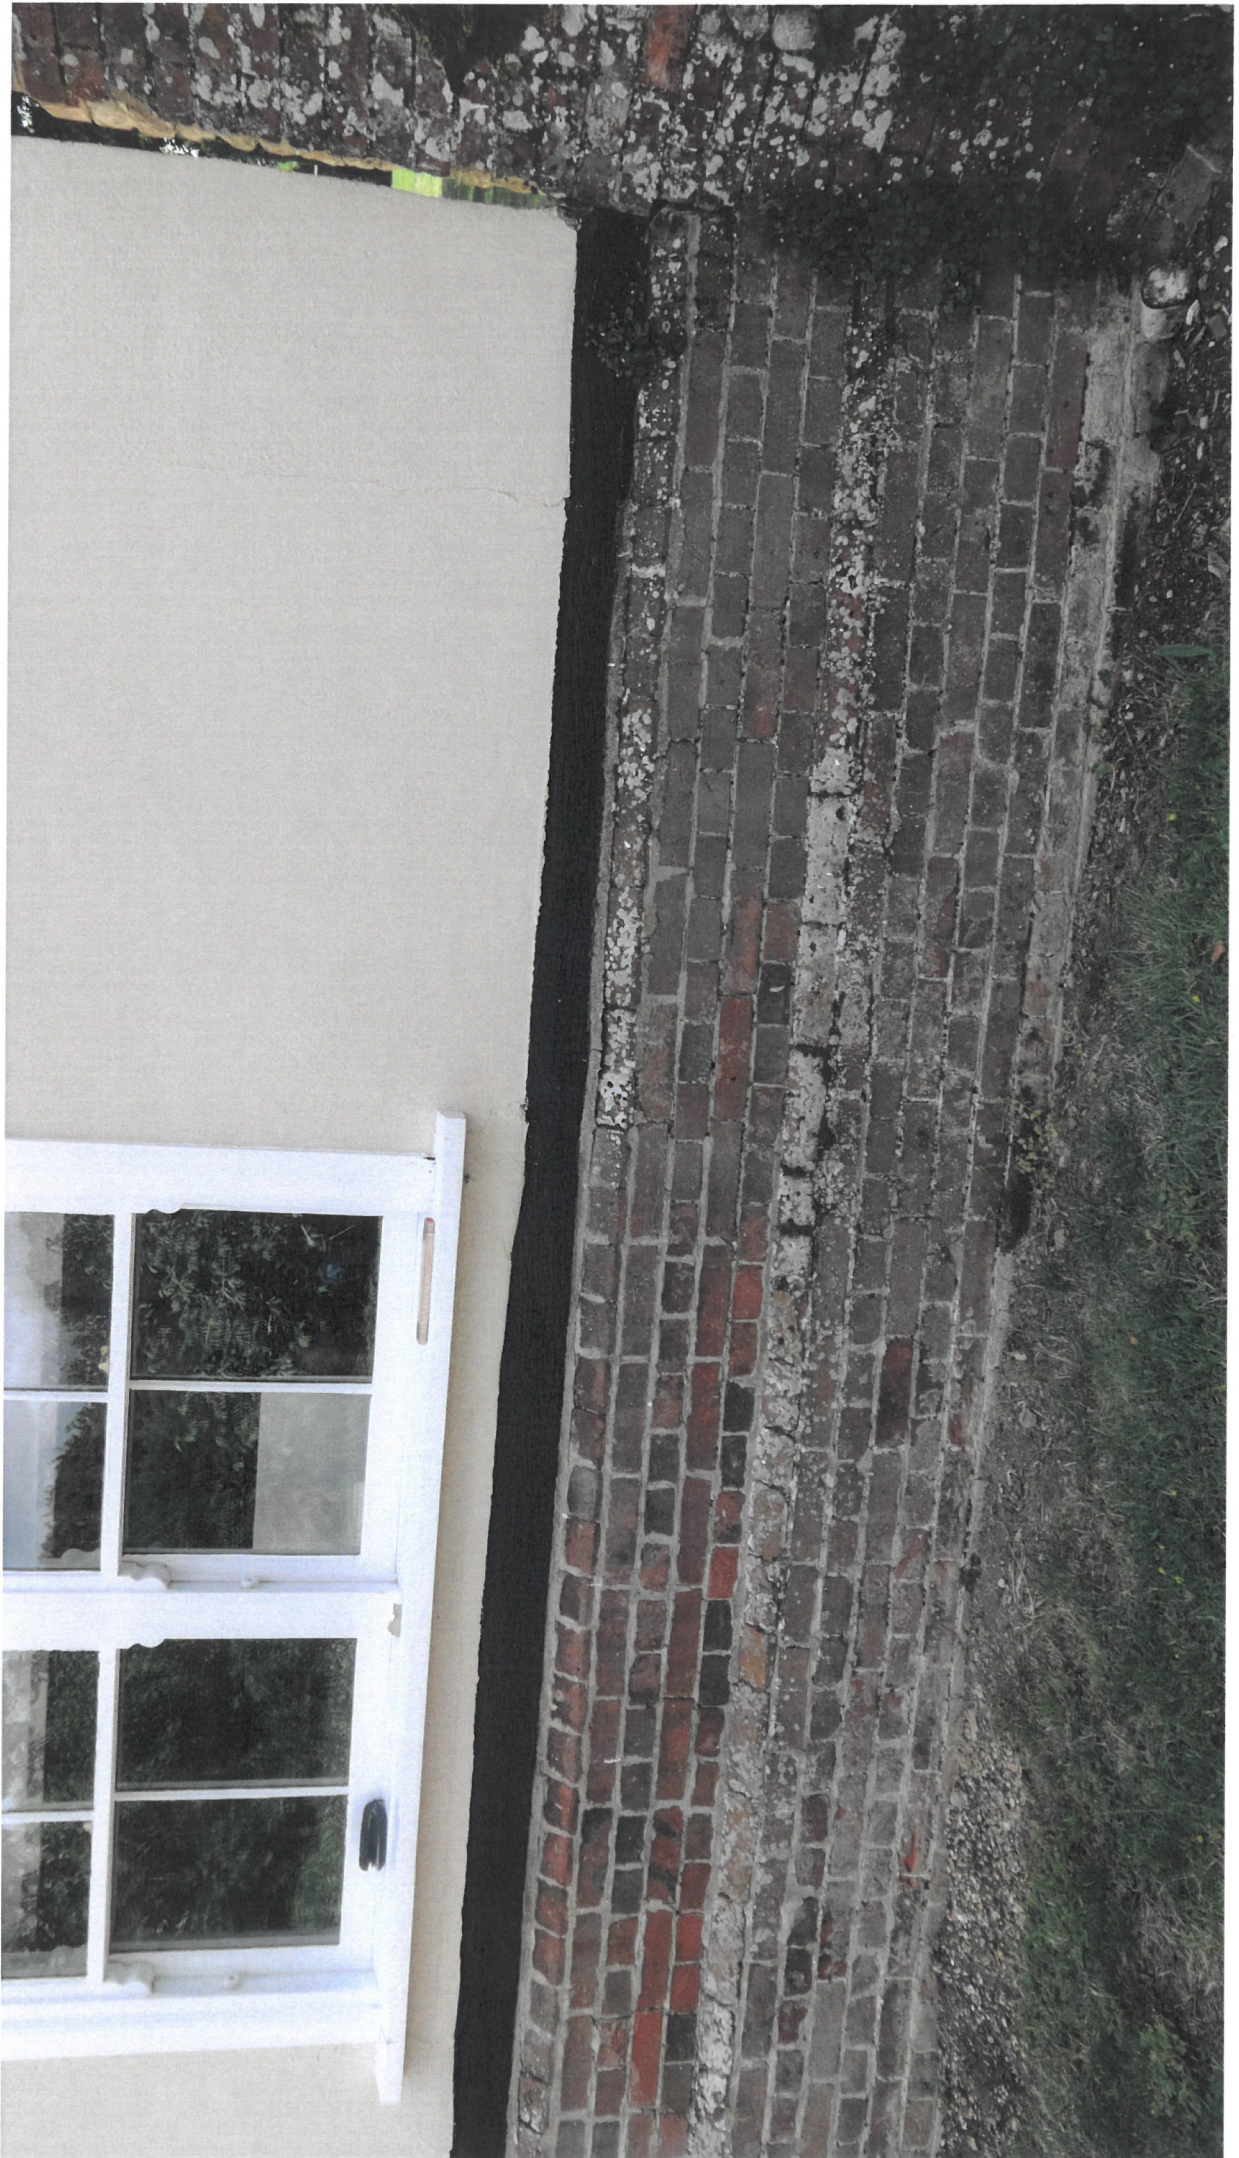
The plate also has unsympathetic repair work completed with scarf ended (18) joints rather than mortice jointed.

Proposals are to remove the soleplate along its whole length on the south-west elevation. This to be replaced with a section of oak to the same dimensions as the existing in oak.
