# Historical building survey and impact statement

This Heritage Statement has been prepared to support an application for Listed Building Consent and Full Planning Permission for the repair and renovation of the grade 2 listed farmhouse known as Polanguy (No. 1310216, 17/6/88). The proposal has been discussed at various stages with both the senior planning officer Matt Doble and the historic building officer Colin Buck. It has been through a preplanning application which included listed building advice (PA18/02618/PREAPP), and a separate historic building pre-application (PA19/01052/PREAPP).

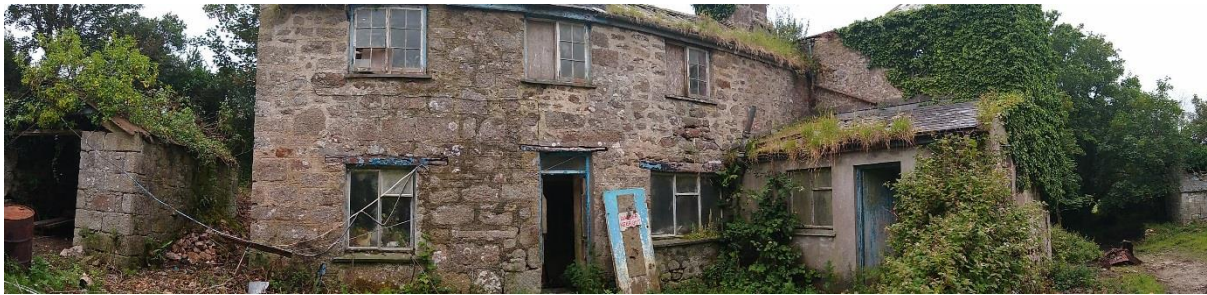
Fig 3 shows the northern elevation of the C17 farmhouse, with C20 block and render extension. The windows are a mixture of wooden 12 pane casements to the first floor and metal framed windows to the ground floor, and are all glazed with 4mm single pane glass. The front door is fibreboard. All lintels are timber and sills are slate. Guttering is a mix of plastic, cement, and profiled iron. The stone is pointed in cement and lime with patches of cement around the openings.

Figure 3 Showing the northern elevation of the C17 farmhouse

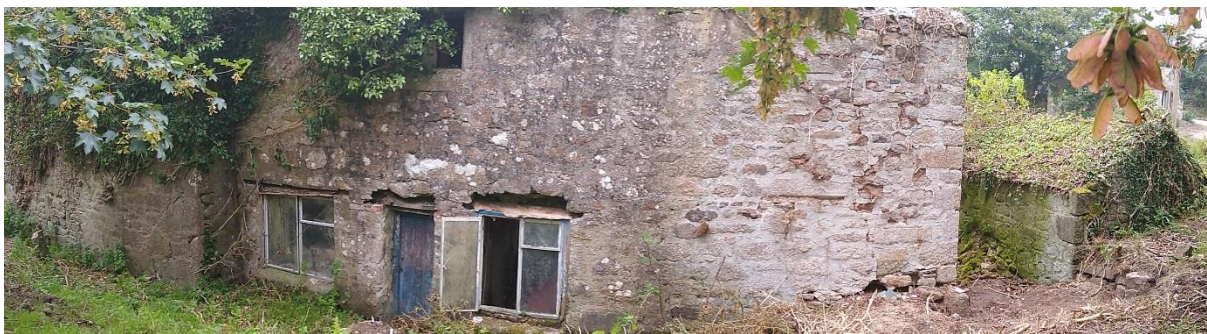
Figure 4 Showing the Southern elevation of the C17 farmhouse

The southern ground floor elevation (Fig 4) features a redundant timber vertically planked door and two C20 metal framed window, all with timber lintels. The door is plastered over on the inside, with ground level ~600mm above the sill on the outside. The lefthand window features a cement rendered sill, while the righthand window features a repurposed granite lintel as a sill. All three openings have been altered in relatively recent history; the door has brickwork on the returns, with the righthand window previously being a door opening (see fig 5 and 6). Repairs/alterations to the stonework above the openings are with cement mortar.

The previously stoned in doorway in the south elevation will be reopened, and fitted with a handmade 16 pane wooden narrow patio door. The external door on the south elevation will need replacing, and will be modelled on the existing vertically clad door. The missing door on the north elevation will match the 4 panelled door with overlight on the west elevation. The door to the block extension will be replaced with a simple vertically clad door, and this building will be painted off-white to imitate a simple limewash. All windows and doors will be painted grey blue in keeping with the existing colour scheme. All timber lintels and fascias will need replacing, and will be done so on a like for like basis. All existing guttering and downpipes will be replaced in half round steel, to match section of the original guttering found around the building. It is proposed that these external works (including the repair of significant features, and replacement of modern windows of low significance) will greatly enhance the aesthetics and significance of the building.

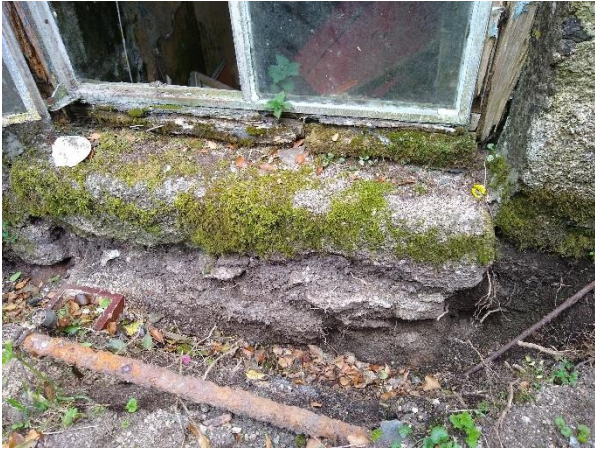
Figure 5 Infilled stonework and reused lintel below window on southern elevation

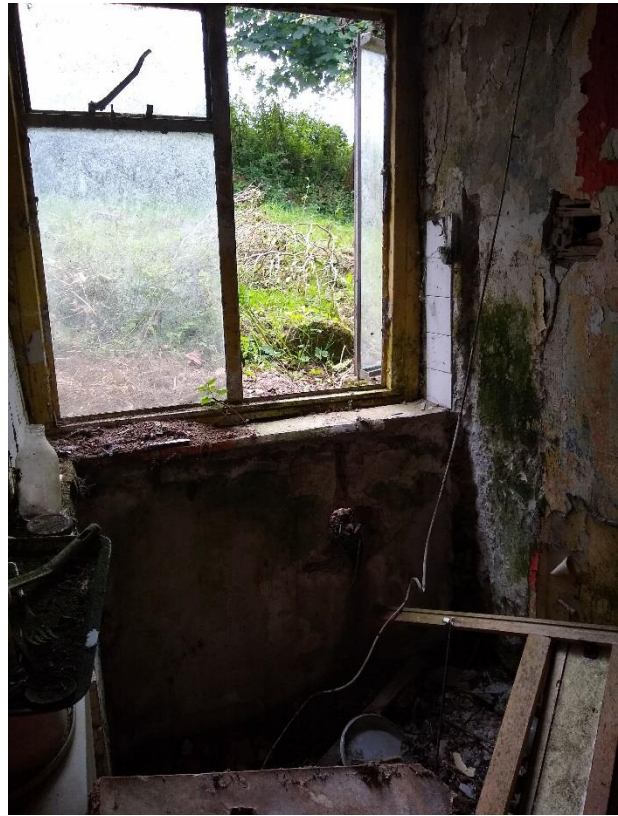
Figure 6 Cement render inside the infilled door opening on the southern elevation

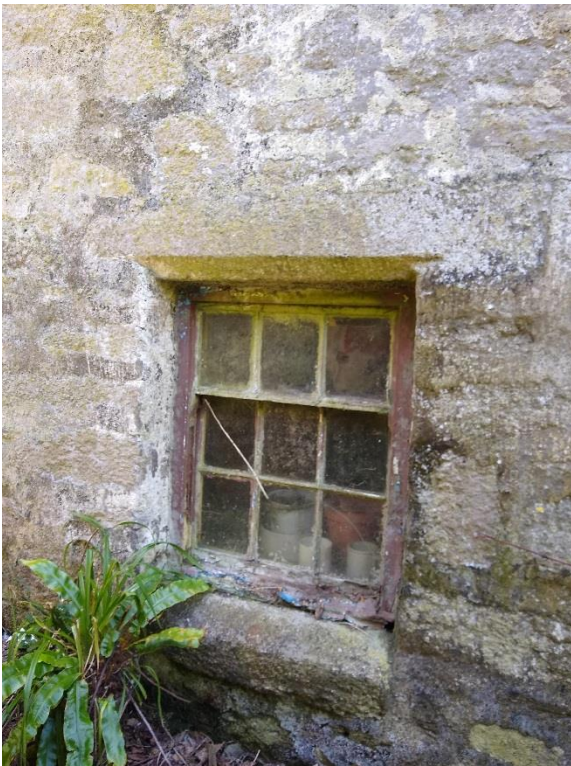
Figure 7 Window on eastern elevation and bag rubbed granite rubble walls

The first floor features an opening with granite pillar returns. The opening however is unlikely original as the lintel and sill feature the remains of mismatching mullions (fig 4). The Eastern elevation features a 9 pane sliding sash with chamfered granite lintel (fig 7). The external finish is a mixture of lime and cement pointing and bag rub.

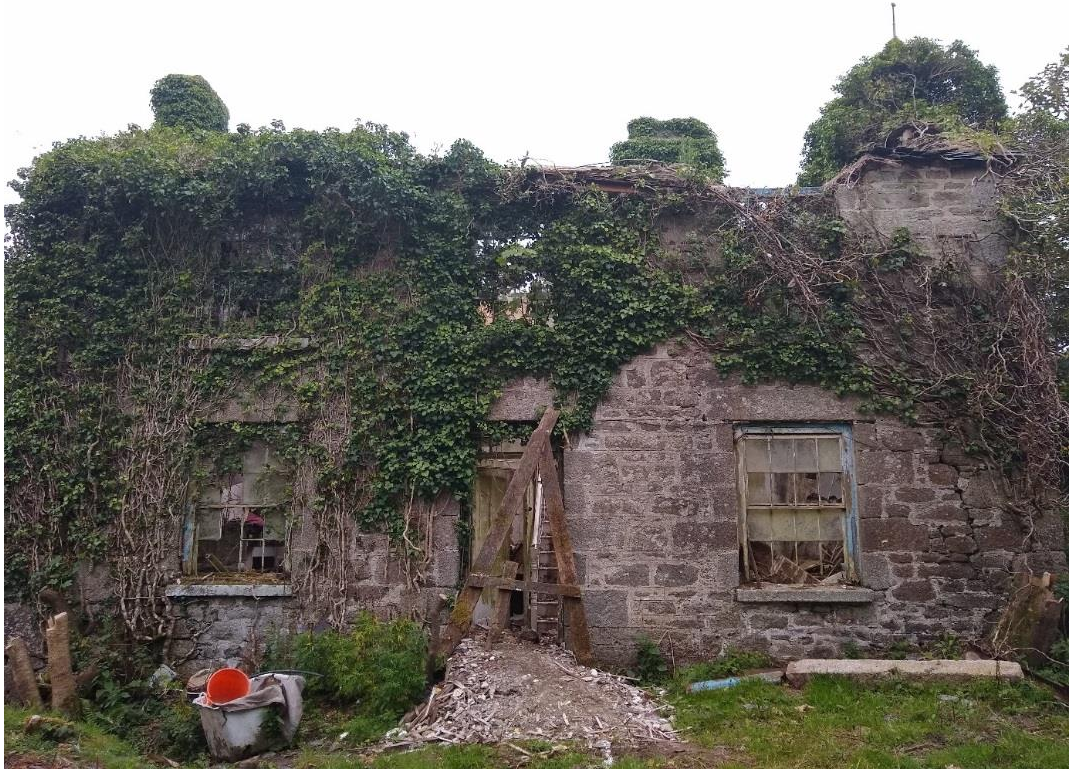
The C19 extension has gable end stacks with red brick shafts (fig 8). The western elevation has symmetrical early to mid C19 16-pane sashes (fig 9) and a central doorway (missing door) with rectangular overhead. All the windows and doorway have dressed granite lintels and the windows have granite sills. The back of this early to mid C19 range has one small 16-pane sash on the first floor to right. A C20 rendered block extension has been built in the northern return between the buildings. The massive stack at the junction of the two ranges is of dressed granite with granite weathering and capping. The roof, while collapsed in large sections, is scantle with patches of grout (fig 10).

*Figure 8 West Elevation of the C19 extension*

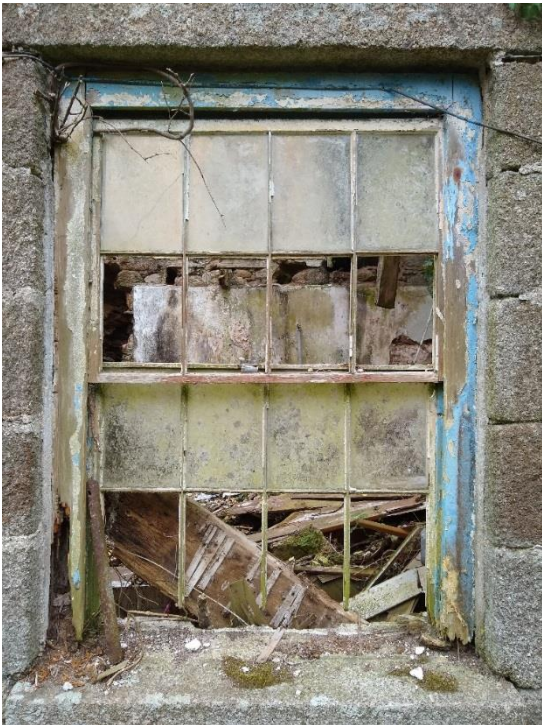
*Figure 9. 16 pane sash windows on west elevation*

The original C19 sash windows on the west elevation will be repaired where possible. Many parts will however need to be replaced, and these will be done so using the existing windows as template. The external door on this elevation will be a new 4 pane (upper panes glazed) to match the existing door which is badly damaged. The windows on the C19 east and south elevations and C17 east elevation will be repaired where necessary. The remaining C20 windows will be replaced with grey blue painted wooden casements based on the 12 pane existing windows on the C17 upper north elevation. All of the existing sash windows will be reglazed with appropriate single glazed panes where they are missing, while the new casements will be 10mm slime-lite. This is in line with guidelines issued by Historic England (Historic England, 2017).

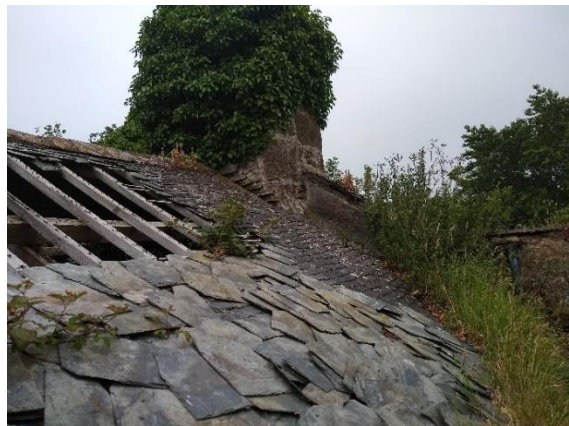
*Figure 10 Scantle roof and main stack*

The farmhouse is in an advanced state of disrepair. The proposed works are designed to enhance the asset through the repair and reinstatement of significant features, and ensure the longterm viability of the house. Externally the roof will be repaired where possible, but will in a large part need replacing. This will be done on a like for like basis as per Historic England guidance (English Heritage (2008), with the scantle being replaced with locally available slates on site. The walls, while in generally a good state of repair, will need significant repair work on the south west and north west corners, where two large trees have caused movement. It is likely that these are repairable with the use of helibars to stitch to joints. It is likely that most of the stonework will need repointing. Areas of blown bag rub on the south and east will also be removed and pointed. Although the current grout is a mixture of cement and lime in different colours, there are areas of yellow lime pointing on the north face. A good match for this will be a CLS28/11 blend in a 3:1 mix with natural hydraulic lime, which will be used throughout the building.

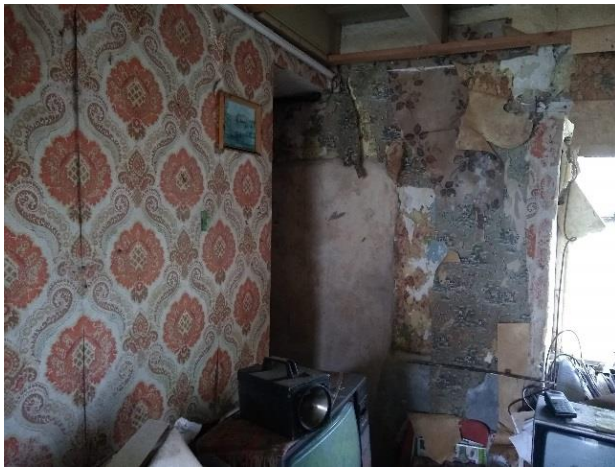
The southern external door to the C17 house has been plastered over with gypsum plaster (fig 11). The current position of the staircase also partially blocks this opening. A small fireplace on the south wall of the left-hand room has been filled in and plastered over. The walls are primarily lime plaster, with patches of cement. All internal subdividing walls are lathe and plaster throughout both the C17 and C19 parts of the house. The C17 kitchen also has the remains of a lathe and plaster ceiling, while the living room has had exposed painted softwood joists covered with fibreboard (partially collapsed). The ground floor ceilings are noticeably high (~2400mm). All floors are concrete with the remains of lino and carpet. Doors are four panelled painted softwood. The large hearth in the living room has a white tile surround (fig 12).

*Figure 11. C17 living room, showing the plastered over external door.*

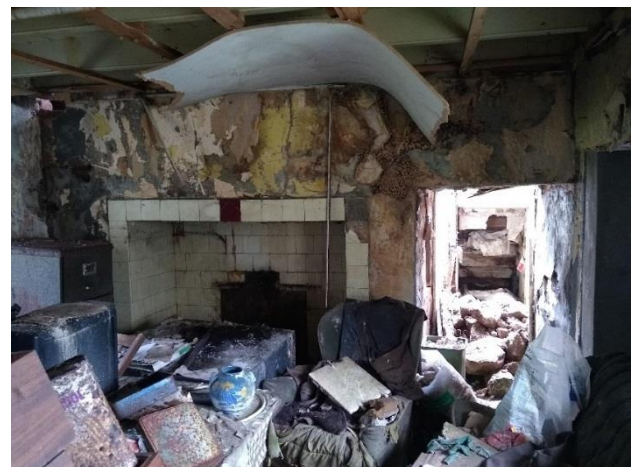
*Figure 12. C17 living room, showing main hearth and passage to C19 house*

The hearth in the existing C17 living room will be taken back to its original form and fitted with a large log burner. The blocked up fireplace in the kitchen will be reopened. All of the fireplaces upstairs will be reopened, even if not utilised.

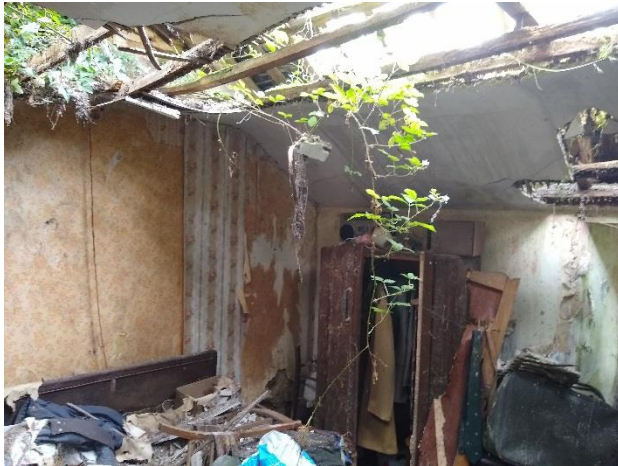
The first floor consists of a small landing accessing three bedrooms. Wooden floorboards throughout with lathe and plaster partitions and a lathe and plaster ceiling following the contours of the raised tie trusses (collapsed in many places, fig 12). The eastern room has a plastered over fireplace on its eastern wall. Roof trusses are simple nailed raised tie construction. Access to the C19 extension is through a walkway above the historic turret staircase on the SW corner. The stairwell has been infilled and covered with floorboards. On removal of the floorboards and some digging a section of slate tiled floor was discovered ~300mm lower than the existing floor (fig 14).

*Figure 13 Collapsed first floor ceiling in C17 house*

Despite the damage caused through the loss of sections of the roof, it is expected that most of the extant walls can be repaired rather than replaced. All repair work and any new sections will be on a like for like basis (lathe and lime plaster). Many of the first floor joists will need replacing, and the groundfloor ceilings will be left with exposed joists, plastered in-between. Much of the first floor will need replacing; this will be like for like with matching wooden floorboards, left exposed. On the groundfloor, the carpet and lino (over concrete) will be replaced with wooden boards, except for in the bathroom, and utility, which will be slate tile. This will allow for the installation of underfloor heating throughout the groundfloor of the building. While this will raise the floor level by ~120mm, this is compensated for by the relatively high ceilings created during the previous renovation. Upstairs will feature traditional column style radiators.

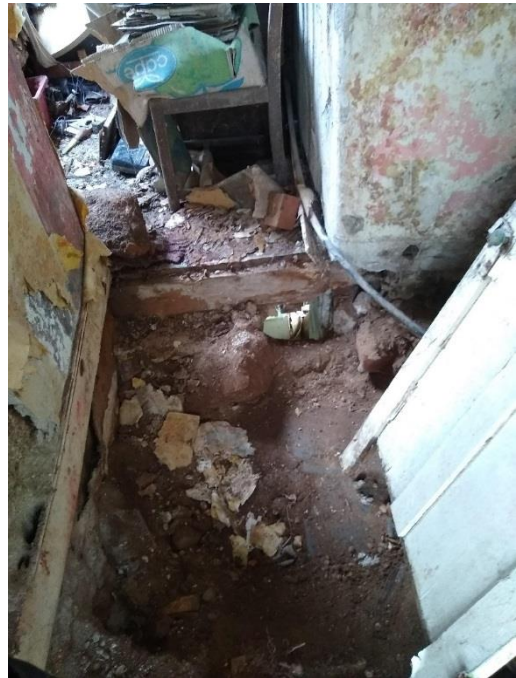
*Figure 14. Slate floor tiles around old stairwell in C17 house*

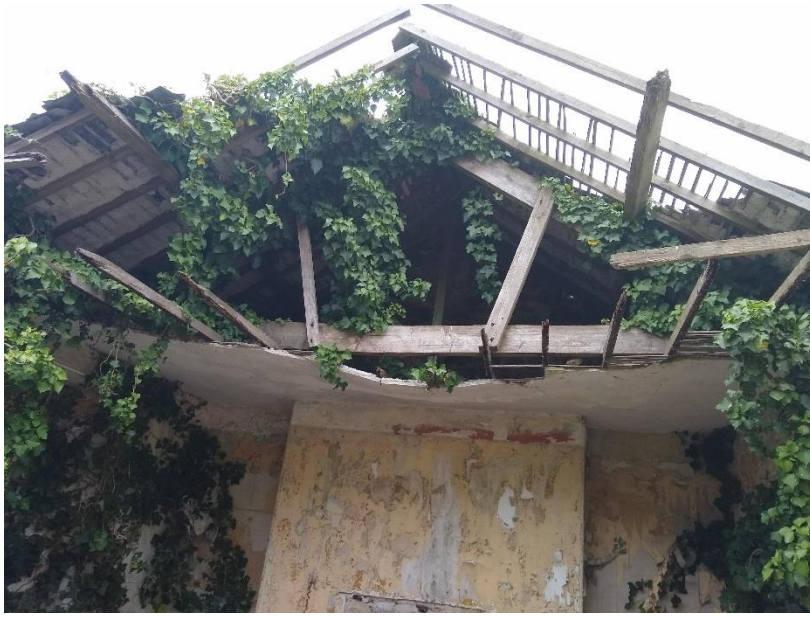
*Figure 19 Showing the remains of the roof and first floor ceiling in C19 house*
