Tree Survey Report

12 Cheshire Lane, Witham St Hughes

ATS-23-002

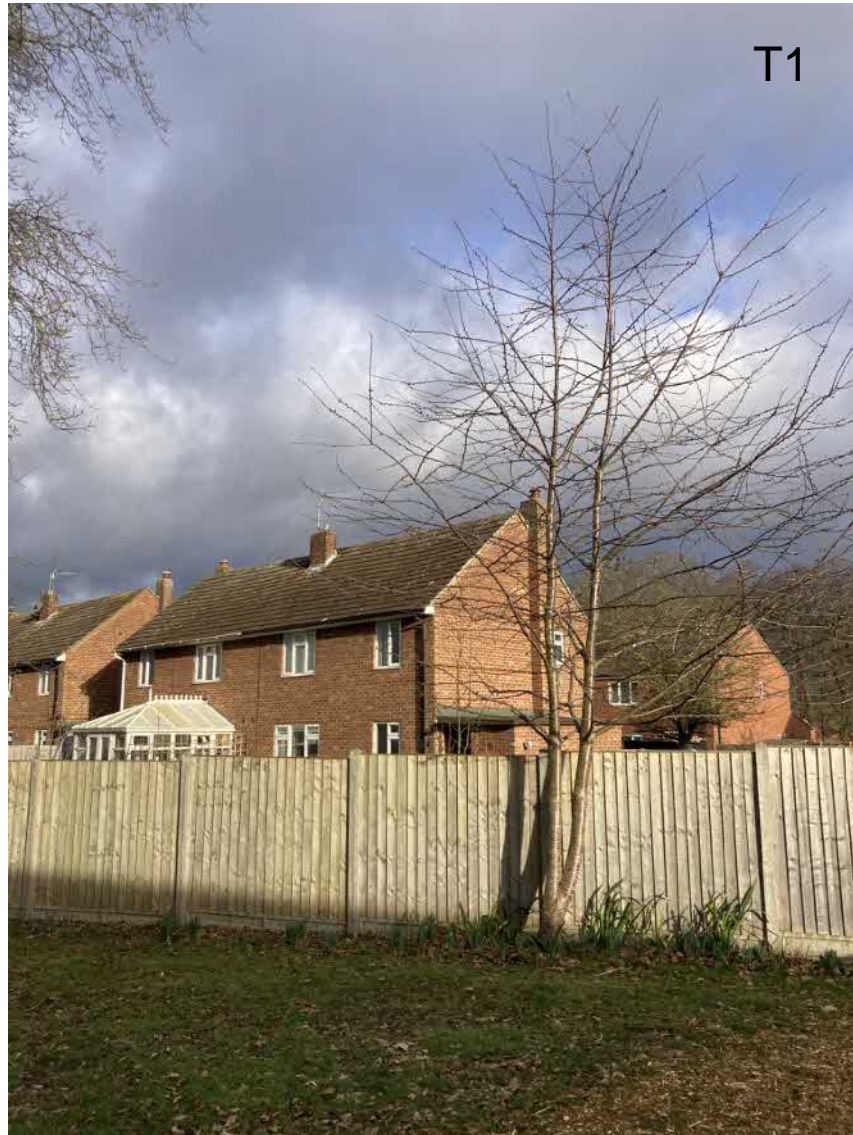
T1 (see image below) should be removed to accommodate the proposed development. T1 is a single self-set *Prunus avium* located close to the southern fenced boundary. T1 is in its early life stage and will not have been part of the original woodland which consists of mature trees (principally oak and pine). T1 is considered to be in retention category C1 due to its age and co-dominant stems

showing an included bark union at the base which has the potential to lead to structural failure in the future.

It is not clear whether T1 is included in the blanket TPO coverage of Area W1 of N745, Witham St Hughs 2017. In any case, permission will need to be sought from NKDC to remove T1. A replacement tree will be planted within the woodland to mitigate the loss of T1. No other trees are required to be removed.

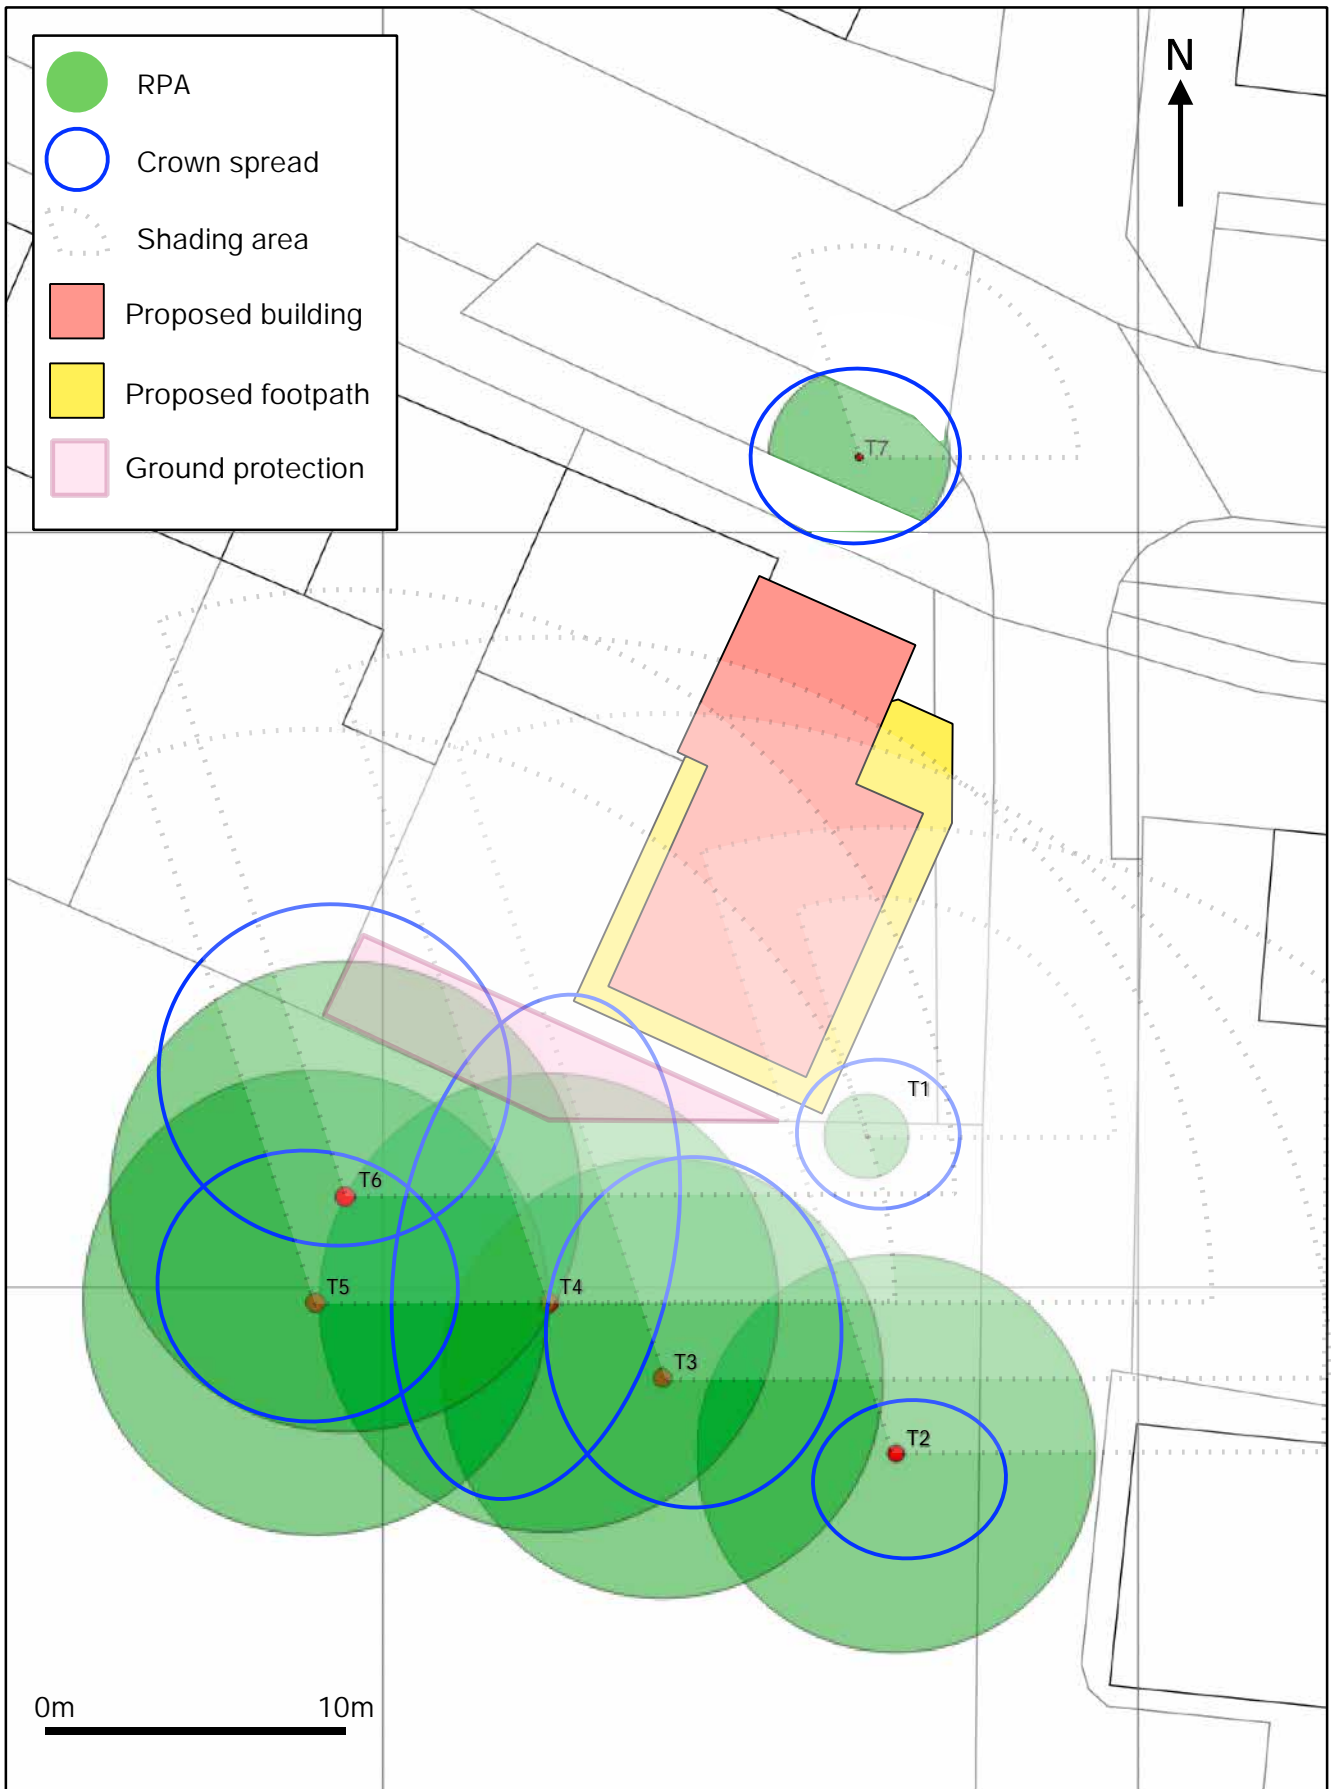
Appendix D - Tree Constraints Plan

To protect the root systems of T4 and T6, ground protection mats (magenta area in Appendix D) should be installed over the ground surface where the RPAs cross into the property boundary. These will help protect them from compaction caused by heavy vehicular traffic associated with the demolition and construction processes.

No materials will be stored within the RPAs of any tree shown in Appendix D. Attention is drawn to T7 at the front of the property, the RPA of which is shown as being constrained by the adjacent footpath and road to a grassed verge. No materials or vehicles will be stored or parked on this grassed area during construction.
