# Preliminary Ecological Appraisal and Preliminary Roost Assessment

# Lowdham Cars, Lowdham Road, Gunthorpe, Nottinghamshire, NG14 7ES Lowdham Cars

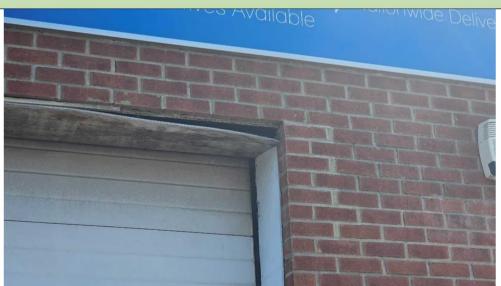
There is one gap above the large metal door on the western elevation where a wooden panel has come loose, possible through water damage. This gap could provide a roosting feature for crevice dwelling bats, however it is unlikely as this gap would be regularly disturbed by the metal door being accessed on a regular basis. There are lights above this doorway which would also deter bats from using this gap.

Close up of gap above doorway on the western elevation of B1 (pictured above)

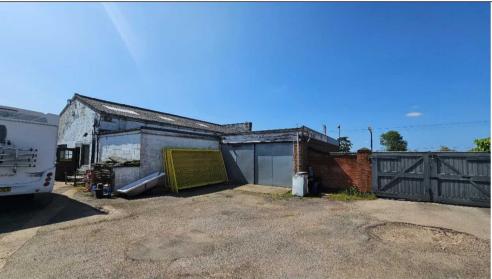
Northern and eastern elevations of B1 (pictured above).

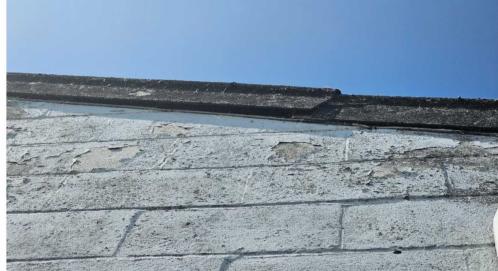
The bargeboards on the eastern elevation of B1 appear to be in poor condition as there is a lifted section which bats could roost underneath, however, there are a number of cobwebs covering the gap which could indicate a lack of recent disturbance by bats.

Close up of gap underneath bargeboard on eastern elevation of B1 (pictured above).

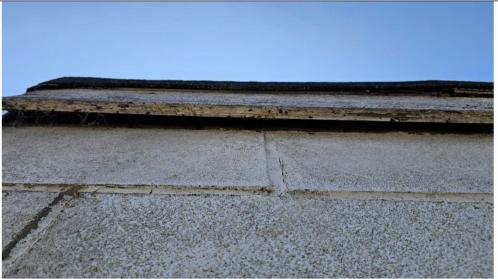
The soffits are constructed of a combination of wood and uPVC, the uPVC soffits on the northern elevation of B1 appears to be in fair condition, there is a section of uPVC missing from the north-west corner, however this does not create a roosting feature for bats to use. The wooden soffits appear to be in poor condition, as there is a large gap between the wall and the soffits in which bats could roost, however, upon closer inspection, a number of cobwebs cover the gap which could indicate a lack of recent disturbance by bats.

Close up of wooden soffit on northern elevation of B1 (pictured above).

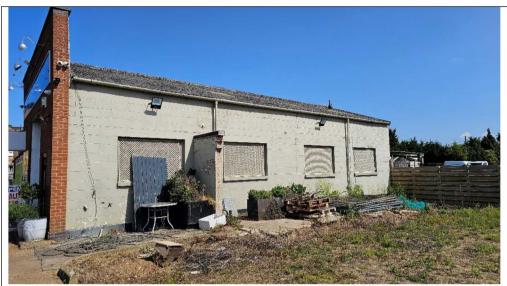
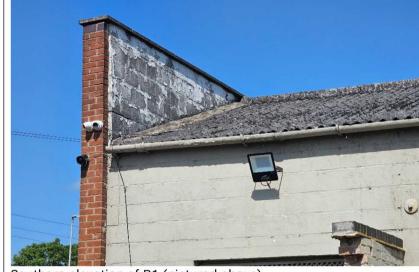
Southern elevation of B1 (pictured above).

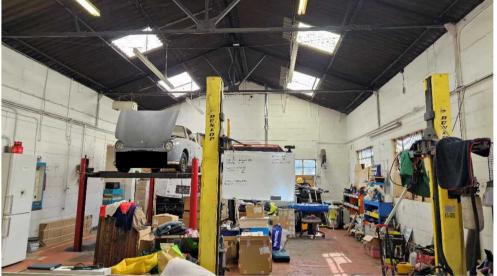
Interior of B1 (pictured above).

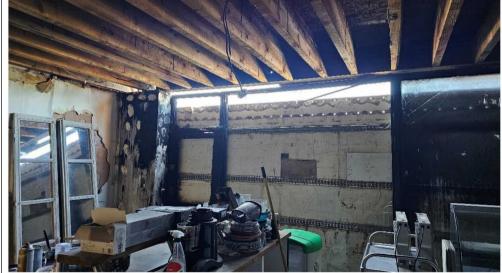
Interior of flat roof section of B1 (pictured above).

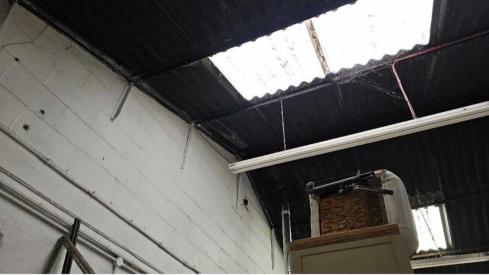
Interior of B1 (pictured above).

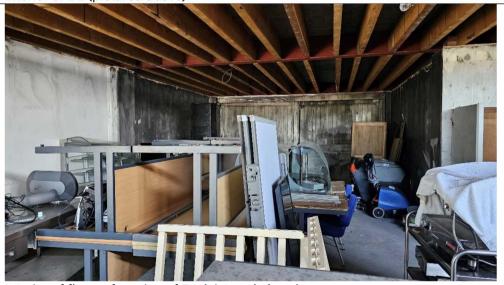
Interior of flat roof section of B1 (pictured above).

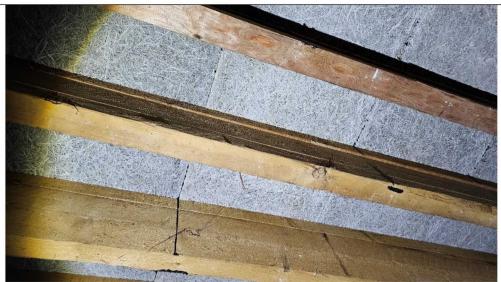
Ceiling structucre of flat roof section of B1 (pictured above).

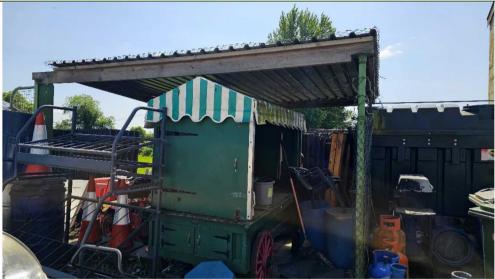
B2 is a small open cover, constructed of metal poles and a flat, corrugated metal roof. The structured does not demonstrate any suitable roosting features, and as all four sides are open and exposed, the structured would not provide any protection from the elements for bats to roost here.

B2 is deemed negligible for roosting bats due to the lack of roosting features and the lack of thermal stability for roosting bats.

Photo of B2 (pictured above).

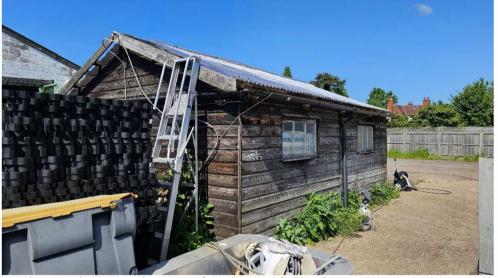
Southern and eastern elevation of B3 (pictured above).

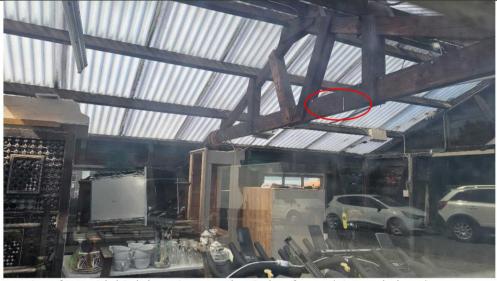
Several bird droppings were identified on the timber beams inside B3, which appears to be used as a perch.

Interior of B3 with bird droppings on the timber frame (pictured above).
