WEYBREADS LTD
CONSULTING STRUCTURAL ENGINEERS

Title **184 Clay St, Thornham Magna Proposed Remedial Works Structural Data**

For	J. McCourt	Date	22-May-23
Job No.	23/010	Drg No.	D1
CAD Plot Scale	1:50 @ A2	Rev	-

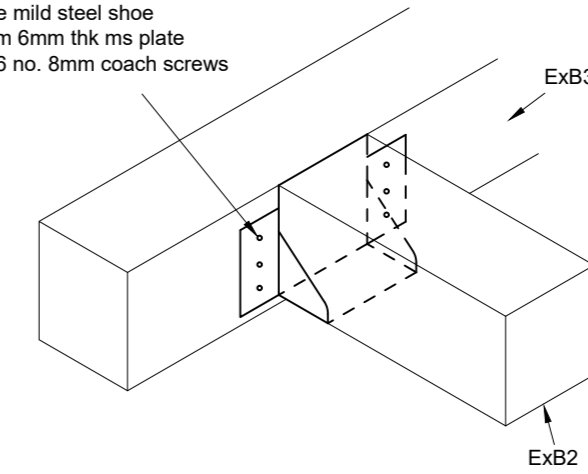
Detail 1 - ExB2 Hanger

(b) Provide traditional steel hangers to ExB2 end bearings on ExB3 & ExB4 (existing tenon joints charred), see detail 1.
(c) Splice repair studs across wall (c), see detail 3.

Purpose made mild steel shoe fabricated from 6mm thk ms plate secured with 6 no. 8mm coach screws

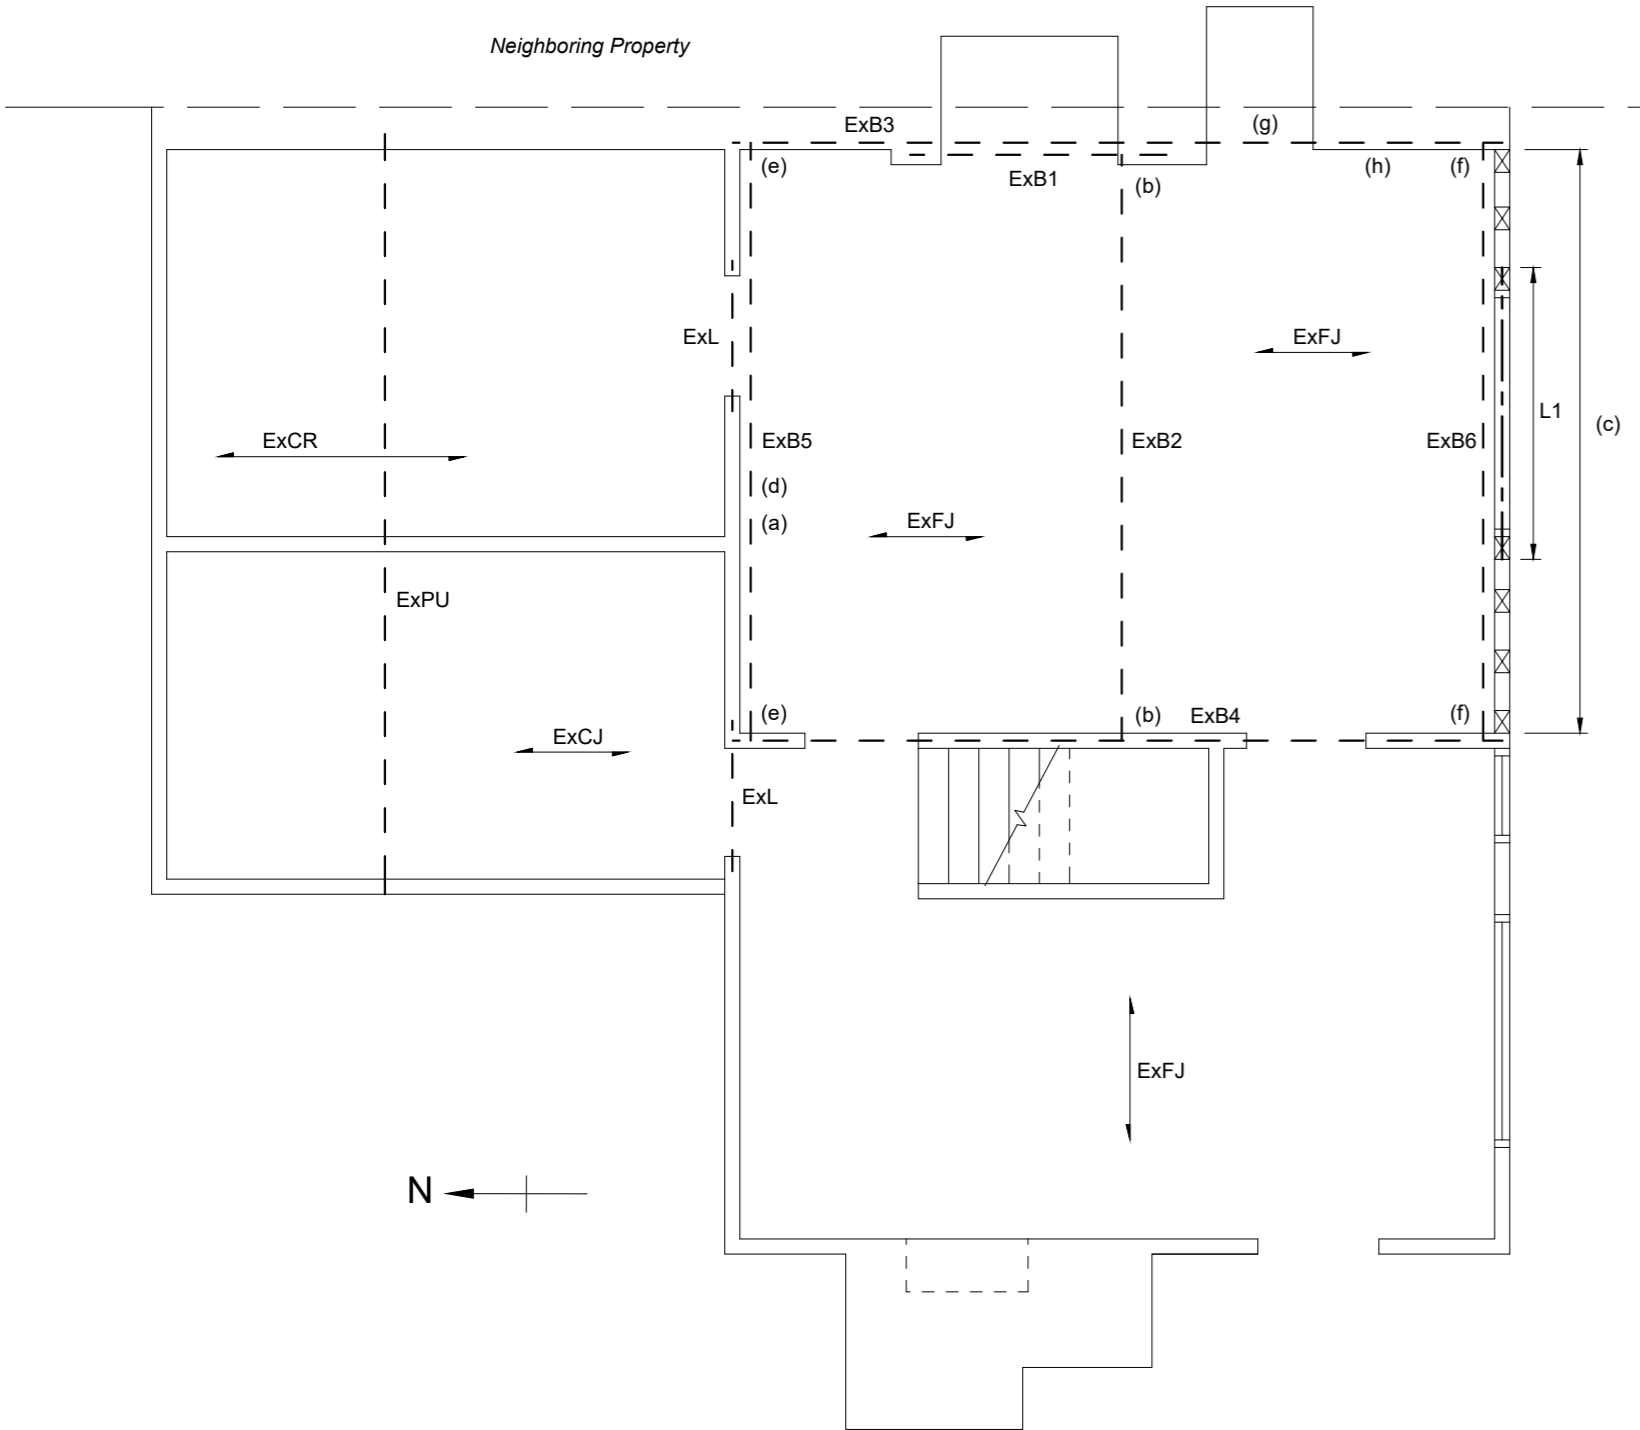
Key Plan - Ground Floor Showing Survey Data & Proposed Remedial Works @ 1:50

(a) Replace joists with substantially charred ends with 'like-for-like' sections, any other joists with end bearings exhibiting a similar level of charring to (a) to be replaced in similar fashion.

(g) Existing timber notched to reduced 225 x 50 section across stair opening and substantially charred. Blast clean ExB3 & splice in min. 225 x 75 section across opening, see detail 5.

ExB6 - Replace existing floor bearing rail with min. 125 x 75mm oak. Min. 75mm end bearing to ExFJ floor joists off rail. Fix rail to each wall stud with 2 no. M8 coachscrews, ends recessed (max. 20mm) & peletted into timber.
L1 - Provide replacement 170 x 90 oak lintel within repaired wall

- REPAIR SCHEDULE**
Generally -
Expose and verify all concealed structure within the Living Room. Contractor to inspect all timbers not visible at time of survey and repair any substantially affected areas in similar fashion to details provided in report, on drawing and below.
Blast clean all charred framework back to sound timber. Use soft blasting material, e.g. sand, corn cob grit or dry ice to avoid excessive erosion of sound timber.

(d) Provide 125 x 75 oak bearing rail, fixed to blast-cleaned rail ExB5 with M10 bolts @ 200 crs, ends recessed (max. 20mm) & peletted into timber.
(e) Tie straps not present to ends of floor beams ExB3 & ExB4, & tenon joints are charred. Provide steel straps similar to those present on South elevation, see detail 4.

(f) Fully expose & verify condition of existing steel strap fixings, replace as detail 4 if required (use galvanised or stainless steel). Existing fixings may require adjustment following blast cleaning of interfacing timbers.
