Arboricultural Impact

Assessment

Glanford House Old Hall Drive Elford B79 9BZ

Undertaken by: Bramley Tree Consultancy Ltd Auther: Esther Bramley Mob : 07580135370 Email: info@bramleytreeconsultancy.co.uk

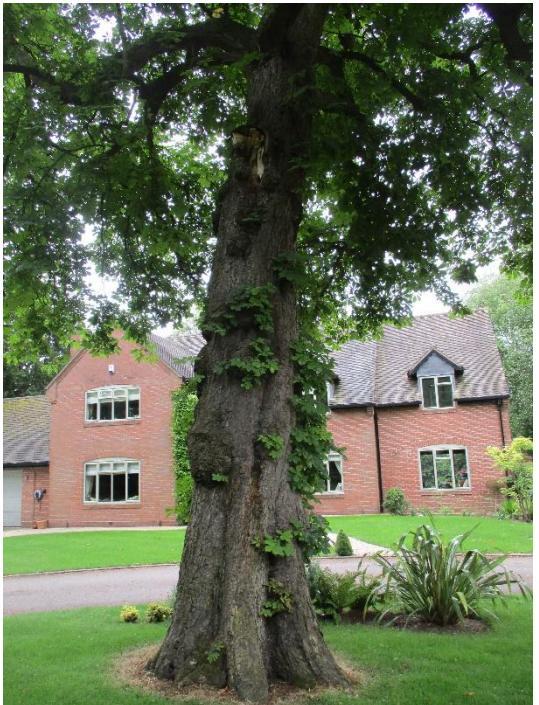
Photo Two – Showing T09 from the front of the property

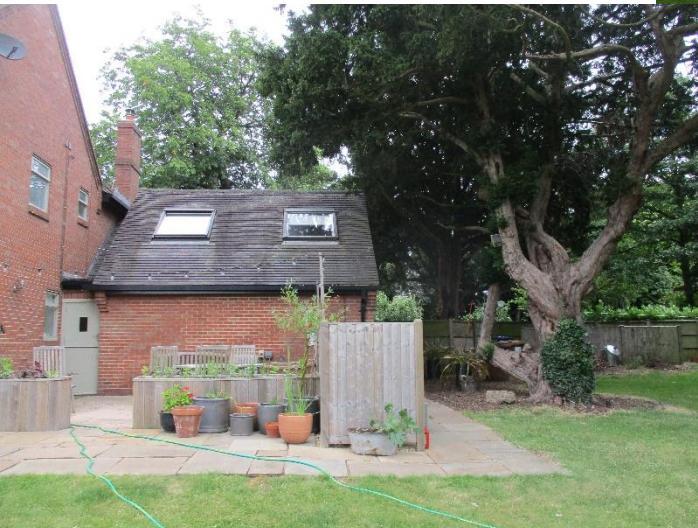
- **8.7** The footprint of proposed extension encroaches into the RPA of trees T09 and T10, the encroachment into T10 is the largest at 10%, however this is less than the recommended maximum encroachment of 20%. The construction of regular strip foundations can result in extensive root loss. The use of a pile and beam type foundation along with site investigation, to ensure the correct siting of the pile, can be used to minimise damage to main structural roots

Photo Three – Showing T10 and area of proposed extension

- **8.3** There are no direct layout incompatibilities with the proposed development.
- **8.4** The crown of T10 will need to be crown raised by 1 to 1.5m over the proposed extension in order to provide clearance to facilitate the proposed extension.
