Heritage Impact Assessment
Alpha Cottage, Gweek
Repairs and Renovations
August 2023

A report by
Enhance Heritage & Planning

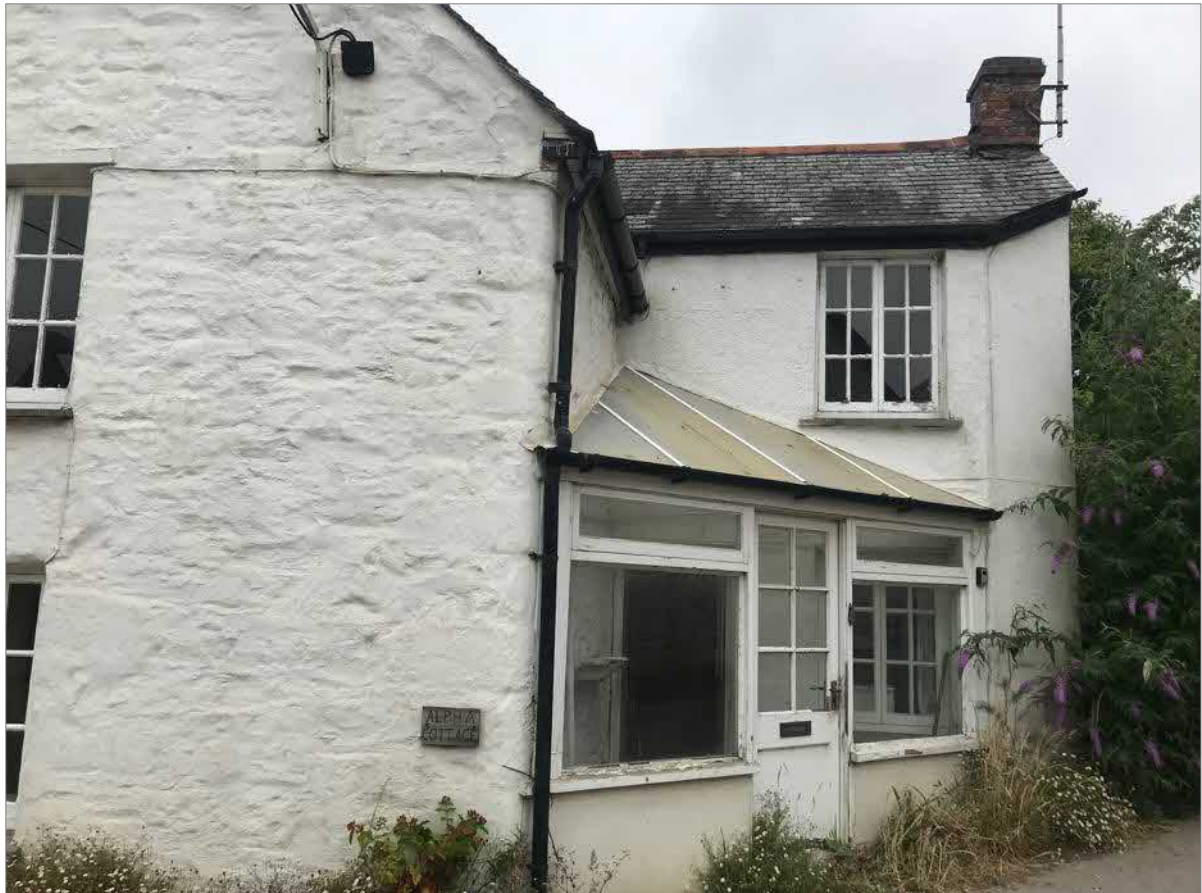
Figure 2: Detail of the south elevation showing wing and 20th century extension

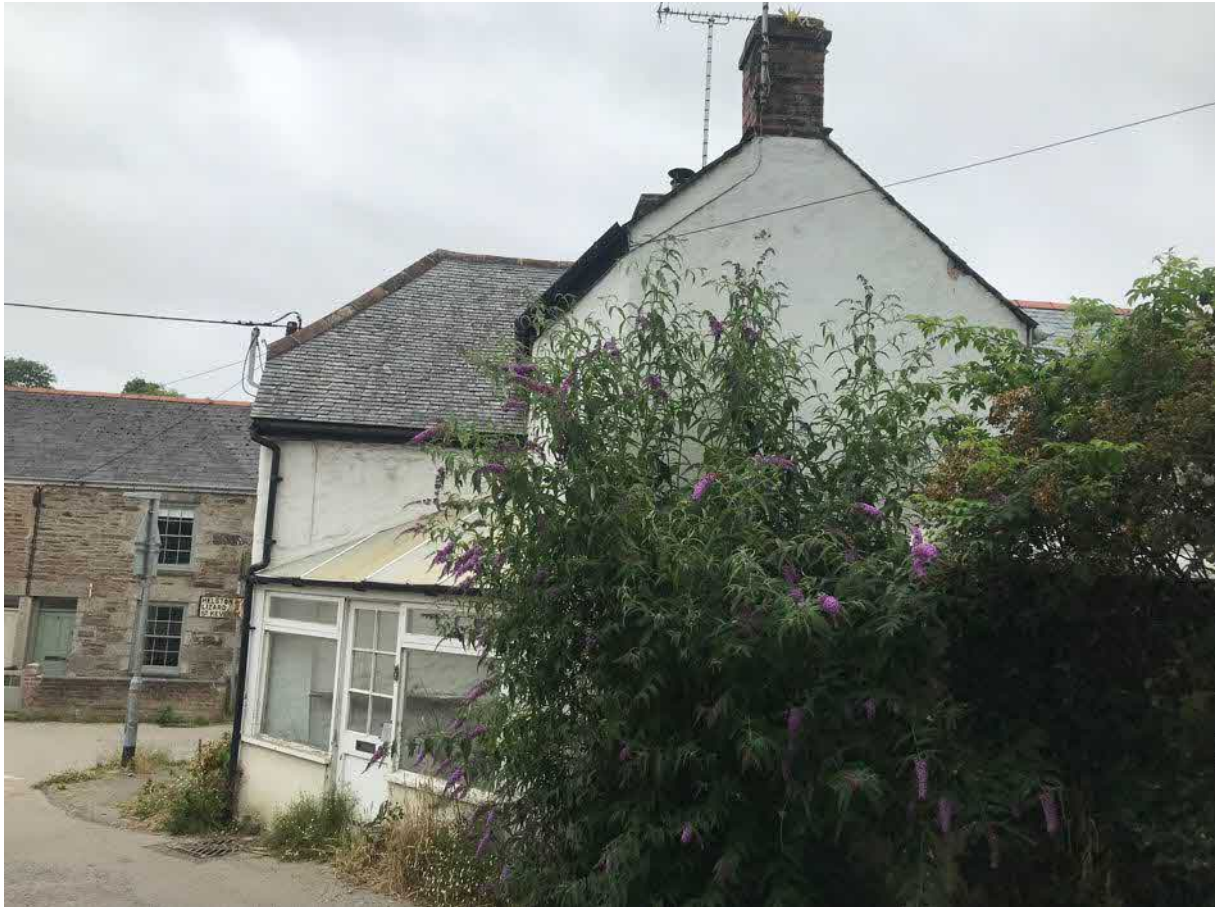
Figure 4: East elevation of Alpha Cottage

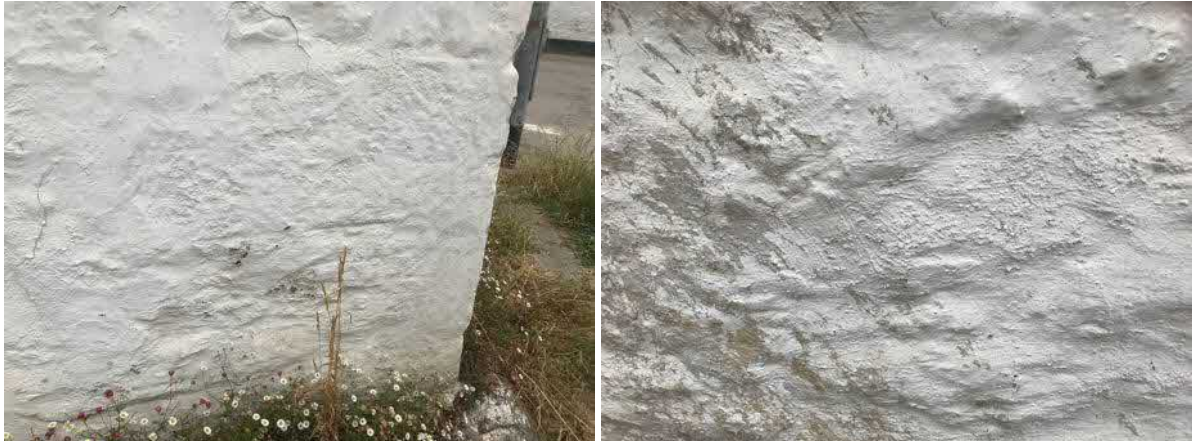
Figure 5: Details showing condition of exterior fabric

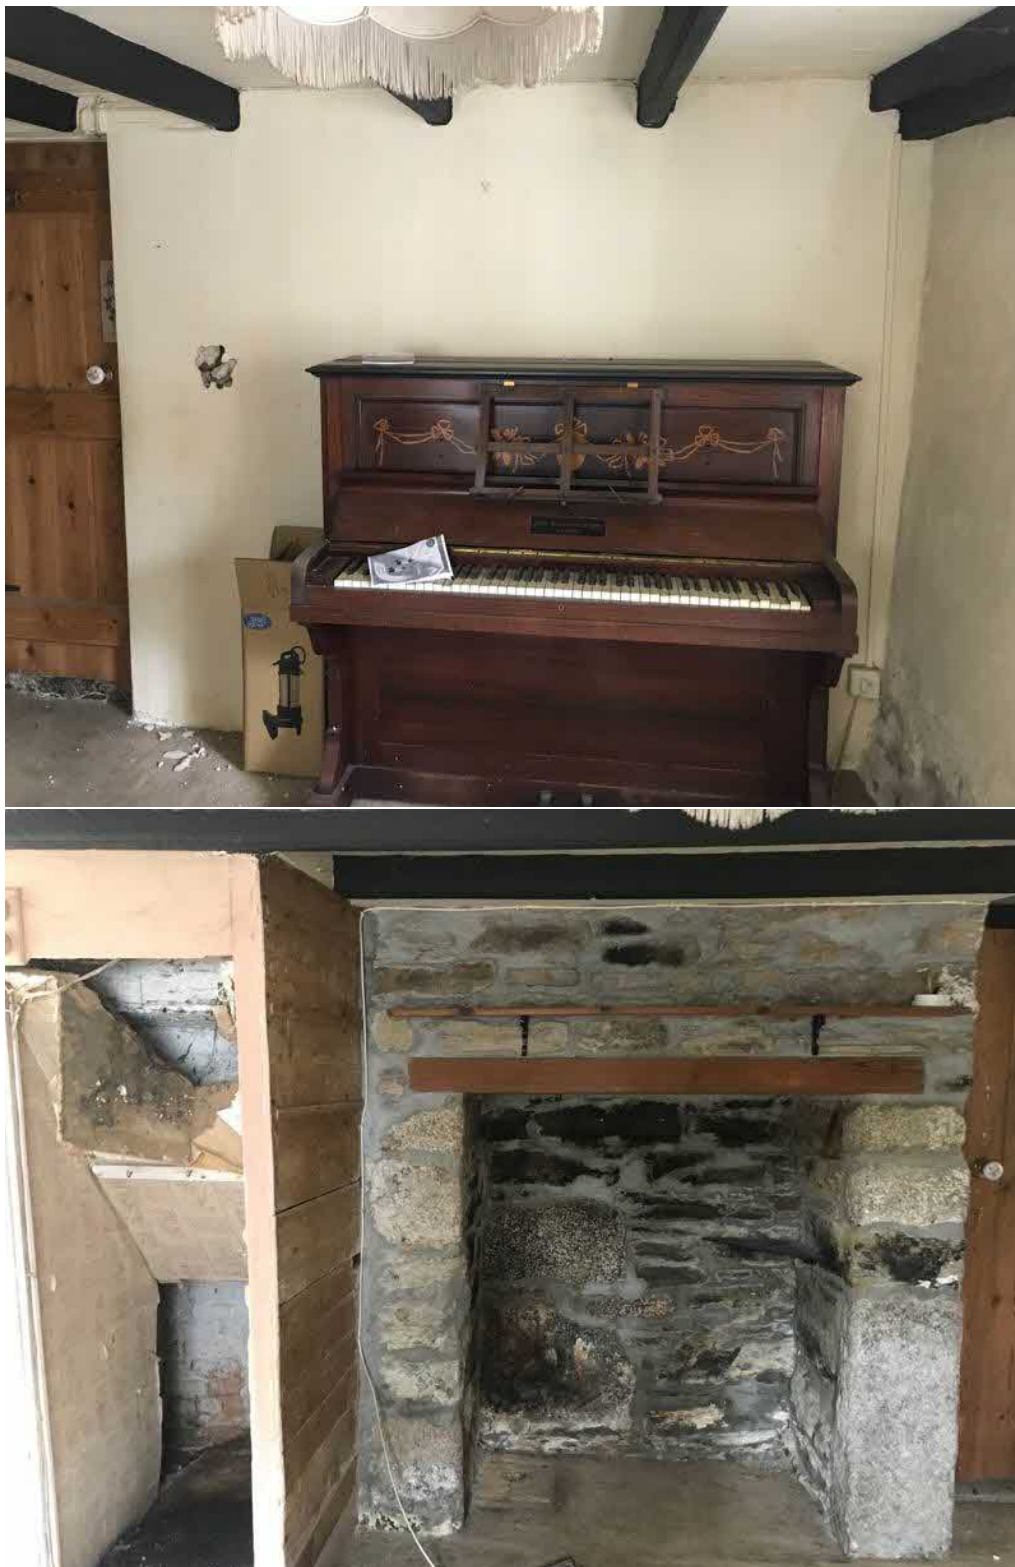
Figure 6: Views of the principal ground floor room of the cottage. Above: note battering-out of the wall, plus mould. Also note area of exposed gypsum plaster and battenning out of wall (this has been done throughout the ground floor).

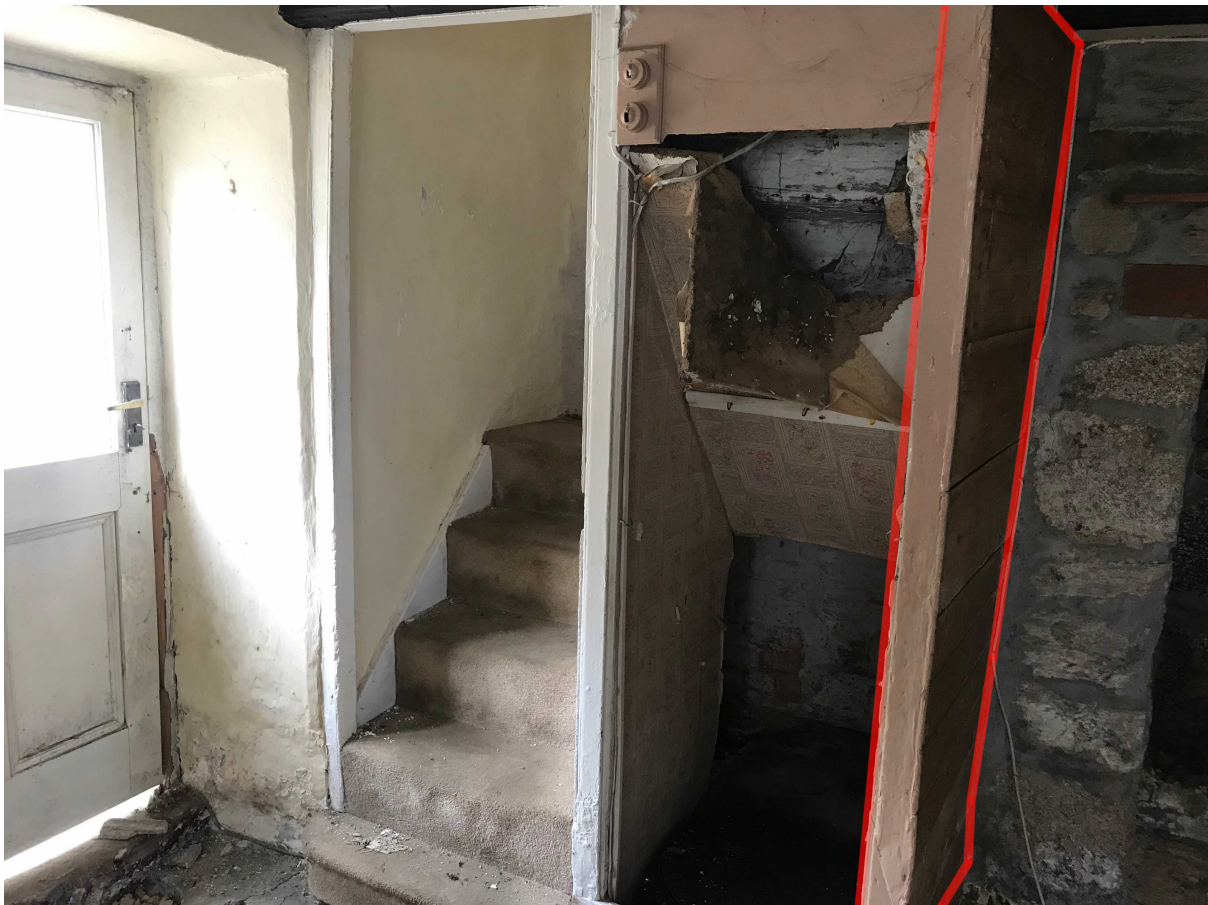
Figure 7: Detail view of staircase showing rot of staircase treads and risers, and with probable 19th century panelling section marked in red.

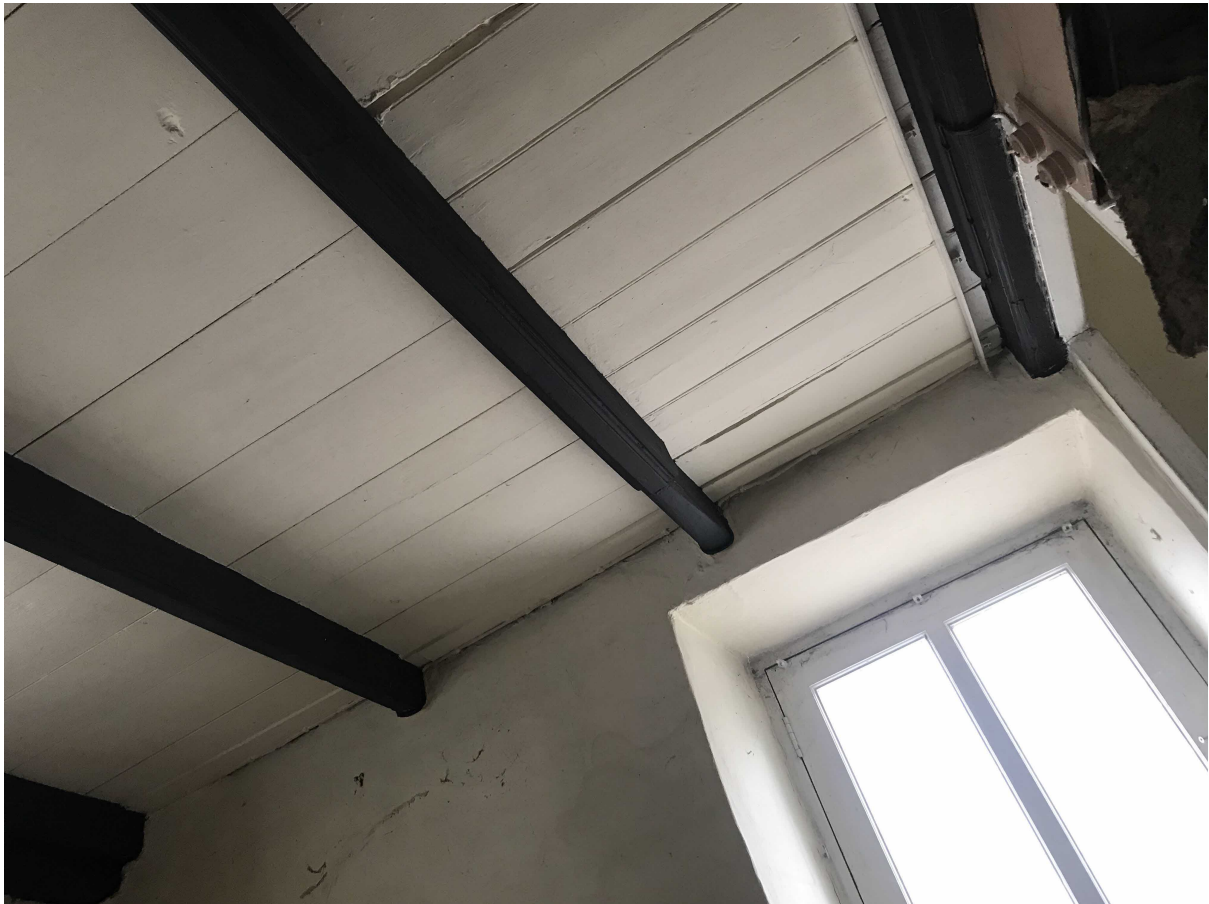
Figure 8: Detail of floor joists, seen from ground floor main room

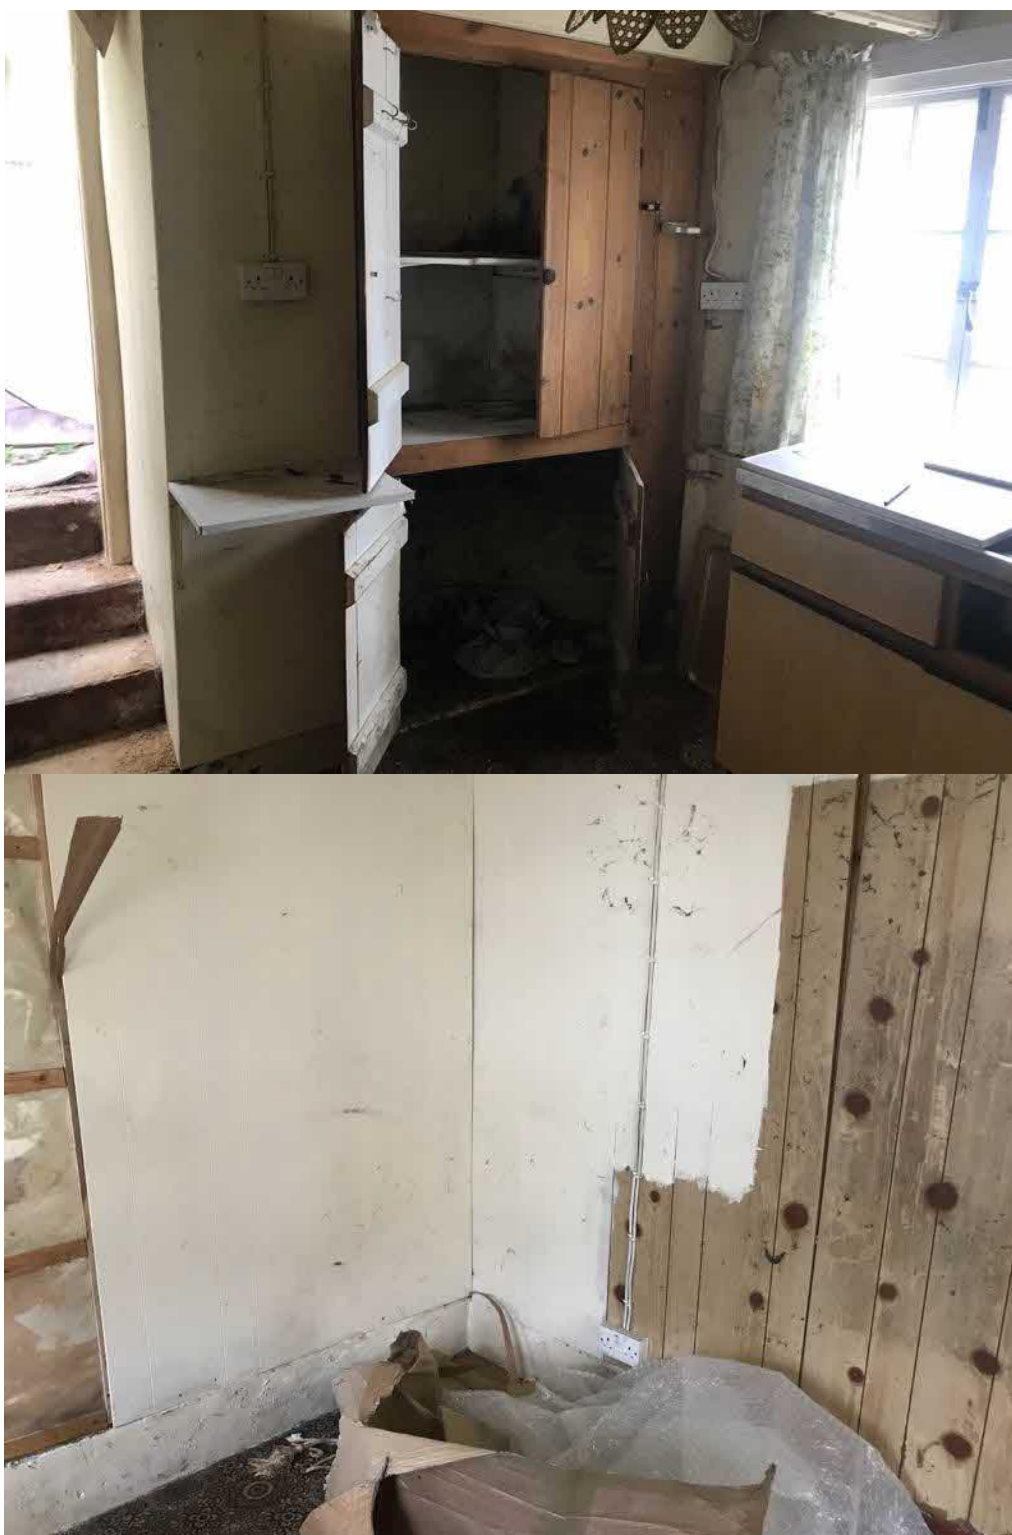
Figure 9: Details of the south eastern and north western corners of the kitchen wing

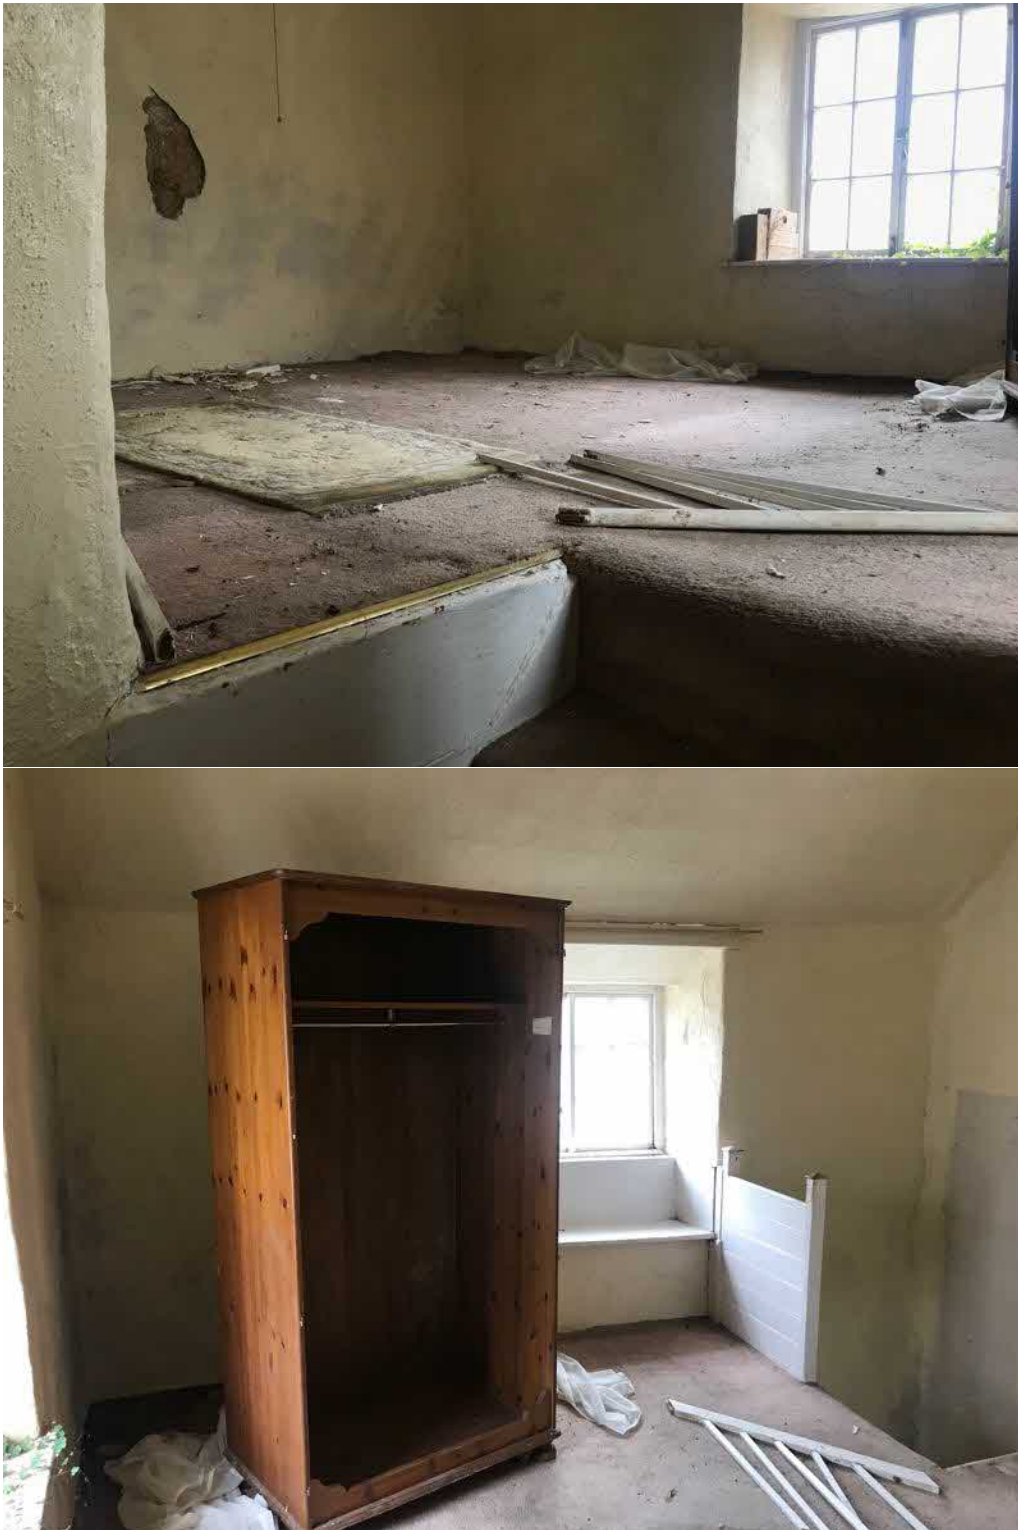
Figure 12: Views of the southeast and north sides of the main room, first floor

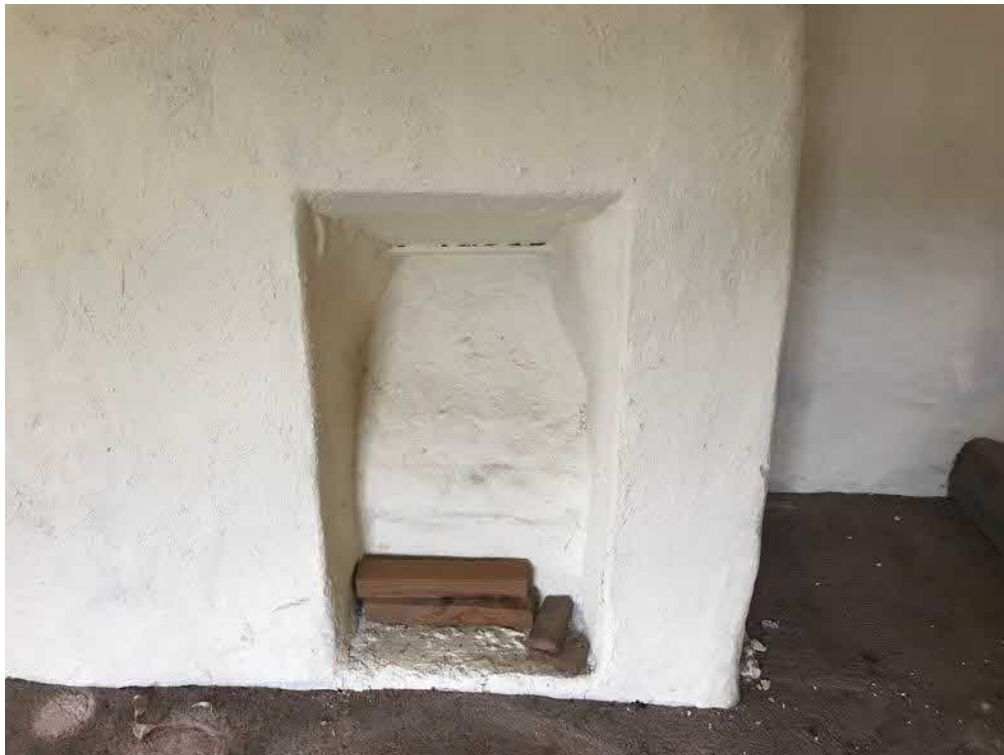
Figure 13: Detail of chimney breast on the first floor.

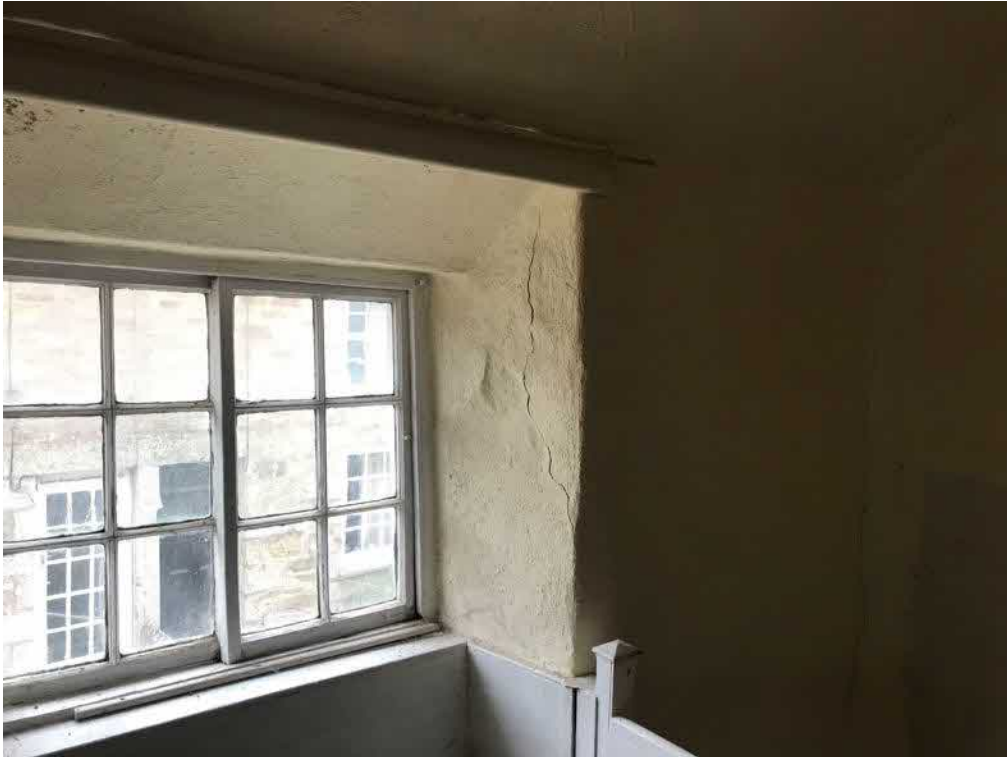
Figure 14: View of 19th century 'Yorkshire' sash window in context.
