Combined Design and Access Statement and Heritage Statement in respect of

Proposed alterations to 1 Belvedere Terrace, South Road, Alnwick, Northumberland, NE66 2NX

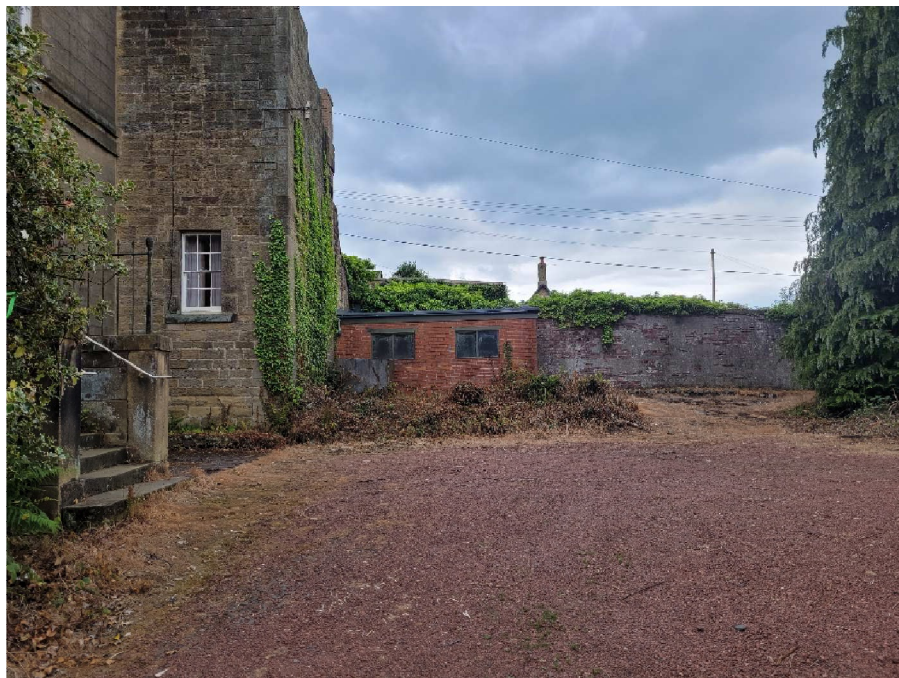
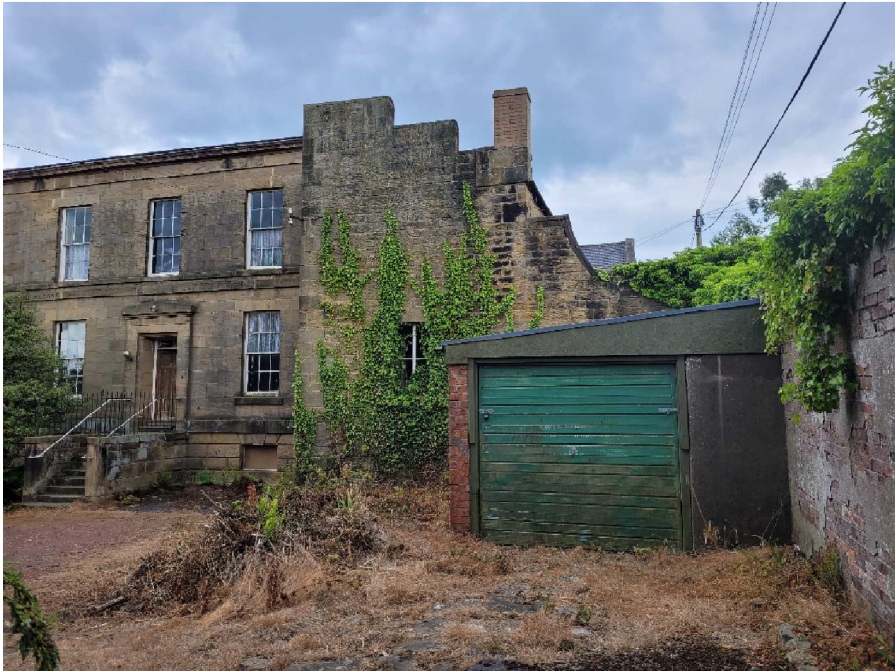
Non original garage to be demolished and patio formed

- 3.1 The refurbishment proposal comprises externally:
 - 3.1.1 Demolish existing non original garage to right hand side elevation and form patio area on footprint of demolished garage.

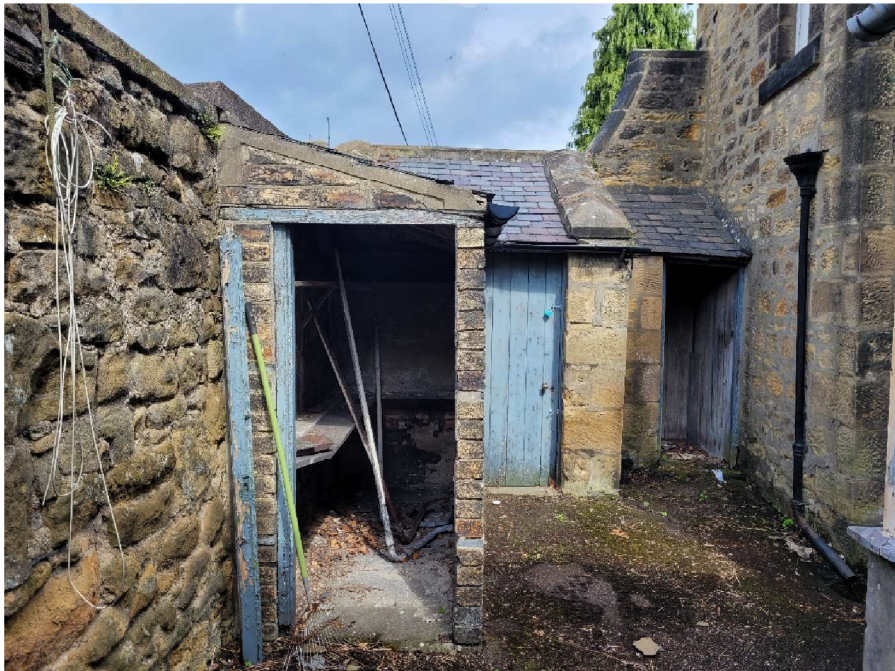
Non original outbuilding to be demolished

- 3.1.2 Demolish existing non original outbuilding to rear.
 - 3.1.3 Demolish non original timber porch to rear and replace with double glazed, powder coated aluminium conservatory including fitting a glazed roof over the steps down to the cellar.

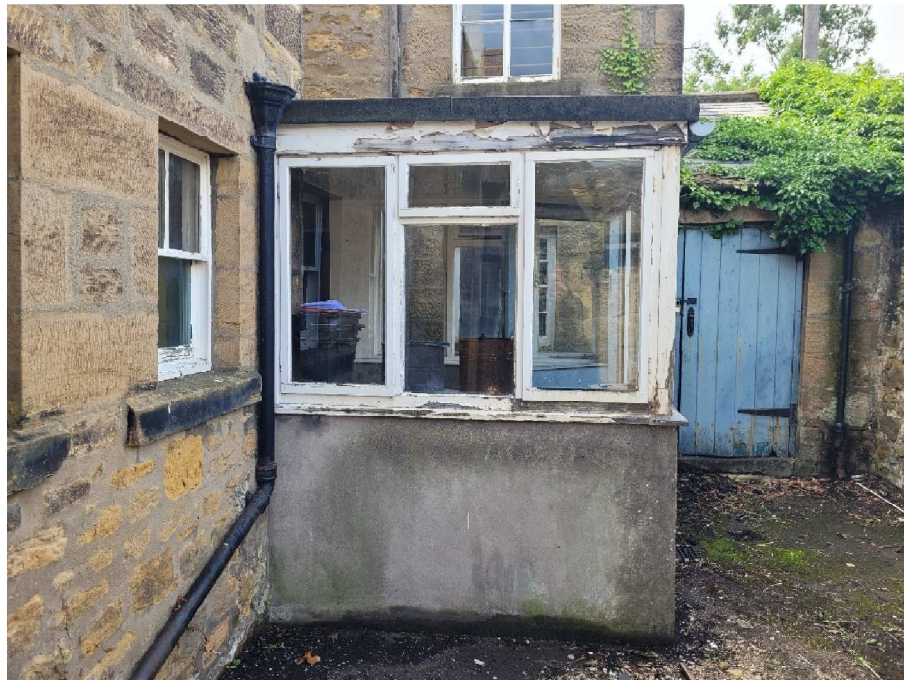
Non original timber porch to be demolished

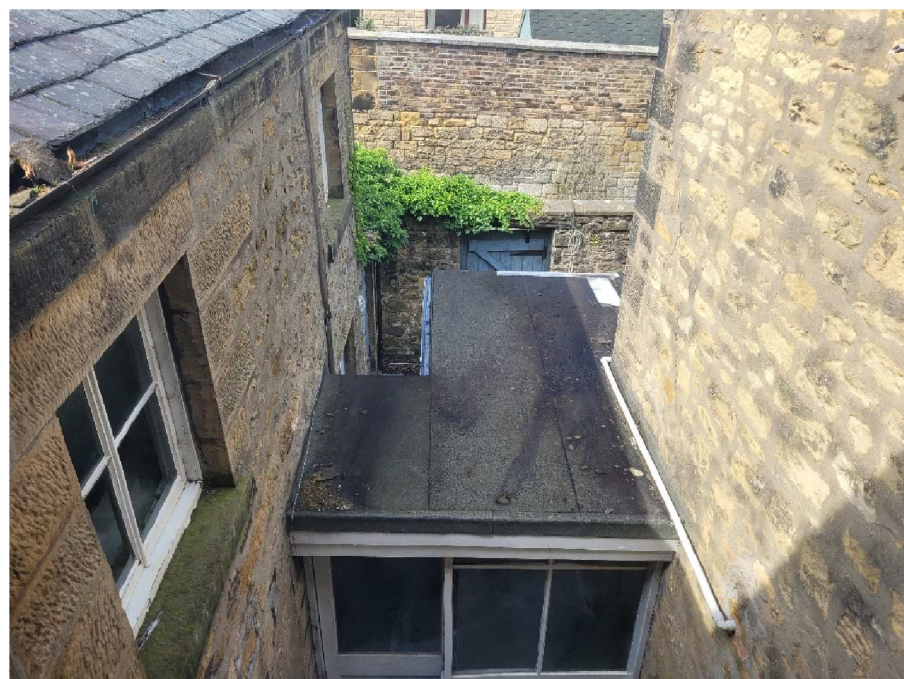
Non original timber porch to be demolished. Stairwell into basement to be glazed over.

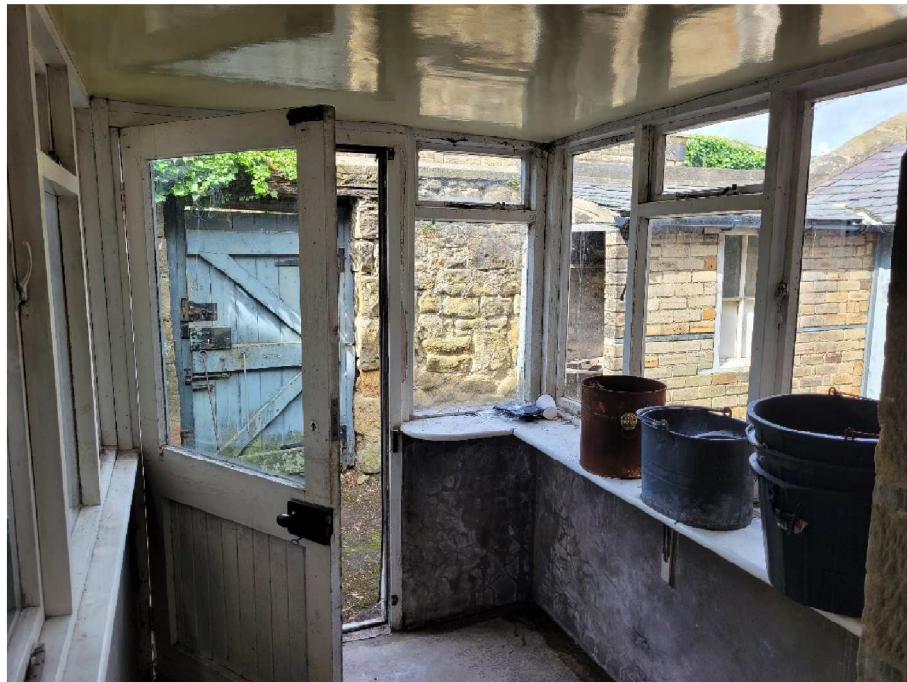
Non original timber porch to be demolished

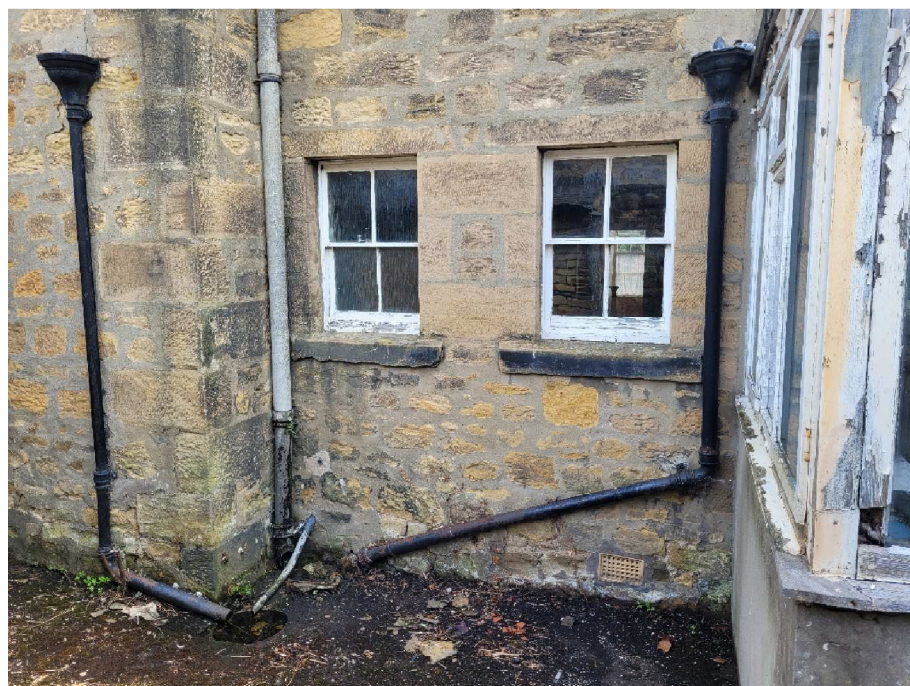
Alter right hand side window to form new rear door opening

- 3.1.4 To rear elevation, widen existing window opening and form new rear door opening and supply and fit new double glazed timber door.
 - 3.1.5 To rear elevation, supply and fit new cast iron effect soil and vent pipe to serve bathroom and connect to new below ground drainage.

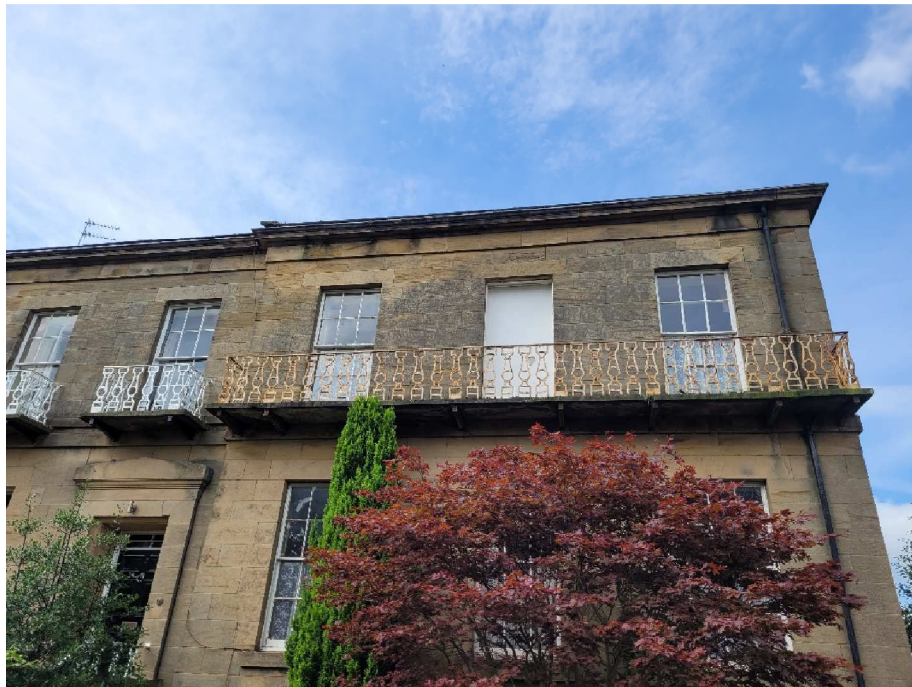
White board to dummy window to be replaced with dummy sash to match elsewhere

- 3.1.8 To front elevation, remove white board to dummy window and fit dummy sash window to match dummy windows elsewhere.
 - 3.1.9 Rake out and re-point defective joints in stonework to rear elevations using a lime / sand mortar. Repair cracking to stonework as required.

- 4.3 To the front elevation, the proposed replacement of a white timber board to the prominent first floor dummy window rear with a dummy sash window to match the original dummy window is also a significant improvement on the appearance of the property.

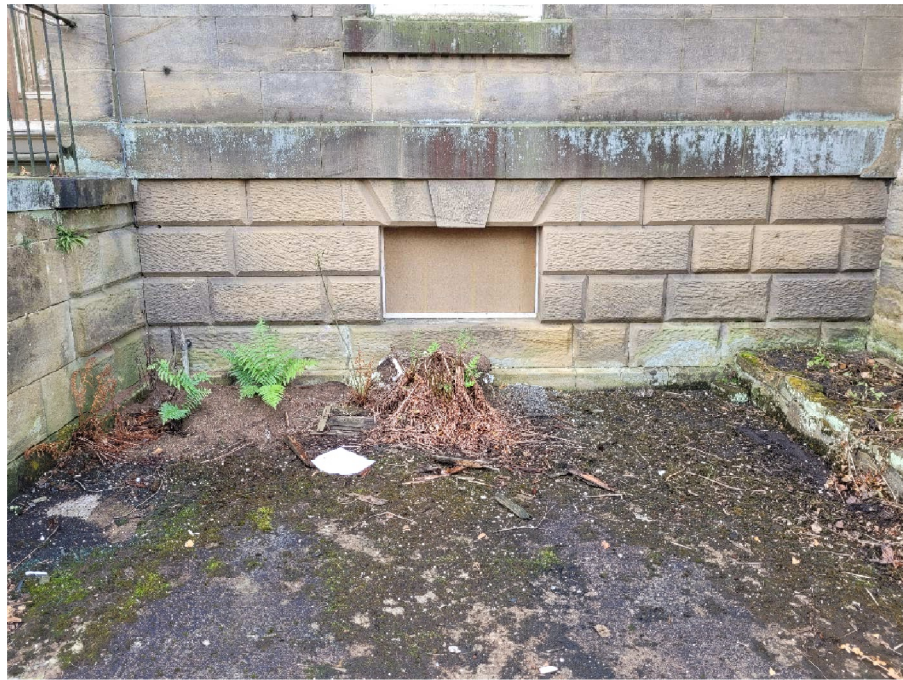
Basement window to be reinstated

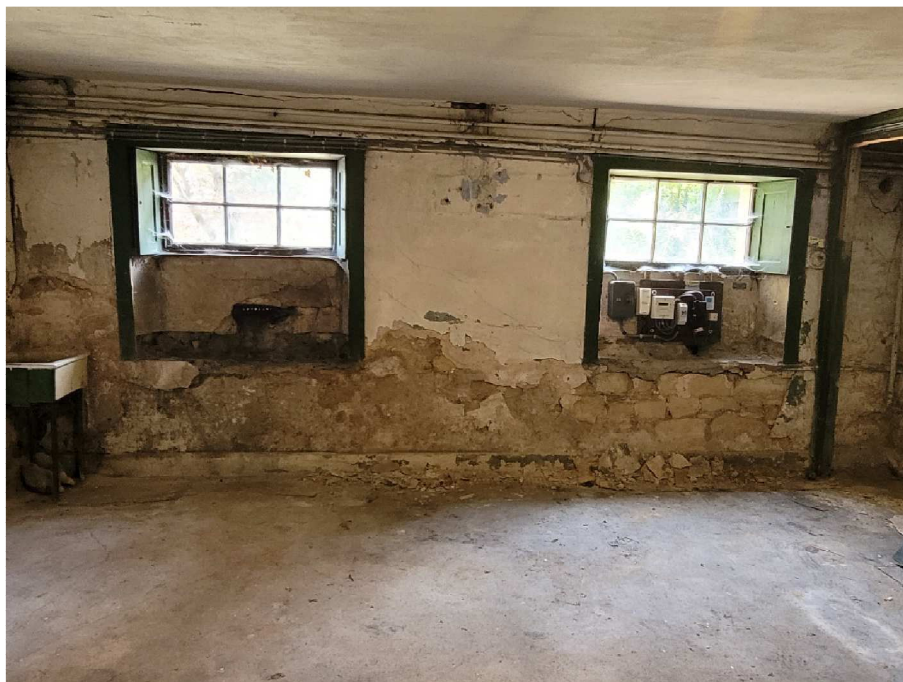
Dampness to basement and incoming electrical supply to right hand side

- 3.2.2 Allow for new insulated concrete floors to cellar incorporating damp proof course.
 - 3.2.3 Allow for remedial damp proofing works to cellar using newton 805 membrane. No cement-based tanking or injection damp proofing work to be undertaken.

- 4.5 There is significant dampness to the cellar and this will be remedied using a Newlath membrane system in preference to cementitious tanking or injection damp proofing works which are not suitable for a Listed Building.

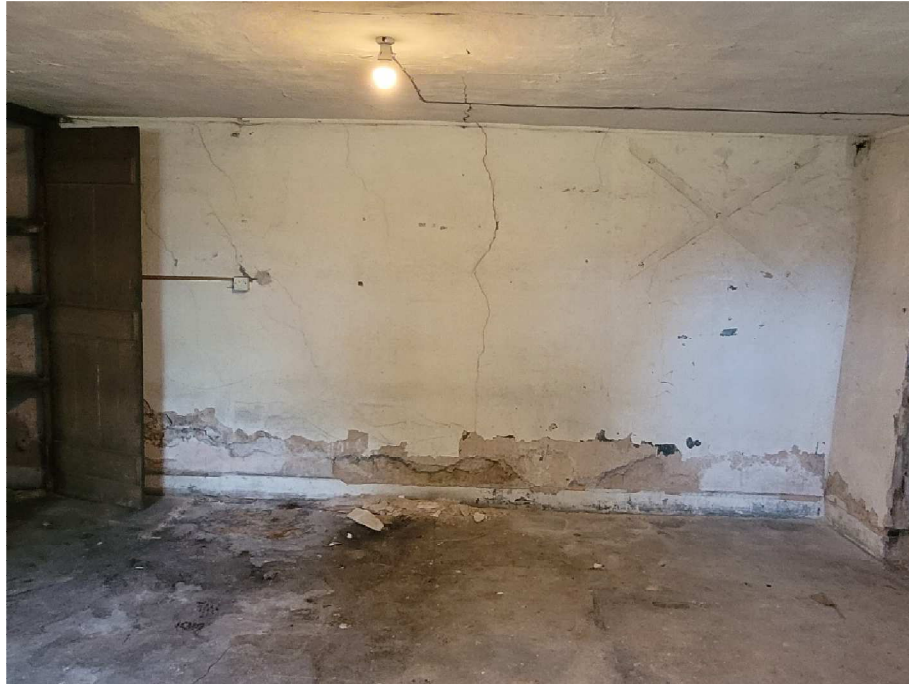
Dampness to basement

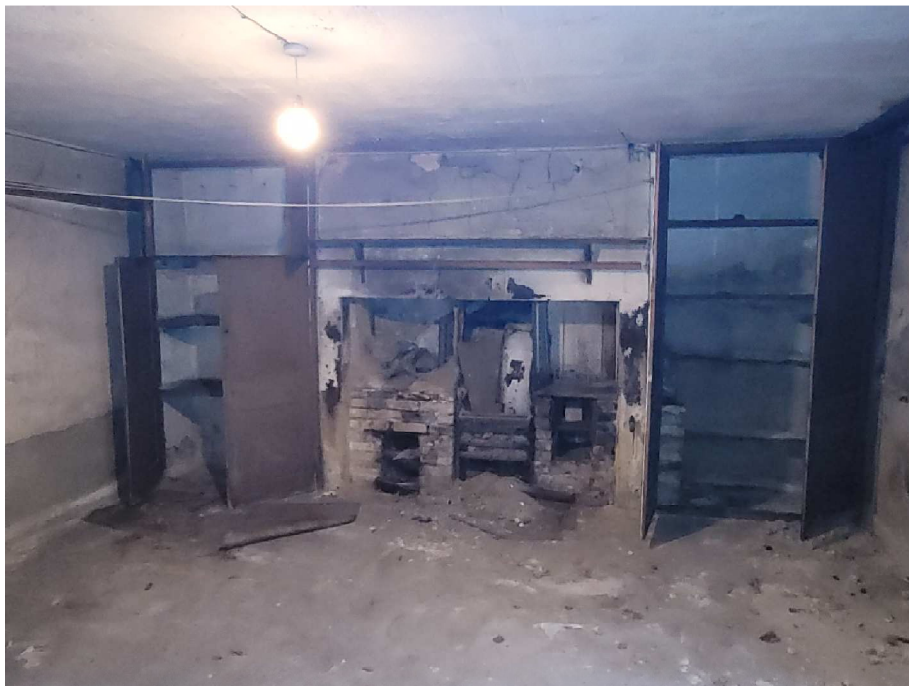
Fireplace to proposed cinema room. Wood burning stove to be fitted

- 3.2.4 Refurbish existing range and leave as a decorative item to the proposed snooker room.
 - 3.2.5 Allow for lining chimney and fitting wood burning stove to cinema room.

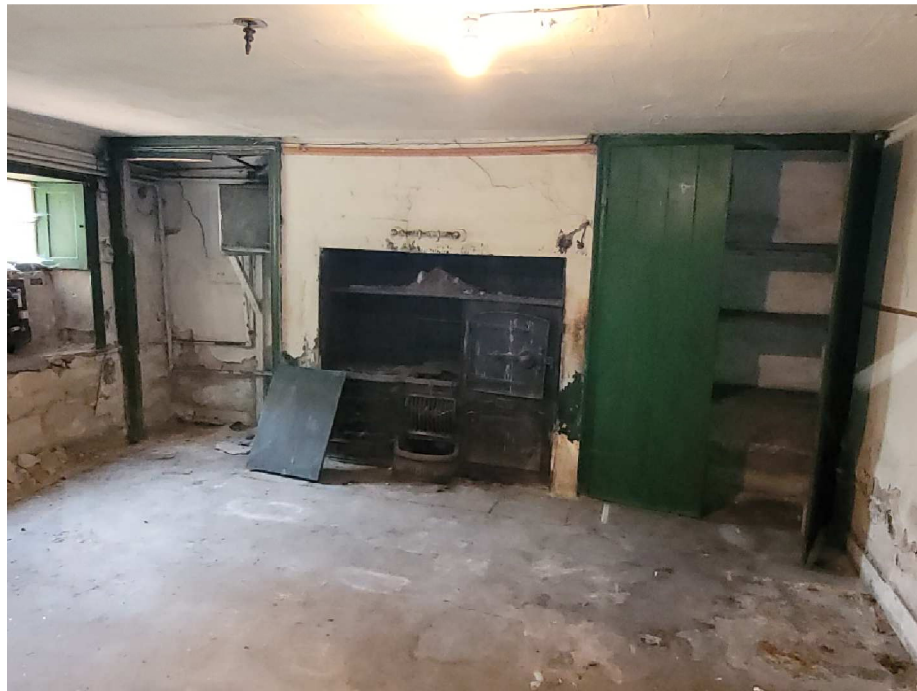
Range to be refurbished and left as decorative item

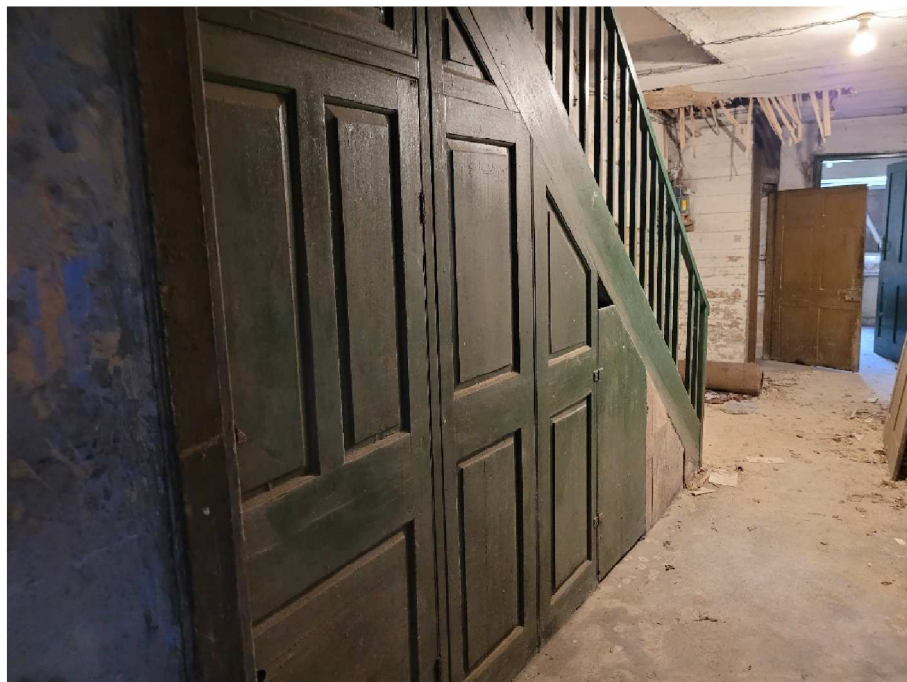
Pannelling to stairs retained and laundry space formed under stairs

- 3.2.6 Form laundry space within understairs cupboard and run drainage (via macerator) to rear.
 - 3.2.7 Relocate existing incoming electrical supply.

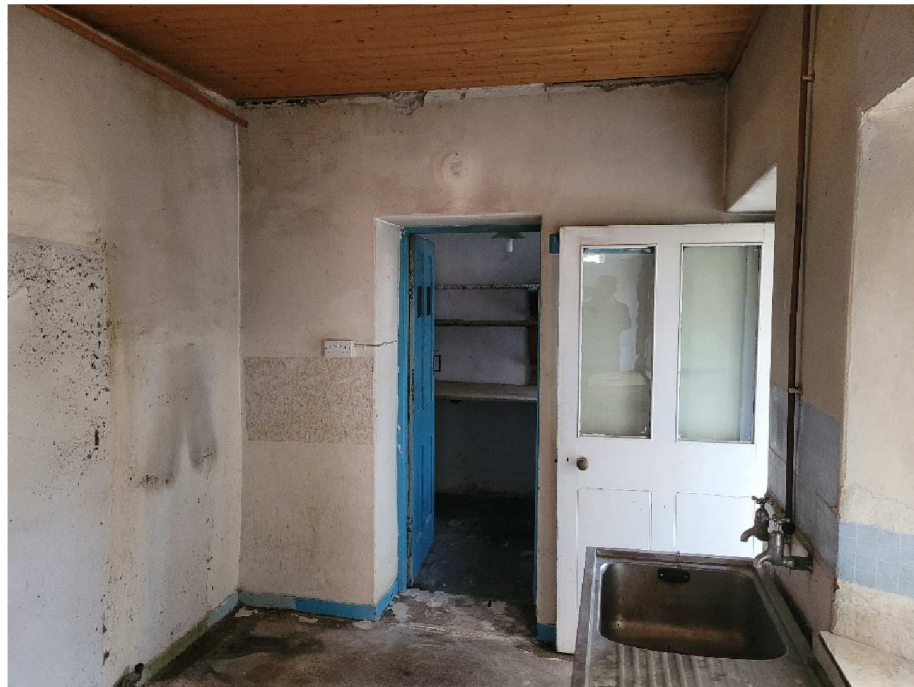
Wall between kitchen and pantry to be removed

- 3.2.8 Take out wall between existing kitchen and pantry, replace existing concrete floor and form new kitchen.
 - 3.2.9 Refurbish existing WC.
 - 3.2.10 Line chimneys and fit new living flame gas fires to existing fireplaces. in dining room, living room and reception room.

- 4.6 At ground floor level, the existing pantry and kitchen will be knocked together to form a new kitchen. While this does involve some demolition, it is considered to be preferable to locate the new kitchen in this area, rather than use one of the main reception rooms for the new kitchen and thus change the character of the building.

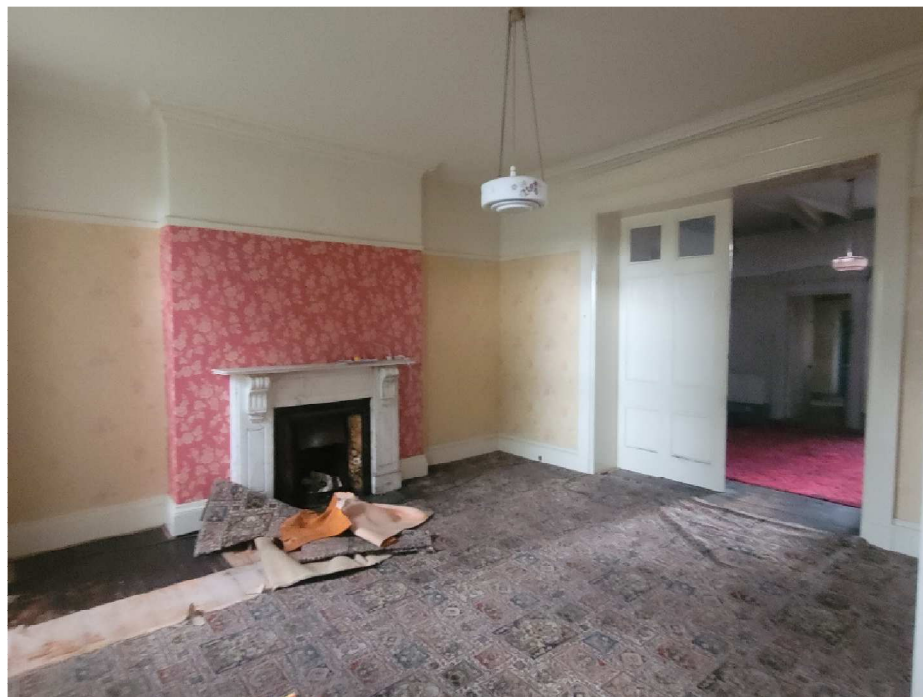
Existing living room. Flue lined and living flame gas fire to be fitted.

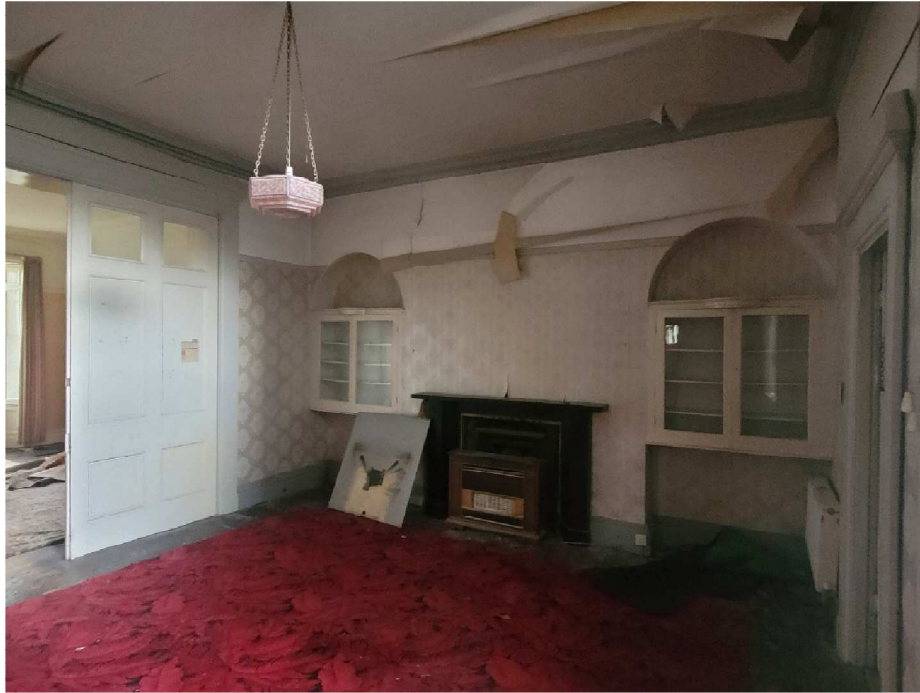
Existing dining room. Flue lined and living flame gas fire to be fitted.

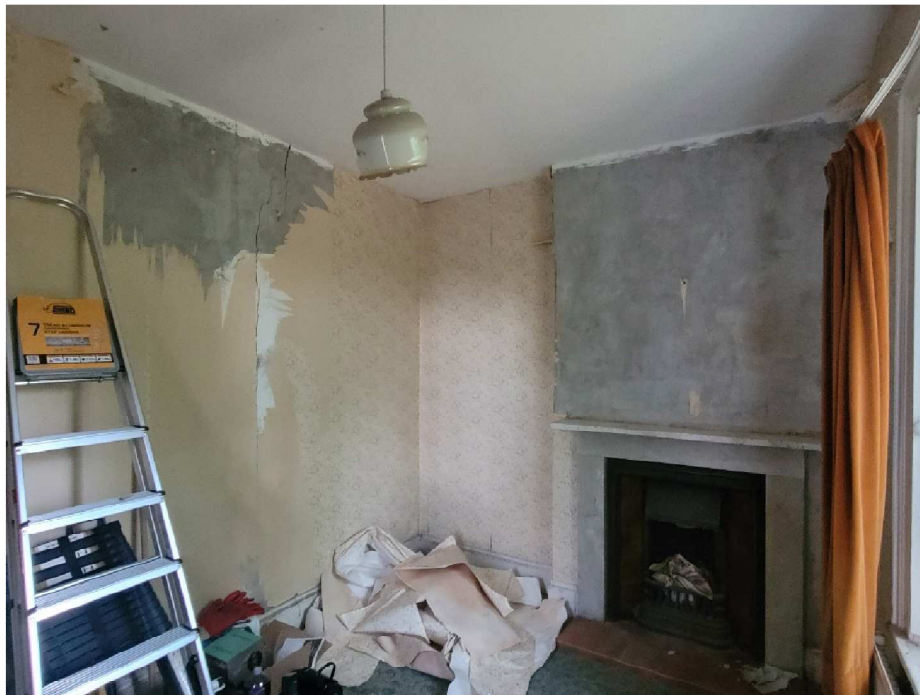
Existing reception room. Flue lined and living flame gas fire to be fitted.

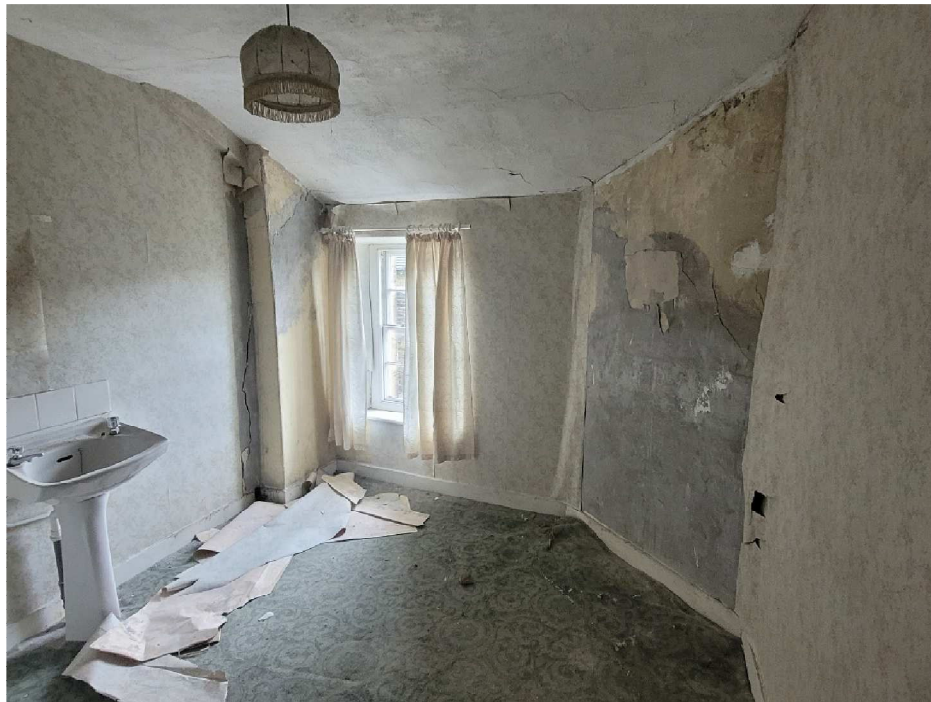
Bedroom 4. Expose fireplace, fit new surround, line and fit living flame gas fire.

- 3.2.11 Open up existing chimney breast to bedroom 4 and find original fireplace. Line flue, fit new fire surround and supply and fit living flame gas fire.

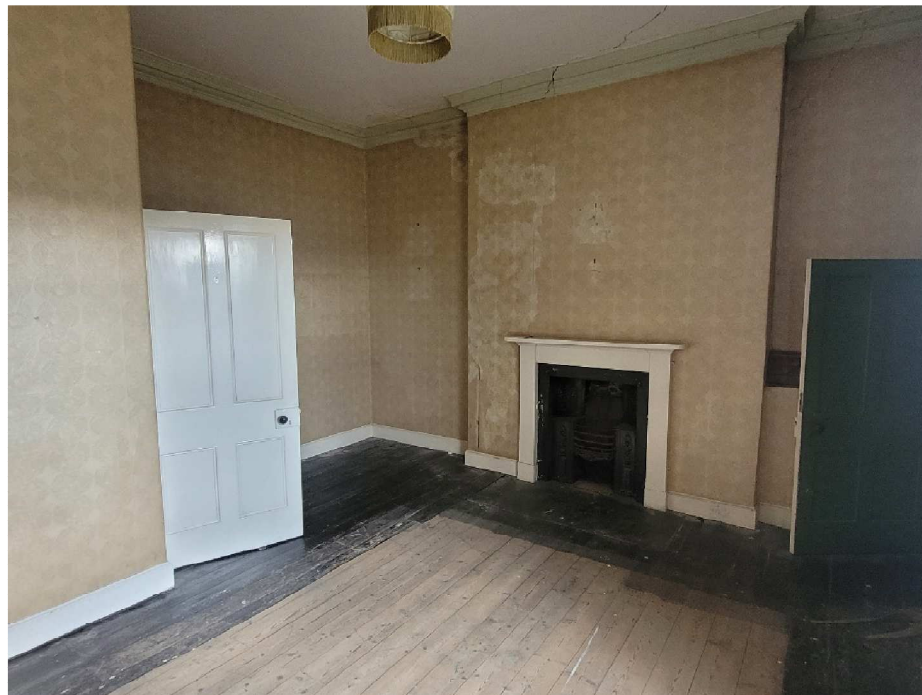
Bedroom 1. Alter partitions to form shower room. Reinststate coving. Line flue and fit living flame gas fire

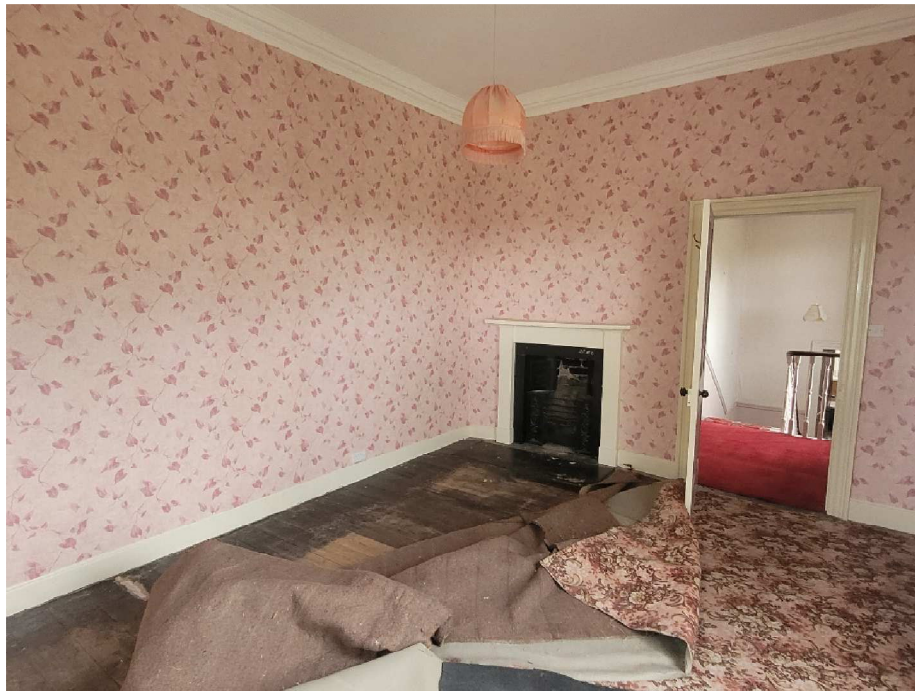
Bedroom 3. Line flue and fit living flame gas fire

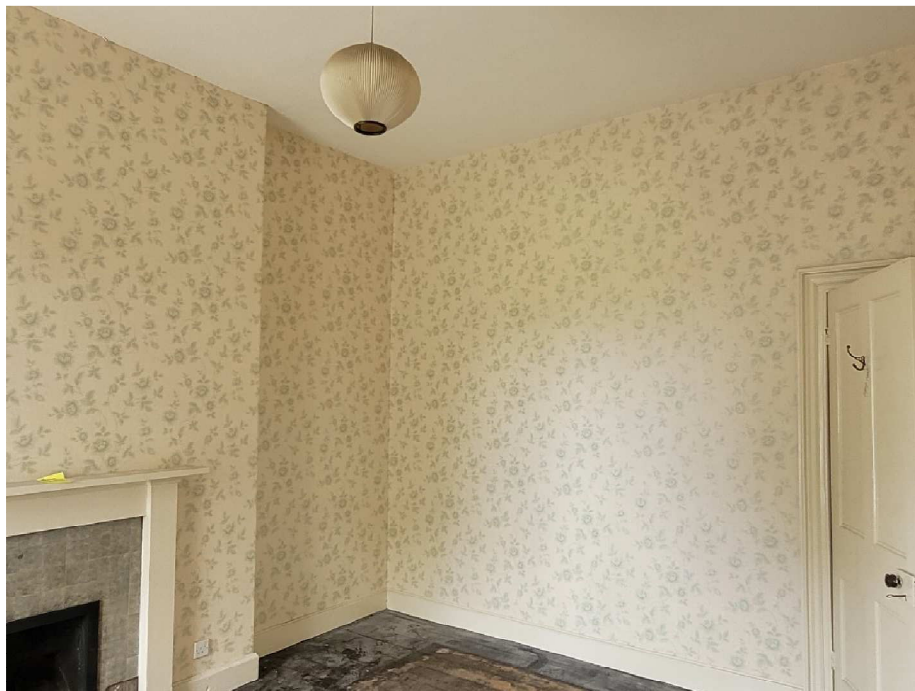
Bedroom 2. Remove section of wall and form shower room. Line flue and fit living flame gas fire

- 3.2.12 Line flues and fit living flame gas fires to existing fireplaces in bedrooms 1, 2 and 3.
 - 3.2.13 Form opening in solid wall of bedroom 2 and form new shower room.

- 4.8 A small shower room is proposed which does required the removal of a section of sold wall and the alteration of the dimensions of two of the bedrooms but in our opinion, the intervention is minimal and is justified in order to provide adequate sanitary facilities for a dwelling of this size.

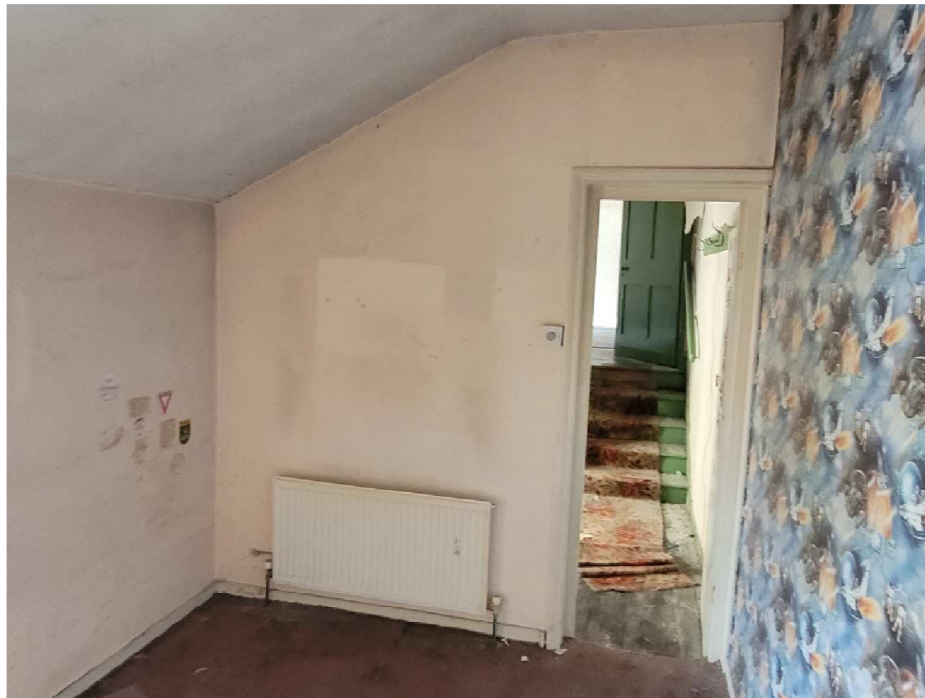
First floor lower rear addition. Remove wall and form master ensuite and dressing room.

- 3.2.14 Strip out lower dressing room and bedroom and form new master ensuite and dressing room.
 - 3.2.15 Enlarge existing trap hatch to roof void.

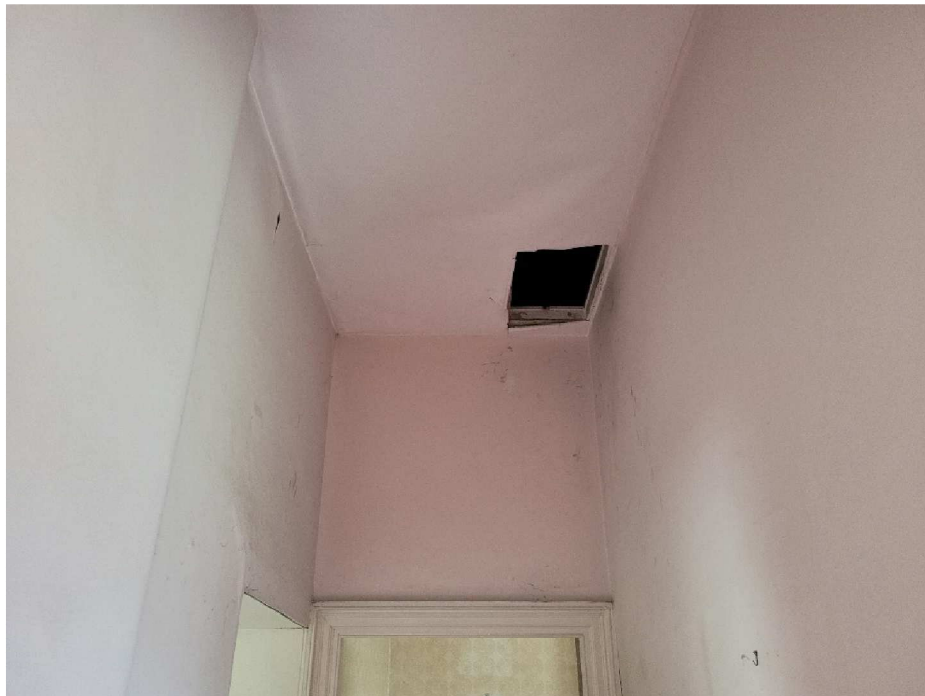
First floor landing. Enlarge existing trap hatch.
