DATE: May 2023

Cedarwood
TREE CONSULTANTS

BS5837: 2012 TREE REPORT

9 Barber's Lane, Catherine de Baines, Solihull

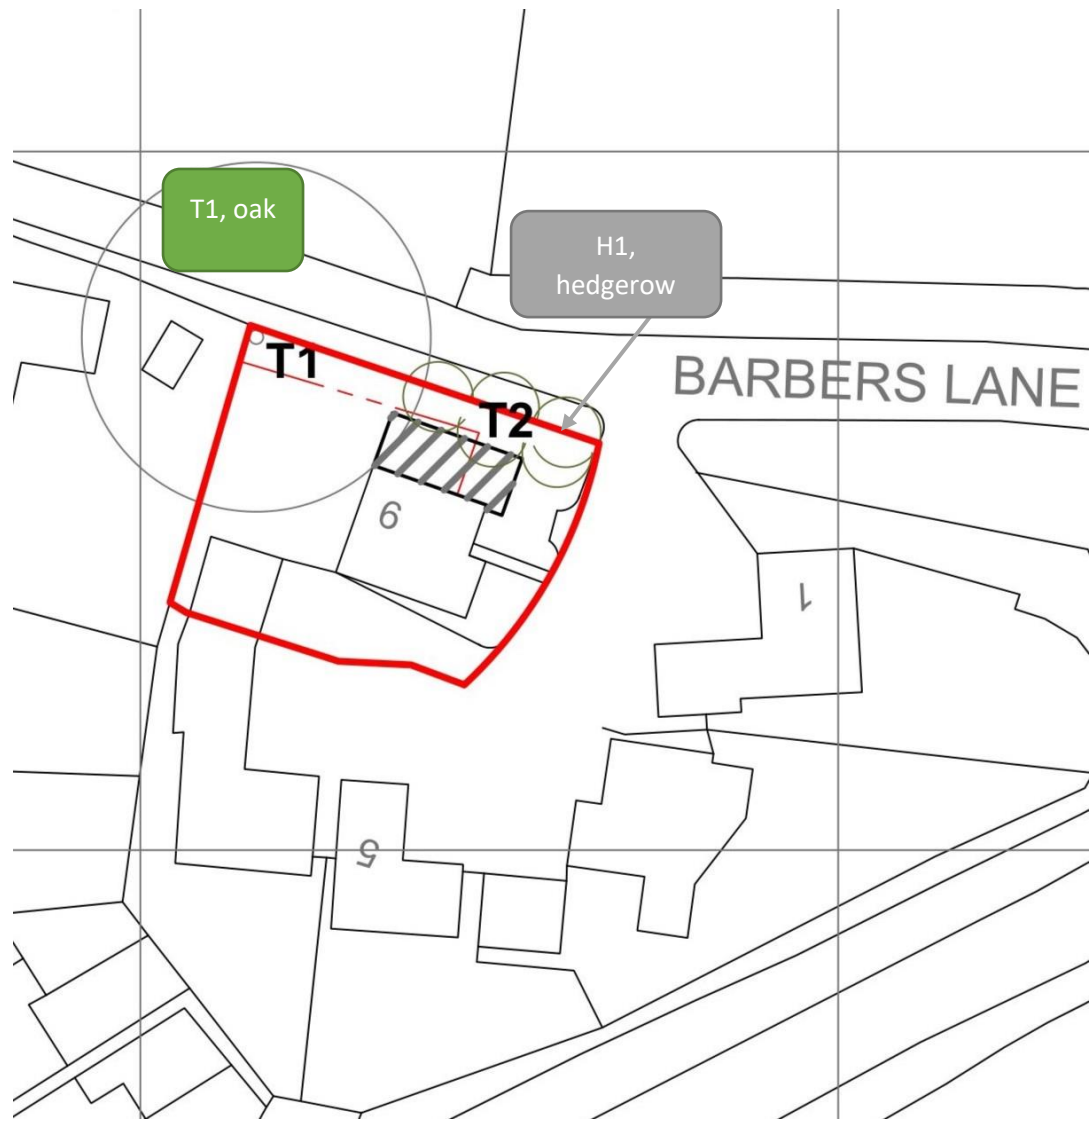
Appendix IV: Tree Constraints Plan

4.2 In summary: The oak, T1, is a good specimen. It does not require any pruning for the works. There could be some minor encroachment into the Root Protection Area on the western edge. This can be undertaken with sensitive excavation and the use of a pile construction method. The hedgerow is in a poor condition and would benefit from management to create a more substantial feature.

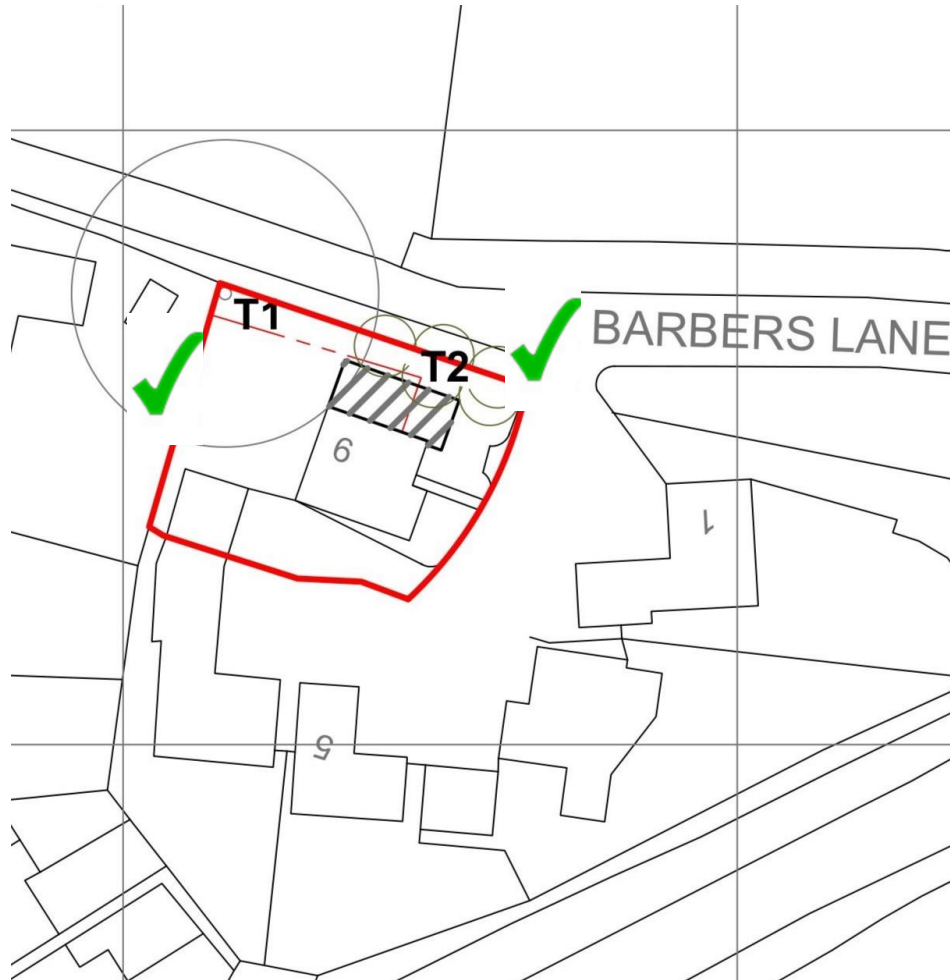
Appendix V: Arboricultural Impact Assessment Plan

The corner of the extension nearest to the oak slightly encroaches the Root Protection Area. A special construction methodology is proposed to minimise excavation of foundations. The area around the oak will be aerated and mulched to provide preferable growing and rooting conditions. No tree removals are needed for this development.

6.3 Mitigation Works: A pile construction method shall be used for the point where the western edge of the extension encroaches the eastern edge of the Root Protection Area. The excavation work shall be supervised to ensure that no roots exceeding 10mm diameter are damaged.

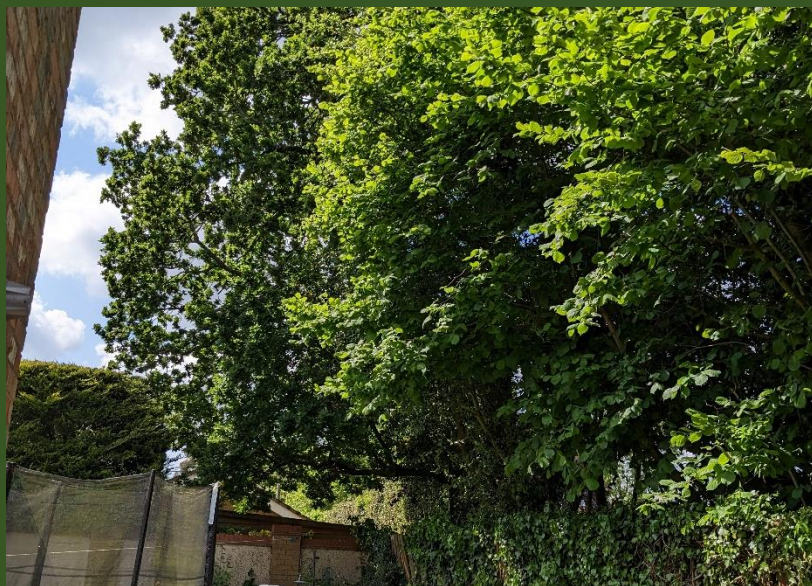
Image 9: The boundary hedge, which is to be retained and enhanced.

6.4.1 Mitigation Planting: The boundary hedge shall be enhanced with new planting, aerating of the soil and use of mulch. The proposal is to enhance the planting with new plantings of hawthorn, hazel and field maple to complement the existing holly, hazel and oak. This is aimed at creating a hedgerow of more than five species, a characteristic of a healthier hedge. The hedging shall consist of at least five rows of plants planted as 45-60cm whips at three plants per linear metre. The feature shall be dug over first and mulched to 100mm depth. The mulch shall be maintained to this depth for at least five years post-planting. The mulch shall be extended to the oak, T1.
