**WESTSIDE FORESTRY LTD**

Tree Survey and Arboricultural  
Impact Assessment

Haddon House, St Johns Hill,  
Shenstone WS14 0JB

July 2023

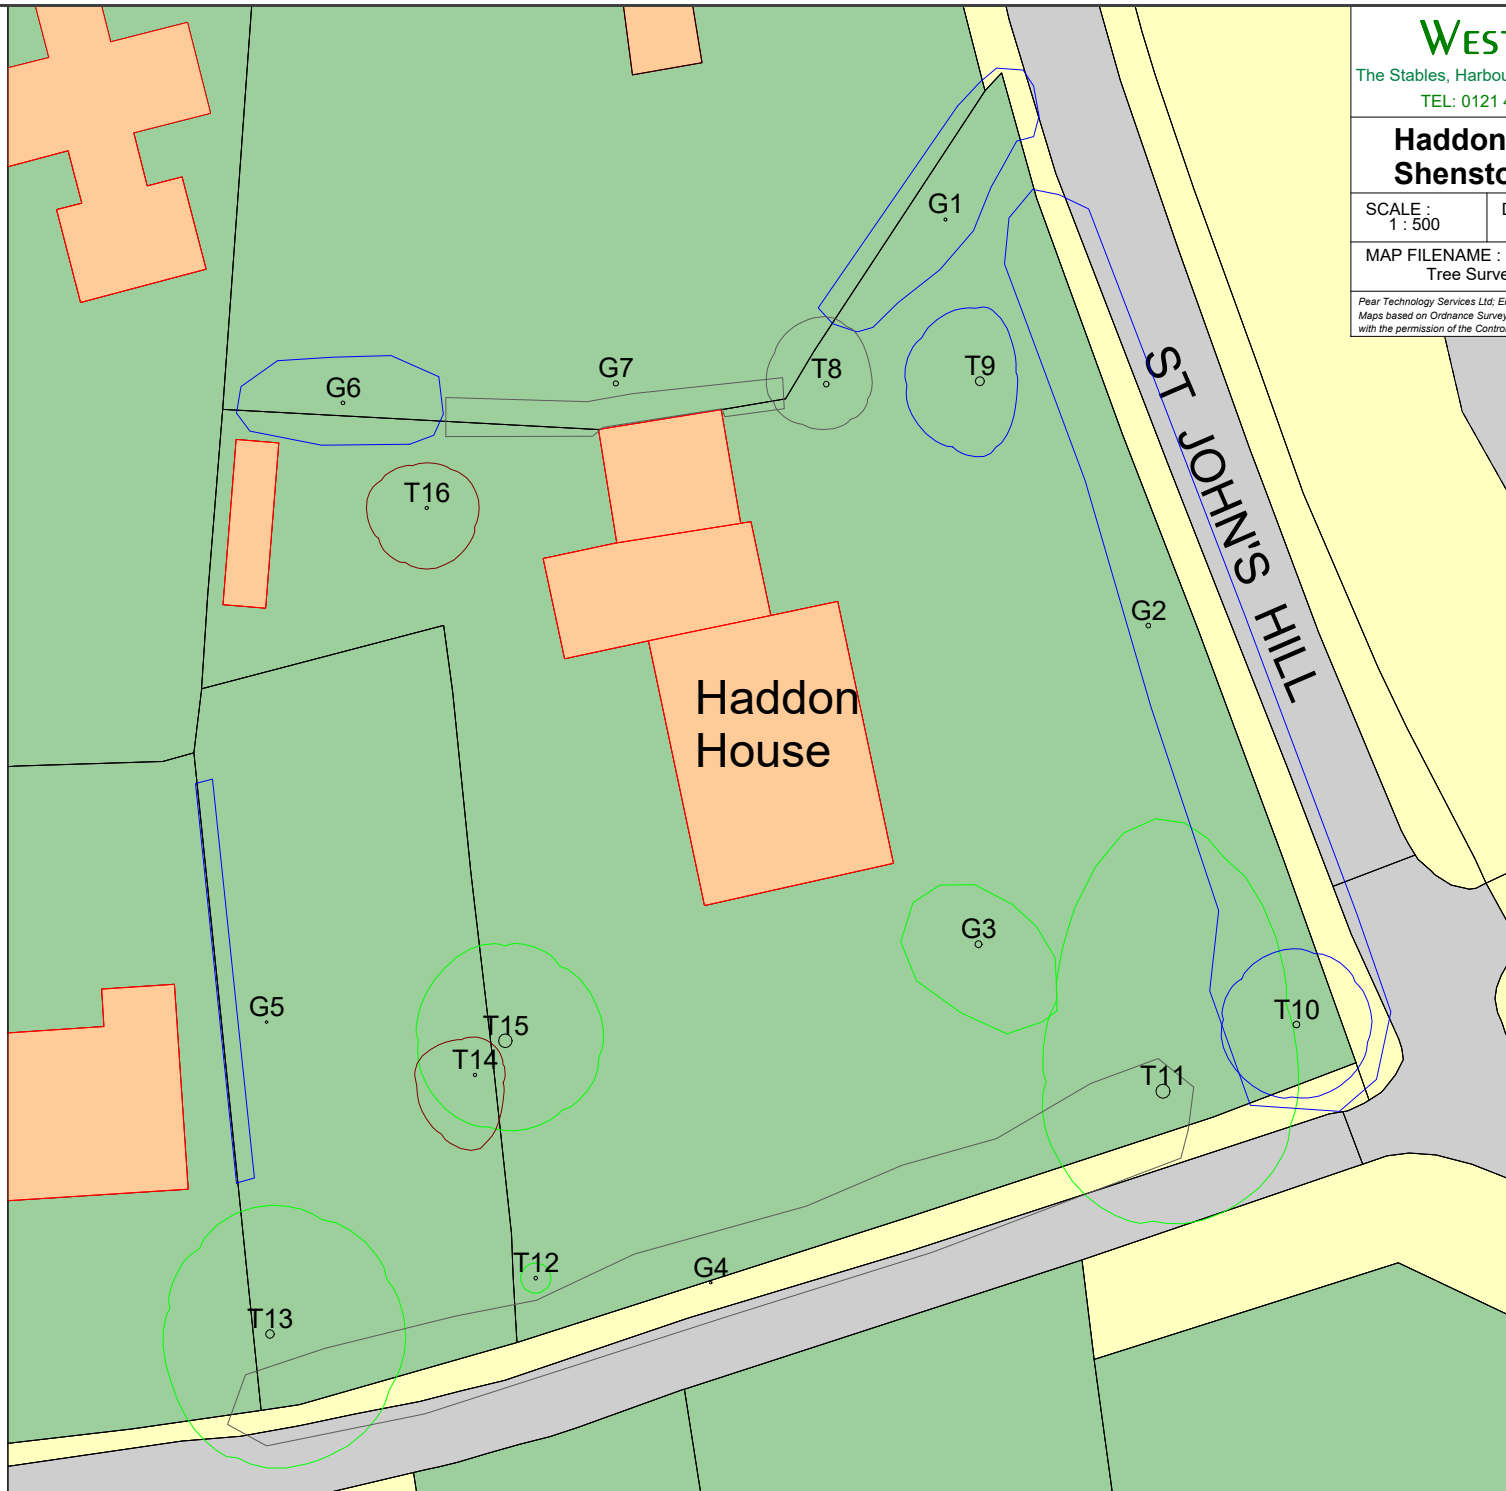
MAP FILENAME :  
Tree Survey Constraints Plan

- 2.2.3 Findings for each of the individual trees surveyed are summarised on the **Tree Survey (Constraints) Plan**, at **Appendix 3** contained at the rear of this report and listed individually within the **Tree Survey Table** at **Appendix 2**.

3.1.2 A total of 9 individual trees and 7 groups of trees were surveyed (a few saplings are present but have not been surveyed given their diminutive size), as shown on the **Tree Survey Plans at Appendix 3**, located to the rear of this report.

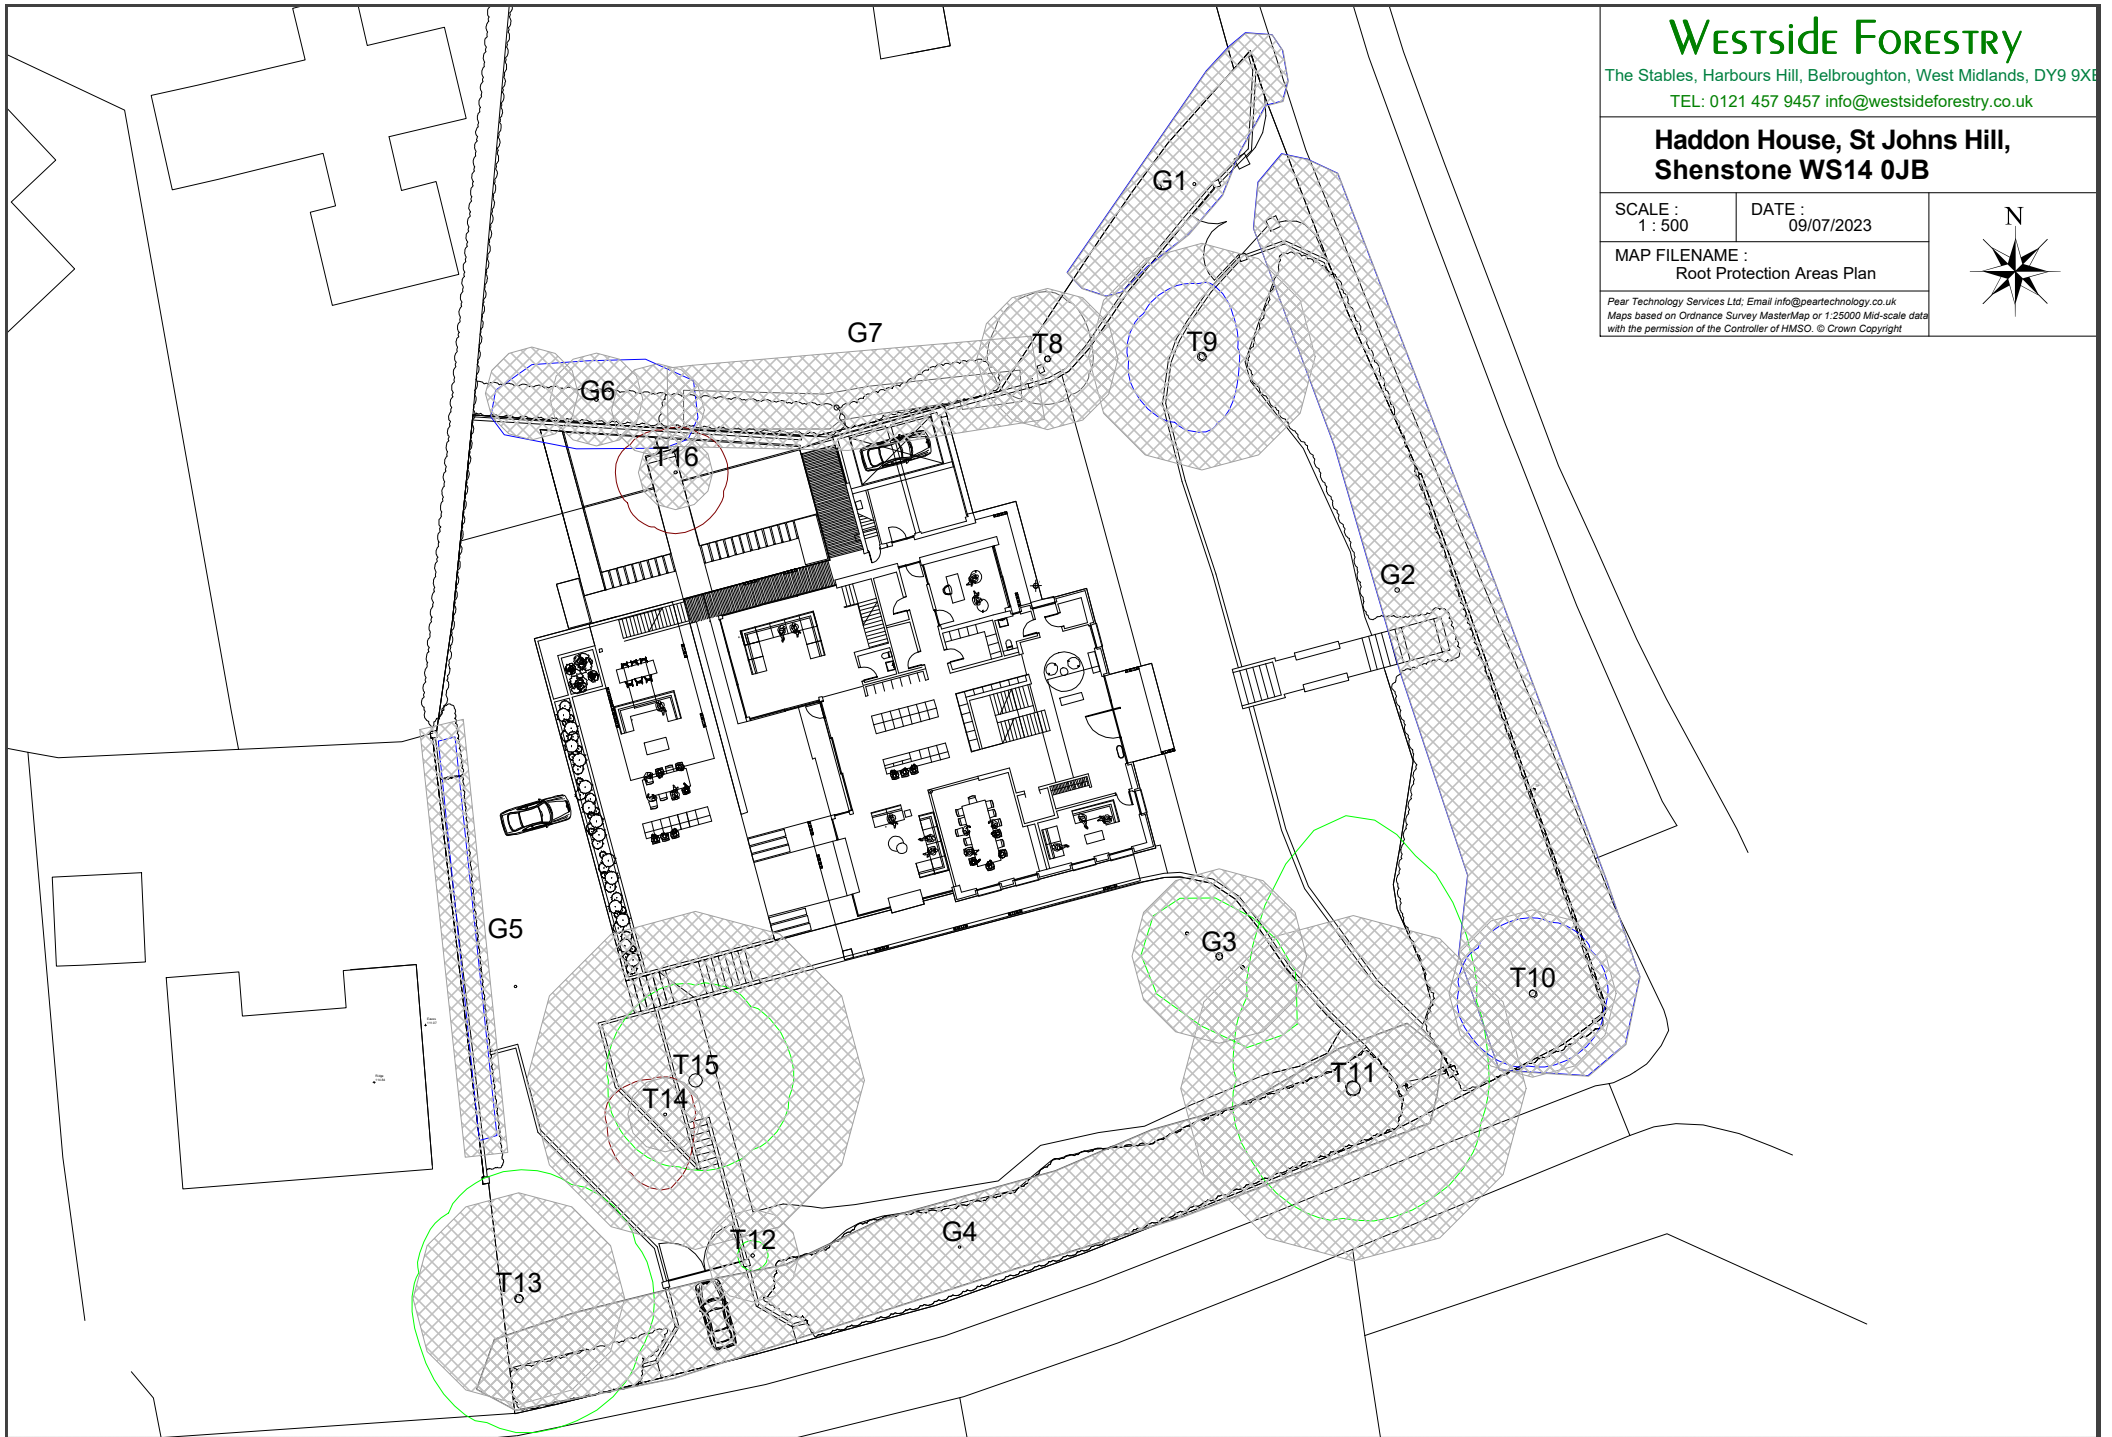
MAP FILENAME :  
Root Protection Areas Plan

3.6.2 The **Root Protection Areas Plan** at **Appendix 4**, located to the rear of this report shows the approximate extent of Root Protection Areas (RPA's).

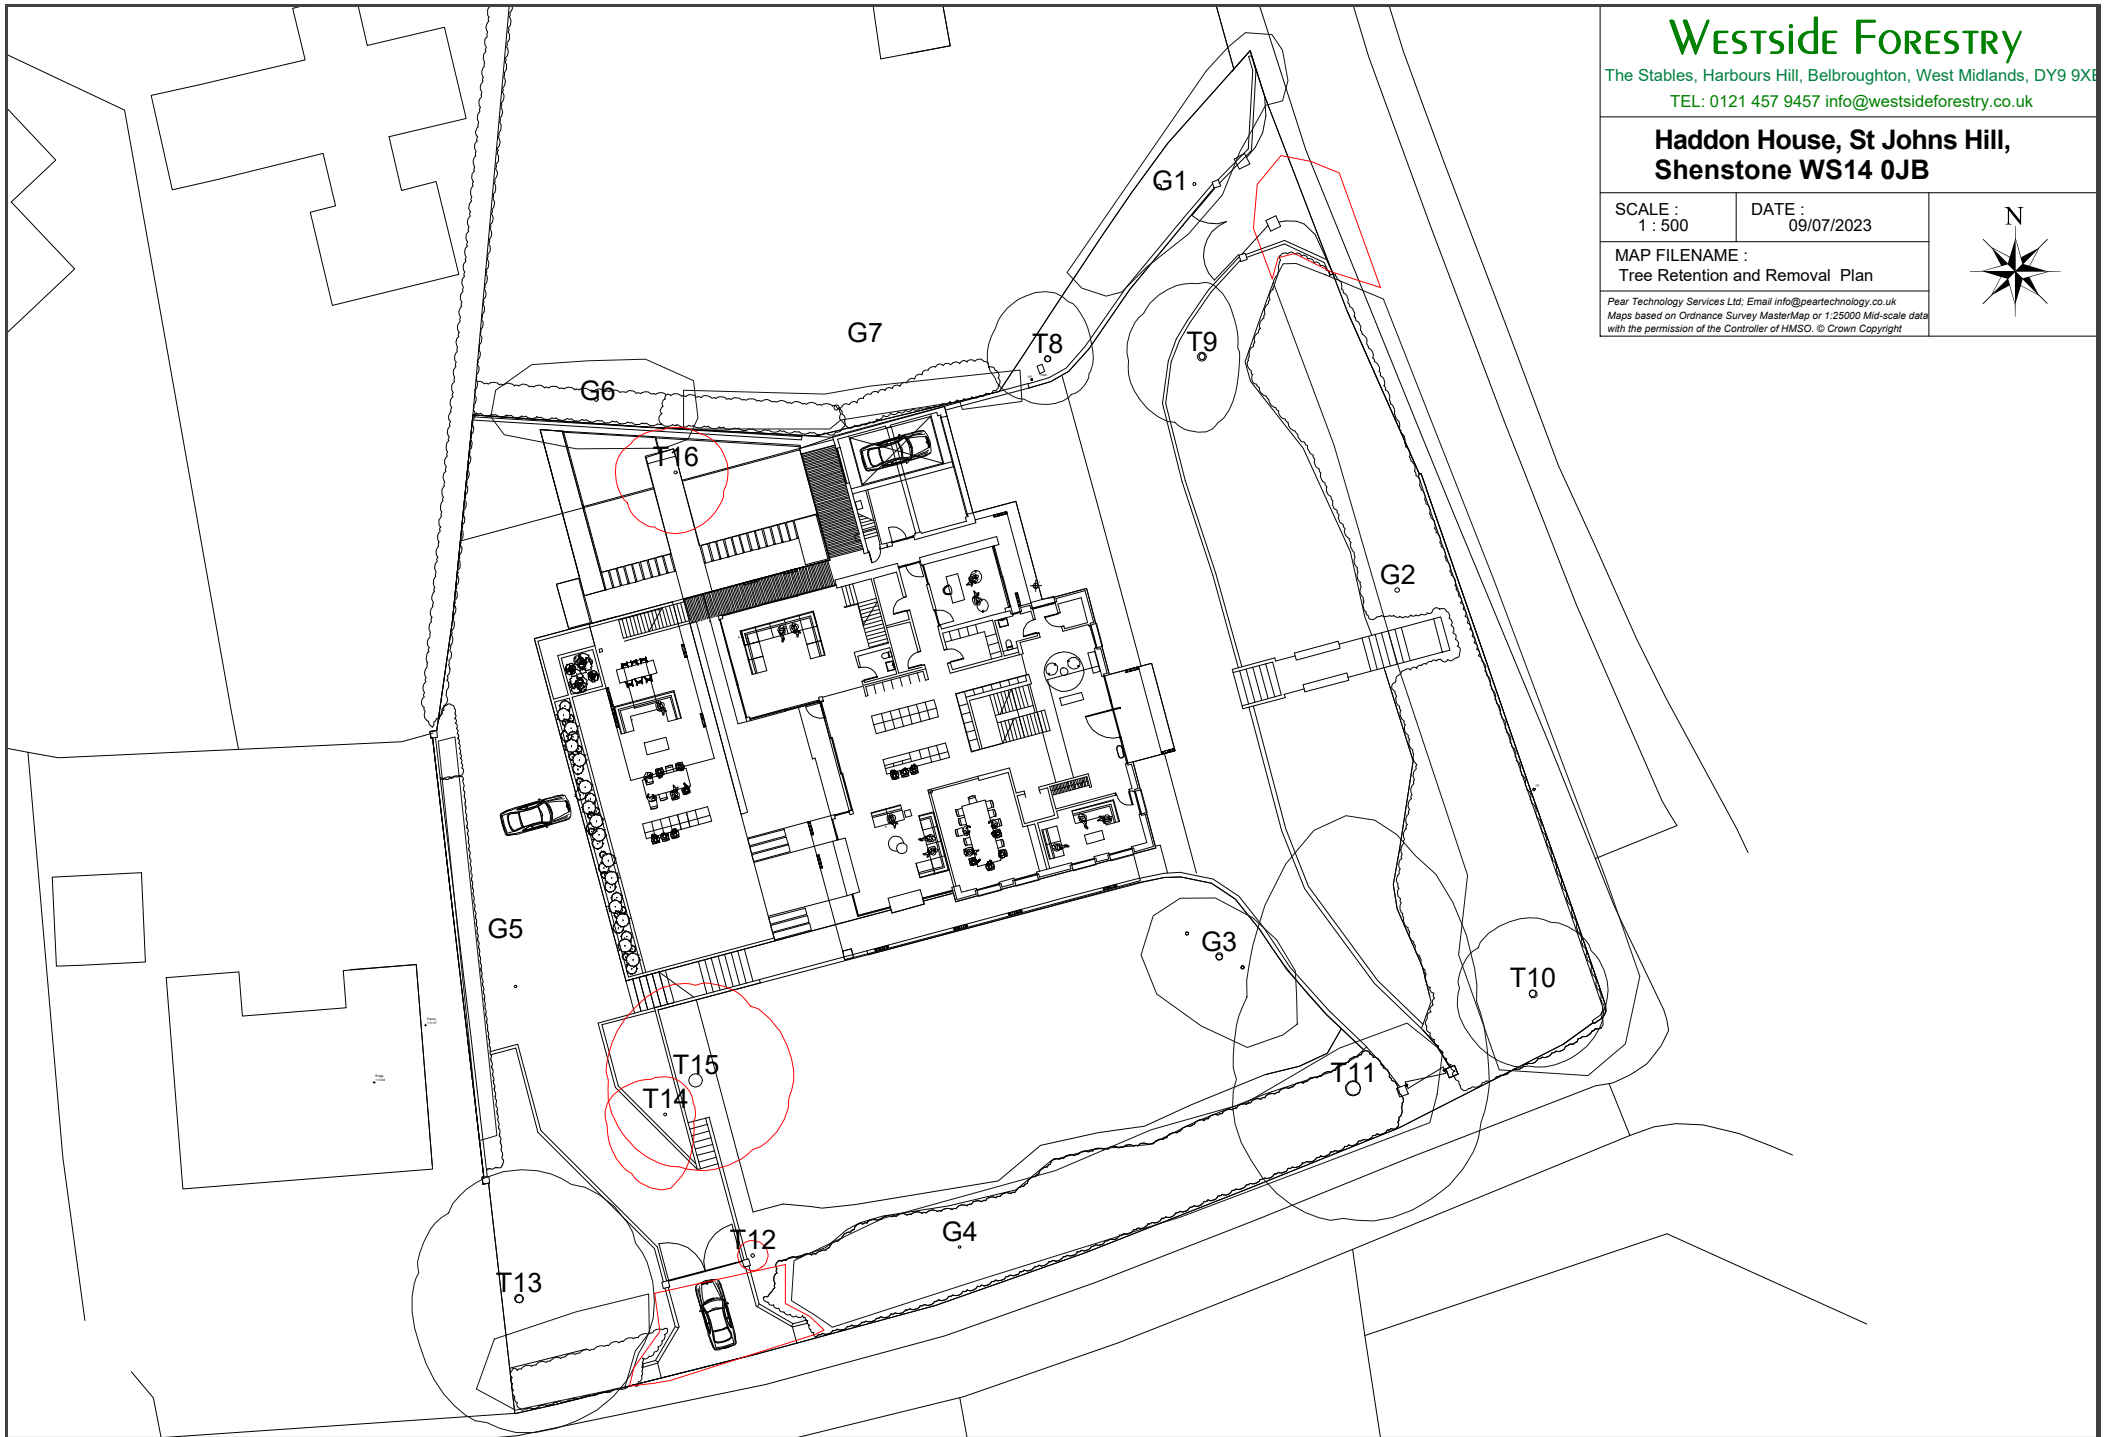
MAP FILENAME :  
Tree Retention and Removal Plan

3.9.1 The extent of tree loss predicted in relation to the current scheme proposals is illustrated on **Tree Retention and Removal Plan** at **Appendix 5**.

3.9.2 Given the consideration of the existing arboricultural context and the suggested extent of the redevelopment (as set out on the drawings provided) it is likely that the proposed works will result in the loss of 2 individual trees and 2 small sections of two groups, as summarised in Table 3 below:

- 3.8.11 Replacement planting is to be introduced to mitigate the loss of trees T15 and T12, to improve the species diversity, to provide screening and improve the general amenity of the locality.

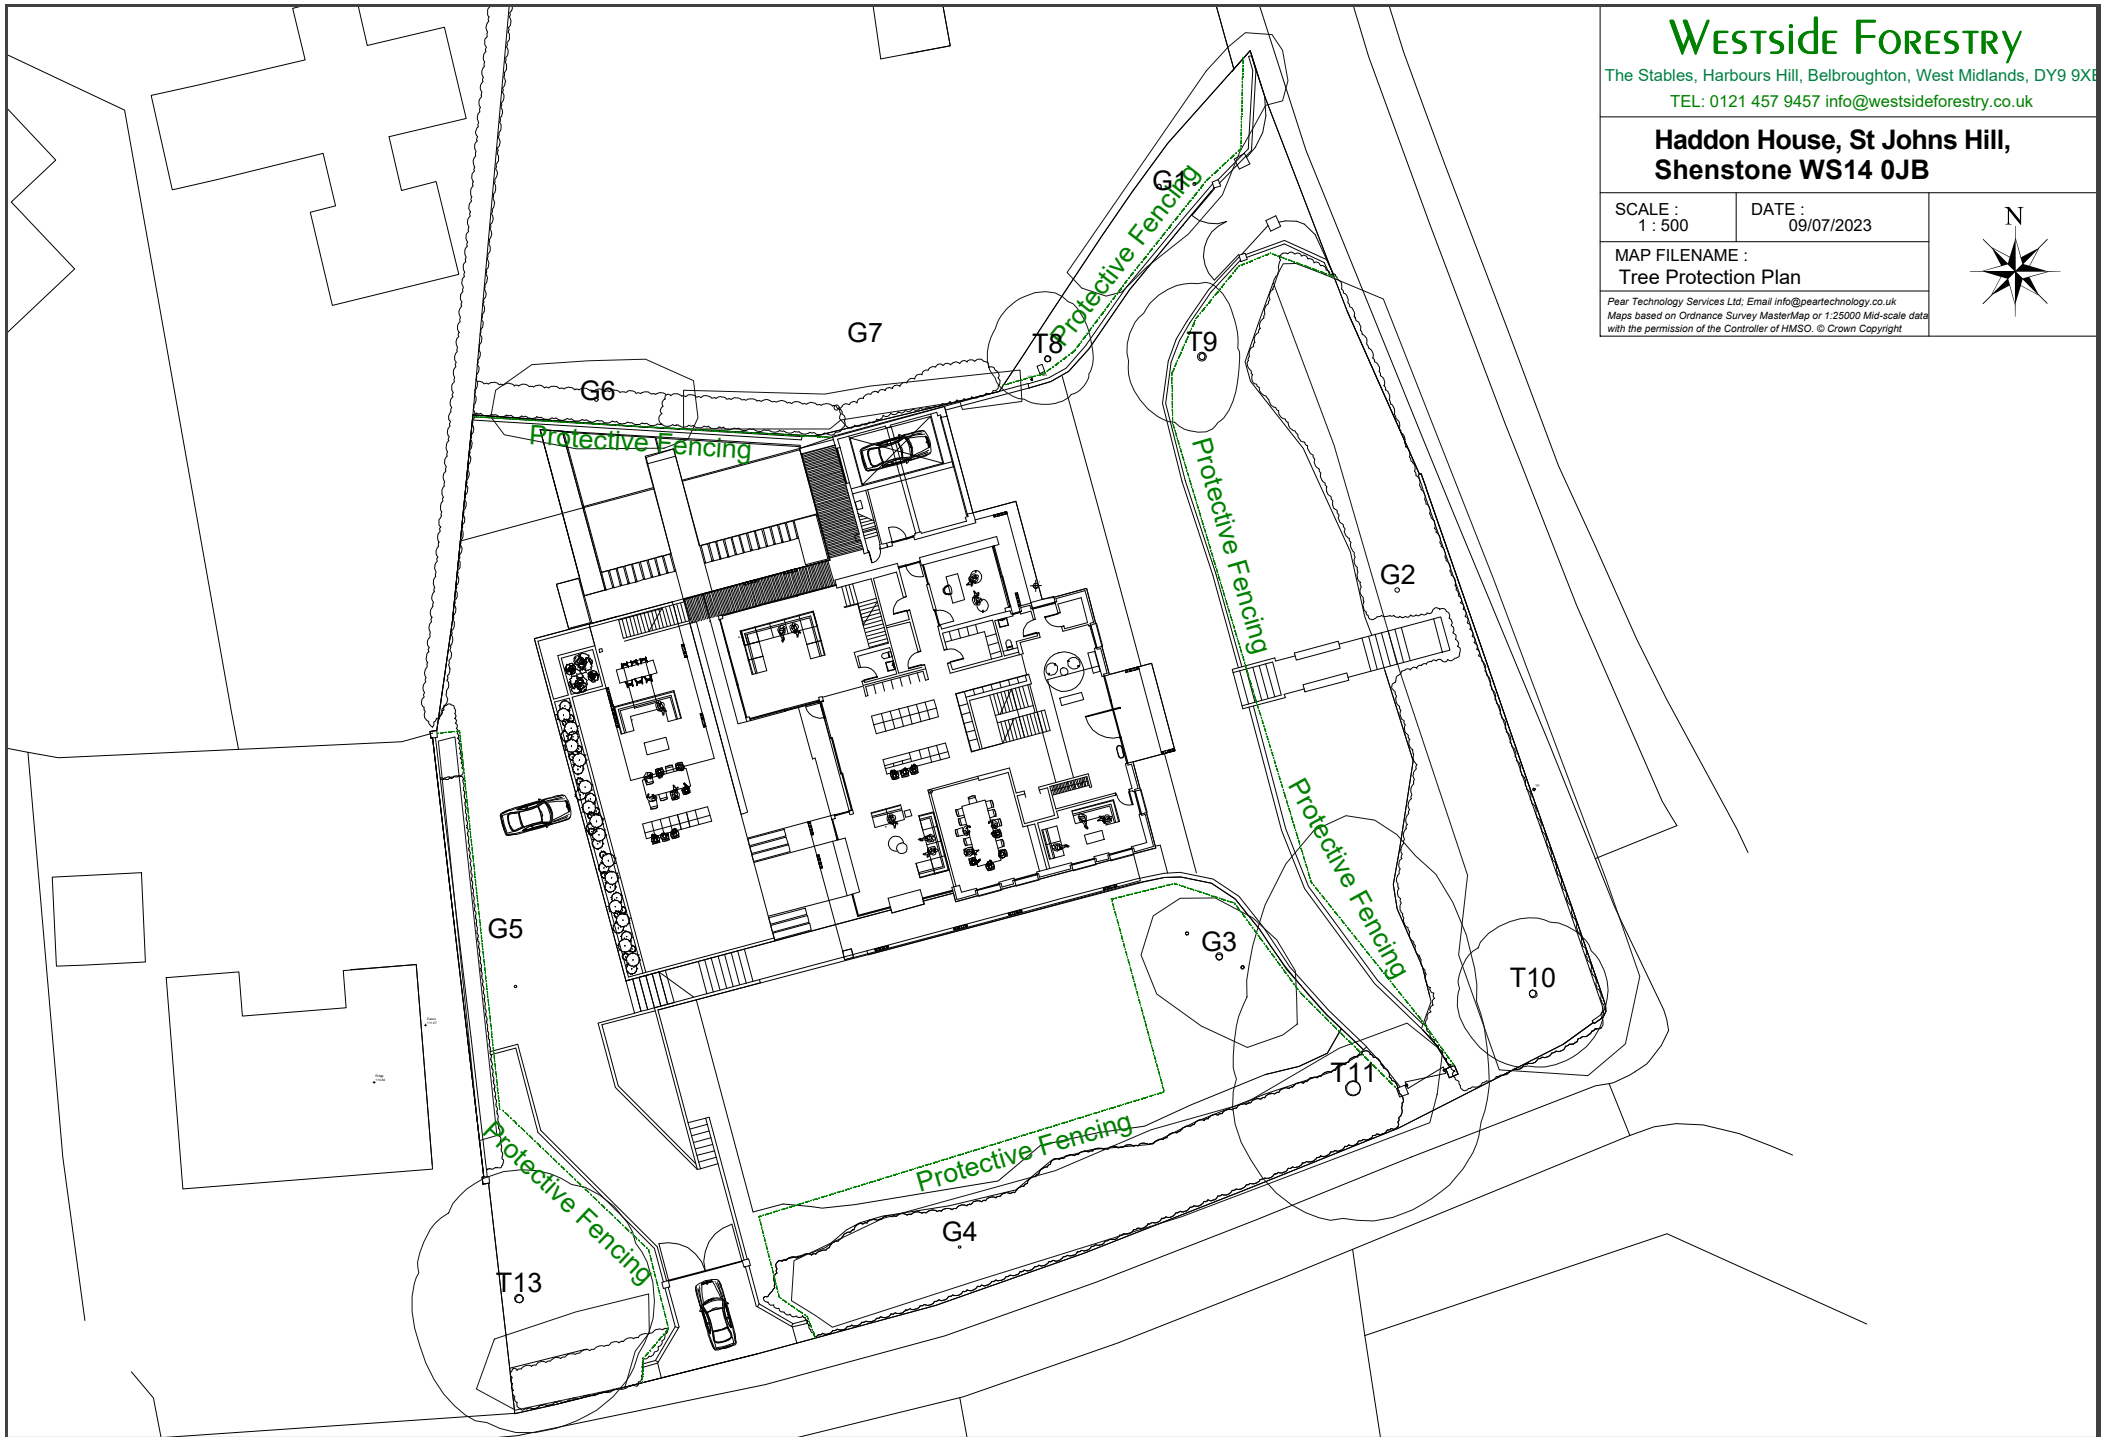
MAP FILENAME :  
Tree Protection Plan

4.0.2 Tree protection measures are illustrated on **Tree Protection Plan at Appendix 6** and outlined further below.

- 3.8.9 It is recommended that the large dead branches, within the canopies of Robina T8 and Beech T11 be removed, for safety reasons.
- 3.8.10 The retained trees and vegetation may be suitably protected during development activities, by the erection of protective fencing.
