David Wattam BSc(Hons)For-HND-Arb RIDINGS FORESTRY UK LTD
BS5837 2012 TREE SURVEY

South Cave Sports Pavilion, Bull Field, South Cave, East Riding of Yorkshire.

Wednesday, March 1, 2023

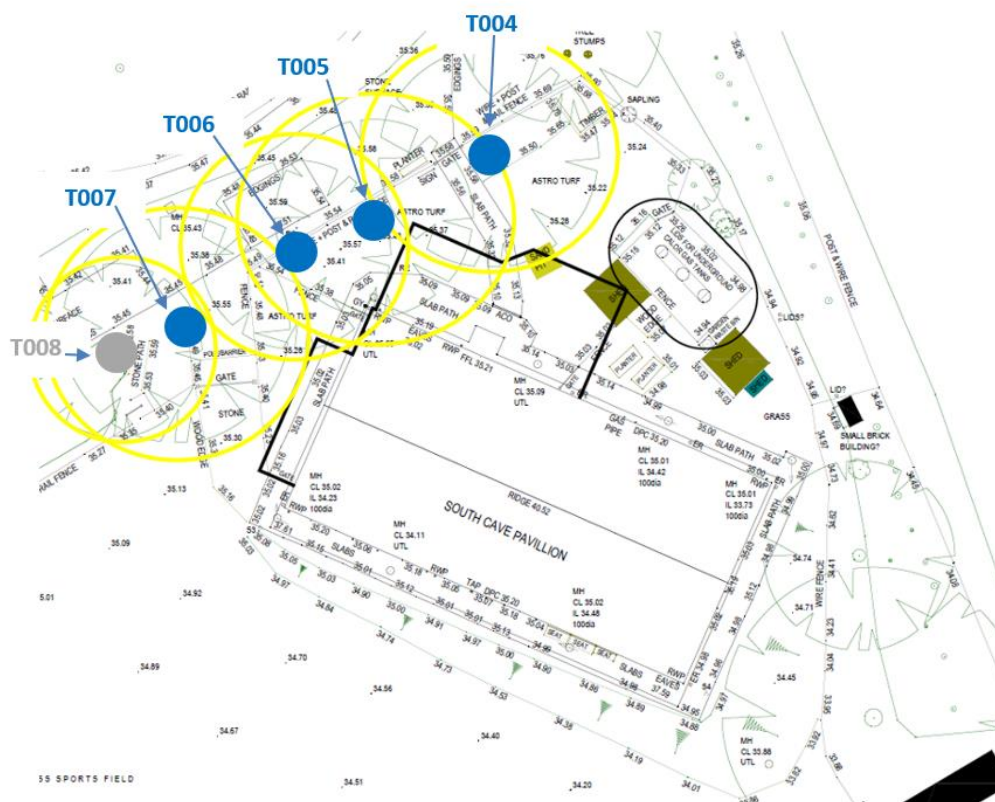
The new extension to the north and west of the existing building is shown on the plan below.

T004, T005, T006, T007 & T008 are the closest to proposed building works regarding the pavilion. The extension to the north of the pavilion directly effects the root protection areas (RPA) of T004, T005 and T006. The RPA of T005 is the most compromised by the proposed development.

No details regarding the construction of foundations have been provided. However, hand digging or micro piles, as discussed earlier, could be employed. Hand digging would avoid damage to the protective bark covering larger roots. Roots, whilst exposed, should be wrapped in dry, clean hessian sacking to prevent desiccation and to protect from rapid temperature changes. Roots smaller than 25 mm diameter may be pruned back, preferably to a side branch, using a proprietary cutting tool such as bypass secateurs or handsaws. Roots larger than 25 mm should only be severed following consultation with an arboriculturist, as they may be essential to the tree's health and stability. Prior to backfilling, any hessian wrapping should be removed and retained roots should be surrounded with sharp sand (builders' sand should not be used because of its high salt content which is toxic to tree roots), or other loose granular fill, before soil or other material is replaced. This material should be free of contaminants and other foreign objects potentially injurious to tree roots.

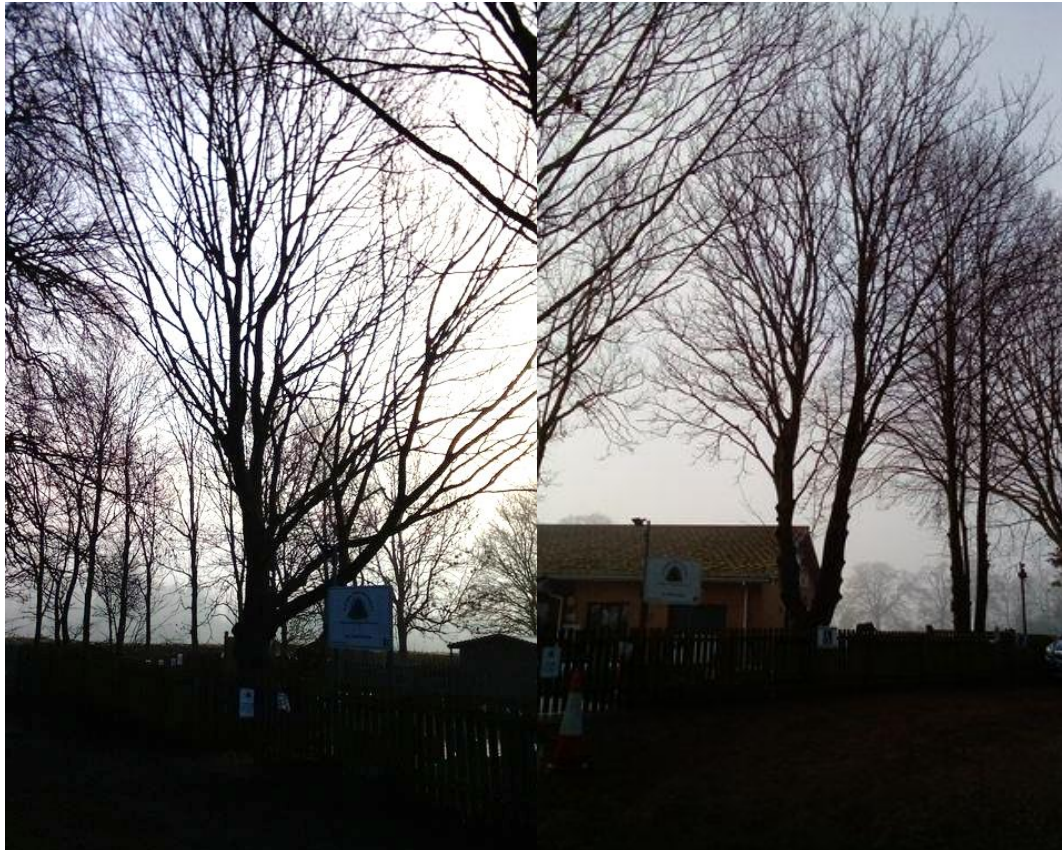
Access is clearly an issue regarding these trees. Any foundation works would be difficult to undertake without some damage occurring to roots of all the trees listed above. T005 is undoubtedly too close to the proposed extension. A large percentage of the RPA is compromised, also in my opinion, the tree would be over domineering and cause problems with leaf litter etc. Another option for any building works within the RPA would be to utilize piling systems There are two types of piling systems that can be employed within the RPA. One is Micro piling the other is Screw Piling. Micro piling involves hitting the piles into the ground whilst screw piles are rotated into the ground using a handheld or excavator mounted torque head. Installation occurs at a constant speed, inducing no vibration and requiring no pre-auguring. A screw pile displaces a comparatively small amount of soil & tree roots compared to a traditional micro pile. The helices attached to the screw pile shaft are deliberately made from thin steel plate, with a blunt protruding edge to ensure that where possible, roots are moved out of the way during installation rather than severing them. The pile shaft is considerable smaller than that of a micro pile so again, displacement of soil and tree roots is minimised. Should a micro pile encounter a root, the root would be severed.

T004

T005

T004 and T005 have been classed as Grade B trees. These are trees present in numbers, usually growing as groups or woodlands, such that they attract a higher collective rating than they might as individuals; or trees occurring as collectives but situated so as to make little visual contribution to the wider locality. The area has a woodland feel. However, the trees throughout this area, including the adjacent leisure facility, are even aged and have mostly been classed as mature. The loss of these to trees could facilitate this development and could also introduce newly planted trees into the area to diversify the overall age class thus, promoting the principles of continuous cover forestry. If assessing the area as a woodland it would be classed as high canopy. There is no understorey, no shrub layer and very little field layer. The trees throughout the whole area have received very little management.

The loss of T004 and T005 could be mitigated by producing a management plan for the whole area coupled with a comprehensive planting programme to address the even age structure of the wooded area. Trees within G1 and G2 have been planted very close together. A number of trees are being suppressed, some are heavily clad in Ivy and Ash dieback is present. If the age structure of trees on site are not altered, then this valuable amenity will be lost to future generations.

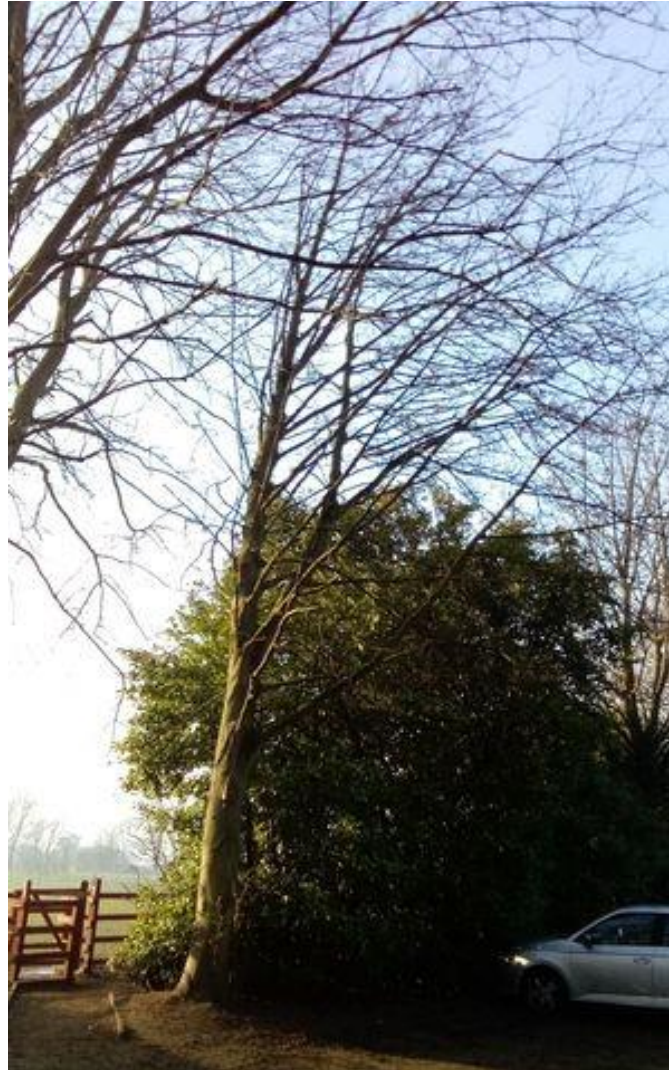
T008 Sycamore

T008 has been classed as Grade C with poor overall physiological and structural condition.. See Picture below.

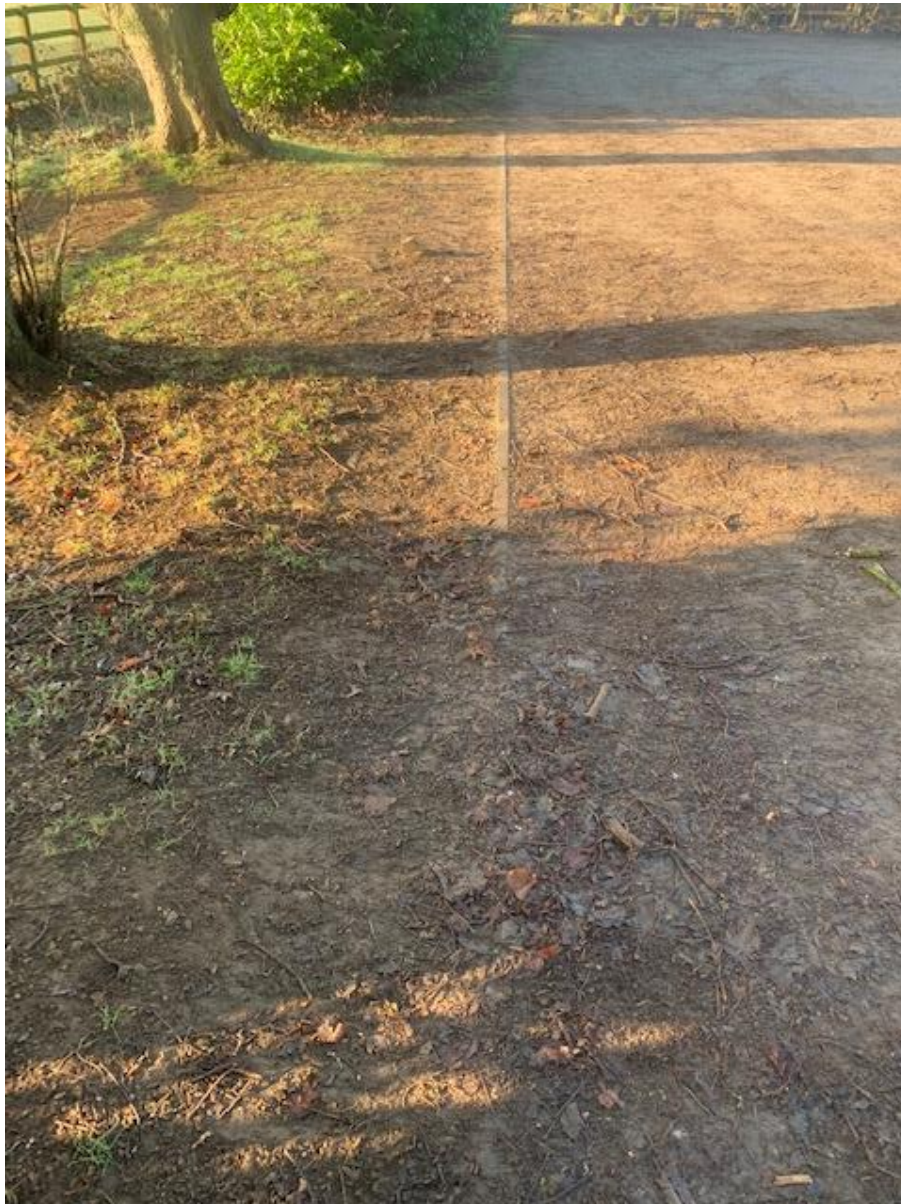
Concrete edging can be found around the existing car park. Please see picture below.

Ideally, existing edgings, footings and surfaces should remain in place. Existing surfaces could be sympathetically levelled and the overall surface of the car park and entranceway raised. This would avoid damage to tree rooting systems.

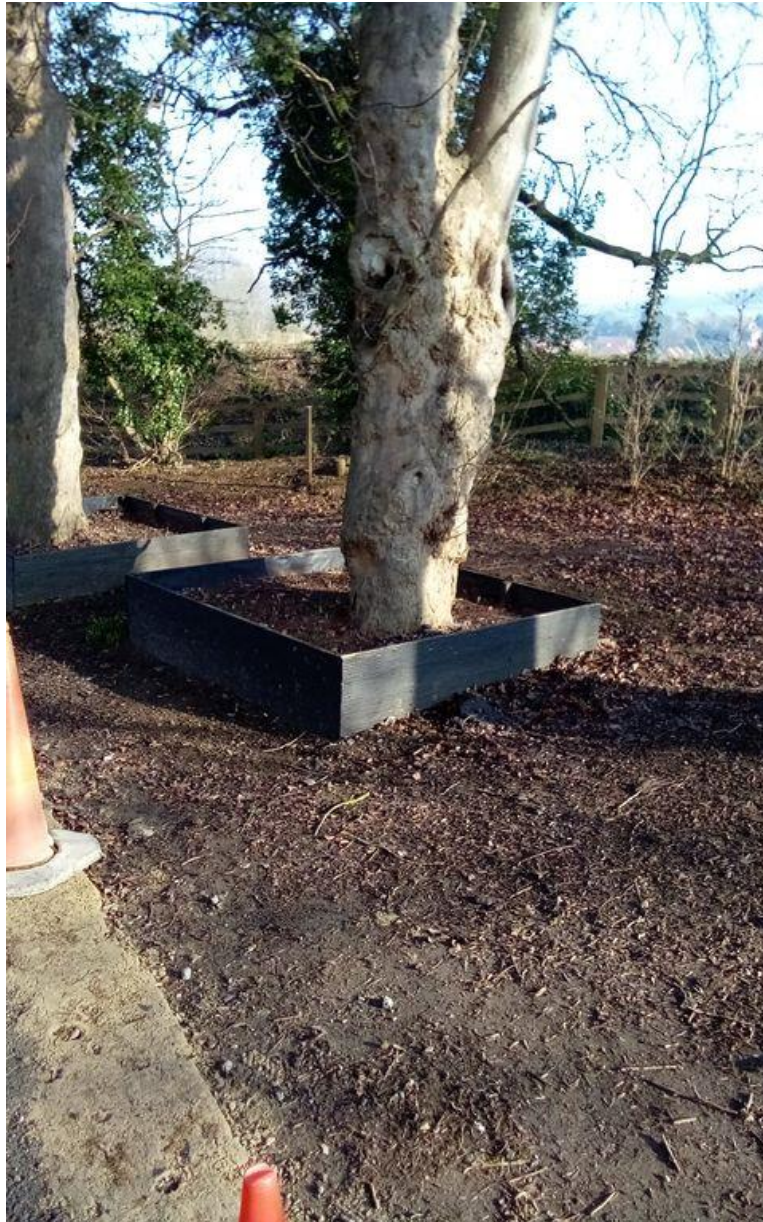
T028 and T029 have been classed as Grade B trees. These two trees are on the cusp of being classed as over mature. There are some cavities within the branch structures of both trees and could be a habitat for bats. Unfortunately, they have had planters built around the base of both trees. Please see picture below.

This practice is highly detrimental to tree health and stability causing the rot around the base of the tree.
