Design and Access Statement

**Westbrook House
High Street
North Wootton
Somerset
BA4 4AD**

LBC Westbrook House September 2023

1.1 Introduction

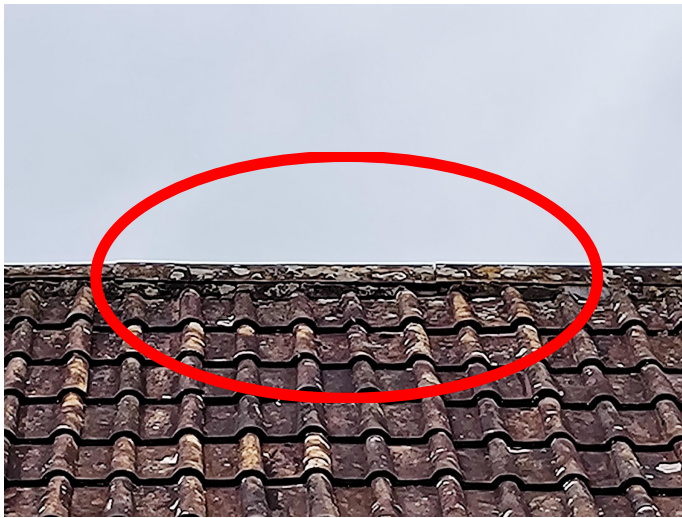
The roof is double roman tiled with cast iron gutters at the front and rear and three red brick chimney stacks. The roof at present is sound, but there are a number of leaks into the attic space that need fixing as water is ingressing along the ridge tiles where the bedding mortar has failed in places.

Photo showing bedding mortar failure

- Conduct minor repairs to ridge tiles on the main roof and other minor repair work necessary (e.g. replace broken tiles/ slipped tiles).
- Repair and/replace south drip end on roof verge.
- Repoint red brick chimney stacks as necessary/appropriate using standard cement.
- Repair and replace lead flashings as necessary around the base of chimneys.

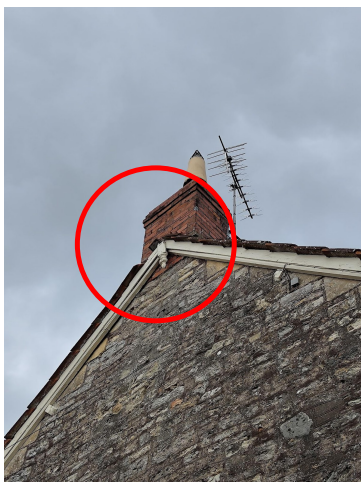
There are also some slipped/broken tiles that need replacing as well as the West gable end rake/drip end that needs replacement since it is rotting.

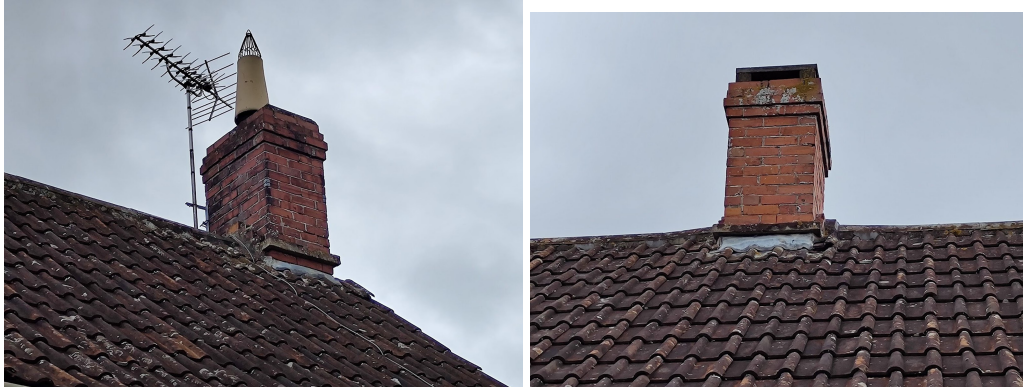
The three chimney stacks appear sound, however could do with some minor cement repointing where necessary. Some of the lead flashing around the base of the stacks also needs replacement, where necessary.

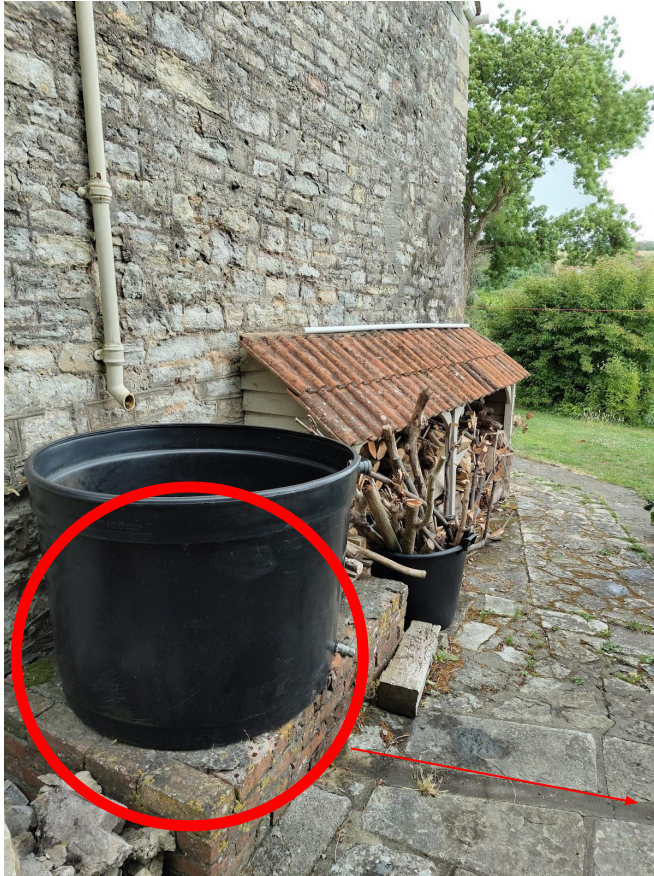
The main house has a single gutter channel running along the front (West face) of the property which then moves around towards the South gable end, feeding a down pipe into a broken and leaky water butt. This is causing harm to the setting of the listed building and is visually intrusive.

Photo showing old water butt with degrading brick base and outflow.

The applicant wishes to remove the water butt and red brick base, which shows signs of degradation through water damage, and extend the guttering system to ground level and into a coiled pipe (100mm deep) running away from the property to the rear of the garden.

The above drainage upgrade aims to take rainwater away from the property at a major point thereby reducing: permeation into stonework, surface water flooding and soil movement.

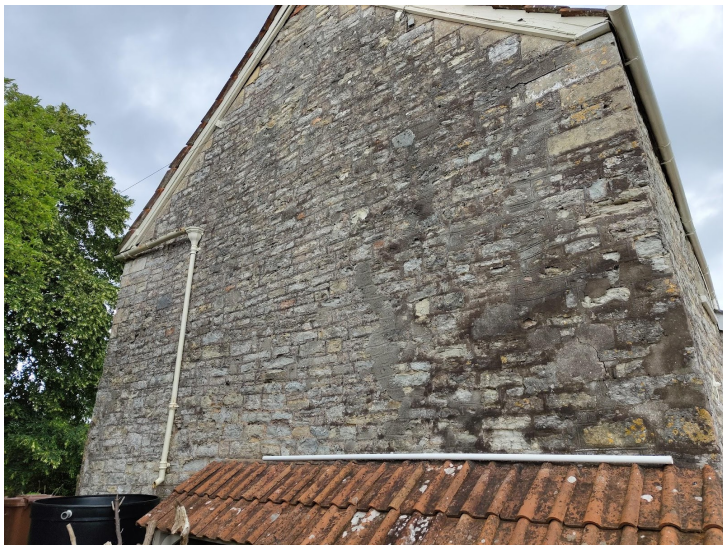
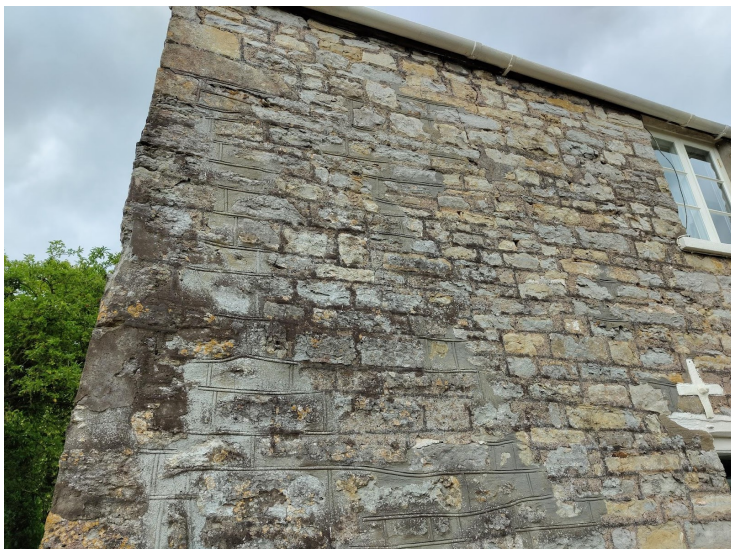
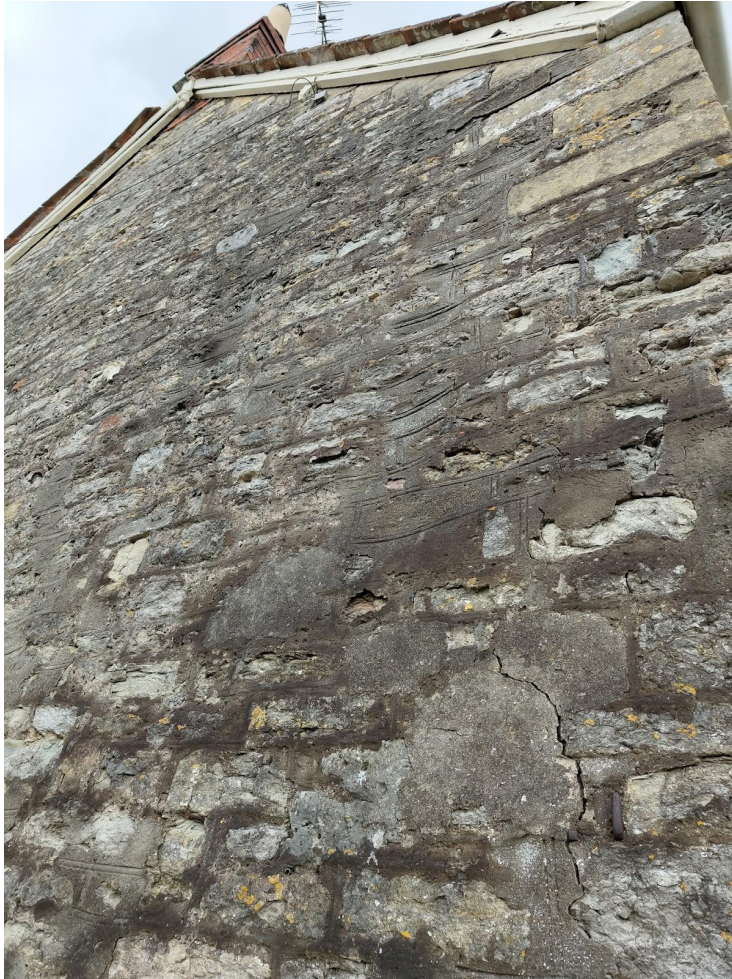
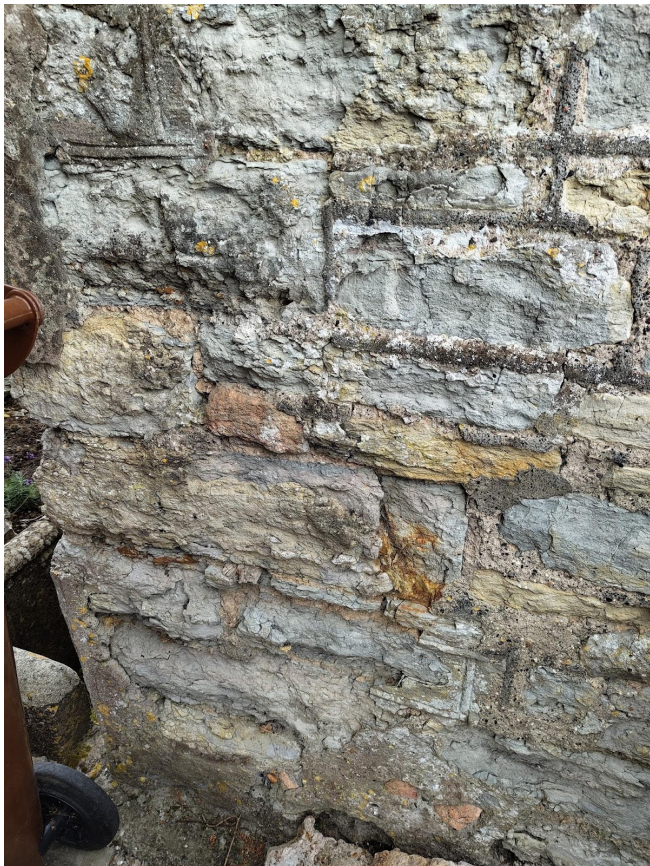
The current masonry and pointing on the South gable end wall is in very poor condition with signs of lamination and crumbling of both the stone and pointing. The pointing is predominantly cement which is not suitable for stone work and not of historic value. The cement can be clearly seen to be failing allowing water to pass behind it in places which is affecting the historical significance and future of the property.

Photos above showing the state of South gable end; lamination, disintegration of stone and poor cement repairs from the past.

The applicant wishes to employ a local conservation mason, erect scaffolding, rake out and repoint with a lime mortar NHL 3.5. There are some stones that show severe degradation and these will need replacing as necessary with Blue Lias.

N.B: NHL (Non-hydraulic Lime 3.5) is suitable for hard stone in exposed locations. The applicant is happy to discuss this in more detail with a Conservation Officer during the application process.

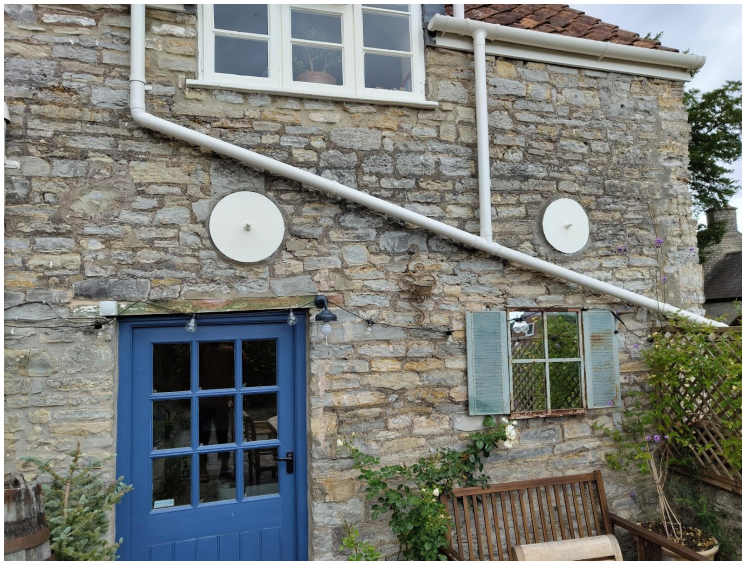
The north wall of the Annex is of concern since water ingresses into the room during high rainfall and this is affecting the condition of the wall on the inside.

Photo showing North Wall of the Annex.

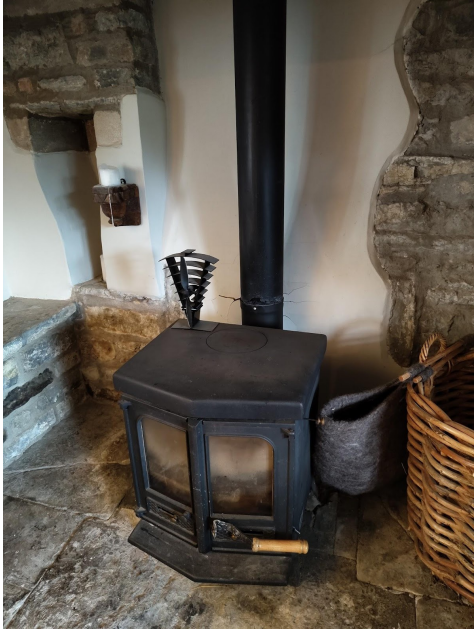
The current wood burning stove in the living room is over 20 years old, inefficient and NOT HETAS approved. The applicant wishes to re-install a more efficient and environmentally friendly ECO design wood burning stove, replacing the existing flue and chimney cowl.

Photo shows old wood burning stove in living room.

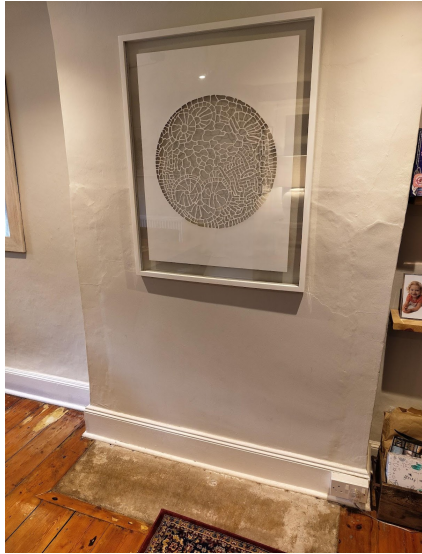
The applicant wishes to reinstate an original fireplace that would have once been used in the dining room/living room on the north side of the property. Currently it is blocked up and used to house the old oil boiler flue, exiting up the north chimney. The proposal is to knock out the fireplace, make good and install a small 4kw ECO HETAS approved stove with a new chimney cowl and the addition of a new hearth.

Photo shows blocked fireplace in the dining room with the original hearth.
