BERKELEY HOUSE, LYNSTED

TREE SURVEY

DWG No: **FV04329-01**
 Scale: **1:200 (A1)**
 Date: **24 - 07 - 2023**
 By: **KCF**

TREE CONDITION SURVEY

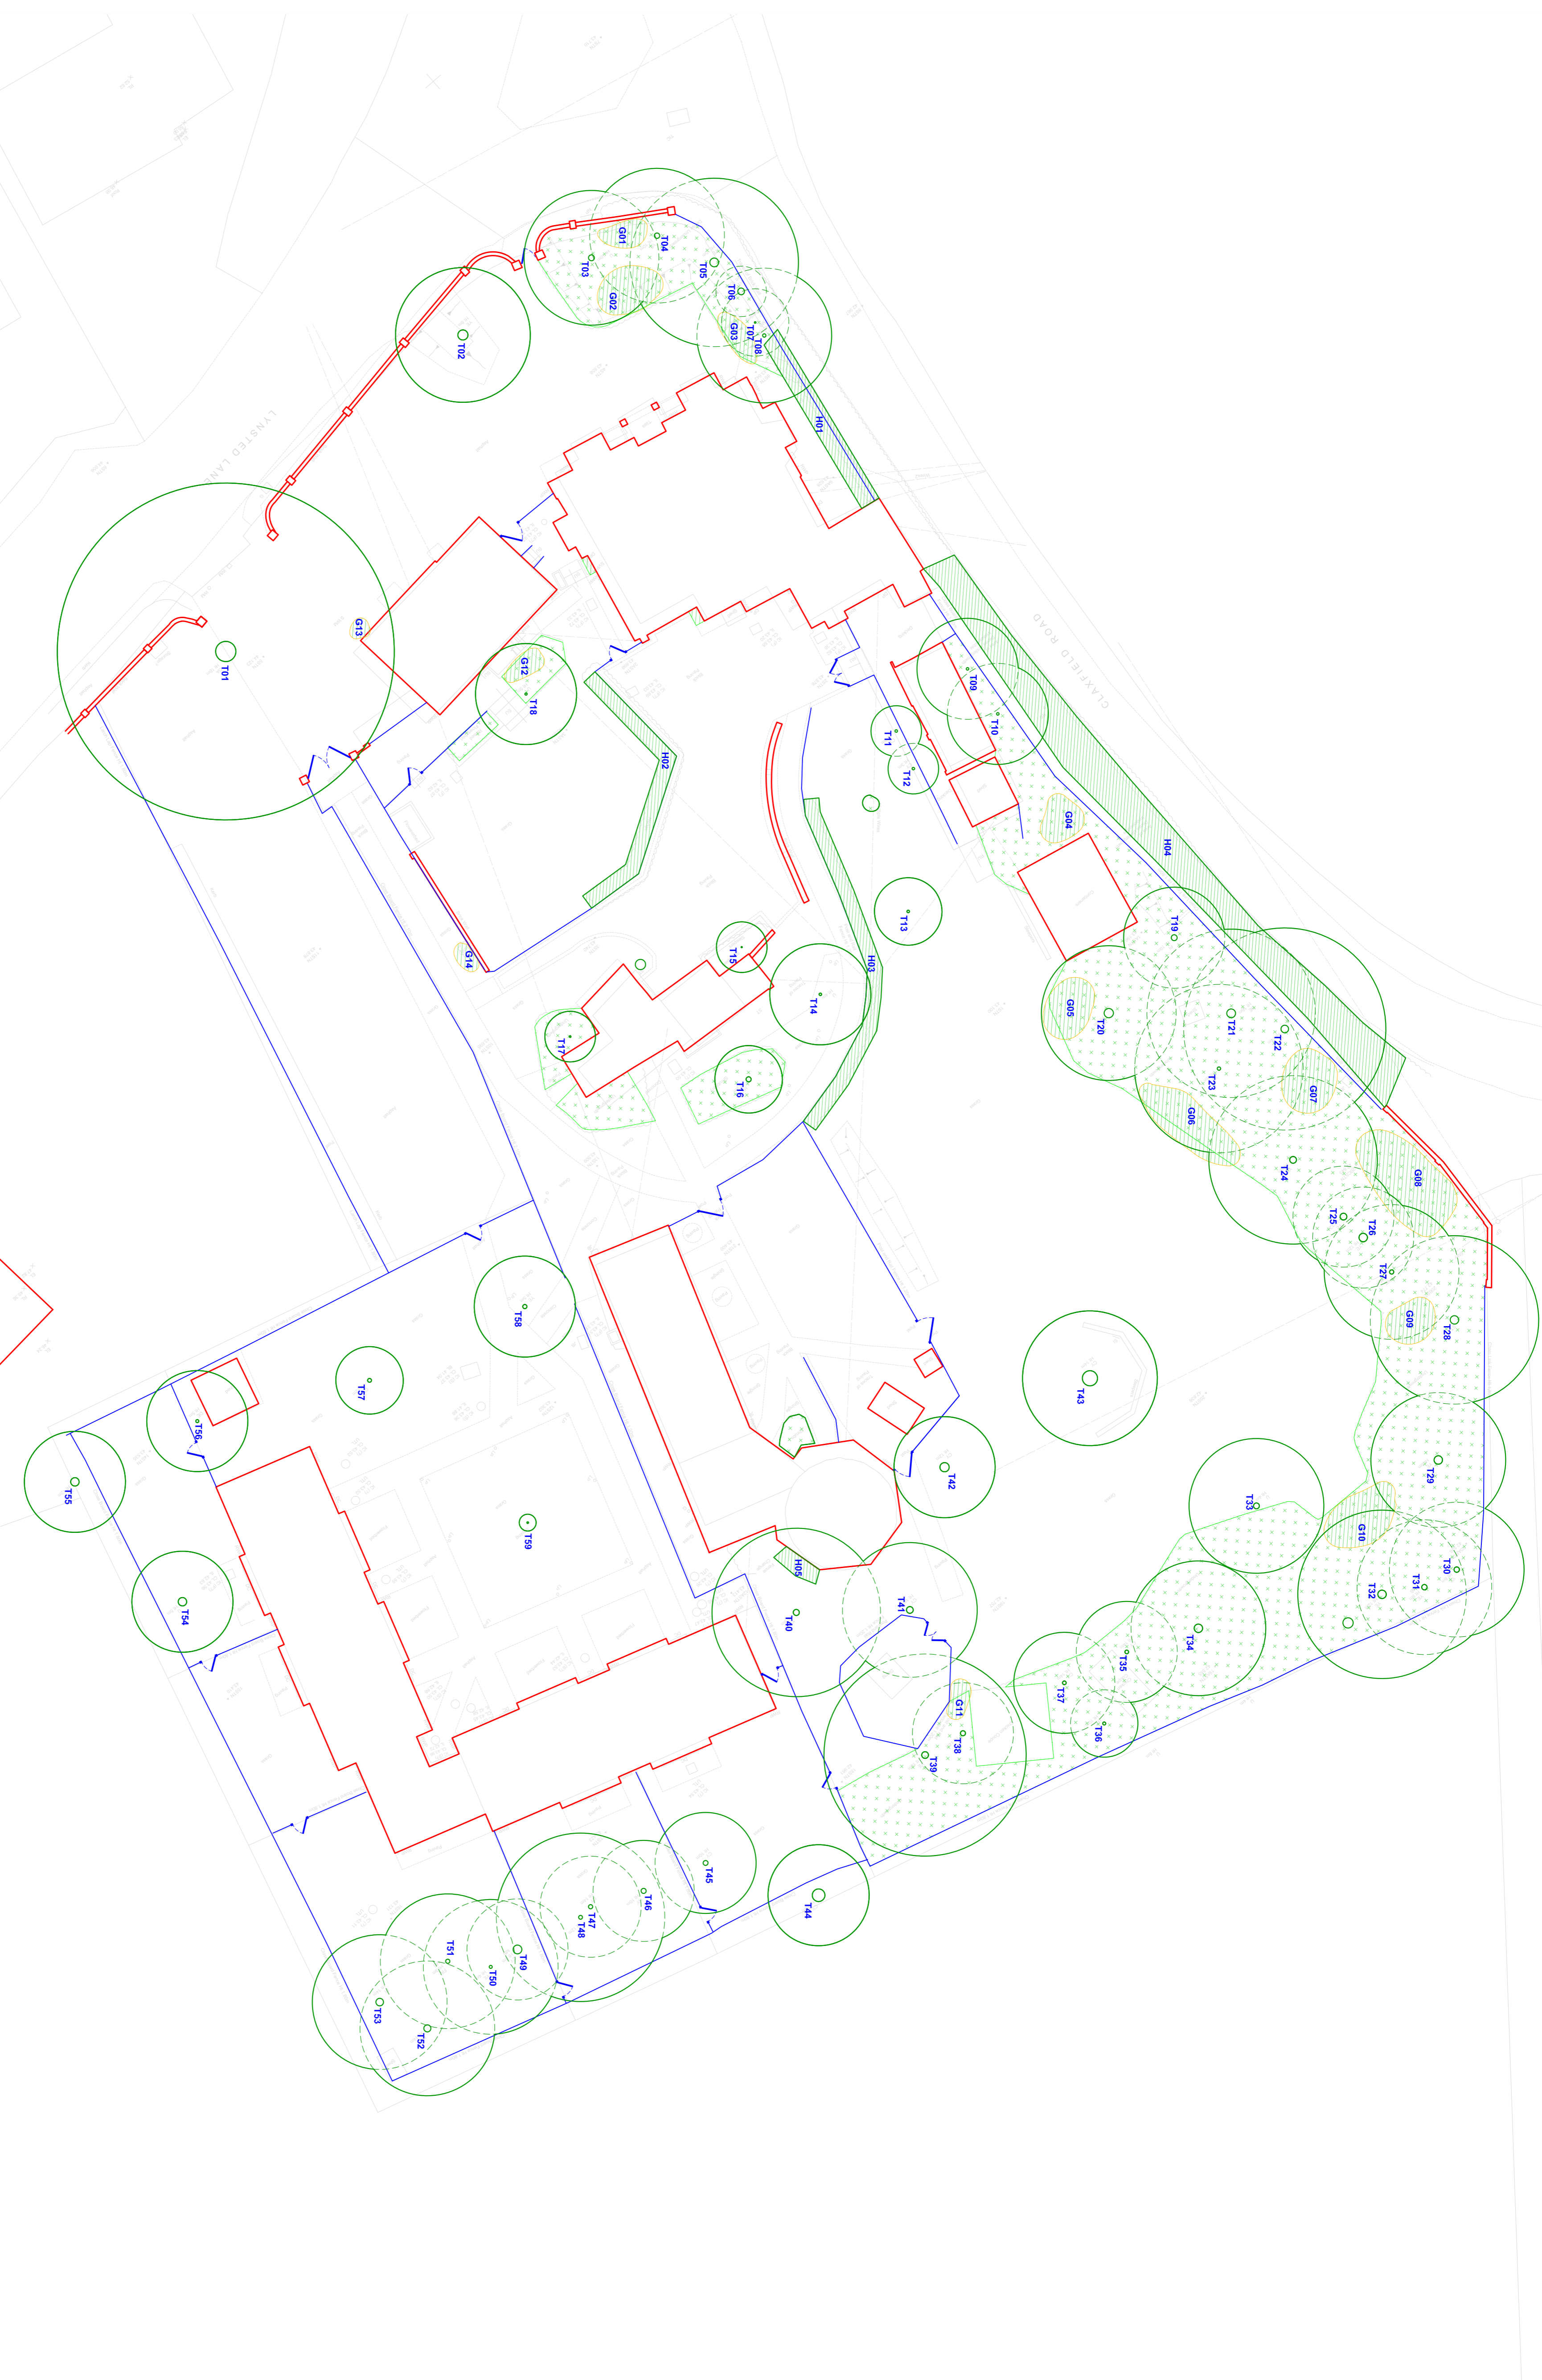
REF	BOTANICAL NAME	COMMON NAME	HEIGHT (m)	SPREAD (m)	GIRTH (cm)	DIAMETER (cm)	STEMS	CONDITION	PROTECTED	NOTES
T01	<i>Quercus ilex</i>	Holme Oak	12	10	360	115	1	(A) Healthy	YES	
T02	<i>Taxus baccata</i>	Yew	7	4	60	20	7	(A) Healthy	YES	Ivy Growth to be removed
T03	<i>Taxus baccata</i>	Yew	8	4	45	15	8	(C) Poor Condition	YES	Dense Ivy Growth to be removed
T04	<i>Taxus baccata</i>	Yew	7	4	127	41	3	(B) Good	YES	Low quality tree development, and in competition with larger pre-established trees
T05	<i>Taxus baccata</i>	Yew	9	5	210	67	1	(A) Healthy	YES	Ivy Growth to be removed
T06	<i>Ilex aquifolium</i>	Holly	4	1.5	10	4	1	(C) Poor Condition	NO	Poor tree development, and in competition with larger pre-established trees
T07	<i>Ilex aquifolium</i>	Holly	6	2	36	12	1	(C) Poor Condition	YES	Poor tree development, and in competition with larger pre-established trees
T08	<i>Fagus sylvatica f. purpurea</i>	Copper Beech	9	4	50	16	4	(B) Good	YES

T09	<i>Taxus cuspidata sp.</i>	Japanese Yew	9	3	-	-	-	(A) Healthy	YES	Not being maintained, and outgrowing small space behind building.
T10	<i>Taxus baccata</i>	Yew	9	3	-	-	-	(A) Healthy	YES	
T11	<i>Juniperus sabina</i>	Savin Juniper	2.5	1.5	17	6	1	(B) Good	NO	Building side of plant is exposed with no foliage, where growing against trellis
T12	<i>Juniperus sabina</i>	Savin Juniper	2.5	1.5	10	4	1	(B) Good	NO	Building side of plant is exposed with no foliage, where growing against trellis
T13	<i>Prunus avium</i>	Sweet Cherry	4.5	2	34	11	1	(A) Healthy	YES	
T14	<i>Laburnum anagyroides 'Medik'</i>	Common Laburnum	3	3	55	18	1	(A) Healthy	YES	
T15	<i>Alnus cordata</i>	Italian alder	5	1.5	10	4	2	(A) Healthy	NO	
T16	<i>Ilex aquifolium</i>	Holly	8	2	60	20	4	(A) Healthy	YES	
T17	<i>Taxus baccata</i>	Yew	4	1.5	30	10	4	(A) Healthy	YES	
T18	<i>Laburnum anagyroides 'Medik'</i>	Common Laburnum	5	3	50	16	1	(A) Healthy	YES

T19	<i>Pinus sylvestris</i>	Scots Pine	5	3	30	10	1	(B) Good	YES	Ivy Growth to be removed, Requires general maintenance, removing dead dying and damaged branches
T20	<i>Taxus baccata</i>	Yew	6	4	250	80	1	(A) Healthy	YES	
T21	<i>Tilia cordata</i>	Small-leaved Lime	10	5	200	64	1	(A) Healthy	YES	
T22	<i>Tilia cordata</i>	Small-leaved Lime	11	6	200	64	1	(A) Healthy	YES	
T23	<i>Taxus baccata</i>	Yew	6	4	106	34	1	(A) Healthy	YES	
T24	<i>Taxus baccata</i>	Yew	7	5	34	11	5	(B) Good	YES	Requires general maintenance, removing dead dying and damaged branches
T25	<i>Taxus baccata</i>	Yew	6	3	50	16	6	(A) Healthy	YES	
T26	<i>Taxus baccata</i>	Yew	6	3	70	23	3	(A) Healthy	YES	
T27	<i>Taxus baccata</i>	Yew	7	4	70	23	4	(A) Healthy	YES	
T28	<i>Crataegus monogyna</i>	Hawthorn	5	3	50	16	1	(B) Good	YES	Ivy Growth to be removed. A top heavy tree, relying on wall for support
T29	<i>Rhus typhina</i>	Stag's Horn	4	4	18	6	2	(A) Healthy	NO

T30	<i>Taxus baccata</i>	Yew	7	3	90	29	1	(B) Good	YES	Ivy Growth to be removed, Requires general maintenance, removing dead dying and damaged branches
T31	<i>Taxus baccata</i>	Yew	8	4	150	48	1	(A) Healthy	YES	
T32	<i>Taxus baccata</i>	Yew	9	5	120	39	1	(A) Healthy	YES	
T33	<i>Laburnum anagyroides 'Medik'</i>	Common Laburnum	6	4	65	21	2	(A) Healthy	YES	
T34	<i>Taxus baccata</i>	Yew	7	4	75	24	10	(A) Healthy	YES	Ivy Growth to be removed
T35	<i>Chamaecyparis lawsoniana</i>	Lawson Cypress	11	3	126	41	1	(A) Healthy	YES	
T36	<i>Ilex aquifolium</i>	Holly	8	2	45	15	1	(C) Poor Condition	YES	Poor tree development, and in competition with larger pre-established trees
T37	<i>Chamaecyparis lawsoniana</i>	Lawson Cypress	12	3	127	41	1	(A) Healthy	YES	
T38	<i>Chamaecyparis lawsoniana</i>	Lawson Cypress	10	3	90	29	1	(A) Healthy	YES	
T39	<i>Taxus baccata</i>	Yew	12	6	150	48	1	(A) Healthy	YES	
T40	<i>Taxus baccata</i>	Yew	10	5	150	48	1	(A) Healthy	YES

T41	<i>Chamaecyparis lawsoniana</i>	Lawson Cypress	12	4	175	56	1	(A) Healthy	YES	
T42	<i>Thuja occidentalis</i>	Northern White Cedar	8	3	210	67	1	(A) Healthy	YES	
T43	<i>Chamaecyparis lawsoniana</i>	Lawson Cypress	12	4	150	48	3	(A) Healthy	YES	
T44	<i>Chamaecyparis lawsoniana</i>	Lawson Cypress	16	3	130	42	1	(A) Healthy	YES	
T45	<i>Chamaecyparis lawsoniana</i>	Lawson Cypress	12	3	100	32	1	(A) Healthy	YES	
T46	<i>Ilex aquifolium</i>	Holly	10	3	90	29	1	(C) Poor Condition	YES	Poor tree development, and in competition with larger pre-established trees
T47	<i>Chamaecyparis lawsoniana</i>	Lawson Cypress	12	3	95	31	1	(B) Good	YES	Growing in dense competition amongst other trees
T48	<i>Ilex aquifolium</i>	Holly	10	5	75	24	1	(B) Good	YES	Growing in dense competition amongst other trees
T49	<i>Chamaecyparis lawsoniana</i>	Lawson Cypress	8	3	90	29	2	(B) Good	YES	Growing in dense competition amongst other trees

T50	<i>Taxus cuspidata sp.</i>	Japanese Yew	4	3	45	15	2	(B) Good	YES	Growing in dense competition amongst other trees
T51	<i>Ficus carica</i>	Fig	3	4	15	5	3	(A) Healthy	NO	
T52	<i>Pinus sylvestris</i>	Scots Pine	12	4	150	48	1	(B) Good	YES	Require formative pruning. Height suggest tree is of age where this will become a risk of falling into adjacent buildings
T53	<i>Pinus sylvestris</i>	Scots Pine	12	4	140	45	1	(B) Good	YES	Require formative pruning. Height suggest tree is of age where this will become a risk of falling into adjacent buildings
T54	<i>Prunus lusitanica</i>	Portuguese Laurel	6	3	75	24	1	(A) Healthy	YES	
T55	<i>Taxus baccata</i>	Yew	12	6	150	48	1	(A) Healthy	YES	
T56	- unidentifiable -	-	5	3	70	23	1	D - Dead	YES	Dead
T57	<i>Chamaecyparis lawsoniana</i>	Lawson Cypress	12	2	85	28	1	(B) Good	YES	Requires general maintenance, removing dead dying and damaged branches
T58	<i>Taxus baccata</i>	Yew	5	3	50	16	3	(A) Healthy	YES

T59	<i>Malus domestica</i>	Apple	1.5	0.5	10	4	1	(A) Healthy	NO

H01	<i>Ligustrum ovalifolium</i>	Wild Privet	4	AS SHOWN	-	-	-	(A) Healthy	NO	
H02	<i>Ligustrum ovalifolium 'Hassk'</i>	Hassk Privet	1.2	AS SHOWN	-	-	-	(A) Healthy	NO	
H03	<i>Ligustrum ovalifolium</i>	Wild Privet	1.2	AS SHOWN	-	-	-	(A) Healthy	NO	
H04	<i>Sambucus nigra (30%) / Hedera helix (70%)</i>	Common Elder (70%) / Ivy (70%)	6	AS SHOWN	-	-	-	(A) Healthy	NO	
H05	<i>Sambucus nigra</i>	Common Elder	2	AS SHOWN	-	-	-	(A) Healthy	NO	
G01	<i>Ligustrum ovalifolium</i>	Wild Privet	4	AS SHOWN	-	-	-	(A) Healthy	NO	
G02	<i>Prunus lusitanica</i>	Portuguese laurel	2.5	AS SHOWN	-	-	-	(A) Healthy	NO	
G03	<i>Prunus lusitanica</i>	Portuguese laurel	3	AS SHOWN	-	-	-	(A) Healthy	NO	
G04	<i>Sambucus nigra</i>	Common Elder	4	AS SHOWN	-	-	-	(A) Healthy	NO	
G05	<i>Sambucus nigra</i>	Common Elder	4	AS SHOWN	-	-	-	(A) Healthy	NO	
G06	<i>Sambucus nigra</i>	Common Elder	3	AS SHOWN	-	-	-	(A) Healthy	NO	
G07	<i>Sambucus nigra</i>	Common Elder	1	AS SHOWN	-	-	-	(A) Healthy	NO

G08	<i>Sambucus nigra</i>	Common Elder	2	AS SHOWN	-	-	-	(A) Healthy	NO	
G09	<i>Sambucus nigra</i>	Common Elder	2	AS SHOWN	-	-	-	(A) Healthy	NO	
G10	<i>Sambucus nigra</i>	Common Elder	2	AS SHOWN	-	-	-	(A) Healthy	NO	
G11	<i>Sambucus nigra</i>	Common Elder	5	AS SHOWN	-	-	-	(A) Healthy	NO	
G12	<i>Sambucus nigra</i>	Common Elder	6	AS SHOWN	-	-	-	(A) Healthy	NO	
G13	<i>Prunus lusitanica</i>	Portuguese laurel	2.4	AS SHOWN	-	-	-	(A) Healthy	NO	
G14	<i>Prunus domestica</i>	Plum	2	AS SHOWN	-	-	-	(A) Healthy	NO

Any tree works on this site will need formal consent from the council via 6 week application (known as a section 211 under the tree regulations).

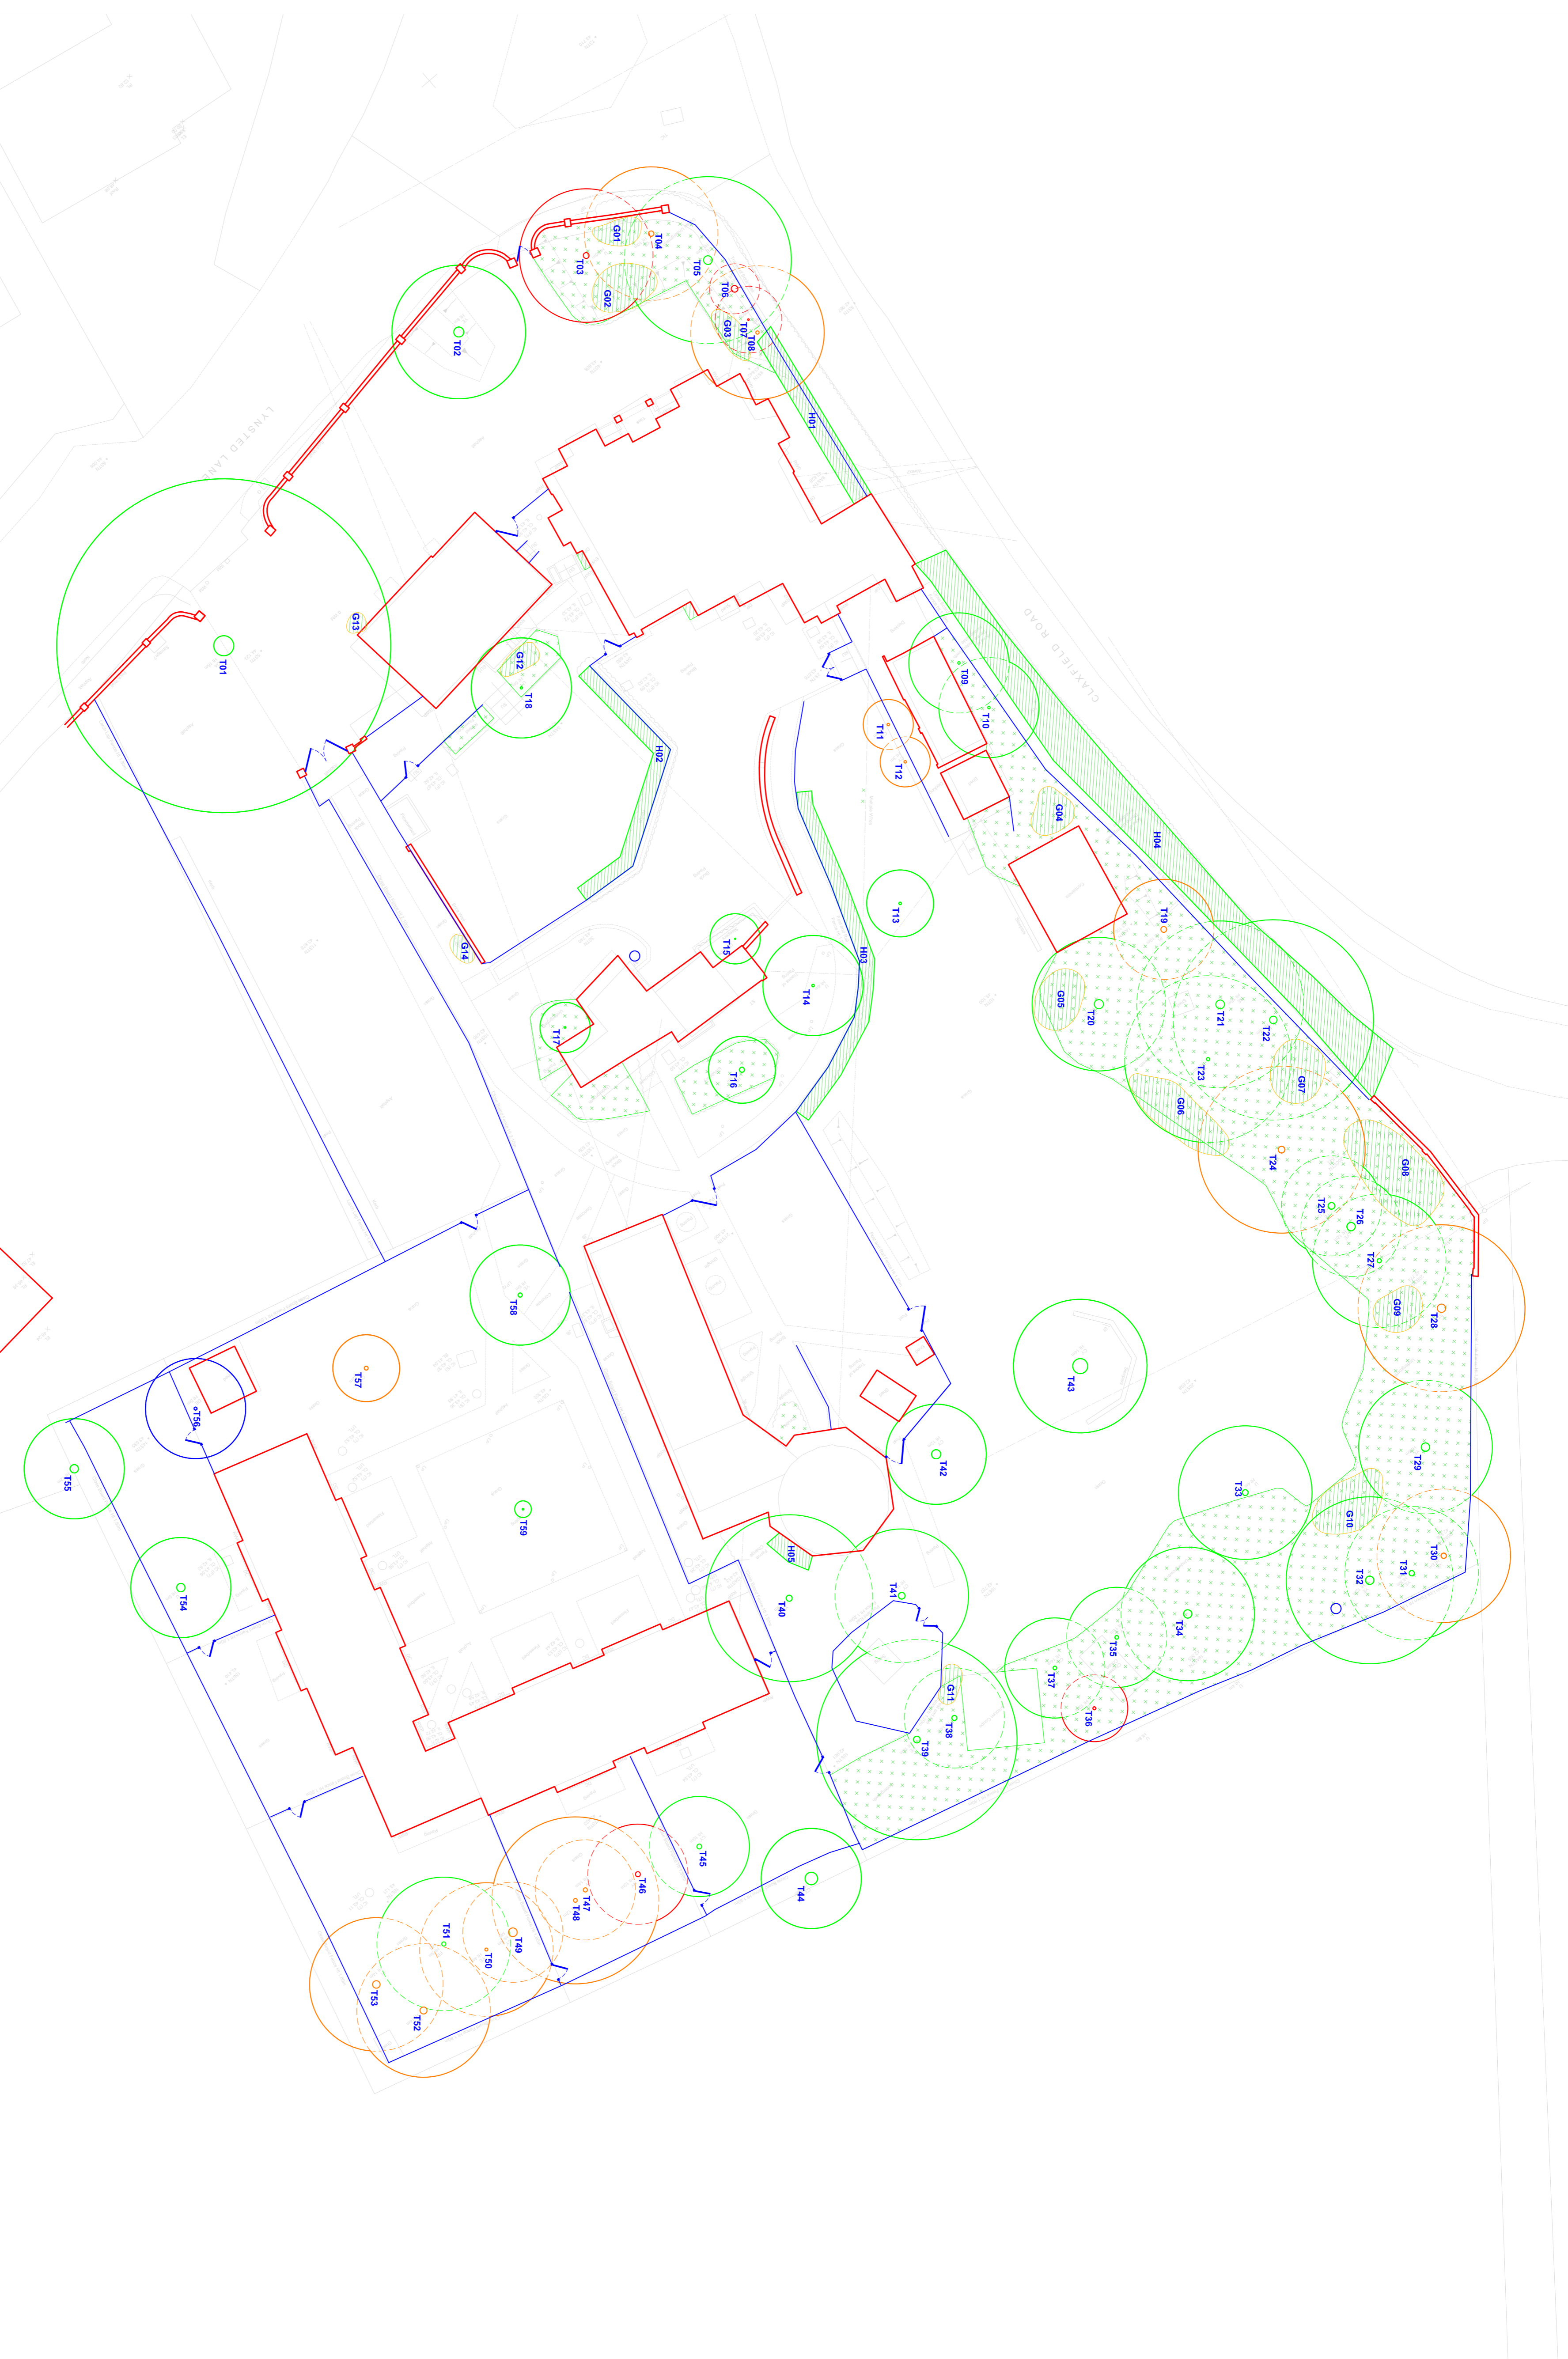
DWG No: **FV04329-02** Date: **24 - 07 - 2023**
 Scale: **1:200 (A1)** By: **KCF**

- Category 'A' (Green)**
Healthy, no works required
- Category 'B' (Orange)**
Minor structural or remaining dead, damaged and dying branches. Including the removal of any by others.
- Category 'C' (Red)**
Tree in poor condition due to lack of sunlight or other reasons. Will require deepening / accessible or removing.
- Category 'D' (Blue)**
Tree is no longer alive, stumps remains to provide ecological value to the surrounding environment
- Existing Hedge**
- Existing Understorey Trees**
- Existing Ground Cover**
- Existing Buildings & Structures**
- Existing Fences**
