ABBOTSFORD THORVERTON, DEVON

HERITAGE STATEMENT
AUGUST 2023

Adrienne Ridler-Lee MSc

The Heritage Consultancy
www.theheritageconsultancy.co.uk

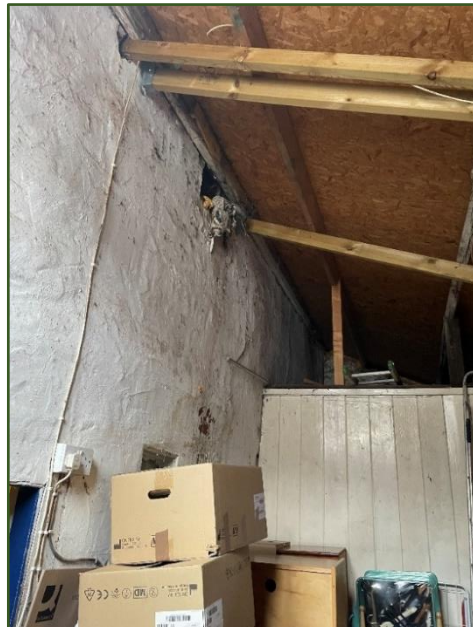
The workshop/store room is constructed of stone rubble, and rendered. The valley roof (fig.18) has been repaired/reconfigured, and is of rubber/resin above modern timbers and ply board (fig.9) likely to date from works in 1998. The front of the workshop/store room comprises weathered wide timber panelled door openings underneath a C20 timber framed double casement (fig.19); neither of which are of historic interest or significance. The southern gable end of the house which the workshop abutts, is currently concealed by rusted corrugated sheeting; the historic fabric of the building concealed beneath. 3 small, irregular window openings are set within crude 'makeshift' frames (fig.18).

Figure 9. Workshop/store – original external wall and roof timbers.

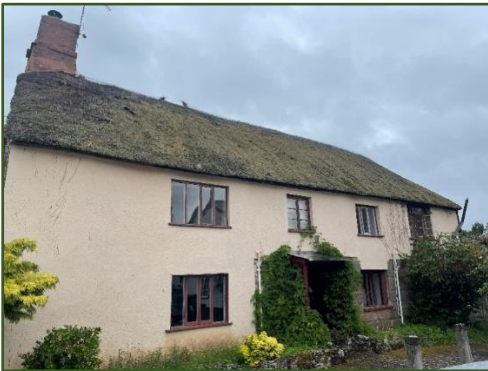
Abbotsford is set back from the road, within The Bury. Approached from the cobbled street, the principal façade (fig.10) is constructed of dressed stone rubble with a C20 render. The render conceals any evidence that may remain of the historic exterior steps to the far left. The list detail (Appendix 1) comments upon the 'asymmetrical 4 window front'. The existing windows are C20 replacements and are of inconsistent size and design. The first floor window to the left has been enlarged, and the bedroom window opening to the far right has likely seen alteration as it is not in keeping with the overall style of the house, or the purpose of the room. The front windows of which there are 7, are mostly simple wooden casement of 3 or 4 lights, with the window above the porch having horizontal glazing bars. All windows and frames are in poor, to parlous condition.

Figure 10. Principal façade of Abbotsford.

The windows all require repair or replacement. Simple timber, flush fitting casements with glazing bars are to be installed, set underneath oak lintels, replacing those which are beyond repair. The frames are to be painted white to compliment other historic buildings within The Bury as seen in figure 58. The applicant requests permission to install discreet Slimlite double glazing to greatly enhance thermal performance and energy efficiency within the home.

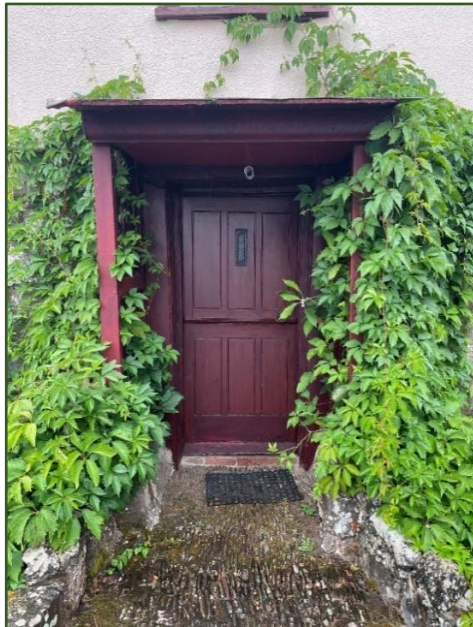
The principal entrance comprises a C20 wooden stable door, set underneath a crude, modern timber framed porch (fig.11) which possesses no historic, or architectural merit. To each side of the entrance, a small garden border sits behind a stone wall. The rainwater goods are a mix of cast iron, with modern UPVC replacements and additions.

Figure 11. Principal entrance set within modern timber framed porch.

The existing lean-to porch is a modern, trellis-sided timber frame. This would be sympathetically replaced by a modest pitch roofed porch, with slate tiles, supported on a weathered oak frame.

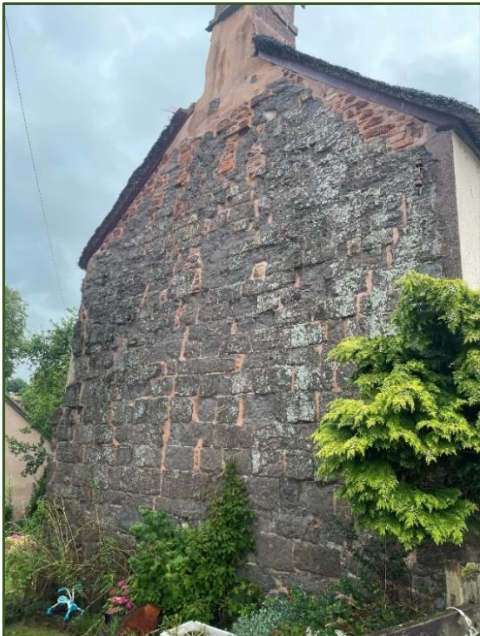
The left hand (north) elevation (fig.12) is of locally sourced dressed stone rubble, with Raddon stone rubble and brick. Alteration in the stone construction at higher level indicates the roof has been raised. The left elevation features no window or door openings. The southernmost elevation (fig.13) is abbutted, and concealed by the adjoining workshop/store, and corrugated iron sheeting at first floor level. The original exterior wall is experienced from within the workshop/store and comprises a wide door opening to the front of the building (fig.14), a small window opening (with a single timber shutter) and a further door opening which leads to the rear store room.

Figure 12. North elevation.

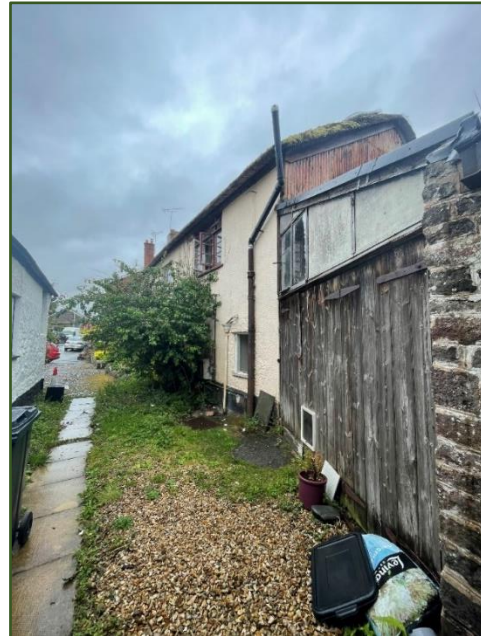
Figure 13. Southern elevation showing Workshop/store, southern gable end concealed with corrugated sheeting.

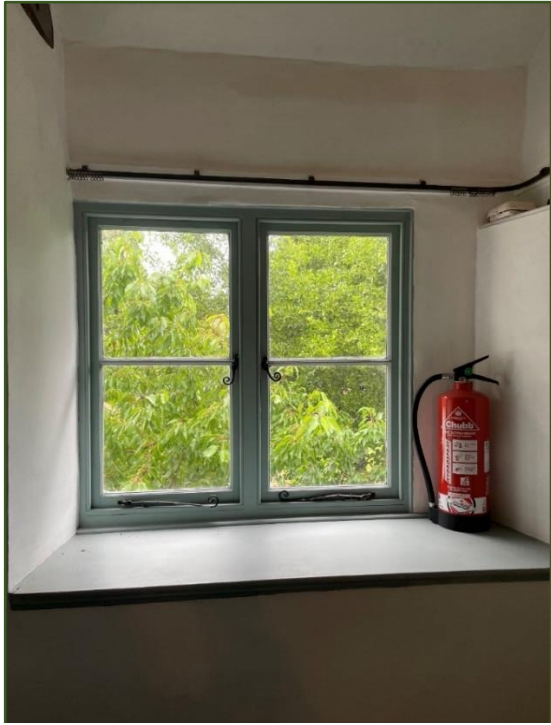
The wooden casement windows feature glazing bars, and are set beneath wooden lintels. The first floor window openings are set underneath the eaves, the recessed landing window (fig.16) being of interest with timber inserts being set within the surrounding stonework. One timber is grooved; its purpose unidentifiable, but this is likely to have been repurposed from another building during repair or alteration. The rear elevation unusually provides no access to/from the house from the garden.

Figure 16. First floor landing window.

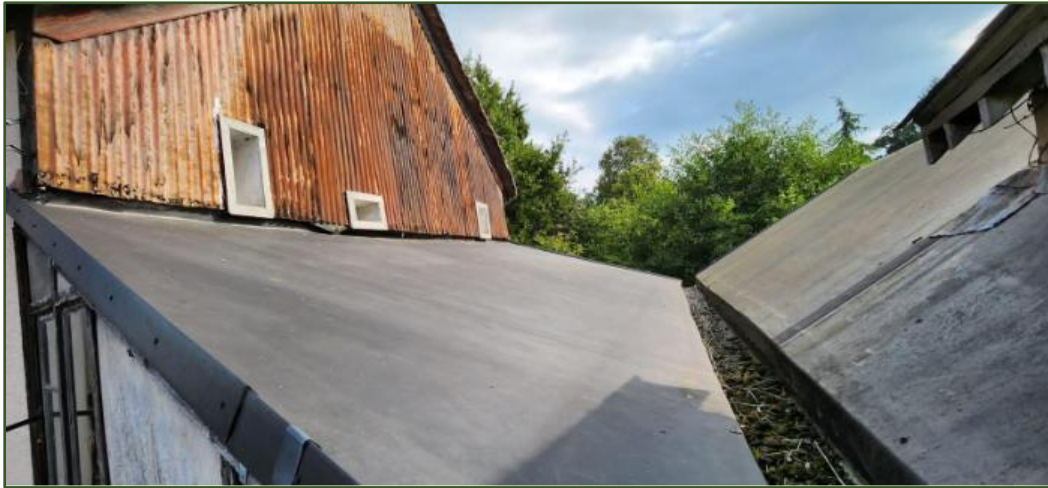
Figure 18. Valley roof, with left gable concealed under corrugated sheeting. Note 3 small window openings.

The scheme proposes to replace the valley roof of the current workshop/store, with a flat roof with resin covering, which will provide longevity, incorporating an aesthetically discreet appearance which will be easier to maintain and will further reveal the south gable end of the house. A previous planning application from 1998 refers to a 'lean to roof' which was likely the workshop/store. The proposed design seeks to restore the roof to this configuration, along with 1 Conservation rooflight. The design is subtle and modest and will blend with the surrounding Welsh slate roof coverings, and will also mitigate the issues commonly encountered with valley roofing, and the subsequent water ingress/damp issues that often arise from such construction. The workshop/store roof is hidden from The Bury by buildings to the west, with only glimpses achievable from the north. There will be no significantly negative harm caused to the heritage asset, or wider Conservation Area by reinstating a flat roof or the incorporation of a discreet rooflight. The corrugated iron sheeting which currently conceals the southern gable end will be removed, with lime render applied which will reveal, restore and enhance the elevation.

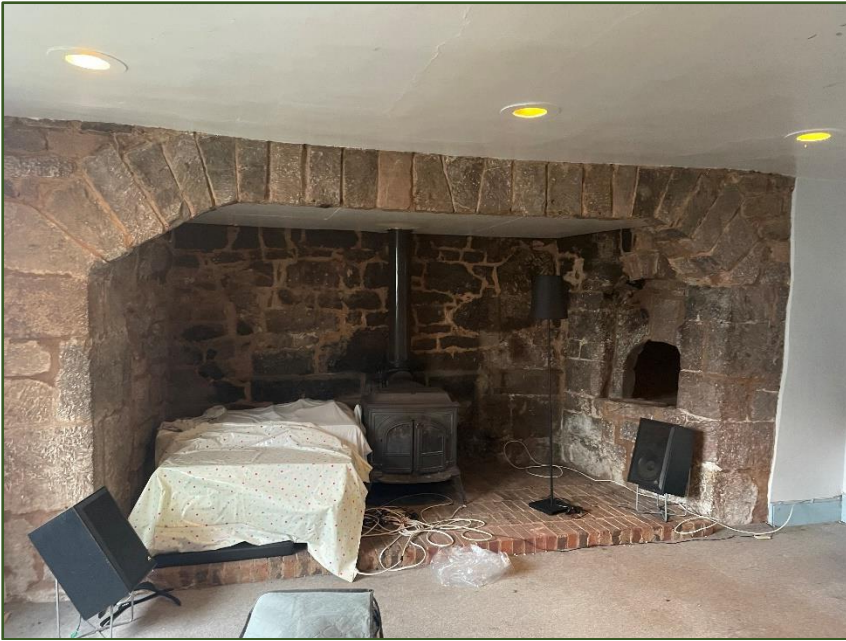
The substantial, and significant sitting room is located to the north of the house; it is within this room that the 'massive fireplace' mentioned in the list description is located. The fireplace (fig.22) is constructed of local stone, with a large bread oven situated to the right hand side (fig.23). The stonework to the rear of the opening is blackened, demonstrating the former operational design and use before a combustion oven was installed. The hearth which would have originally been stone, has been replaced by brickwork. The stone work to the front of the fireplace opening has seen remodelling, with a large steel RSG set behind the later lintel (fig.24); the original keystone visible behind the later stone facade. A white plate installed at the same time as the woodburner conceals additional stonework above.

Figure 22. Fireplace (white asbestos register plate visible) with bread oven.

The applicant intends to carry out additional restorative and modernisation works on the ground floor. The dining room fireplace is to be reinstated as an open fire, with the carpet removed and replaced with distressed oak boards. The area under the stairs is to remain the same. The sitting room ceiling has been identified as being lathe and plaster, with a number of crude recessed lights which are to be removed; the holes being plastered over with the same material as existing. Upon investigation, it has been found that the floor is constructed of stone block underneath a rotted parquet floor which is not salvageable; this is to be replaced by a distressed, oiled oak floor. The fireplace currently features a brick hearth which will be replaced by stone which will be more complimentary to the integrity of the historic opening. The existing wood burning stove is to be replaced with a more energy efficient model; the asbestos plate above to be appropriately removed with a new plate set higher so that the impressive fireplace can be further restored, revealed and enjoyed.

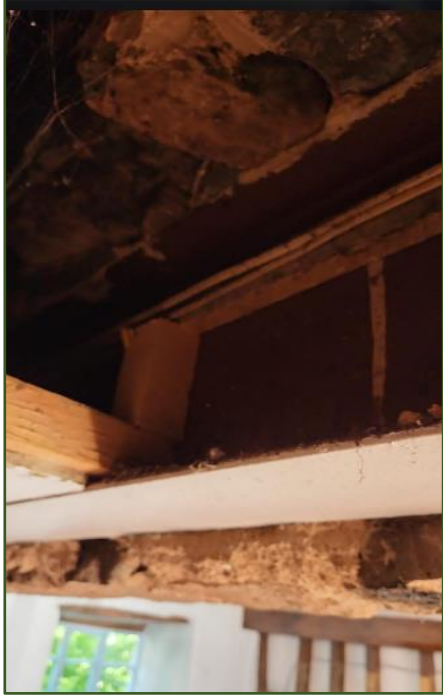
Figure 24. Large steel RSJ set behind existing stone lintel (fireplace). Note keystone to top of photo.

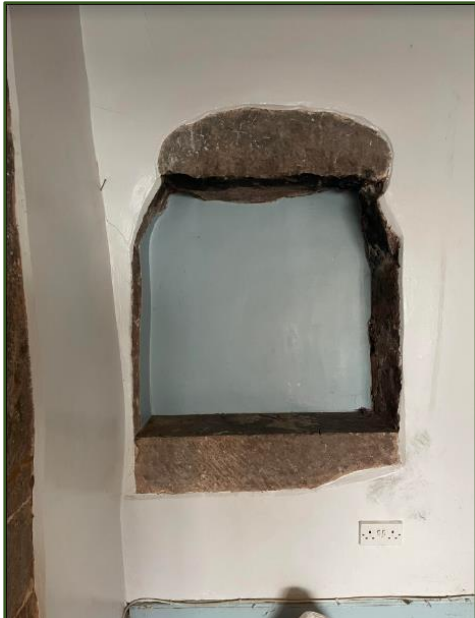
Set within the east facing rear wall is what appears to be a blocked up window or hatch (fig.25), perhaps used to pass flour through for the bread making process (being highly flammable, flour would not have been stored in the house). It is not possible to assess evidence of an opening on the exterior wall due to the render.

Figure 25. Blocked opening to rear of Abbotsford.

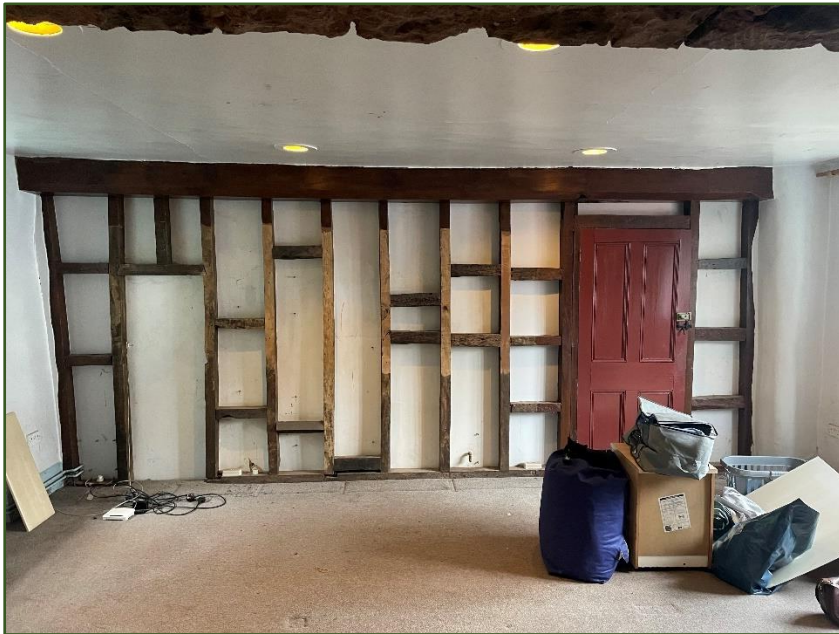
To the south of the sitting room, the wall comprises a timber frame (fig.26) which would have likely once supported a 'plank and muntin' screen. This frame has been subject to sanding, planing and irreversible timber treatments. A number of the timbers have been replaced based on the inconsistency of wood/cut. A small doorway opening within the frame leads to the space underneath the staircase. The frame is currently filled with C20 white plyboard panelling. The 4-panelled, moulded door to the sitting room may be aged, but it is not original; as with other doors in the house, it has been fitted with a Yale lock. The doorcase timbers are of a different cut than the frame, and do not correspond with the doorcase between the dining room and kitchen suggesting replacement. Both the frame and door sit beneath a large beam which is chamfered at the western end, and the east facing end visible within the exterior wall to the rear within the render (fig.27).

Figure 26. Wooden timber framed dividing wall with panelled door with modern Yale lock.

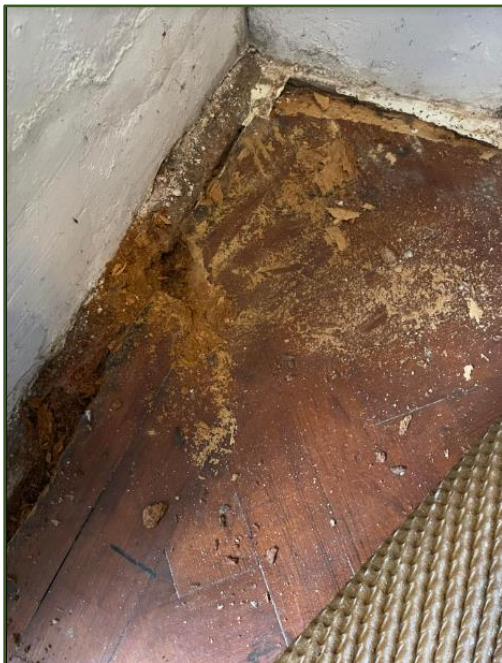
The sitting room is carpeted, yet upon inspection by lifting one corner, parquet flooring is visible (fig.28). The parquet has rotted in places revealing the stone block surface underneath (not visible due to wood debris/dust); a sensible and safe surface considering the former use of the room.

Figure 28. Sitting room rotted parquet flooring.

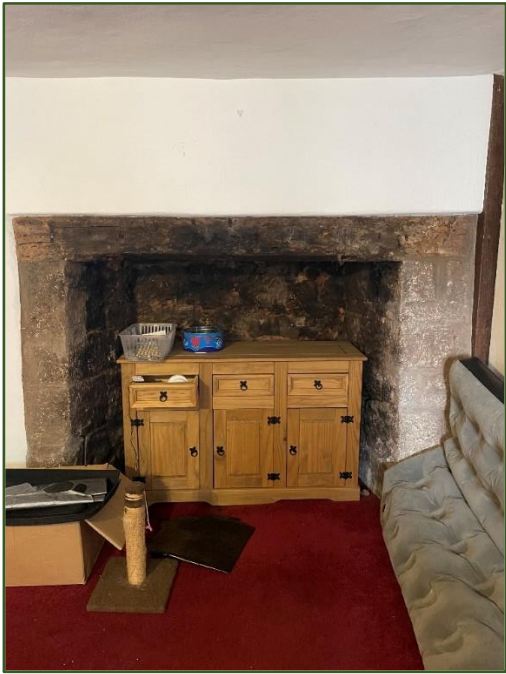
The dining room is located to the south of the entrance hallway and comprises a redundant fireplace opening with stone jambs and a timber lintel (fig.30). The circular hole within the C20 plate indicates a wood burner has previously been installed. A timber frame dividing wall of similar construction to that of the feature in the sitting room indicates the historic existence of screening, and the original intended design and construction of the room. Unlike the sitting room, the square headed door frame (fig.31) is wide, and the timber evidentially from an earlier period to that of the sitting room door case due to the general patina, method of cutting and fixing, with a round wooden peg visible to the top left (further confirming the doorframe in the sitting room has been replaced). A moulded timber has been inserted to the left of the frame. The moulded four panel door with latch is not original. The timber framed casement window with 3 lights has a central opening, with modest iron catch and stay. The room is currently carpeted with a screeded surface beneath.

Figure 30. Dining room fireplace opening.

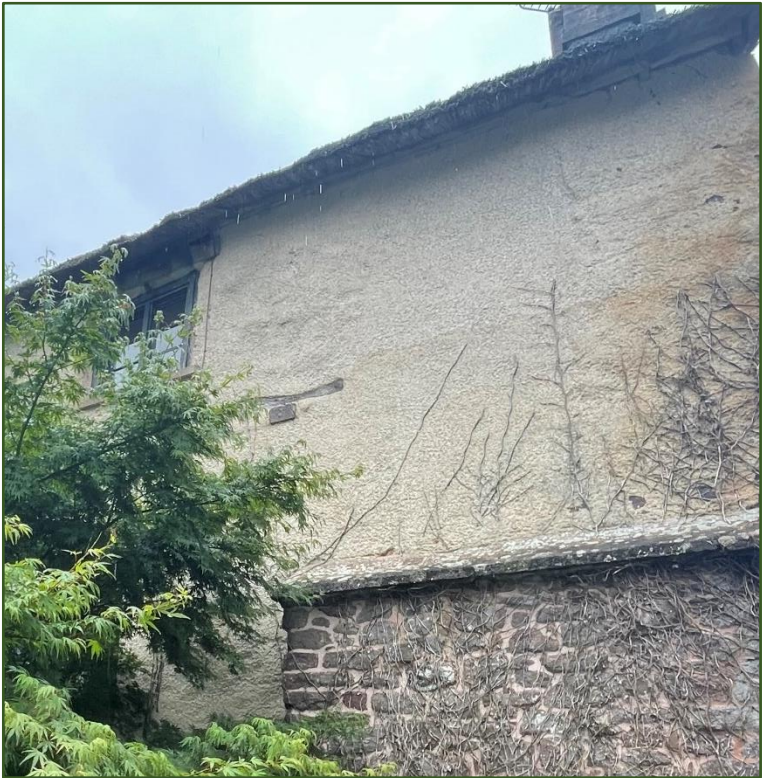
Figure 50. Indentations in render opposite bedroom 1 wall recess.

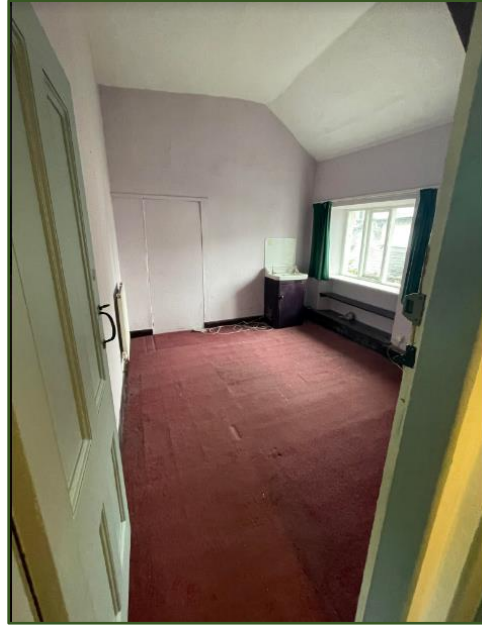
Bedroom 2 (fig. 52) is located centrally to the front of the house. It was possible to lift the carpet in one corner to reveal elm boards of differing width (fig.53) It is not absolutely possible to say if these are original, but they are certainly aged. The bedroom also has a blocked doorway to bedroom 3; the wall is not constructed of historic fabric, and is insulated with fibreglass. Bedroom 3 (fig.54) is located above the kitchen, and has an upright timber post which is located directly above the one below, which then extends through the ceiling into the roof space. A principal rafter and false are visible; as with the other roof truss timbers on the first floor, this rafter is not C17. The false beam conceals pipework from the old water tank cupboard in bedroom 4. The window opening (fig.54) is neither original or in keeping with the room, or house. The wooden panelled wall that separates bedroom 3 and 4 is not historic and looks to be damaged and inappropriately fixed. This lightweight

Figure 52. Bedroom 2; note blocked doorway to bedroom 3.

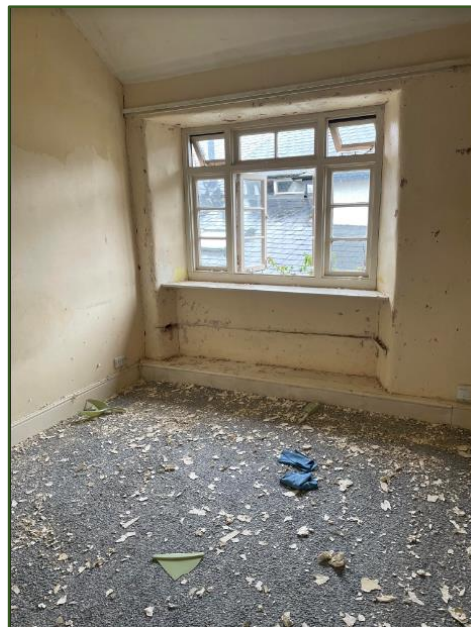
Figure 54. Bedroom 3 with large, inconsistent window set high under eaves.
