Venbridge House, Cheriton Bishop, EX6 6HD

Design and Access Statement, Statement of Significance and Schedule of Works

December 2022 revision A

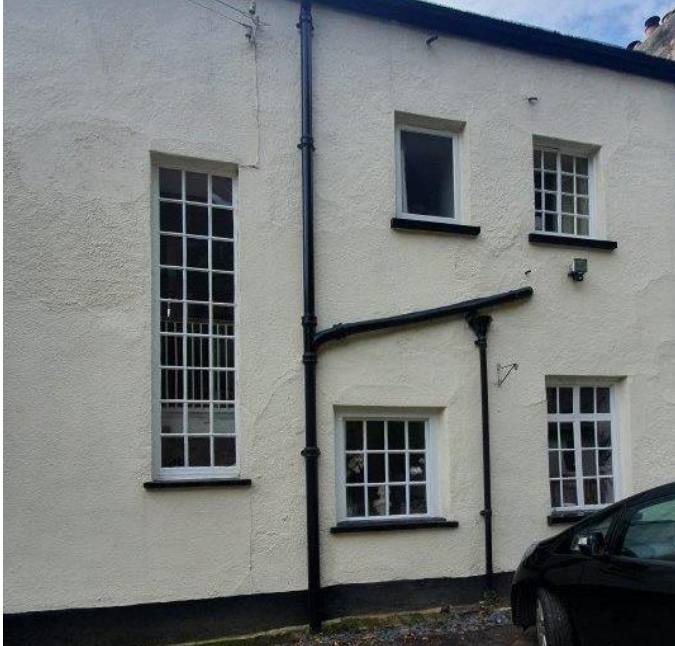
1. **North elevation.** The render is hollow and delaminating in several areas and the wall is damp and therefore deteriorating. This is due to a combination of factors: - limited sun, similar ground levels between outside and out with no DPC, a tarmacked parking area sloping towards the house with no drainage, cement render and modern paint inside and out, limited heating

and ventilation, and the impermeable concrete slab to the annex. There is evidence of woodworm and rot to the skirting boards, floors, and stairs.

Photo above showing patchy/ deteriorating cement render

- b. External render: The existing cement render will be carefully removed from the entire North elevation and Annex North and West elevations and replaced with a lime putty render with haired backing coats and a float coat of unhaired lime render to achieve the contours of the wall required. External paint with SecilTek silicate primer and silicate paint system or a similar compatible, breathable paint system. Undertaken by a specialist conservation builder. Quotes have been sought. NB can only be undertaken outside frost period including its curing process and must be protected from rain. Removal of cob will be undertaken in strips by hand in order to monitor the stability of the underlying cob. (Area shown with green outline on proposed ground floor plan).

- c. Internal finishes to external North wall. Failed and cement plaster to be removed from the annex external walls and the North wall of main house. Ensure wall is dry before lime putty render applied as b. Paint with breathable paint and replace skirting boards to match existing. (Area shown with red outline on proposed ground floor plan).

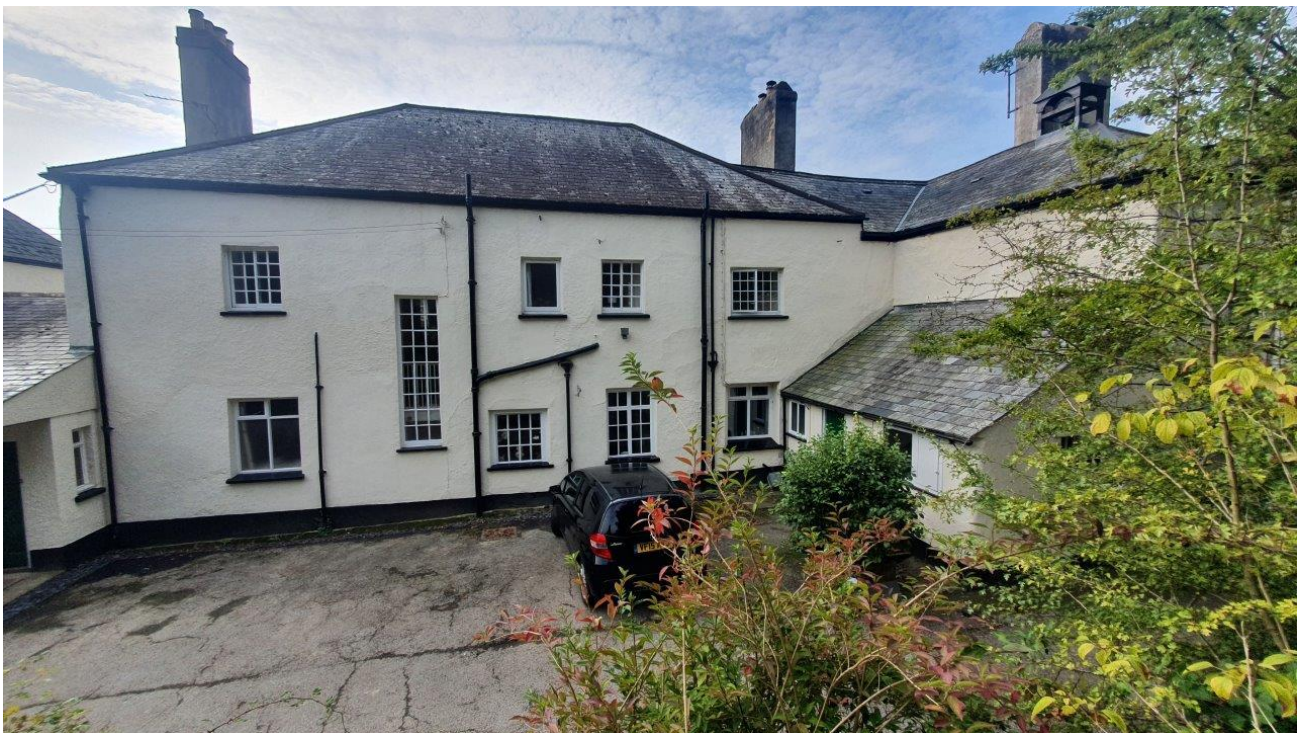
2. **Windows.** The windows to the formal front, the south elevation, are generally in good condition and require general maintenance however, to the North, there is an eclectic mix of traditional casements and modern unsympathetic replacements. See picture below.

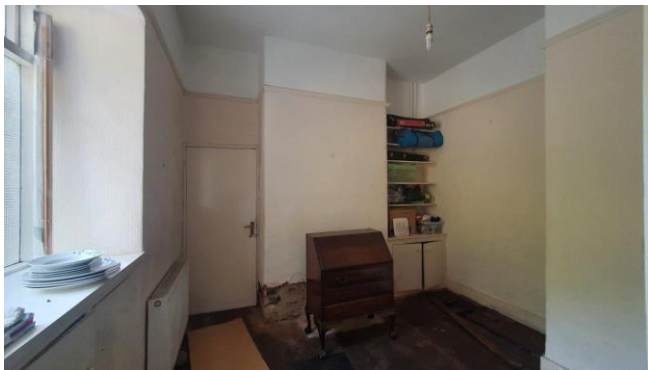
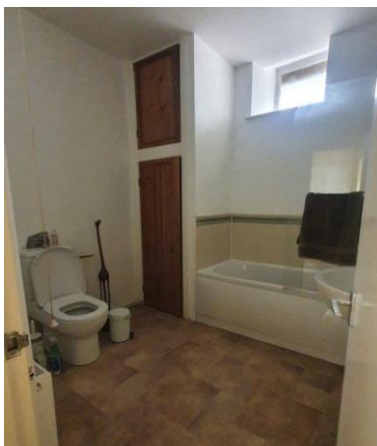
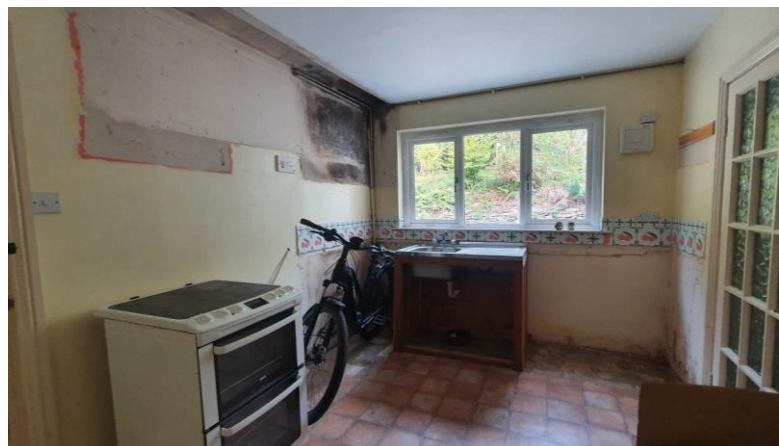
6. **Annex.** The annex is dark, poorly ventilated and insulated, with an awkward layout and unsympathetic internal and external finishes. It is damp and mouldy. Access to the main house is through a small doorway off the kitchen (which does not appear to be original) through the study to the hall, resulting in the study becoming a corridor. See picture below - Annex door viewed from study in main house (to left of chimney breast).

Photos above of annex bathroom and kitchen

Works to improve the damp are noted above – see point 1: - replacement to cement render inside and out and replacement of concrete floor slab with a breathable limecrete floor. Existing windows to be retained. Re-orientating the ground floor entrance, kitchen, bathroom as shown in the submitted plans would bring in south light and a greater connection to the south facing garden. The kitchen would no longer be a corridor off the entrance door and by infilling the new

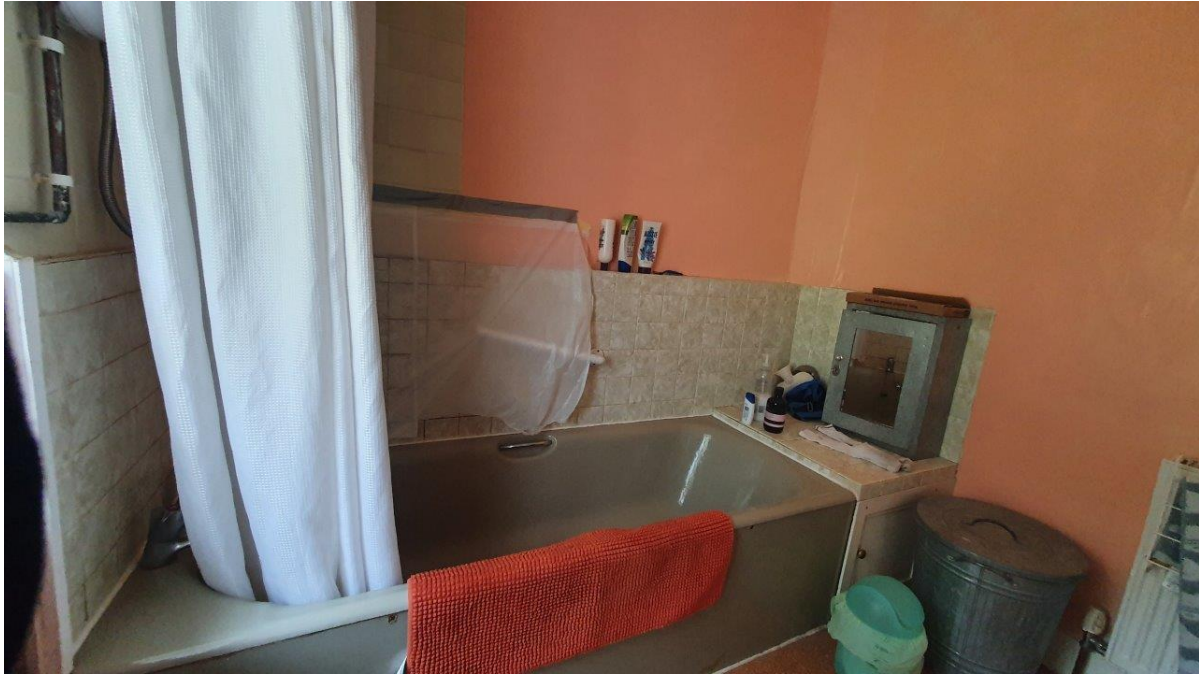
10. **Bathrooms:** The existing bathrooms are dated, leaking and do not reflect the quality of fit out that you would expect in a house of this significance. There are only two bathrooms (one of which is an ensuite) serving six bedrooms over two floors. See picture below of the main bathroom.

- Main bathroom. To replace the bath for a shower and a new WC and WB.
- Ensuite. To remove the modern studwork wall and install new bathroom suite to room. Infill archway and form new doorway with door.
- Second floor to introduce a bathroom to this floor by reducing size of bedroom 6 so both bedrooms on this floor are similar size with a shared bathroom.
- Introduce new ground floor WC to ancillary lean-to.

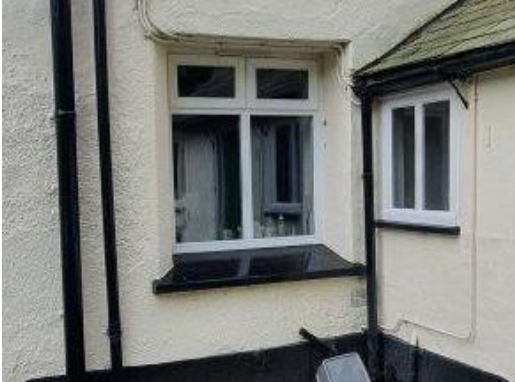
Photo above showing W4.

- c. **W4:** Modern timber window to be replaced with double glazed casement window.

The preapp response supports the replacement of the inappropriate modern window with a more traditional multi-paned design. It notes that slimline double glazing would likely be supported. Detailed joinery drawings of this window are submitted with this application (1:20 elevation and 1:5 vertical and horizontal sections. The details show: -

- i. Flush fitting and balanced casements.
 - ii. Timber beads to match existing historically windows.
 - iii. No through glazing bars.
 - iv. Traditional profiled glazing bars.
 - v. Painted finish.
 - vi. Traditional ironmongery.
 - vii. Black spacer bars to double glazed unit.
 - viii. No trickle vents.
- d. **W5:** to be removed to form new entrance to property. Existing structural lintel, opening height and width to be retained sill to be lowered to form doorway. **See point 3 below for further detail and justification.**
- e. **W6 and W7:** to be retained. Remedial works as required.
- f. **W8:** Modern timber window to be replaced with double glazed casement window.

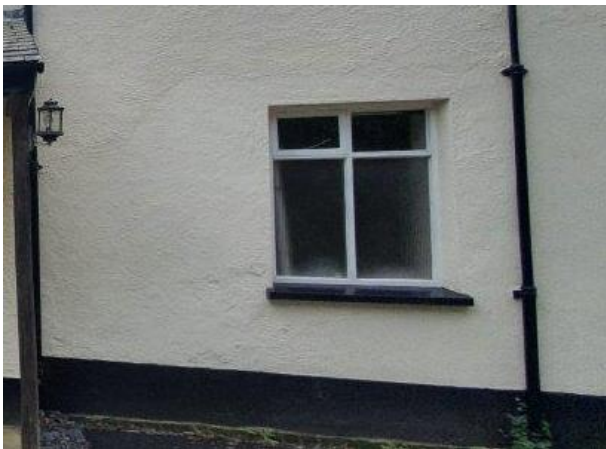
Photo above. W8

W8: Modern timber windows to be replaced with double glazed casement windows.

The preapp response supports the replacement of the inappropriate modern window with a more traditional multi-paned design. It notes that slimline double glazing would likely be

- i. Flush fitting and balanced casements.
- ii. Timber beads to match existing historically windows.
- iii. No through glazing bars.
- iv. Traditional profiled glazing bars.
- v. Painted finish.
- vi. Traditional ironmongery.
- vii. Black spacer bars to double glazed unit.
- viii. No trickle vents.

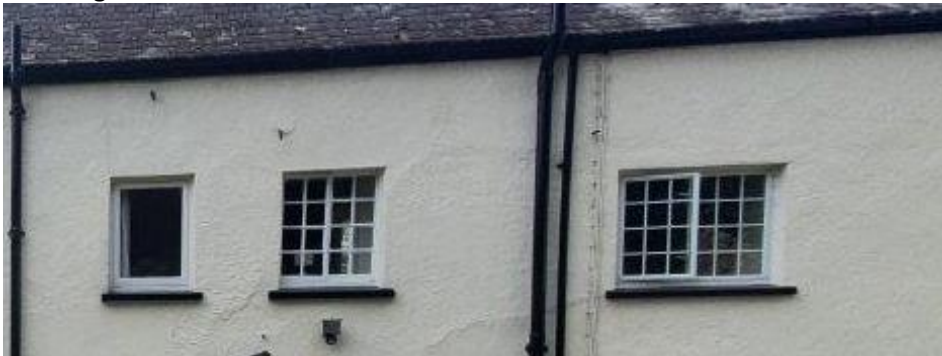
Photo: From right to left – W14, W13 and W12

- j. W12 and W14: W14 = Modern casement timber window of unsympathetic design. W12 = aluminium window. Comment from pre-app *'at present this W12 is overly wide for a dual casement window, consideration should be given as to whether an improved dual casement*

could be achieved with thicker framing or change to a triple casement.’ Both to be replaced with double glazed casement windows.

Detailed joinery drawings of these windows are submitted with this application (1:20 elevation and 1:5 vertical and horizontal sections). The details show: -

- i. Flush fitting and balanced casements.
 - ii. Timber beads to match existing historically windows.
 - iii. No through glazing bars.
 - iv. Traditional profiled glazing bars.
 - v. Painted finish.
 - vi. Traditional ironmongery.
 - vii. Black spacer bars to double glazed unit.
 - viii. No trickle vents.
- k. W13: to be retained. Remedial works as required.
- l. W15: Existing. Sliding window which no longer operates. In accord with the pre-app recommendations the window will be retained and refurbished.

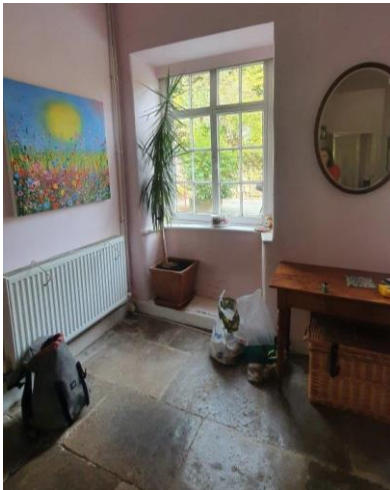
W5 from inside

- c. Fabric loss: Both windows are historical however W5 is different from the other older timber windows in makeup and proportions as it has a larger central mullion and a top opening light (for example in compared to W13 above) which potentially suggests that it is a later addition. Both also have a recessed wall below the sill although in W5 this reduced wall thickness is 300mm high and then steps out to the full thickness of wall; W6 reduced wall thickness extends to the floor plinth.

On balance the proposal is to locate the front door in place of W5. The proposed front door is a traditional Victorian style painted panel timber door such as the one in the picture below. A simple slate pitched painted timber framed porch onto a granite plinth would be introduced. Refer to submitted planning drawings showing detailed proposal.

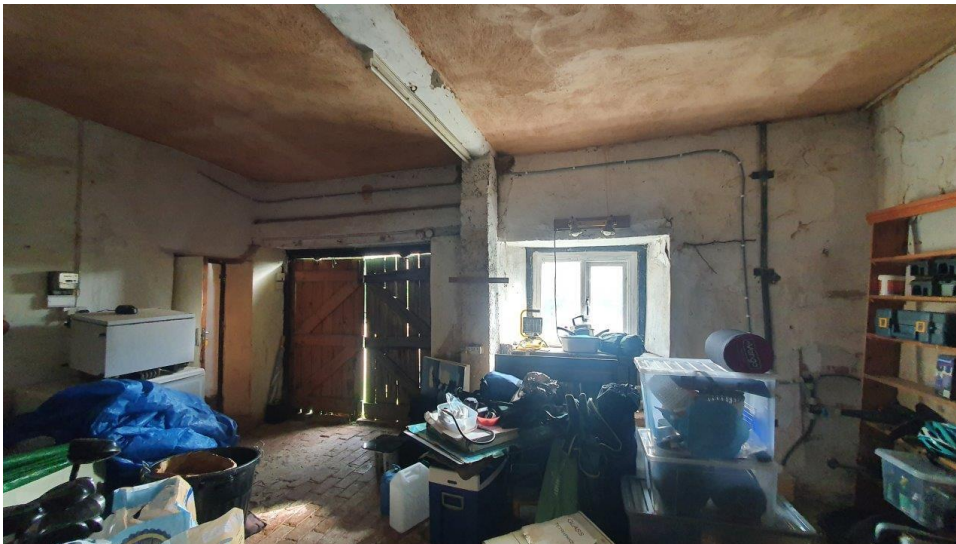
Wherever possible additional loft insulation will be added maintaining ventilation to the roof void. The rendered garage ceiling will be removed and replaced with insulation between the joists and fireboarding to the ceiling. See existing photo below.

- *No objection.*
- *The garage ceiling appears to have been poorly plastered in modern finishes and replacement would offer improvement – replacement with modern boarding – no LBC.*
