Bat Emergence and Re-entry Surveys

Witham Wood, Marley Lane, Haslemere, West Sussex, GU27 3PZ Claire Coleman

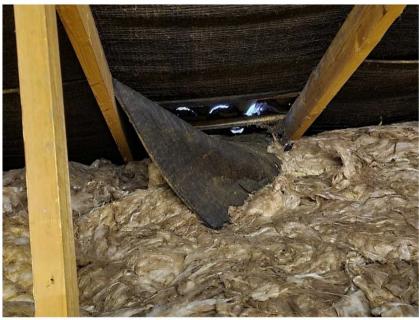
The roost features identified during the PRA were subject to an inspection prior to the BERS to check for evidence of roosting bats. An internal inspection of the loft void was also completed. No additional evidence of bats was identified. All droppings (~14) were collected during the initial PRA, and no new droppings were present during the BERS inspection. The torn roofing felt, initially identified during the PRA (Arbtech Consulting Ltd, 2023) is shown below.

Figure 1: Torn bitumen roofing felt in the main loft (L1) of B1 showing light ingress from underneath roofing tiles.

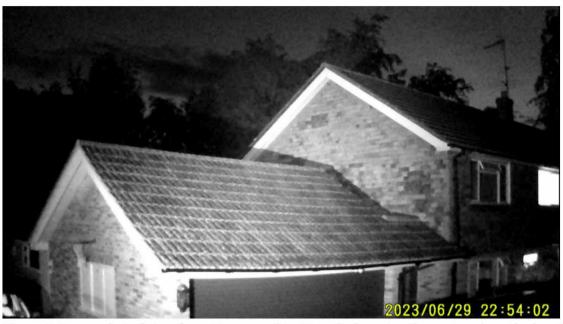
Figure 5: Screenshot of view from IR camera (Position 1) observing the east and south elevations of B1.
