## Preliminary Roost Assessment

Witham Wood, Marley Lane, Haslemere, West Sussex, GU27 3PZ

Claire Coleman

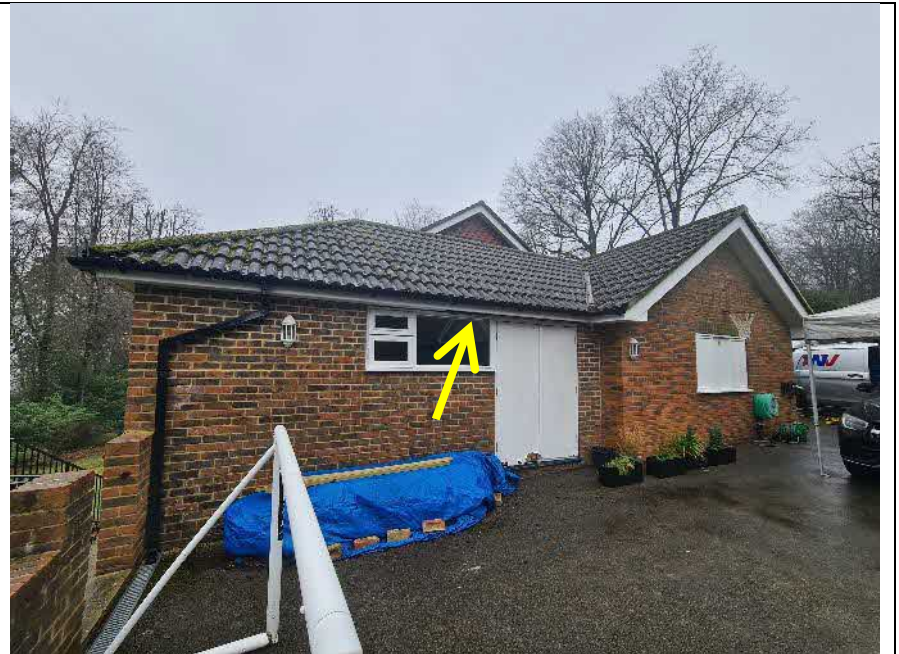
<p>B1 – Northern and western elevations</p> <p><i>Picture 3</i></p>	<p>The brickwork around the property is in excellent condition with no cracks or mortar gaps in which crevice-dwelling bats can roost.</p> <p>There is a lower ground extension at the rear of the property which is rendered and painted white. There are no gaps or cracks in this section of the building which can be used by roosting bats.</p>

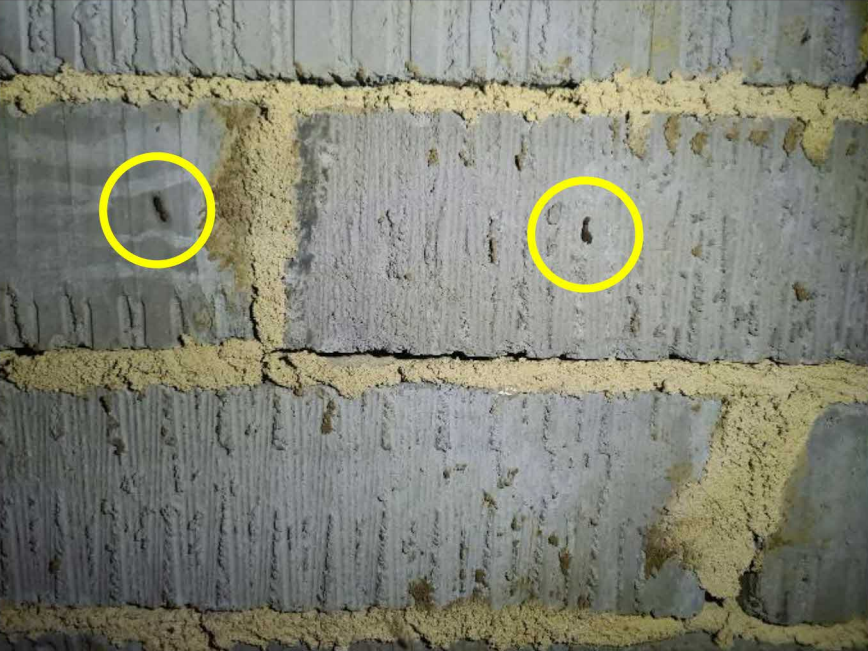
<p>B1 – Evidence of bats (L1)</p> <p>Picture 10</p>	<p>Bat droppings were identified on the walls of L1. Examples are circled in the picture opposite. A sample of these droppings was retained should DNA analysis be required.</p>

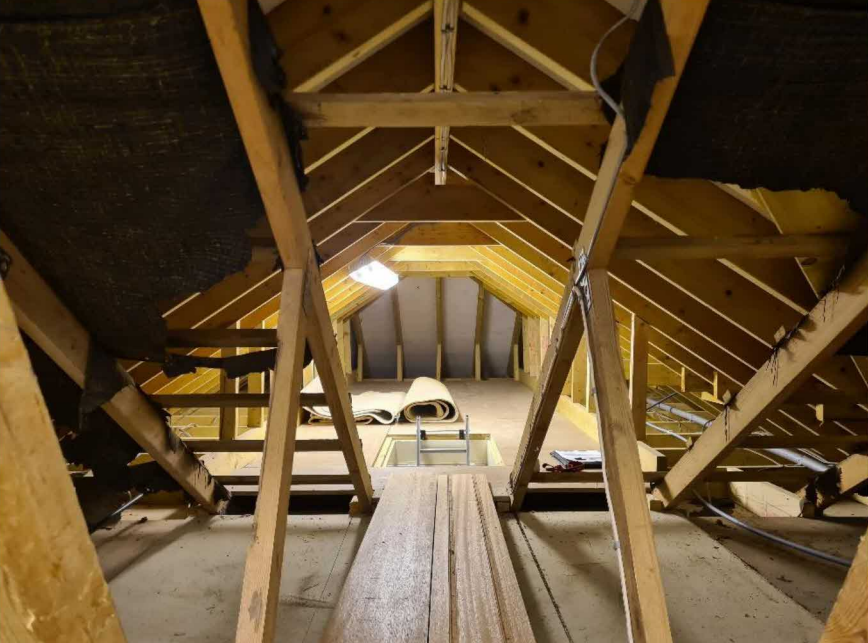
<p>B1 – Interior (L2)</p> <p>Picture 11</p>	<p>The loft space above the garage (L2) is constructed from modern timber beams, including the ridge beam. There is no insulation within this loft space. The roof is partially lined with bitumen felt toward the front of the garage and breathable roofing membrane (BRM) toward the rear. The BRM is in excellent condition, however the bitumen felt is torn and sagging in many places which creates roosting sites for bats. Light is visible entering around the fringes of the loft.</p> <p>A small number of rodent droppings are present in L2, however <b>no bat droppings were found</b>.</p> <p>The approximate internal dimensions of L2 are: 20.4m (L) x 5.2m (W) x 2.1m (H) [Height is measured to the highest point of the loft space].</p> <p>At the time of the survey the internal conditions of L2 were recorded as: temperature = 18.2°C and humidity = 57%.</p>

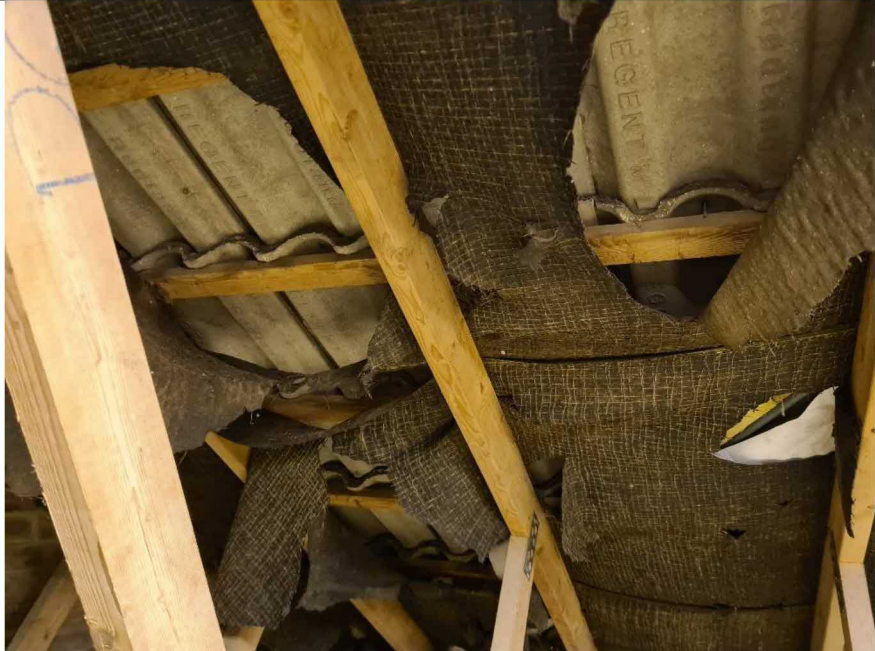
<p>B1 – Interior (L2) <i>Picture 12</i></p>	<p>The picture opposite shows the extensive torn and sagging bitumen felt within L2.</p>
