Existing windows – overview

Existing property

- FRONT

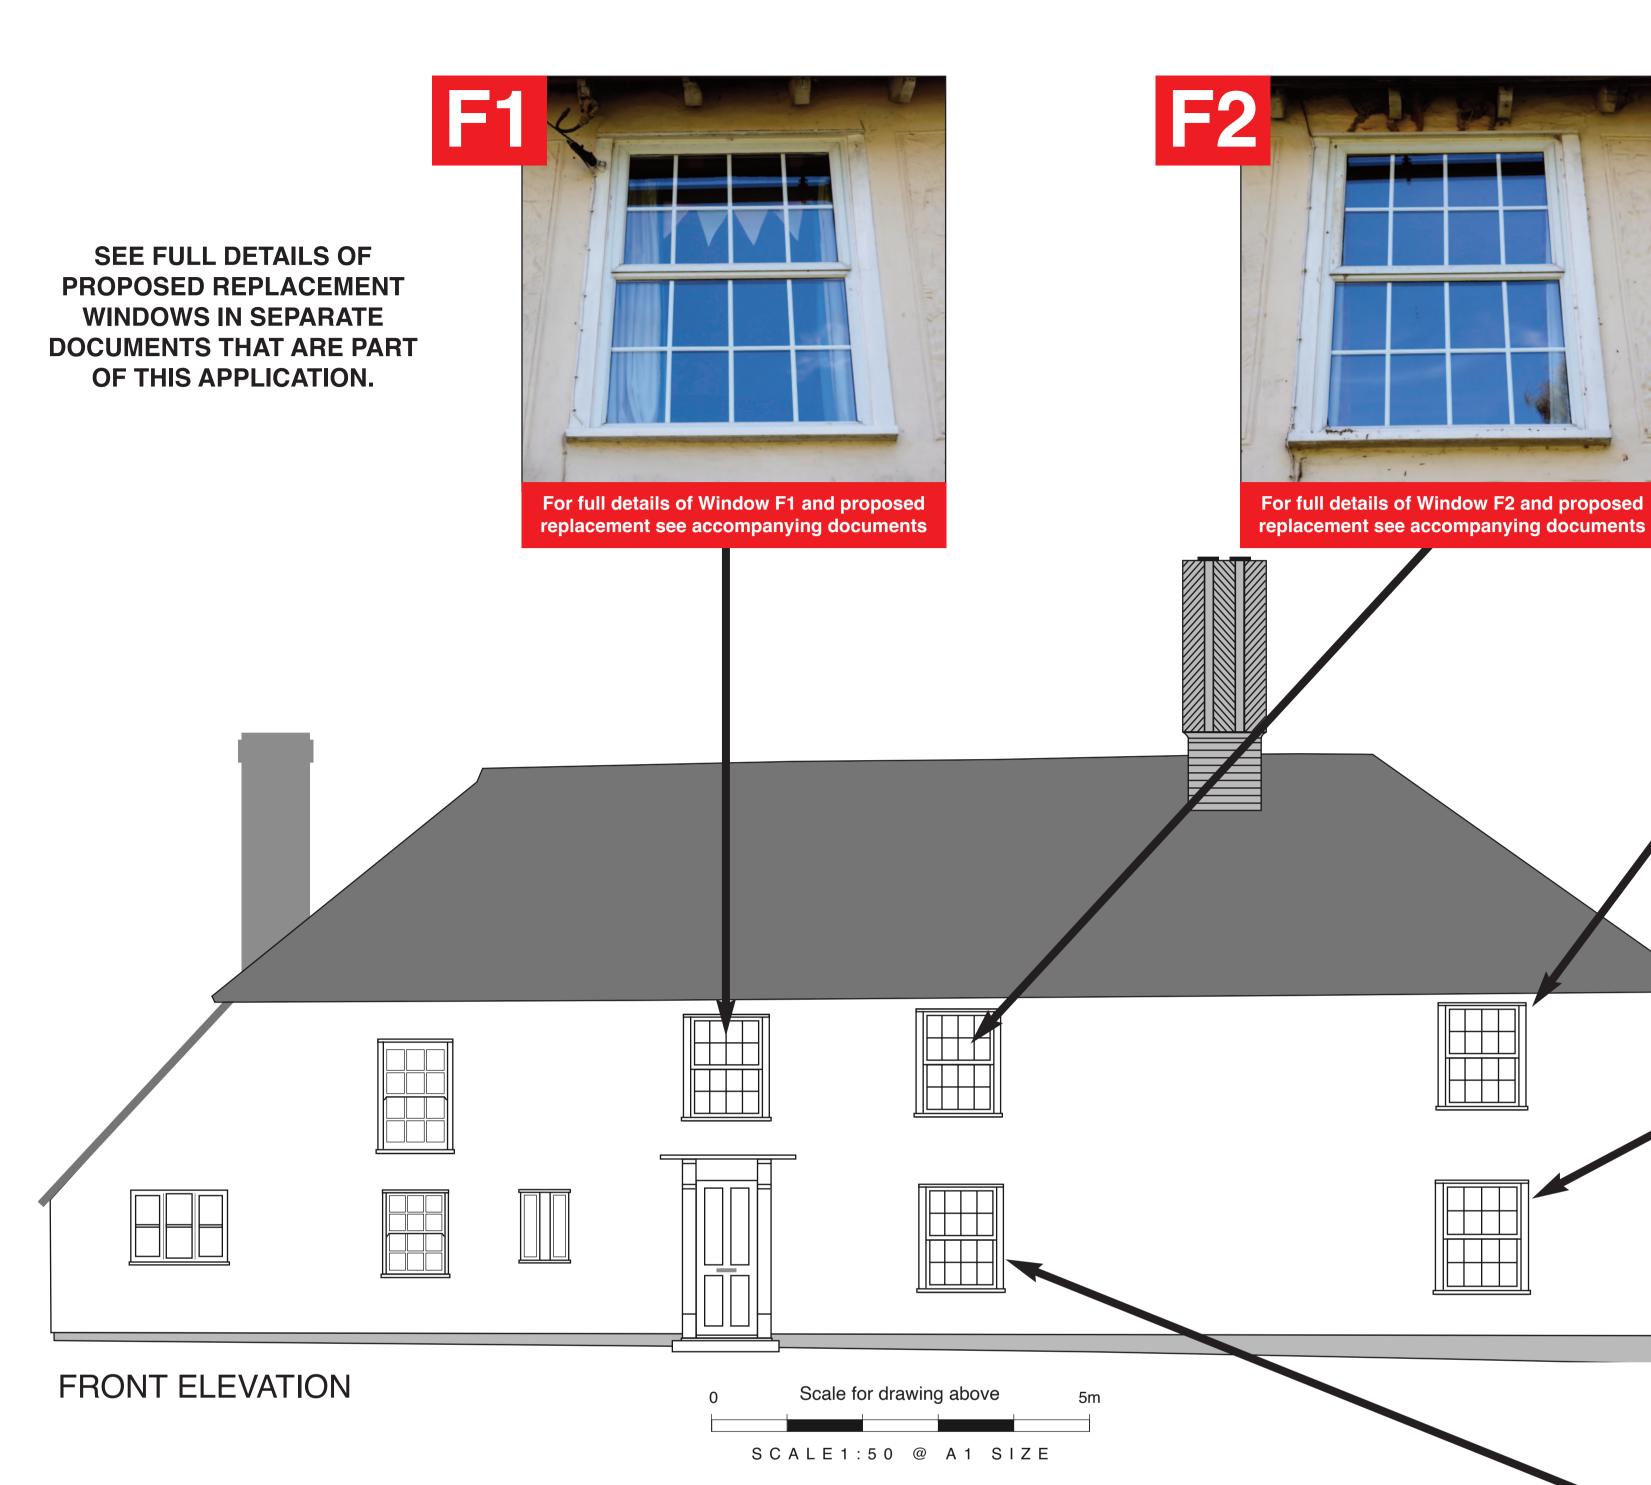
Existing aluminium sash windows

Aluminium construction throughout.

Top hung openers

Modern jointing and construction methods.

Glazing bars are sandwiched between glass.

Rotting timber cills and timber surrounding aluminium windows

The existing windows features, detailed below, are inconsistent with the age, design and importance of the property. The proposed windows will address this problem with the installation of traditionally designed timber sash windows based on the original timber sash window remaining on the front of the property – detailed on the proposed front windows plan.

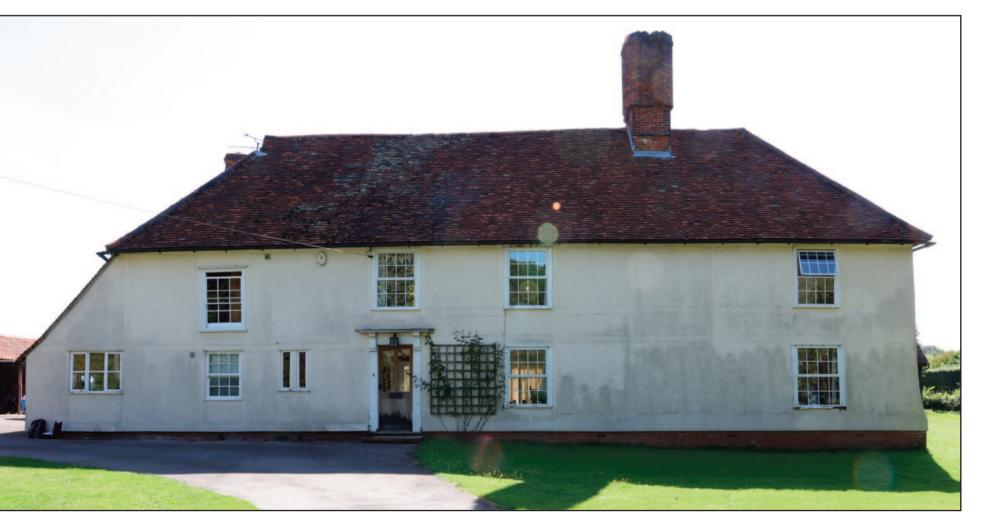
THE PROPERTY – FRONT VIEW (FROM ROAD)

The front of the property is visible from the road.
