**Existing windows – overview**

TITLE: Existing property - rear of property

REFERENCE: PPL1080/existing-rear

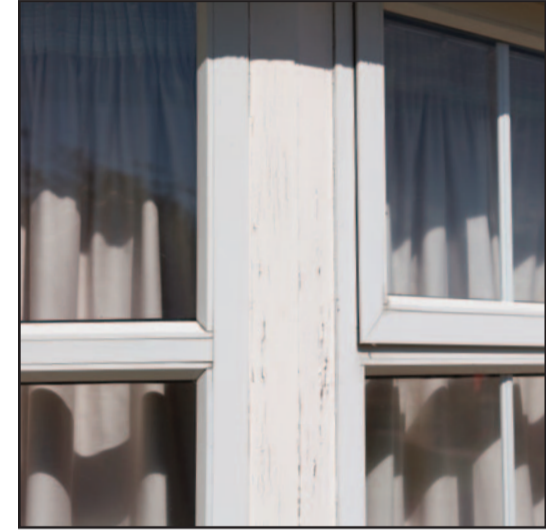
Aluminium windows construction within a timber bay frame.

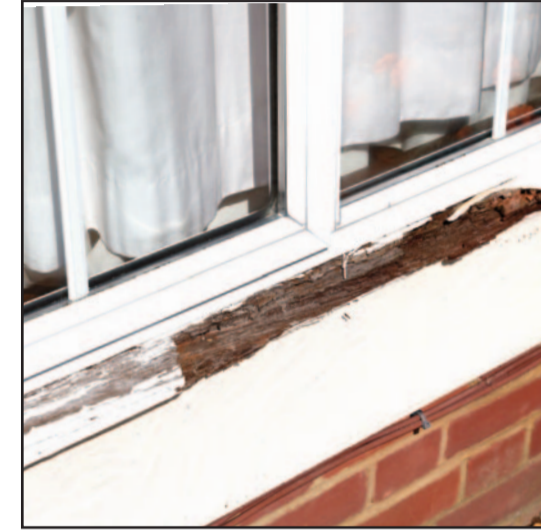
Rotting timber cills

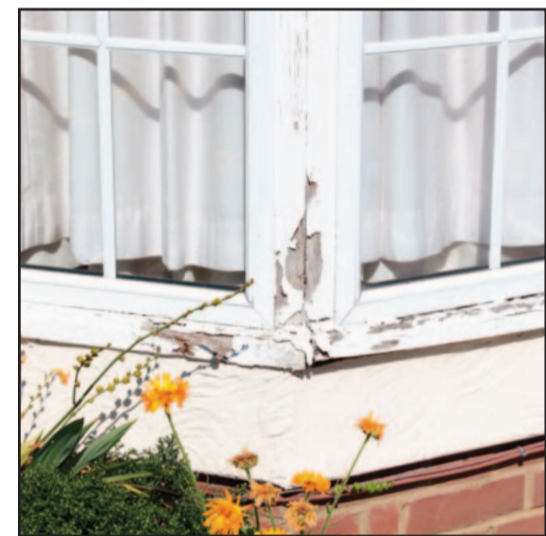
Timber bay frame requiring attention.

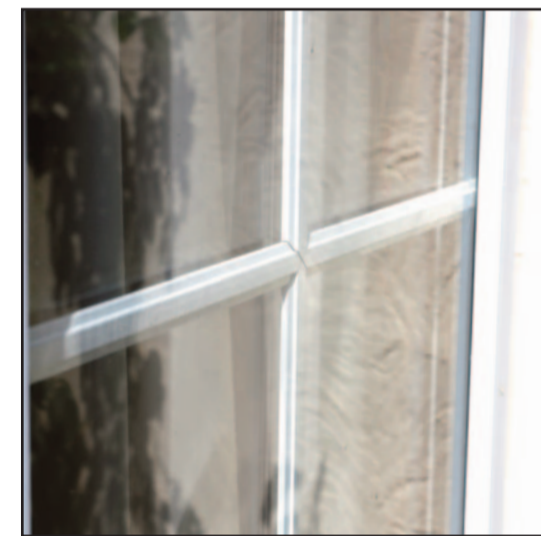
Glazing bars are sandwiched between glass.
