Location: Land Off Timmy's Lane Hurworth Darlington

Report Type: Arboricultural Survey Arboricultural Impact Assessment Arboricultural Method Statement

> Ref: ARB/AE/3186

> > Date: July 2023

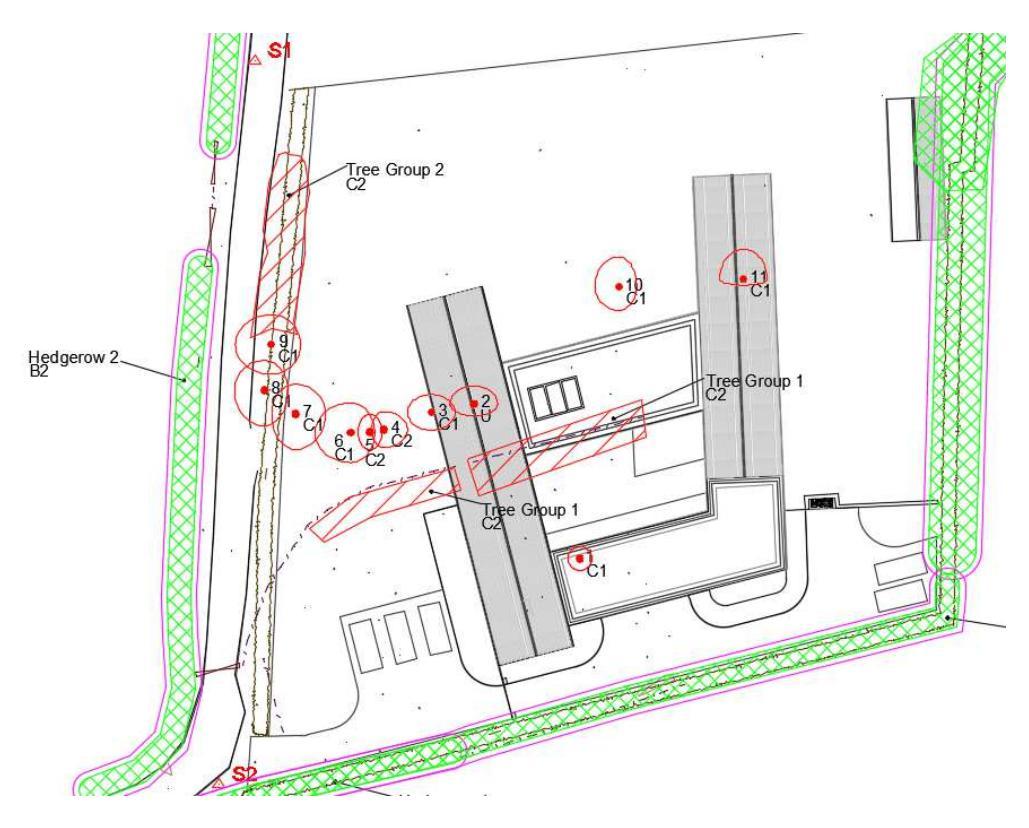
Figure 2: Tree removals (in red)

Trees 1-11, and Groups 1 & 2 require removal to allow construction.

Mitigation / Countermeasure: Of the 11 individual trees outlined for removal, 10 were classified as Category C trees of low quality, and 1 was classified as a Category U tree that requires removal regardless of the proposals due to poor structural condition. Both groups were similarly classified as Category C features of low quality that would not ordinarily constrain design. The arboricultural impact is considered to be very low, and any visual impact is similarly limited due to the trees' lack of stature and long-term value. Replacement tree planting within the site can ensure better quality canopy cover is provided for the long-term on site, and the proposed perimeter hedgerow planting on the sites western boundary will similarly reduce any short-term visual impact when viewed from the adjacent access track.
