**Tree Survey, Arboricultural Impact Assessment  
Preliminary Arboricultural Method Statement & Tree Protection Plan  
In Accordance with BS 5837:2012**

| Proj. No<br><b>9372</b> | <b>Pratts Green Farmhouse, Maltings End, Kirtling, Suffolk, CB8 9HH</b> | | |
| Date of Report: | 10/03/2022 | Revision: | Original |

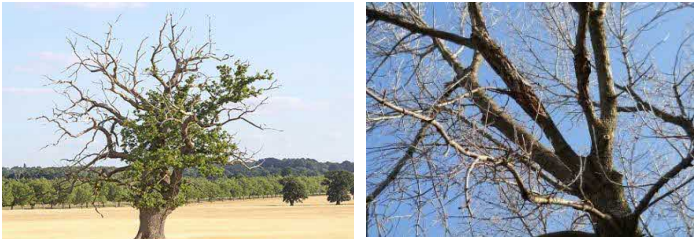
| <b>Symptoms/damage type and cause:</b> | This relates to dead branches in the crown of the tree. In the majority of cases, this is caused by the natural ageing process of the tree or shading due to its close proximity to neighbouring trees. However, in some situations, it may be related to fungal, bacterial or viral infection. |
| <b>Consequence:</b> | Depending upon the location and mass of dead wood removal of the affected tissue may be necessary to prevent harm to persons or property as the wood will become unstable as it decays and in some circumstances is likely to fall from the tree with little or no warning. |

| <b>Control:</b> | Detailed monitoring should be undertaken on those trees showing signs of excessive deadwood production to identify the underlying cause. |

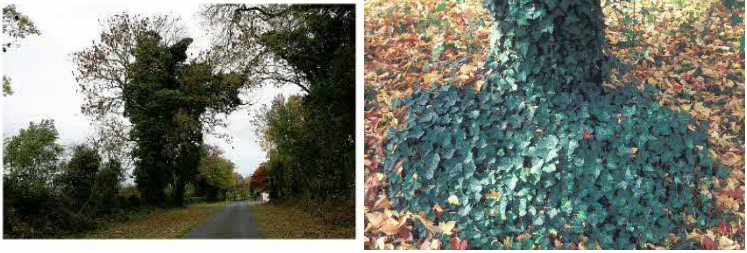
| <b>Symptoms/damage type and cause:</b> | Ivy may grow to varying degrees on all areas of a tree from the base to the upper crown. It is possible that in doing so it will out-compete the host tree for available light thereby suppressing the host. |

| <b>Control:</b> | Ivy should only be removed if absolutely necessary because it provides abundant cover to wildlife and then by severing twice close to the ground and removing a length of stem thereby causing the gradual dying away of the aerial parts of the plant providing extended benefit to wildlife whilst relieving the pressure on the tree. |
