Number
109/001

Project
Refurbishment @
Station House
Station Road
Misterton
Bassetlaw
DN10 4DH

Date
October 2023

DESIGN AND ACCESS STATEMENT INCLUDING HERITAGE STATEMENT

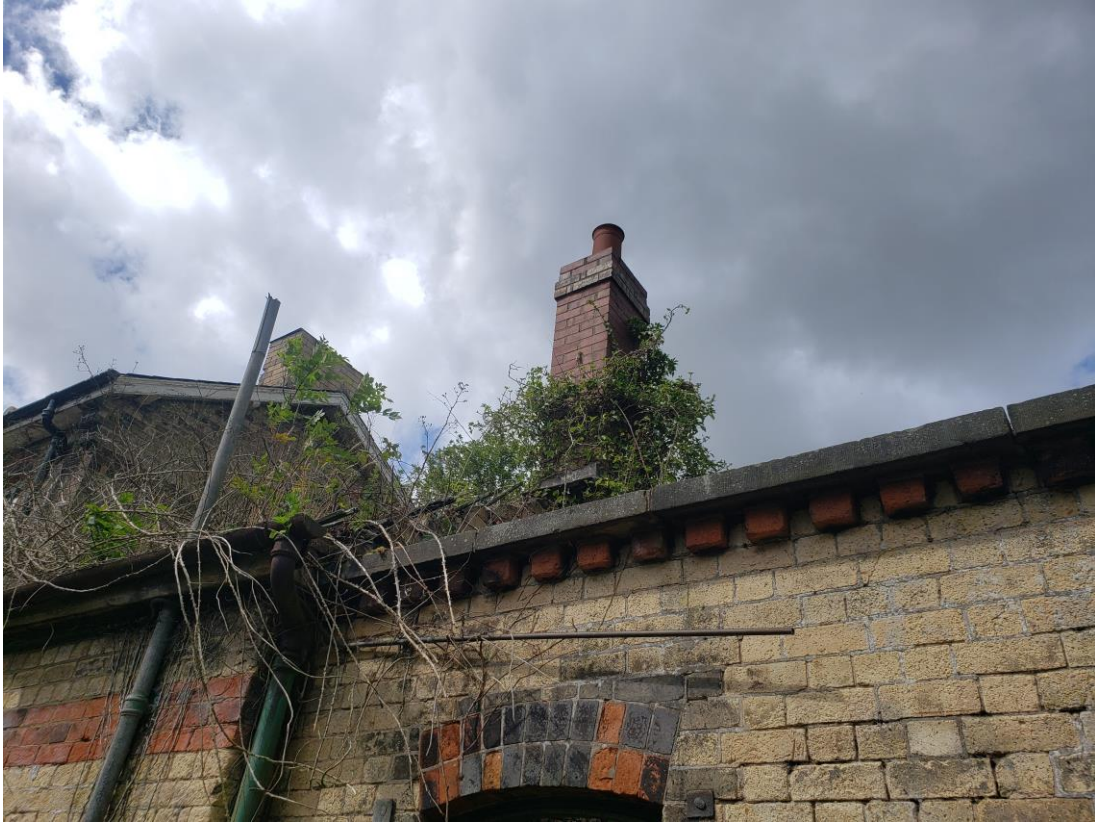
Current red brick chimney between outbuildings 1 and 2

The original brick chimney between outbuilding 1 and 2 used to be a detailed design matching the rest of the chimneys on the dwelling. In the past it has been dropped to roof level and re-built in a simple style in red brick. The intention is to drop the chimney again removing the red brick (dropped to around flat roof level) rebuilt in the simple style in gault 'yellow' brick. The brick will match the existing house.

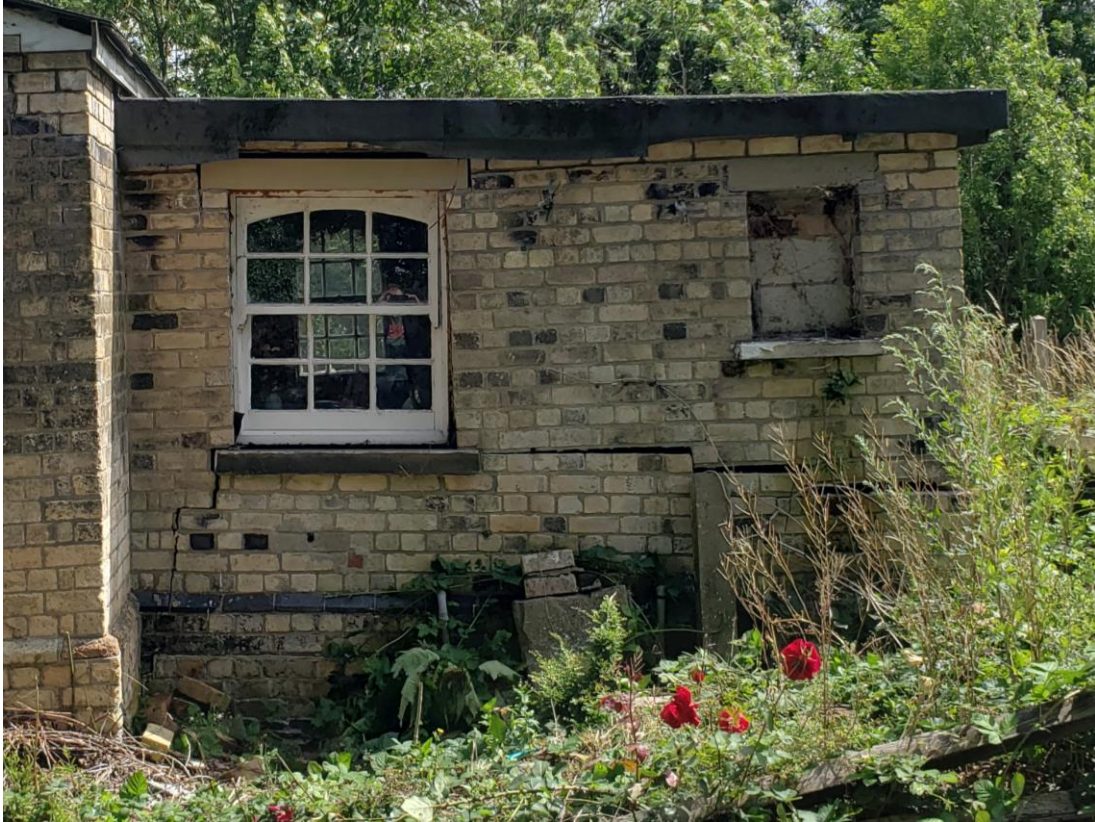
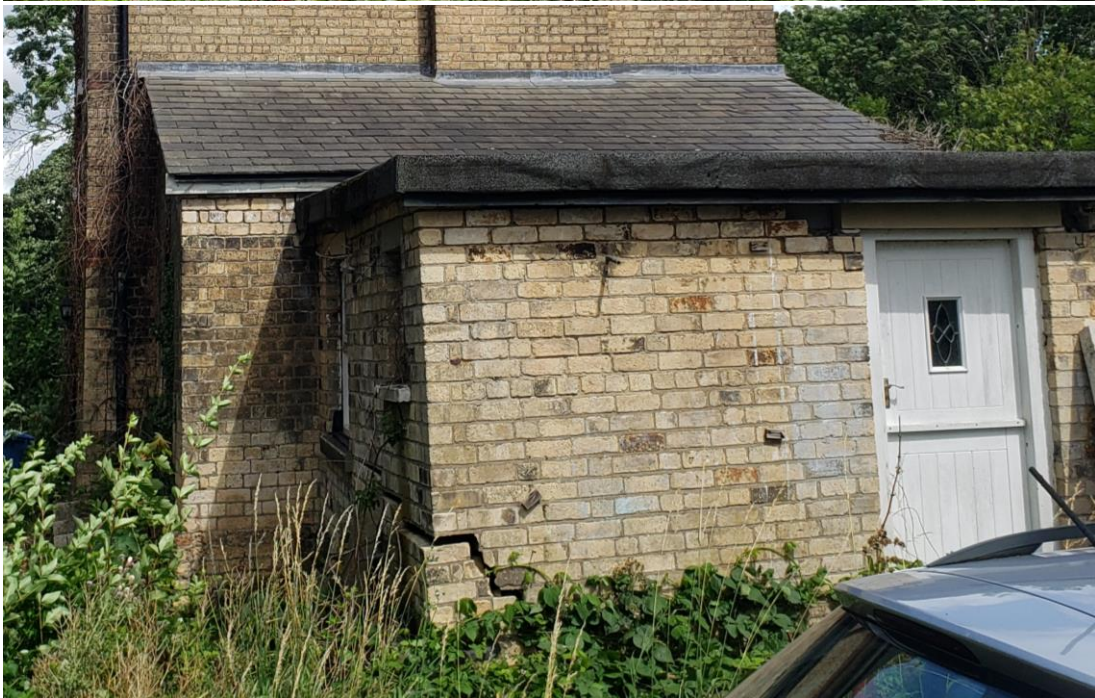
2 images above showing subsidence in the kitchen (South West Corner)

The current corner of the building has subsided and has resulted in horizontal cracking of the brickwork. A structural Engineer will be engaged to assess the cause of the subsidence and provide a suitable remedy. The brickwork will be made good to match the adjacent brickwork.

Underpinning to the kitchen corner and making good the brickwork

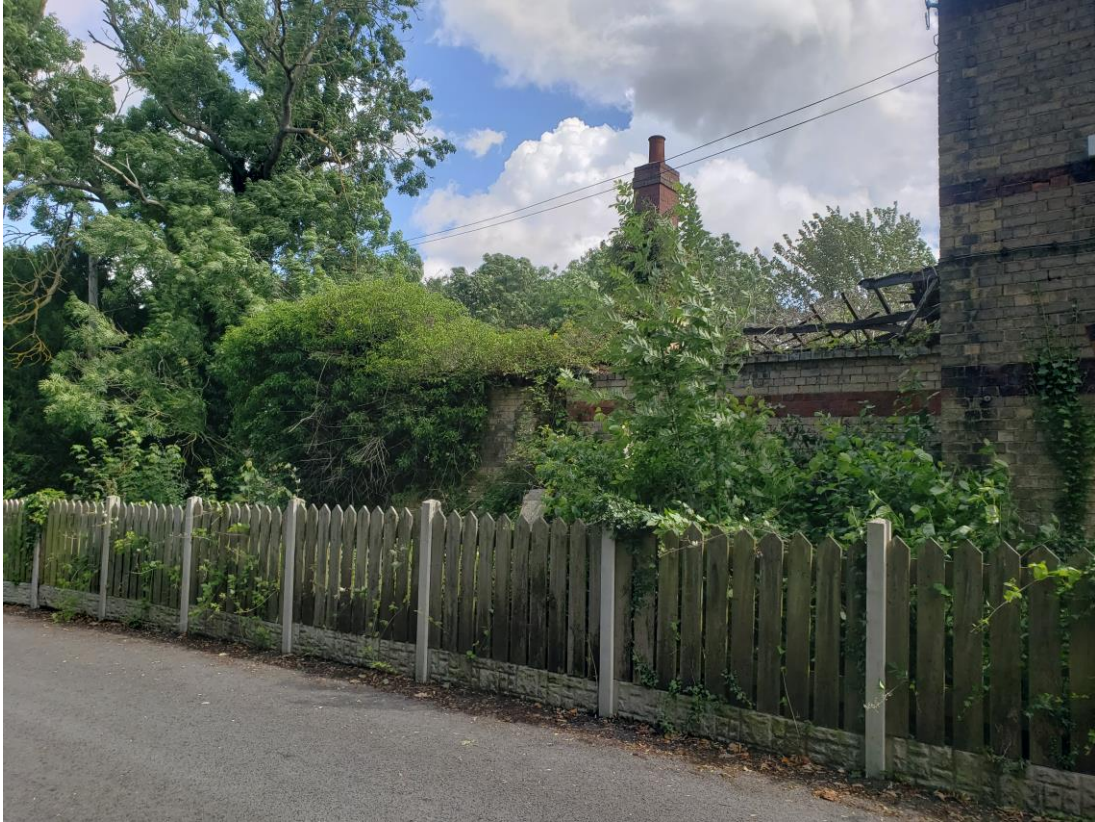
Image above showing the collapsed roof over Outbuilding 1 and the overgrown garden / outbuilding 2 and 3

The current roof to outbuilding 1 has had the slates removed as the roof was collapsing. A new traditional roof constructed from timber ridge / rafters and ceiling joists is proposed with a slate roof covering to match the main house.

Outbuildings 2 and 3 have very little roof left and the intention is to provide a new flat roof over the 2 outbuildings made from timber supports and boards with a rubber roof covering (in black). The roof will be below the level of the parapet so it will not be seen from the outside.

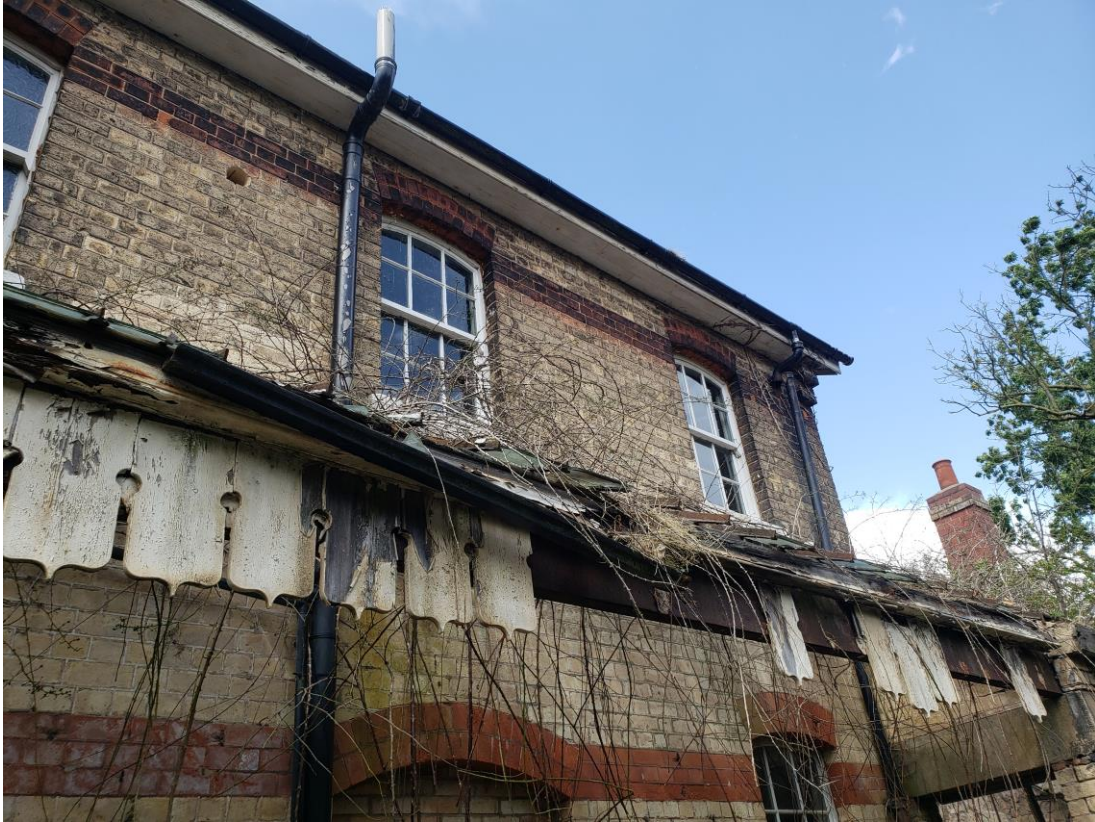
Image above shown the glazed canopy and timber feature fascia in dis-repair

The current glass canopy is supported from a steel beam at the eaves and connected to the wall at the abutment. There are steel glazing bars with single glazed infill glass. Any remaining glass will be removed and disposed of. The steel beam and glazing bars will be cleaned, treated and decorated. New toughened single pane clear glass will be fitted between the glazing bars putting the glass canopy back to how it was originally.

Any remaining timber fascia section that are complete and salvageable will remain. A template will be made of the timber section and new pieces made to replace the missing, broken or rotten ones. They will all be decorated to return the decorative valance back to how it was originally.

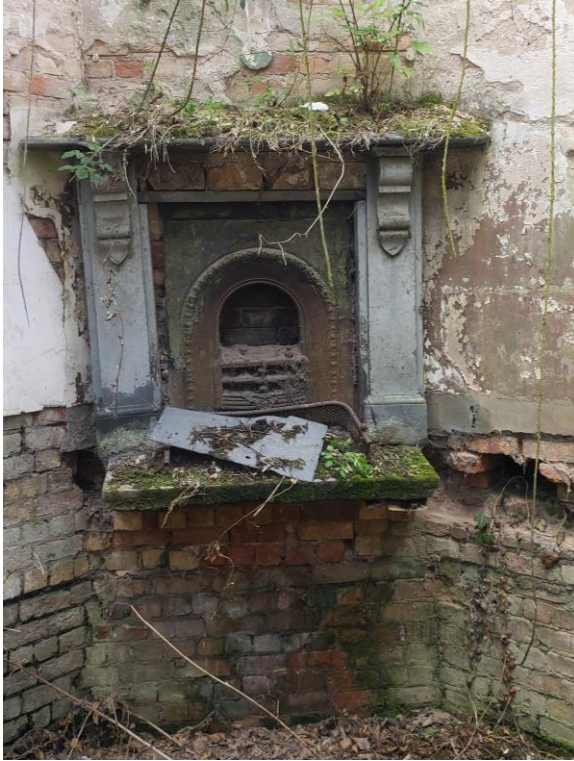
Fire place 5 in Outbuilding 1 (floor missing)

The floor in outbuilding 1 has rotted away and has been removed from site. A new timber joist and floor board floor will be constructed in Outbuilding 1. Under the existing fireplace a masonry wall will be constructed to support the fireplace and hearth to ensure it remains in-situ.

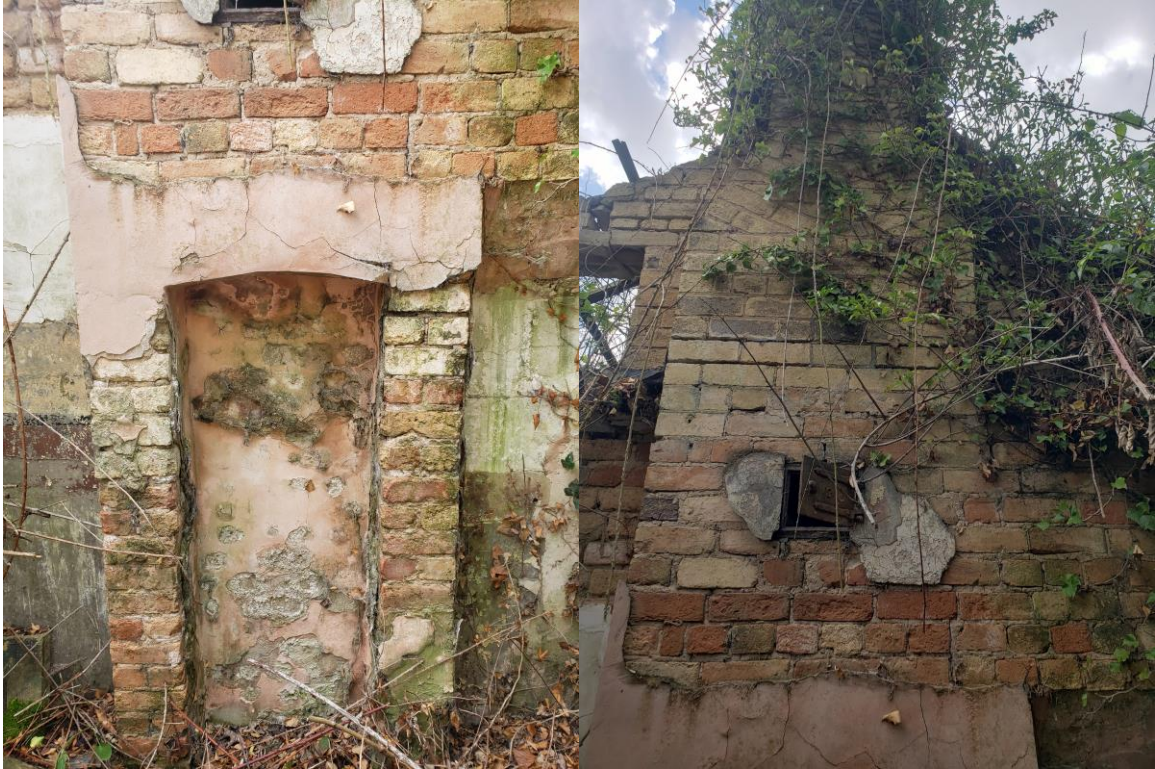
Fire place 7 in outbuilding 2. No fire or surround present. Sweeping door over fire place. Exposed brickwork within room suggests the entire original chimney was constructed from Gault brick. The top section is currently red brick.
