Hele View

Percolation & Infiltration Testing

Client: Hazel Walker
Document Reference: 220315-22127-Soakage Test

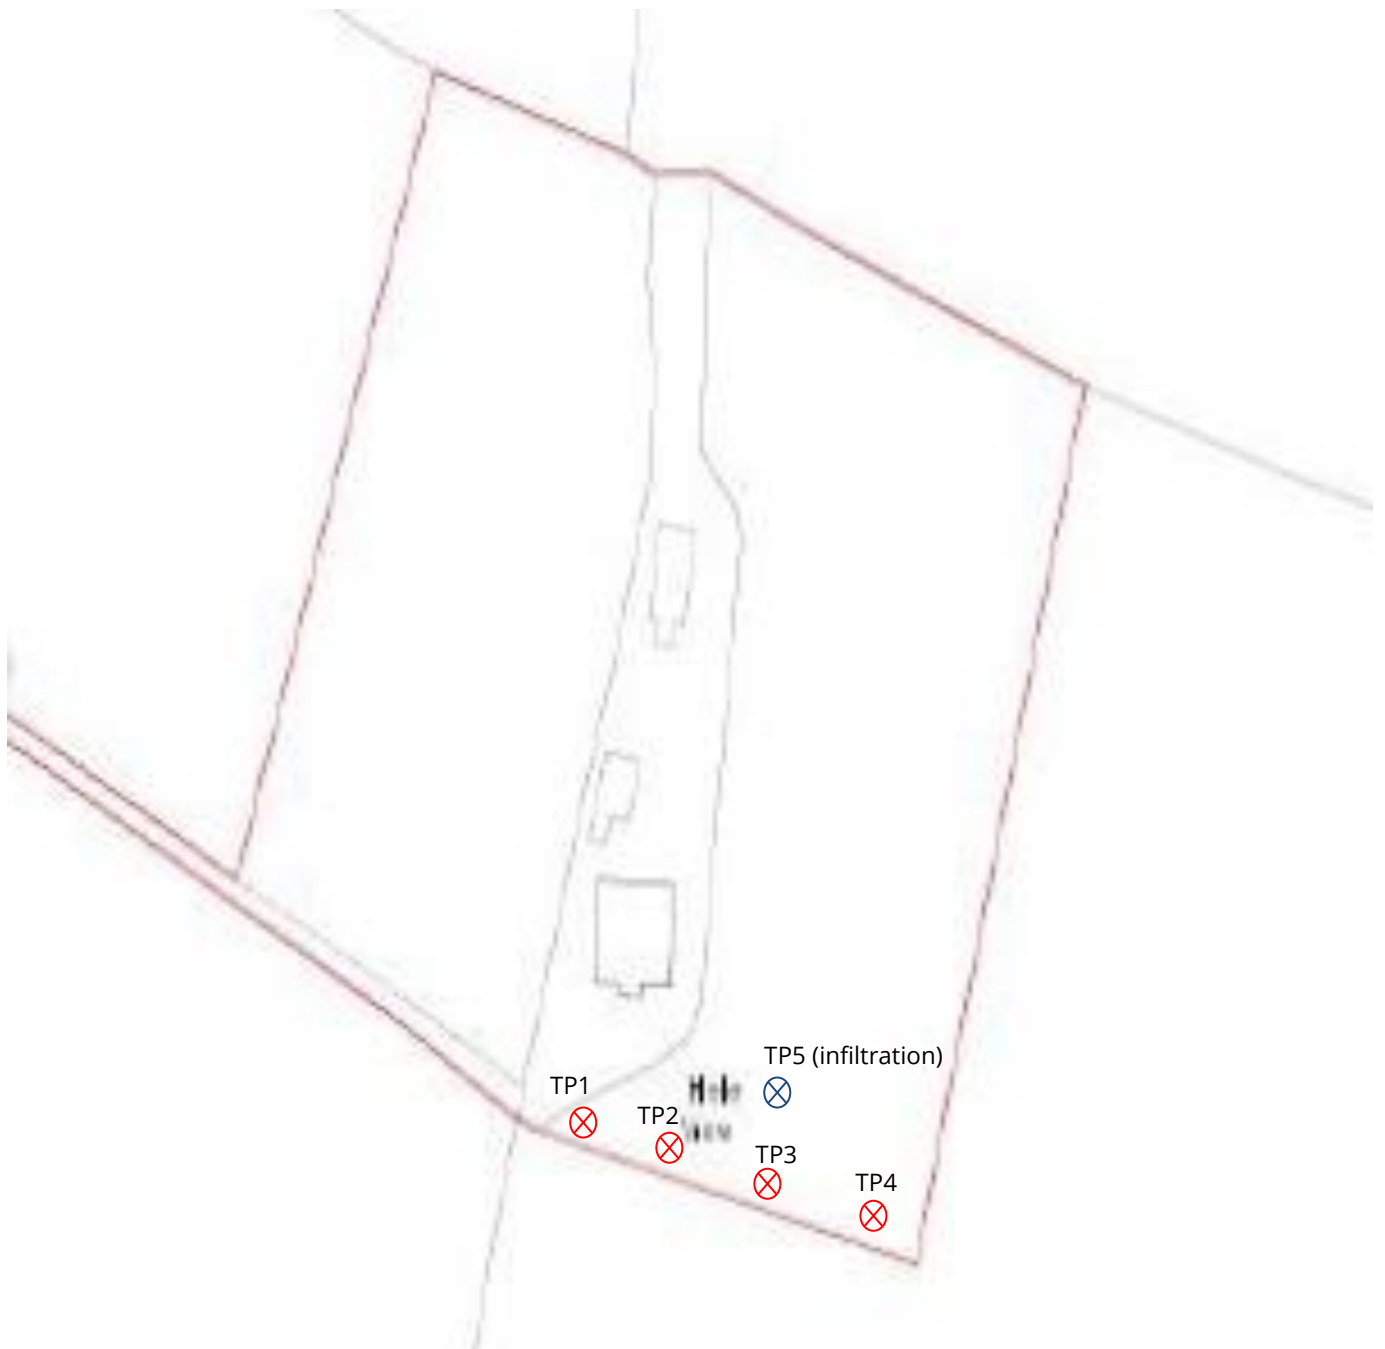
4.2 Appendix B: Trial Pit Locations

A total of 5 trial pits were excavated in the area anticipated for the foul water drainage field as indicated in Appendix B. 4 no. pits were excavated by hand to the requisite depth of 600mm BGL.

1 no. pit was excavated using a 2 tonne tracked excavator to a depth of 2.4m BGL to assess groundwater levels and subsequently for infiltration tests.

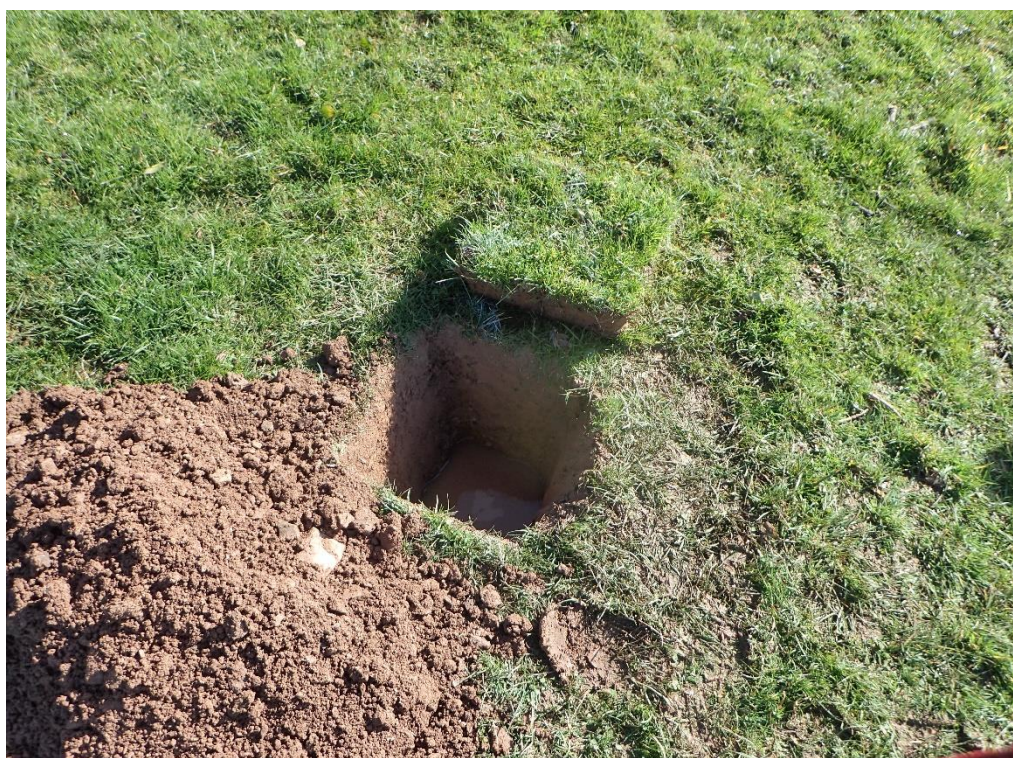
Trial Pit 1

The results of the tests are presented in Appendix C. Of the 4 percolation tests, only one pit drained to any extent with a resulting average V_p of 32. In accordance with BS 6297 a minimum V_p of 15 s/mm is required to ensure infiltrating water does not enter the ground too rapidly. Further, where V_p is above 100 s/mm effective soakaway is unlikely to be achieved which may lead to wastewater ponding on the surface. The effective V_p across the site is greater than 100 on the basis that 4 out of 5 trial pits did not drain.

An alternative system of drainage will be required. This is likely to comprise a direct discharge to watercourse.

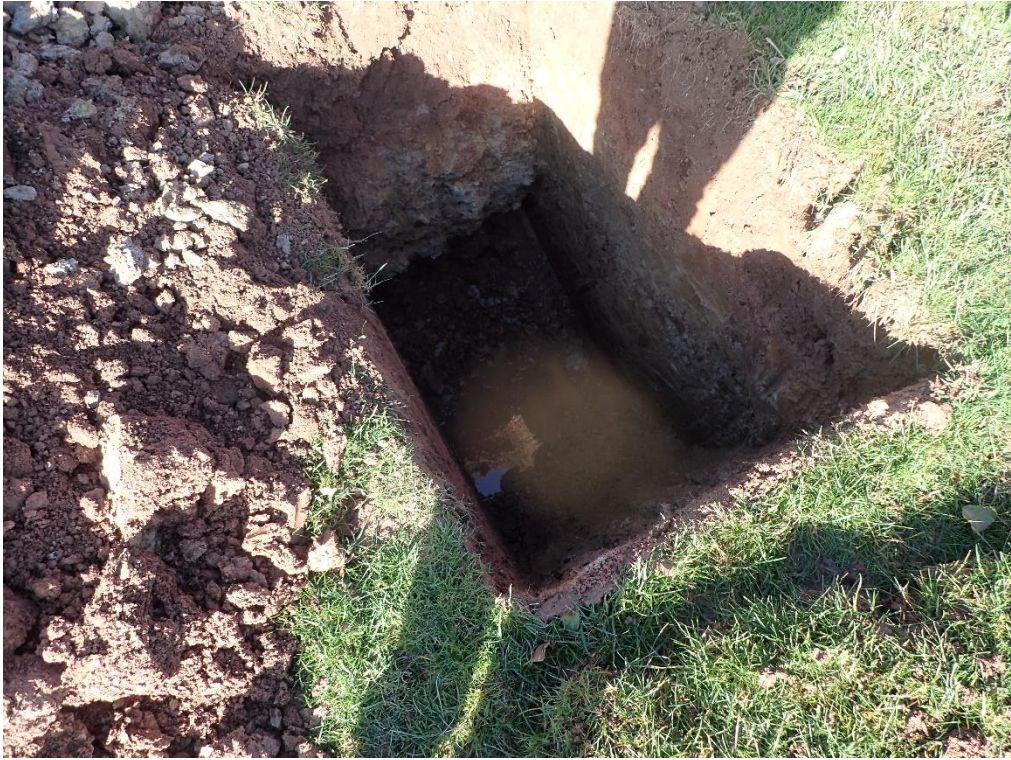
Groundwater test

No groundwater was observed. Minor seepage entered the excavation from surface water saturation with no increase in depth.

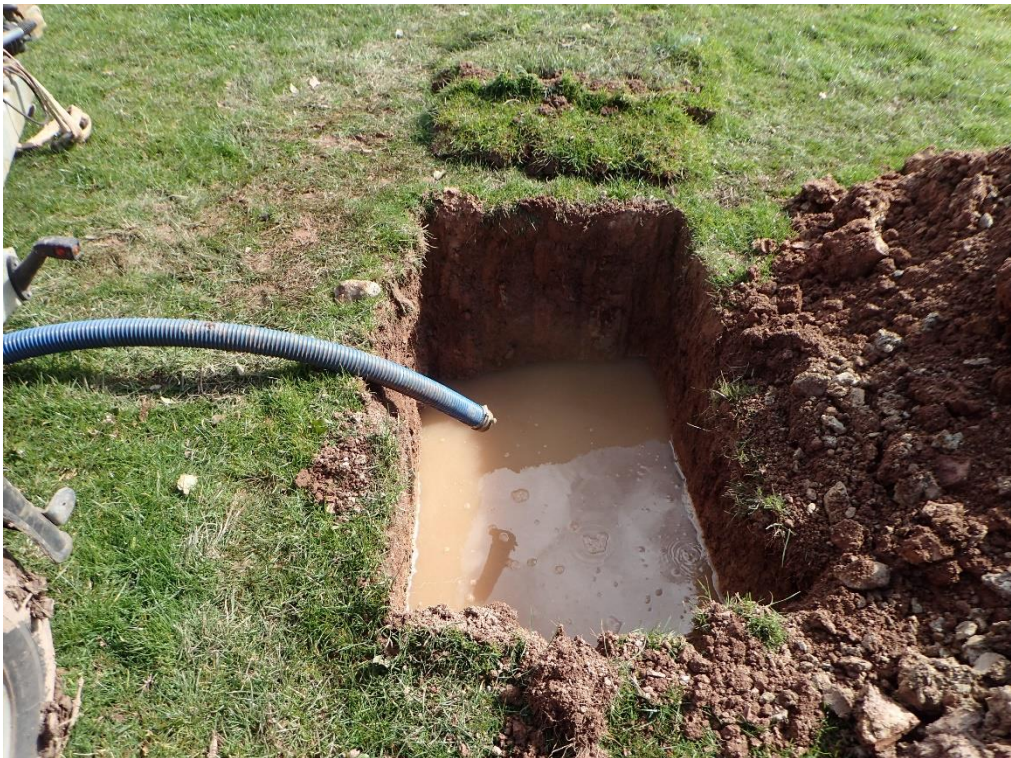
Infiltration test

Infiltration testing was undertaken on a single trial pit. Water was filled to a depth of 1.75m with no visible reduction over 6 hrs. Infiltration tests were subsequently abandoned.

Tests abandoned. No reduction in depth over 6 hrs.

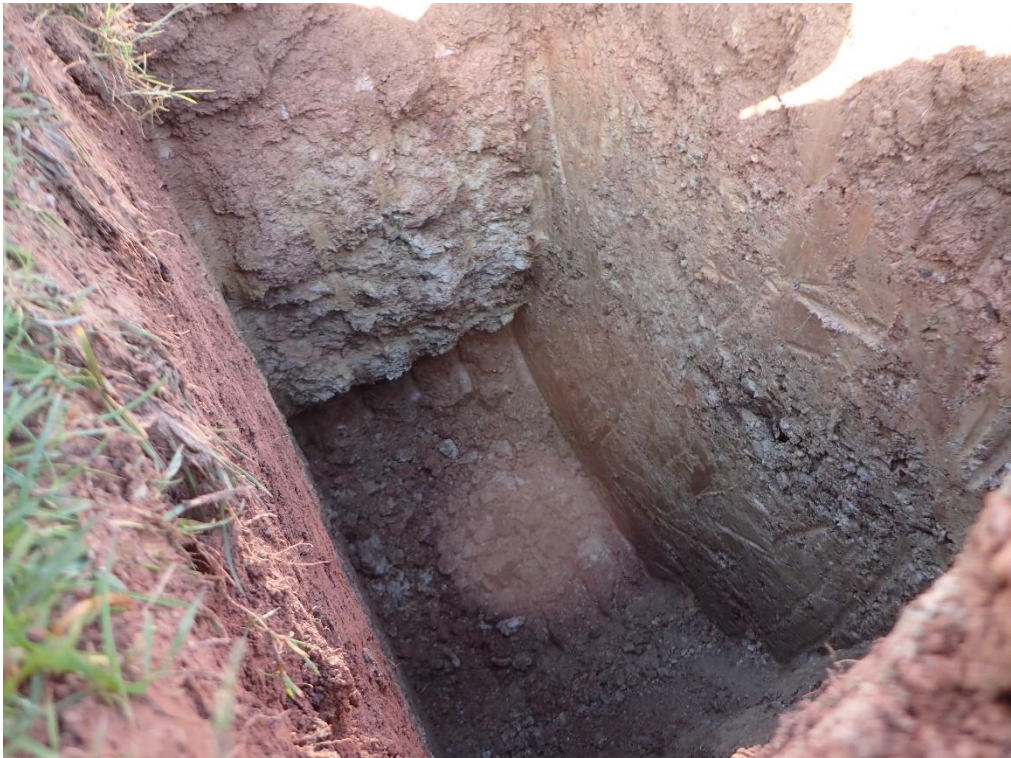
Soil profile

The ground encountered comprised a superficial covering of turf and topsoil with consolidated cohesive clay soils from ground level to the base of the deepest pit at 2.4m BGL.
