Greestone House
Greestone Place
Lincoln
LN2 1PP

Heritage Impact Assessment

Emergency New Gas Mains Connection to the southern Elevation of Greestone House, Lincoln

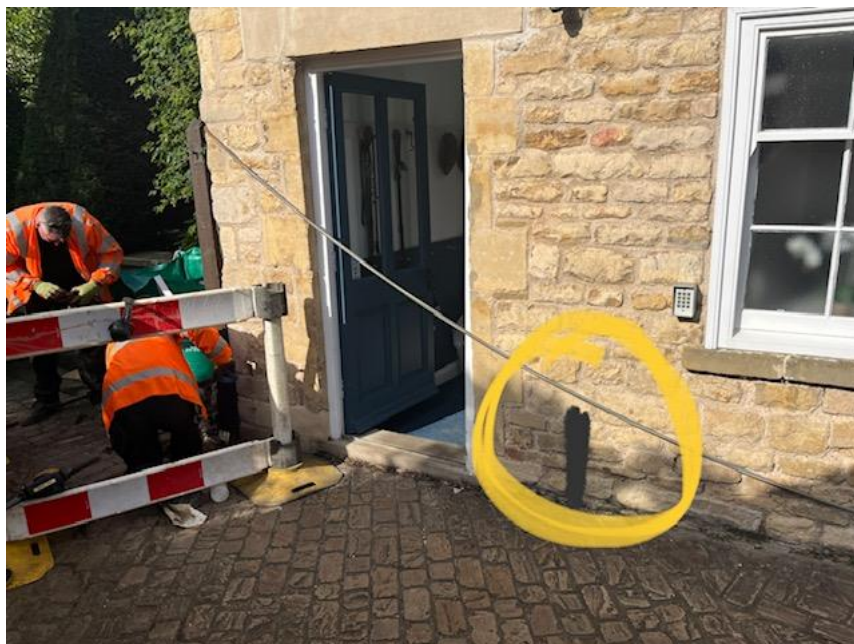
A new meter was proposed on the external face of the building, after a constructive conversation with Sarah Harrison (City of Lincoln Heritage) it was agreed by Cadent that due to the Listing of the building that the existing meter could be retained within the property, however where the gas service pipe enters a property, a grey pipe running vertically and then through an external wall would have to protrude approximately 350mm from the driveway.

Above: Proposed location of pipe to internal meter

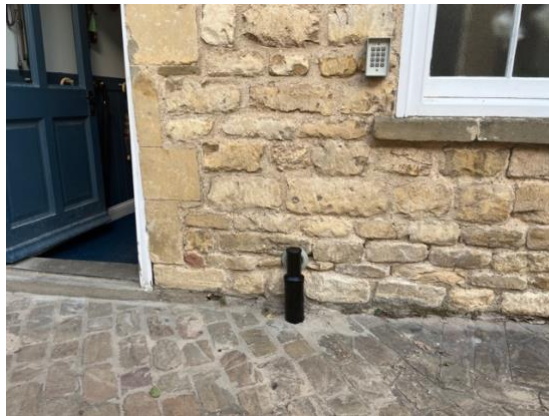
It is considered that the proposed gas pipe has not have any negative impact on the southern façade of the building. It has been painted black to match existing downpipes and external ironmongery, it passes through the cobbled stone on the drive, where it is connected underground to the national gas network on Greestone Terrace.

There has been some loss of historic fabric through the removal of one cobble stones at ground level to enable the external pipe to connect to replaced polyethylene pipe underground.

Above: The installed pipe to internal meter

Due to the age of the property the existing gas pipes from the mains (on Greestone Terrace) are metallic and no longer legal or in line with the government guidelines. Due to a gas leak, Cadent (gas distribution network) had to excavate around the existing gas inlet/pipe into the house to get access to and replace the existing steel pipe with a polyethylene pipe.
