Project Title
The PCC of Holy Cross Church
Goodnestone
Near Wingham
Kent
CT3 1PL

Drawing Description
Site Plan of Church Path
To Be Re-covered

17133A_100

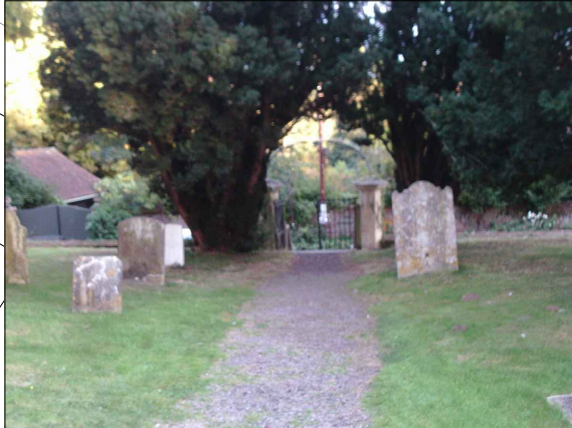
Fig 1. View of path looking towards eastern steps

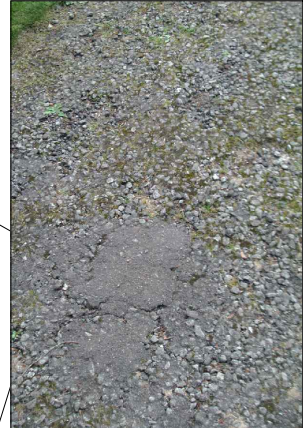
Fig 2. View of path condition showing damage to existing tarmac surface

Porous asphalt paving
 Description: To Path
 Standard: To BS EN 13108-7.
 Binder course:
 Paving grade: 100/150
 Compacted thickness: 45 mm
 Surface course
 Manufacturer: Contractor's choice
 Type: Porous Asphalt
 Paving grade: 70/100
 Compacted thickness: 25 mm

Laying generally
 Preparation: Remove all loose material, rubbish and standing water.
 Adjacent work: Form neat junctions. Do not damage.
 New paving
 Keep traffic free until it has cooled to prevailing atmospheric temperature.
 Do not allow rollers to stand at any time.
 Prevent damage.
 Lines and levels: With regular falls to prevent ponding.
 Overall texture: Smooth, even and free from dragging, tearing or segregation.
 Condition on completion: Clean.
Levels
 Permissible deviation from the required levels, falls and cambers (maximum): In accordance with BS 5949:87, clause 5.2.

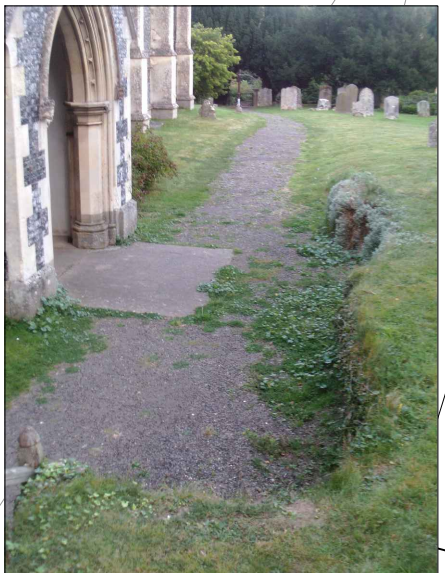
Fig 3. View looking east from south porch

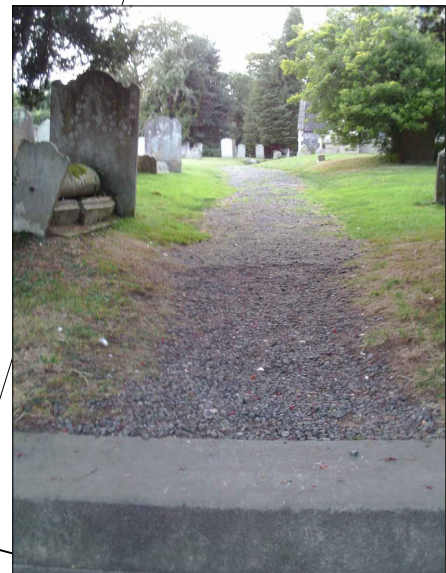
Fig 4. View from eastern steps looking west
