Site Investigation Report

Auger Ref: 144882.1.USI

Job Information				
Client	Crawford & Co			
Client ref	SU2204182			
Visit date	06/03/2023			
Report date	18/04/2023

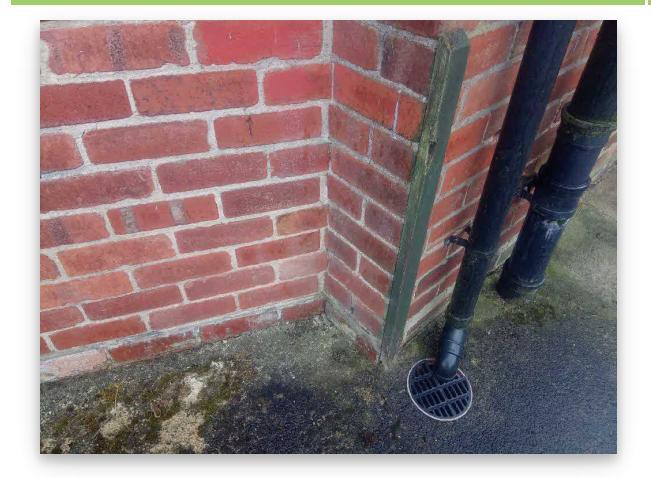
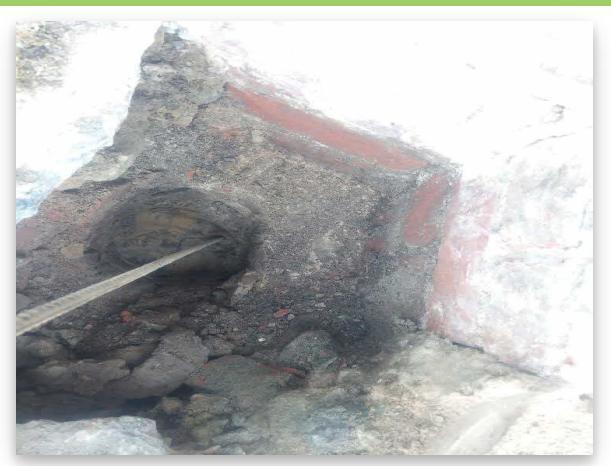
Fig 1.1: Trial Hole 1 Location

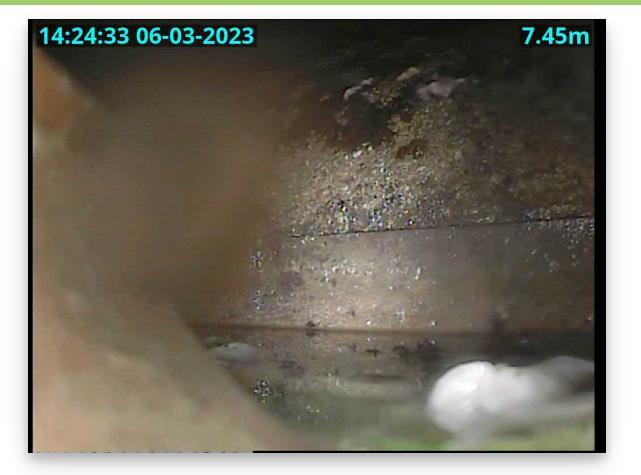
Fig 2.1: Water holding in MH1

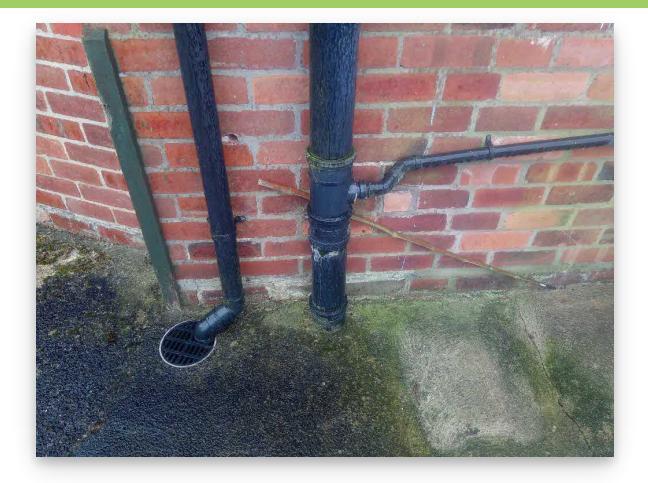
Fig 3.1: SVP and RWG1
