Arboricultural Method Statement, Impact Assessment and Tree Protection Plan in Accordance with BS 5837:2012

38 PARKWOOD ROAD, BEXLEY, KENT, DA5 3NW

SouthOaks Arboricultural Consultancy

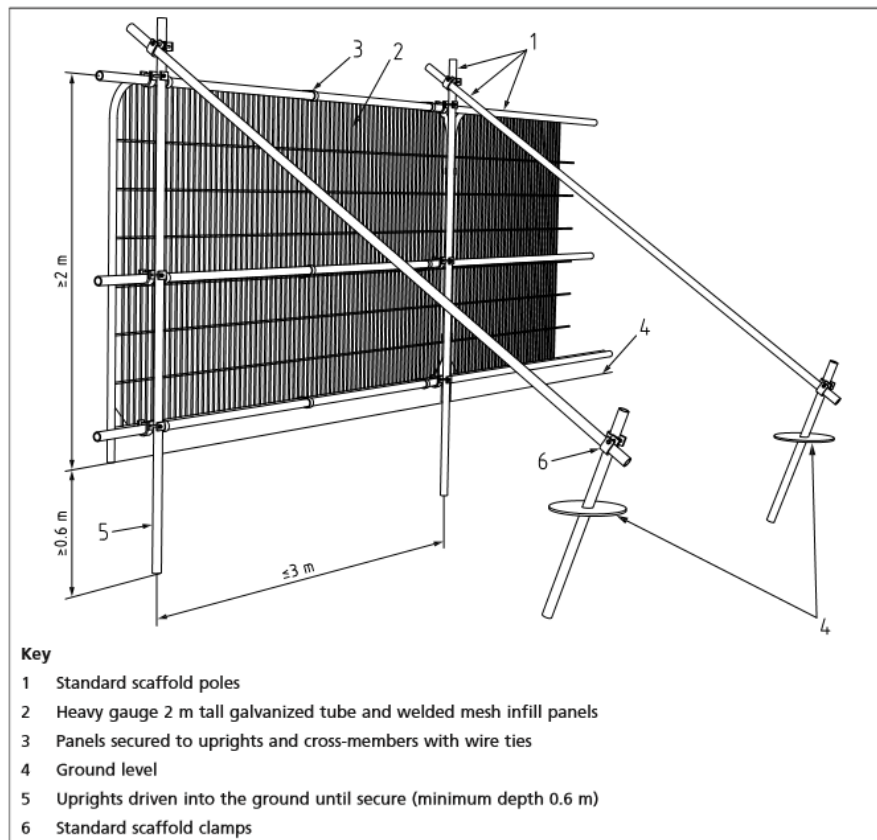
Figure 1 – Default specification for protective barrier

The default barrier specification should consist of vertical and horizontal scaffold framework, the verticals should be spaced at a maximum of 3 meters apart (see figure 1) with mesh panels welded onto the framework. The uprights driven into the ground should not make contact with structural roots or underground services.
