## Tree Survey and Constraints Report

St Aidan's Catholic Academy

Report prepared for WSP

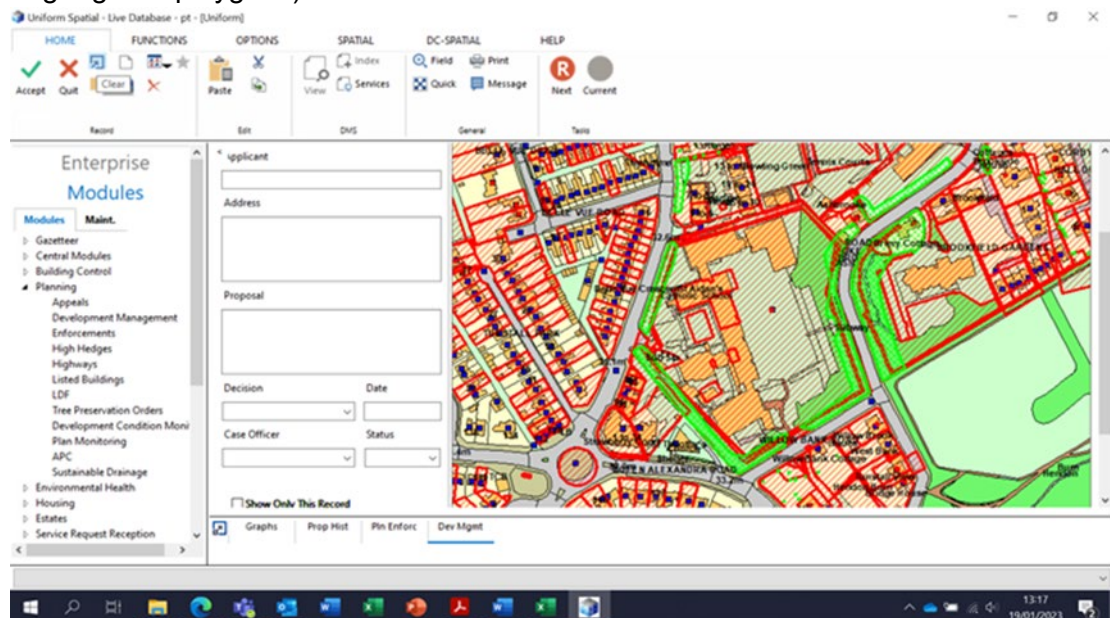
The site is surrounded by protected trees TPO 5, please see screenshot below (the bright green polygons).
