**PHOTOGRAPHS -  
GUEST AMENITY AREAS  
PEACOCK LAKE GLAMPING  
5 PEACOCK CLOSE  
GUNTHORPE  
NOTTINGHAM  
NG14 7RA**

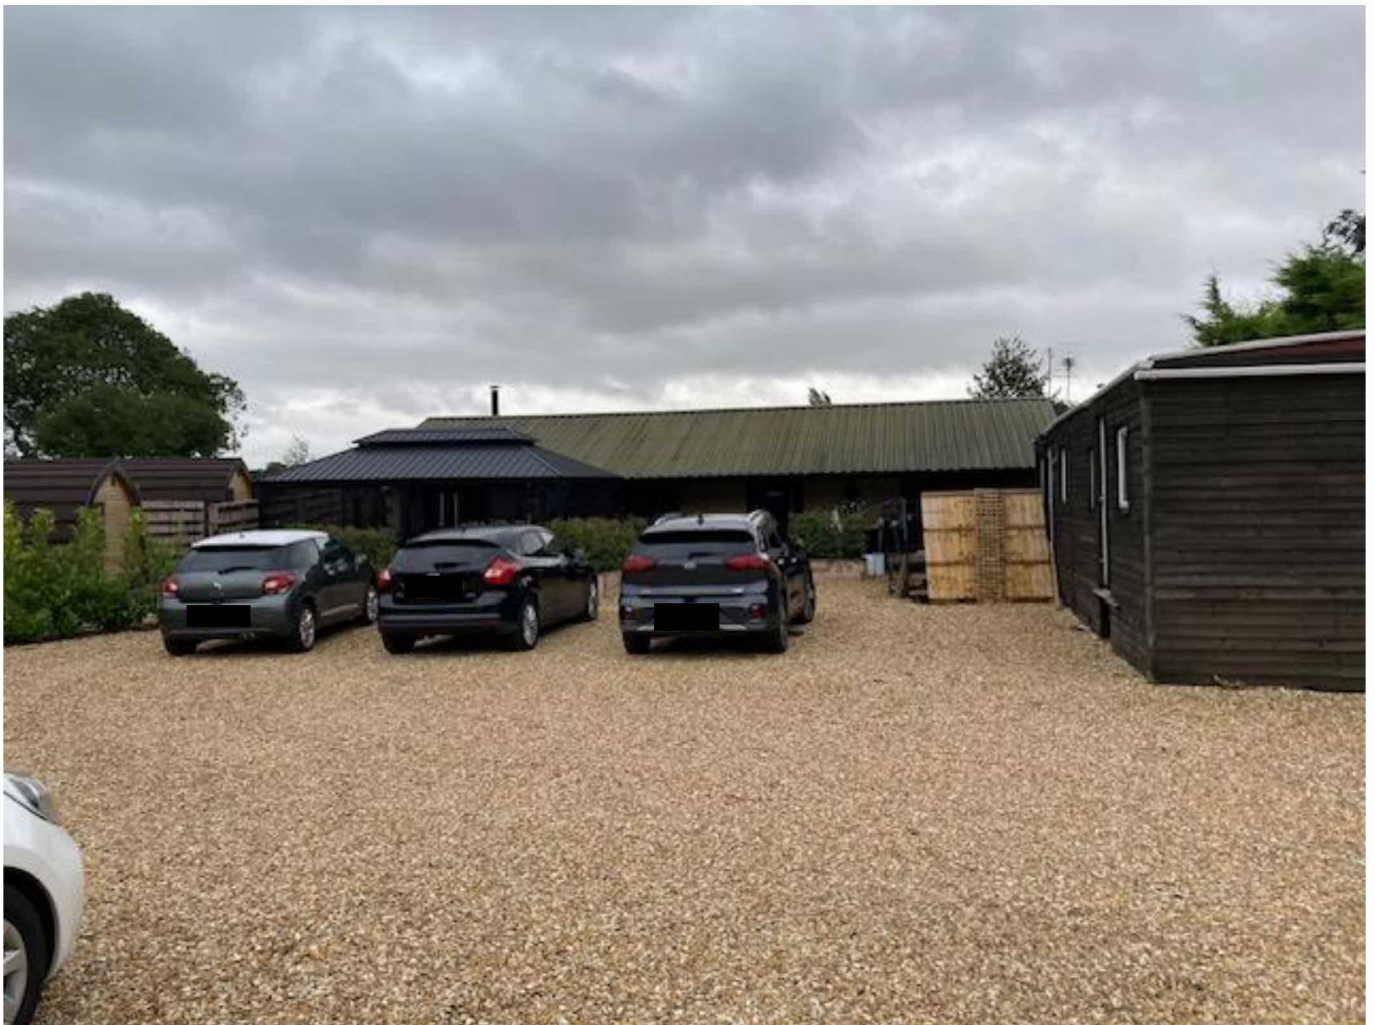
**1. The front north west facing view of the guest amenity areas viewed from the gravel drive and parking area.**

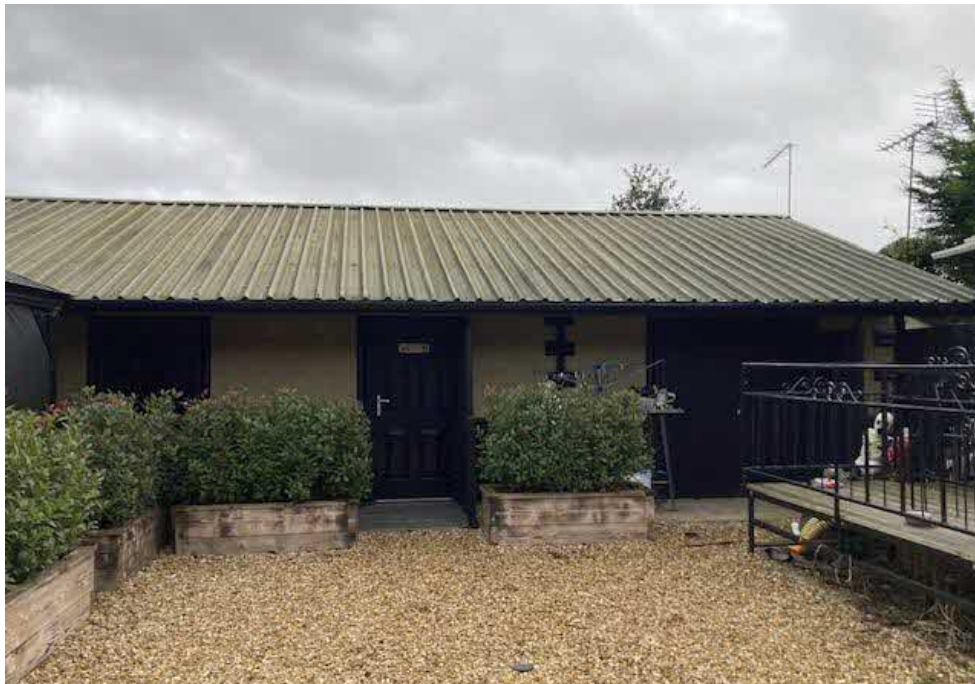
2. The front north west facing elevation with canopy of the amenity building – south west end.

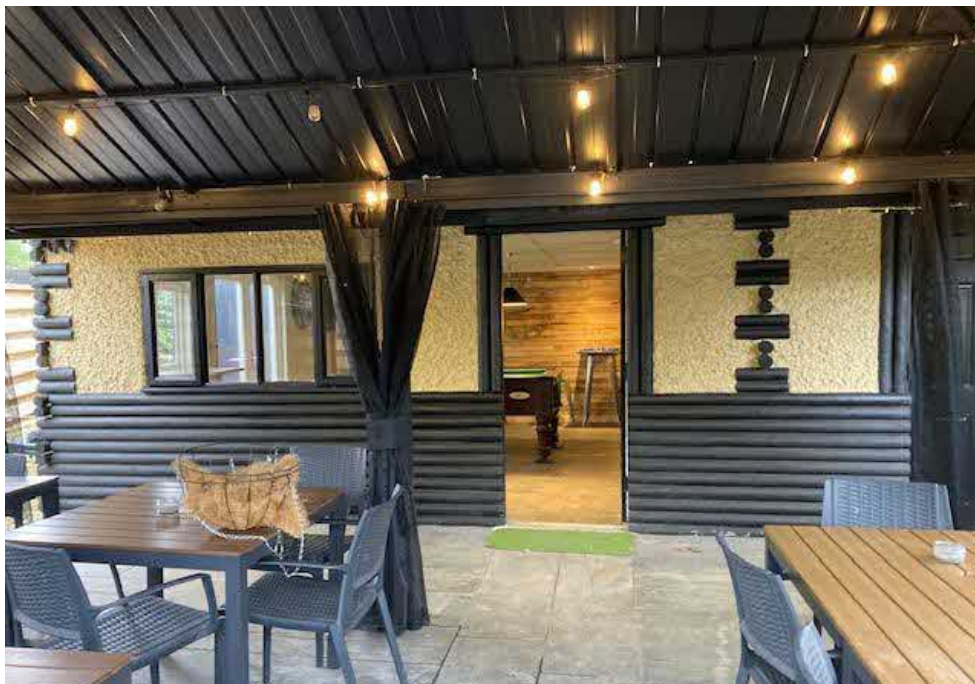
3. The front north west elevation of the amenity building (games room) – north east end.

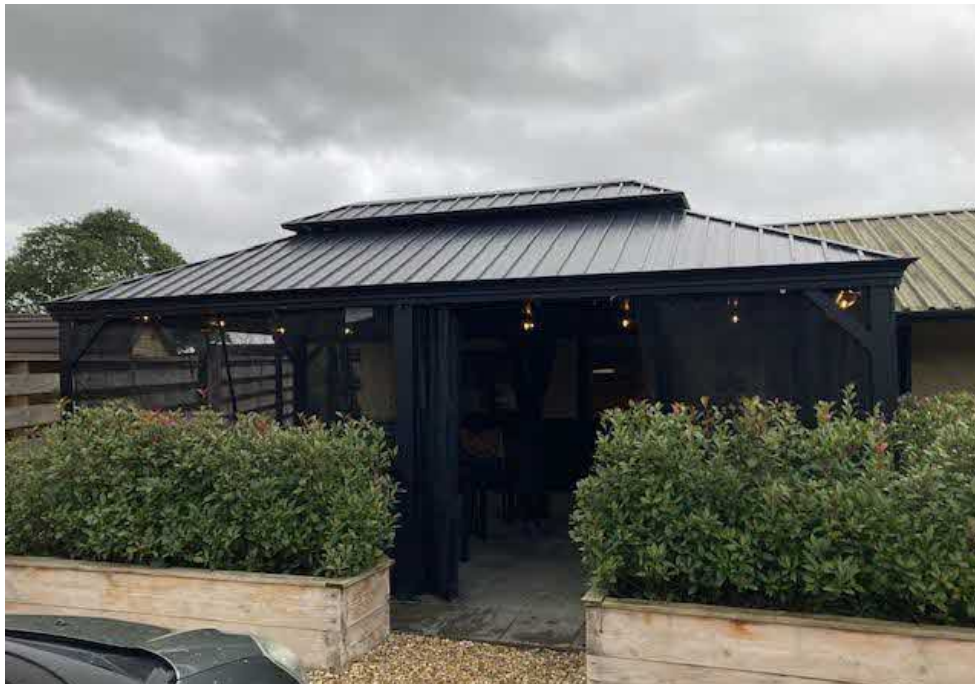
**4. The pergola structure in front of the amenity building north east end.**

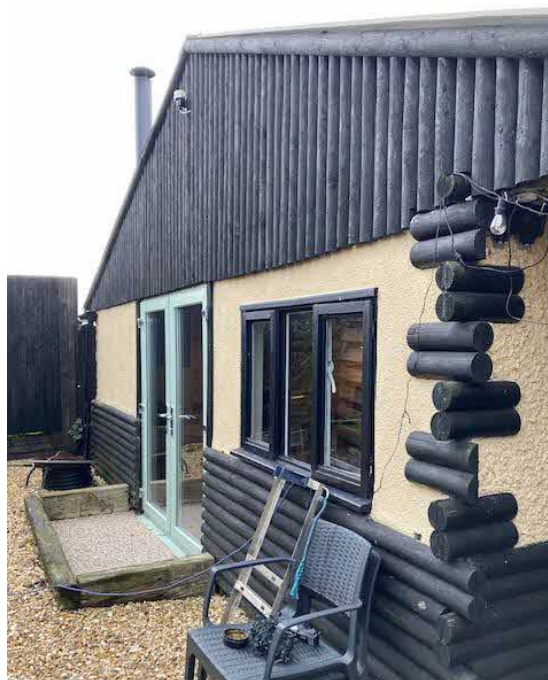
**5. The north east gable end of the amenity building (glazed doors into games room).**

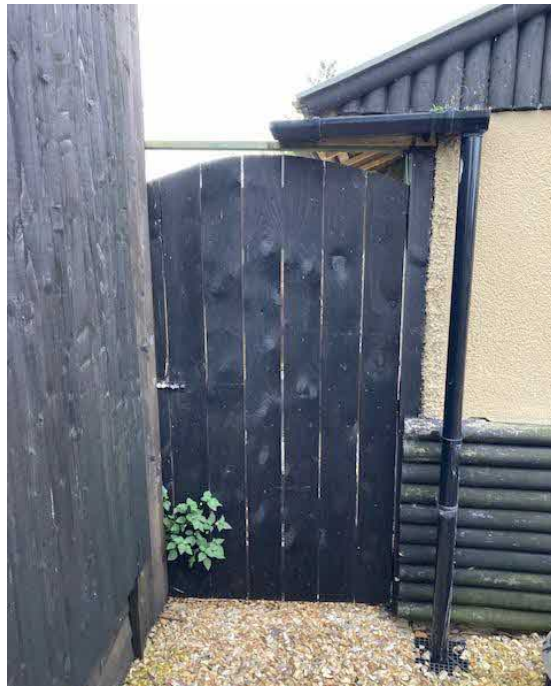
**6. The timber boarded gate at the rear east corner of the amenity building.**

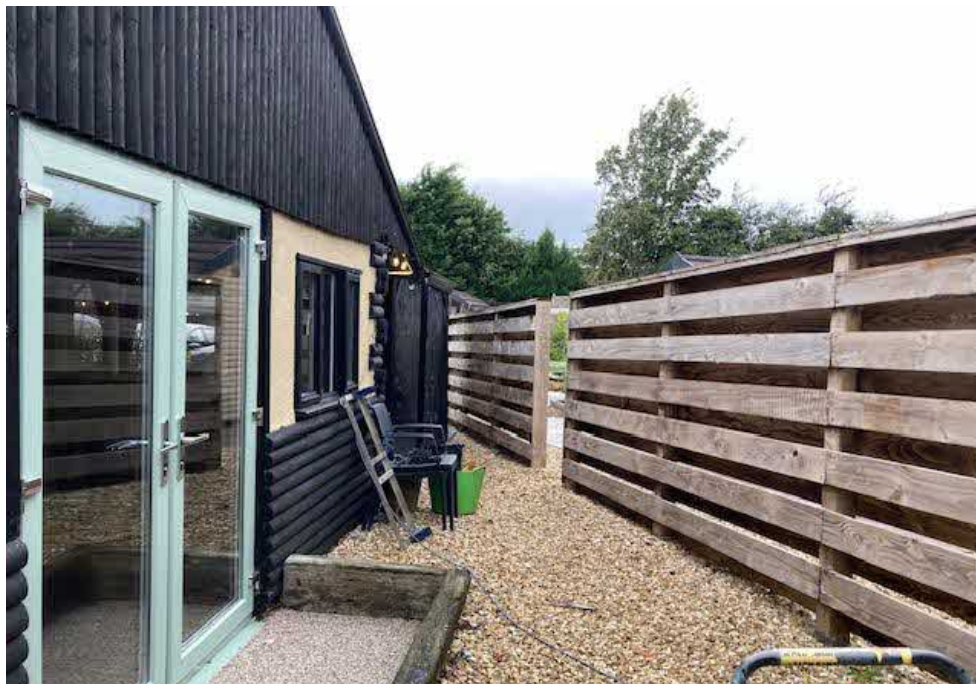
**7. The timber screen fence at the north east side of the amenity building.**

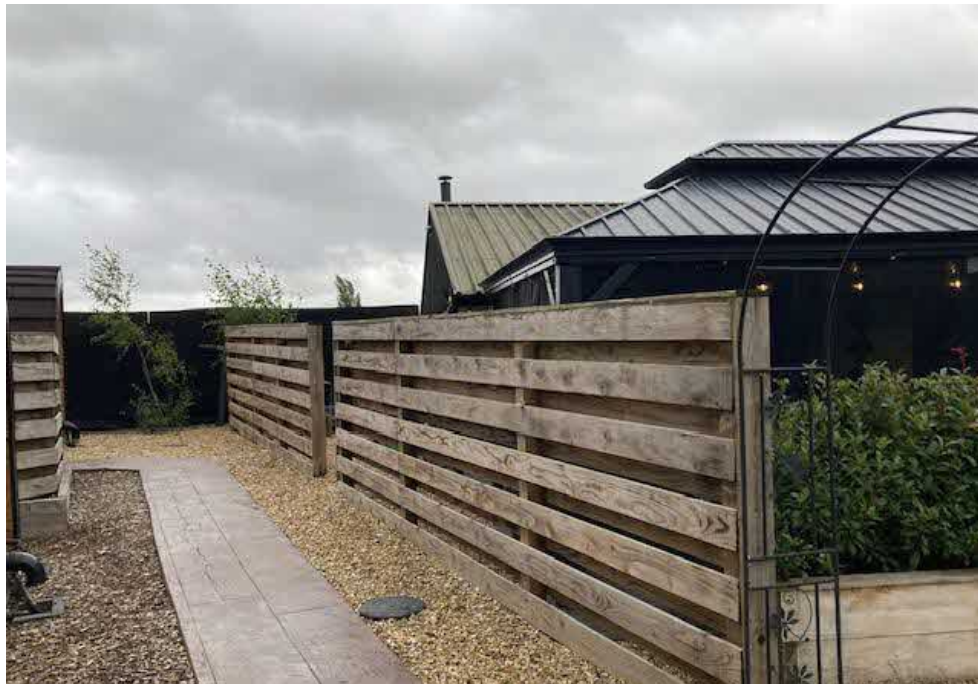
8. Outside the timber north east screen fence.

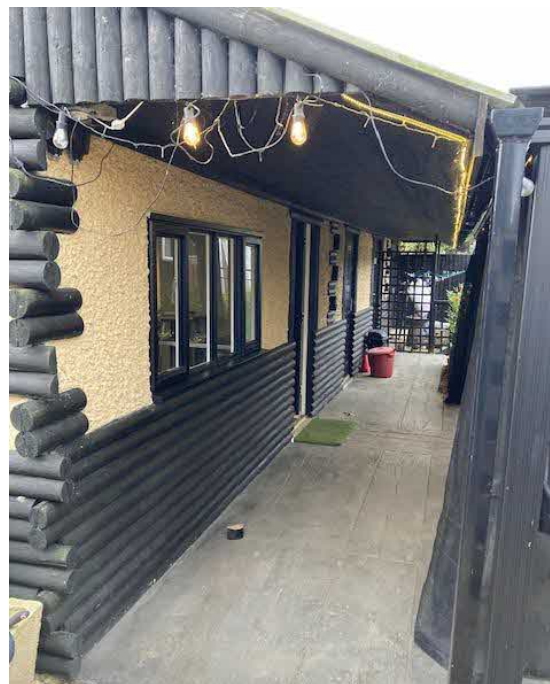
9. Looking west down the front covered path under the canopy roof.

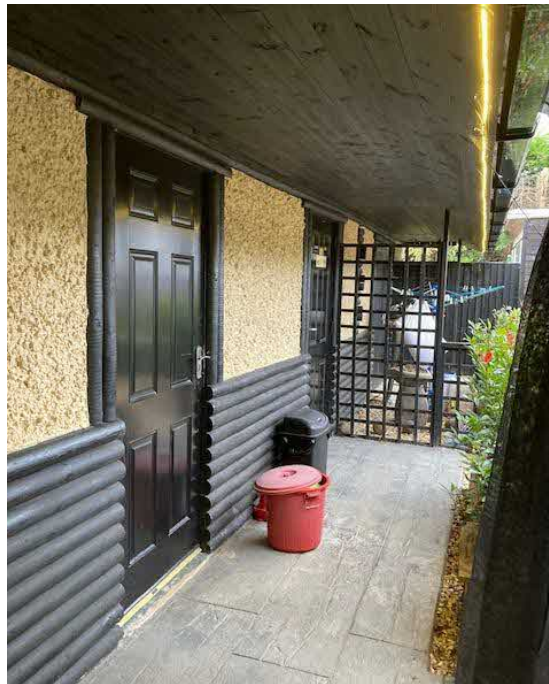
10. Looking west further under the front covered path.

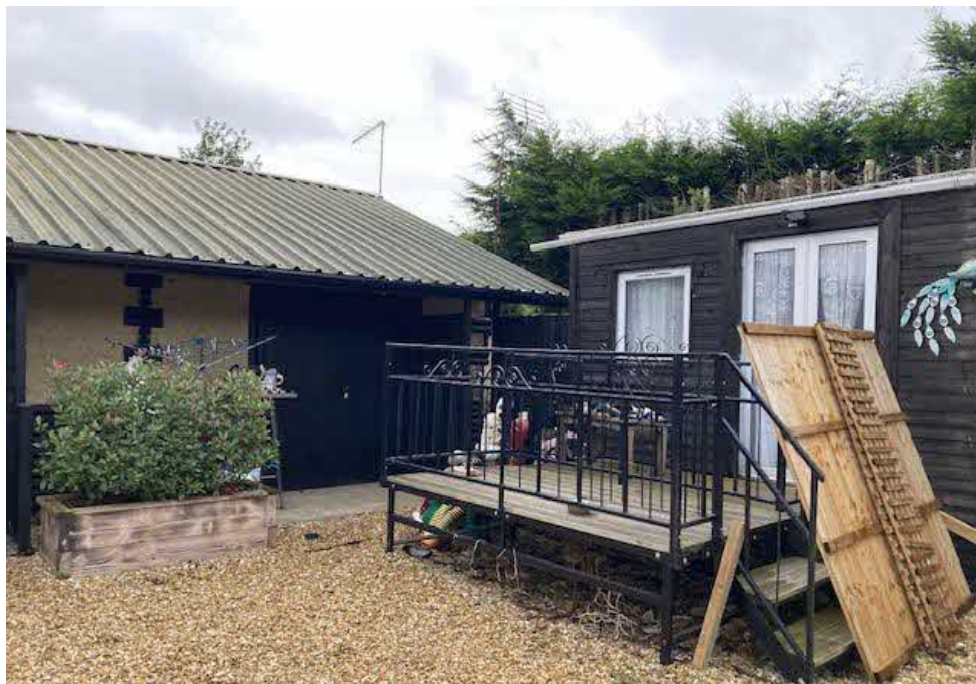
11. The south end of the amenity building adjacent to the second amenity building.

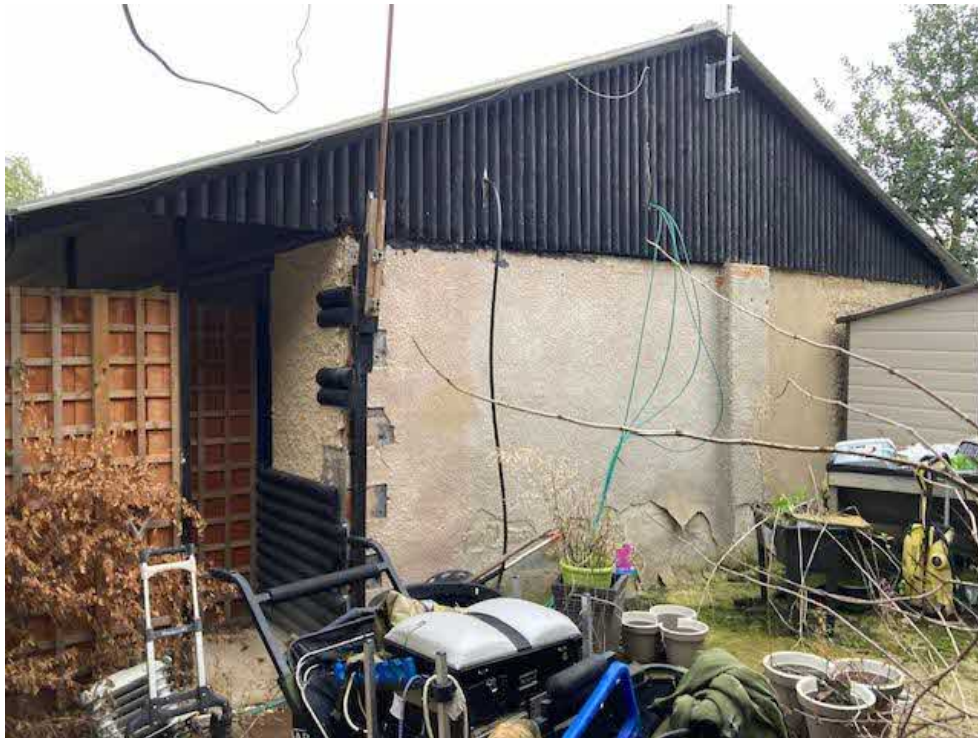
12. The south west gable end of the amenity building.

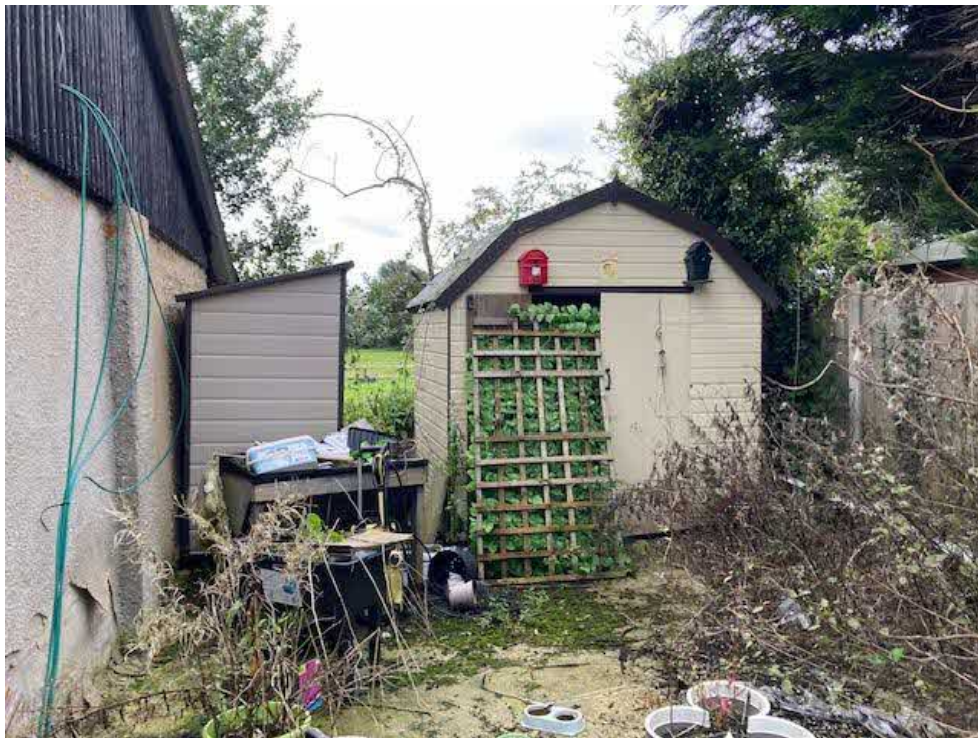
13. Sheds in the south corner back yard.

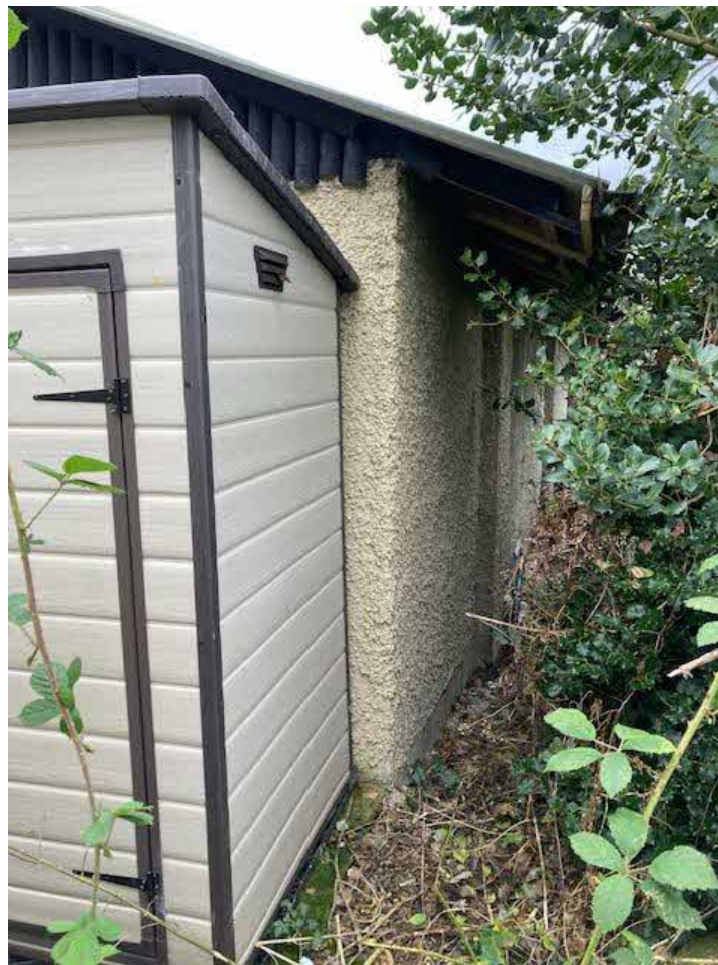
14. The rear south corner of the amenity building and small shed.

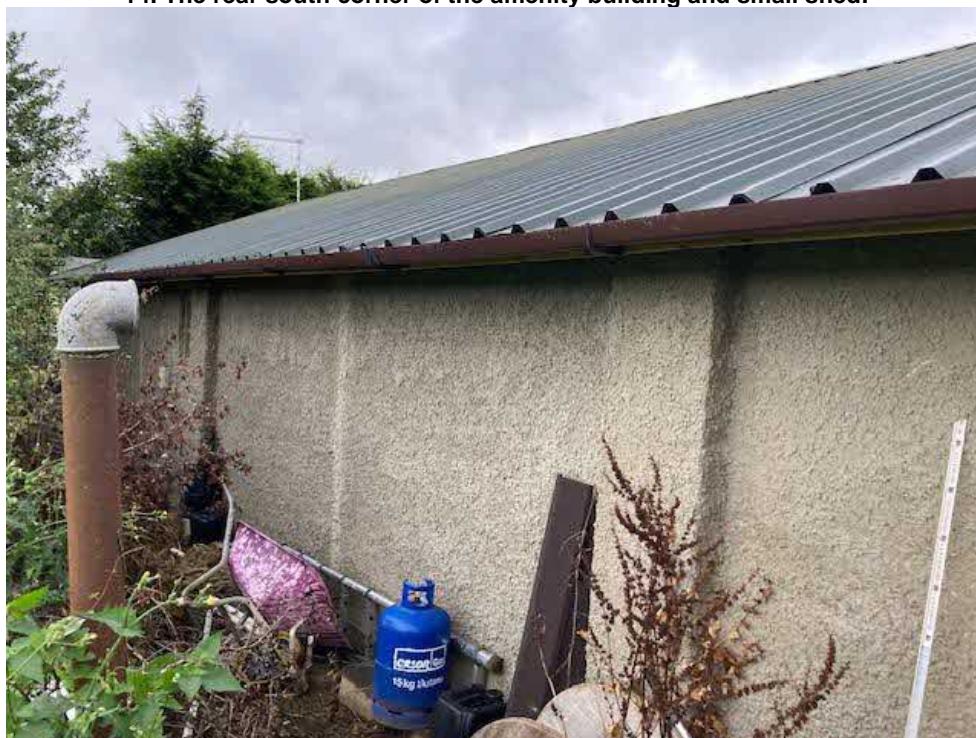
15. The rear south east facing rendered wall of the amenity building.

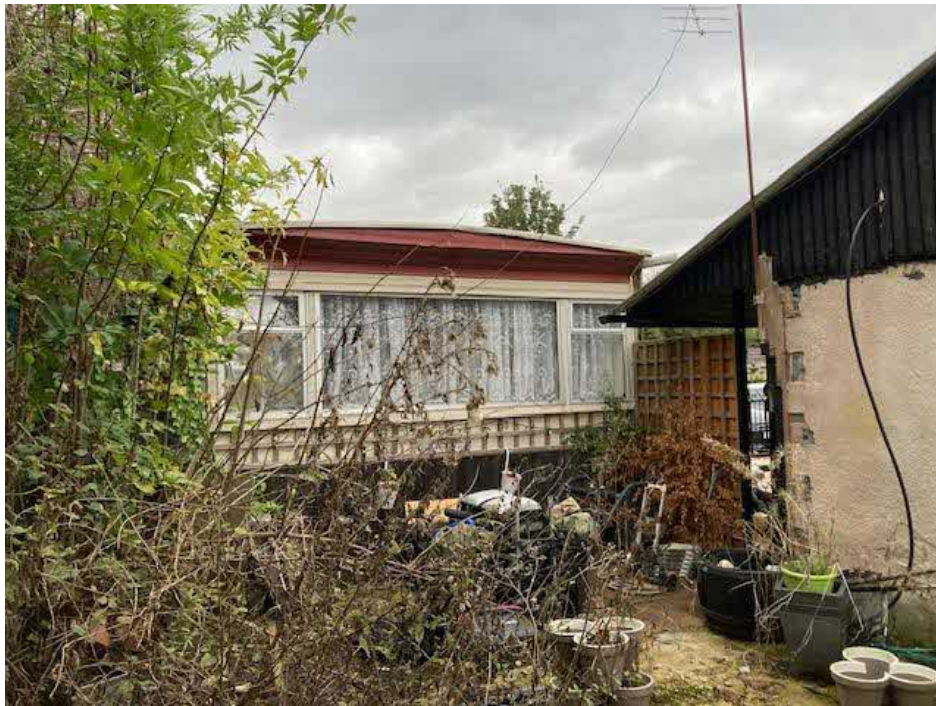
16. The corner junction between the amenity building and smaller front amenity cabin.

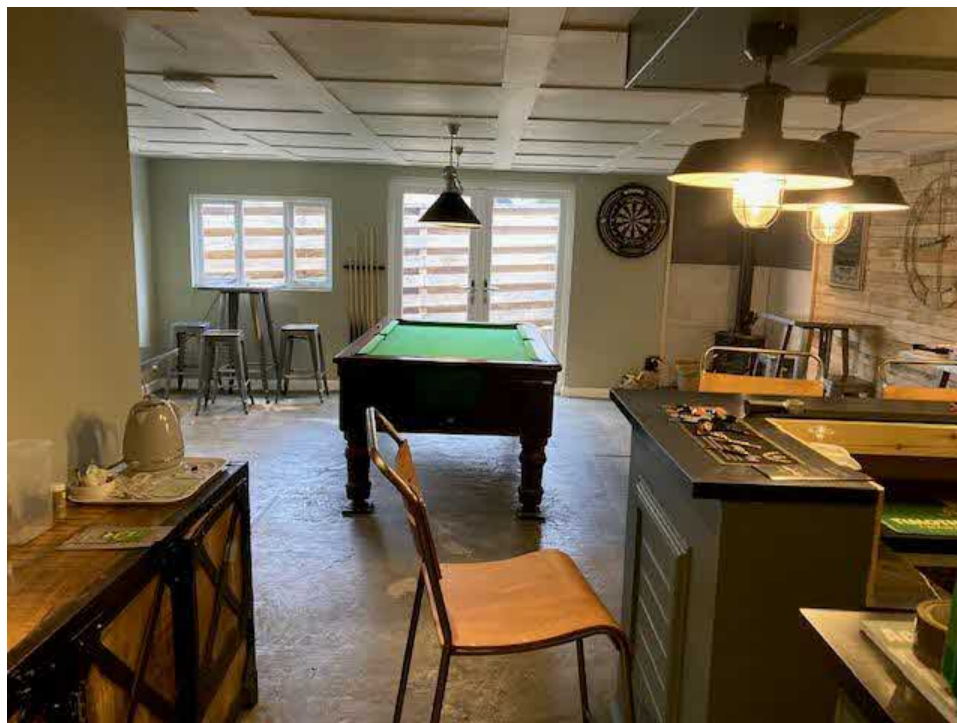
17. The games room in the east end of the amenity building.

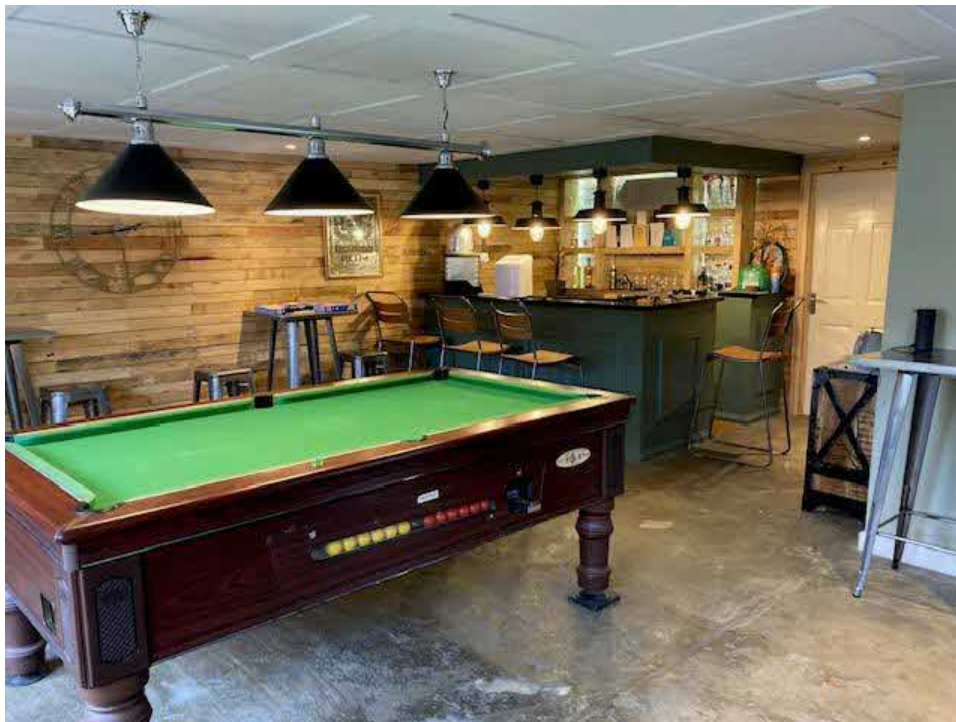
18. The bar and kitchen door at the rear south corner of the games room.

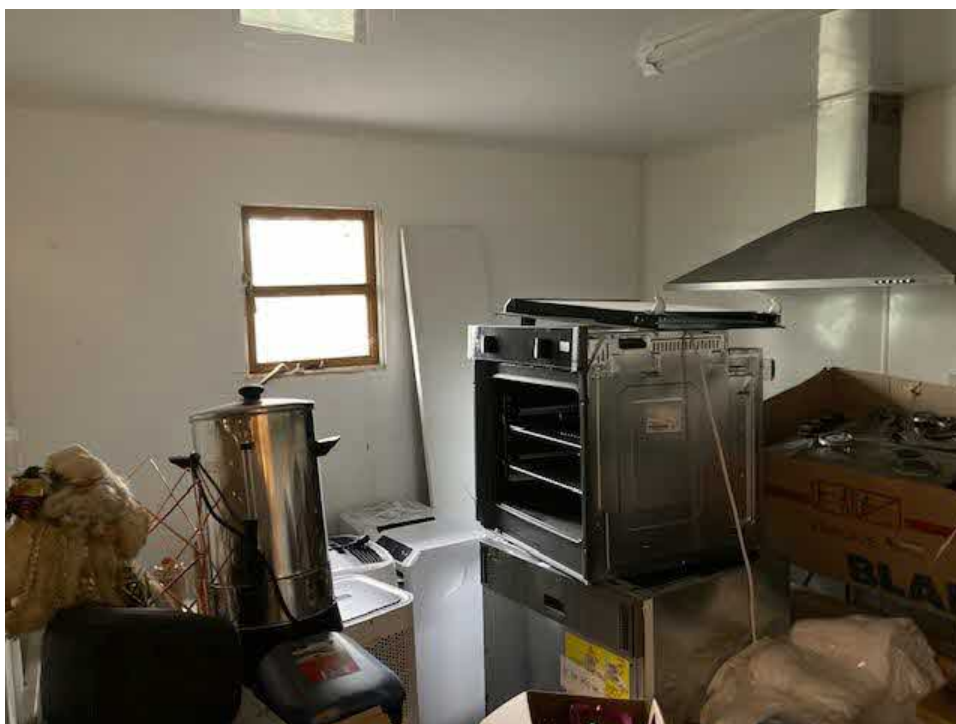
19. The kitchen (used as store room) with rear south east facing small window.

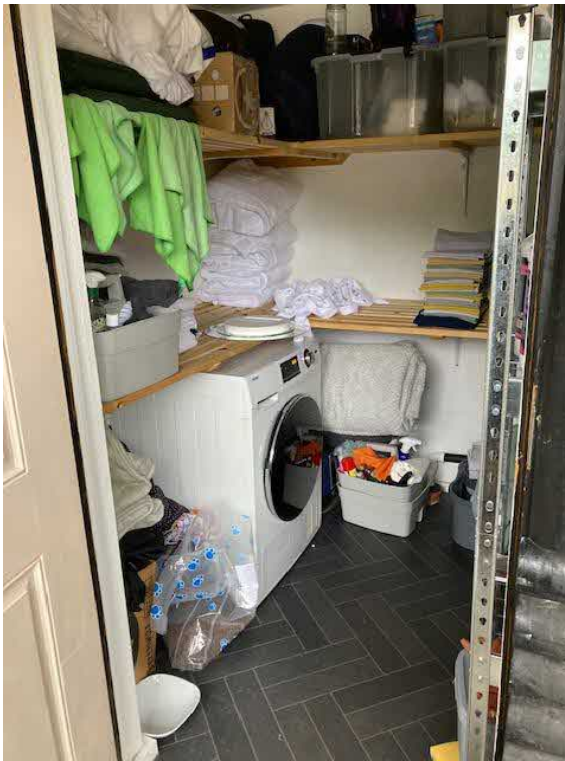
20. Looking into the utility room through the external door.

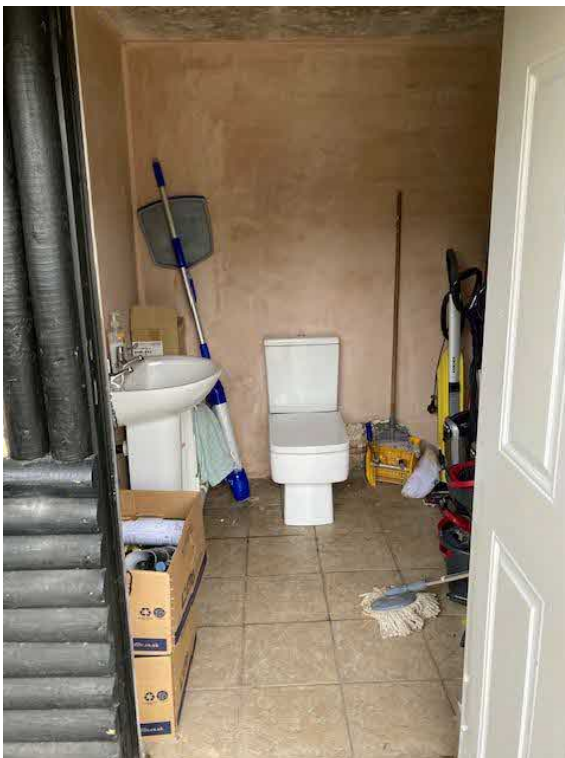
21. Looking into the toilet room through the external door.

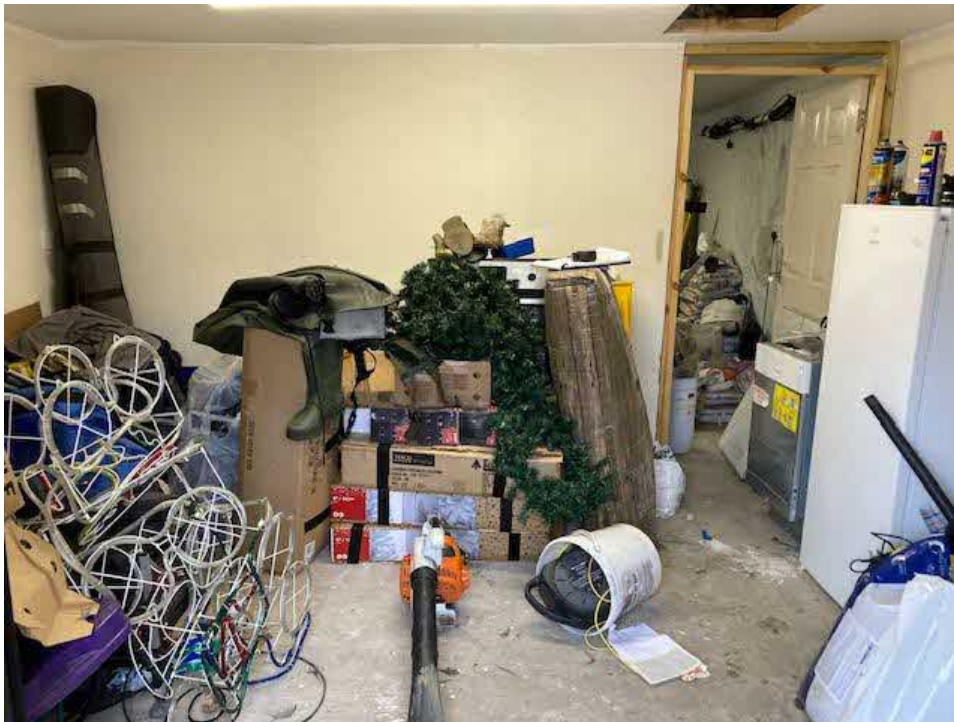
22. Looking into the front south store room through the pair of timber double doors.

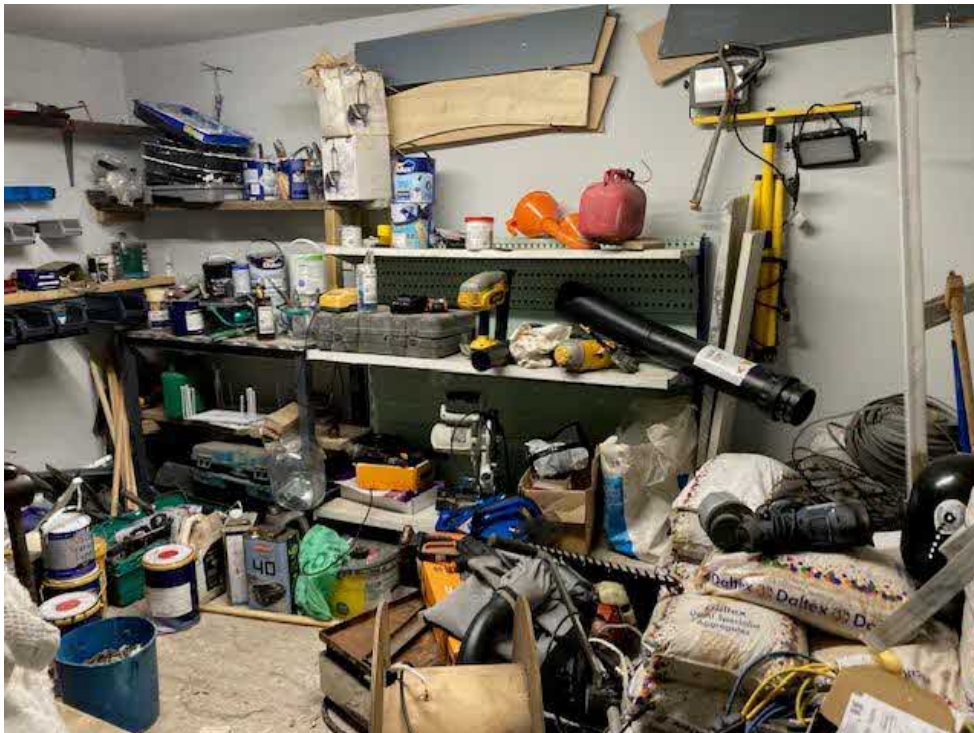
23. The rear workshop store room behind the above south store room.

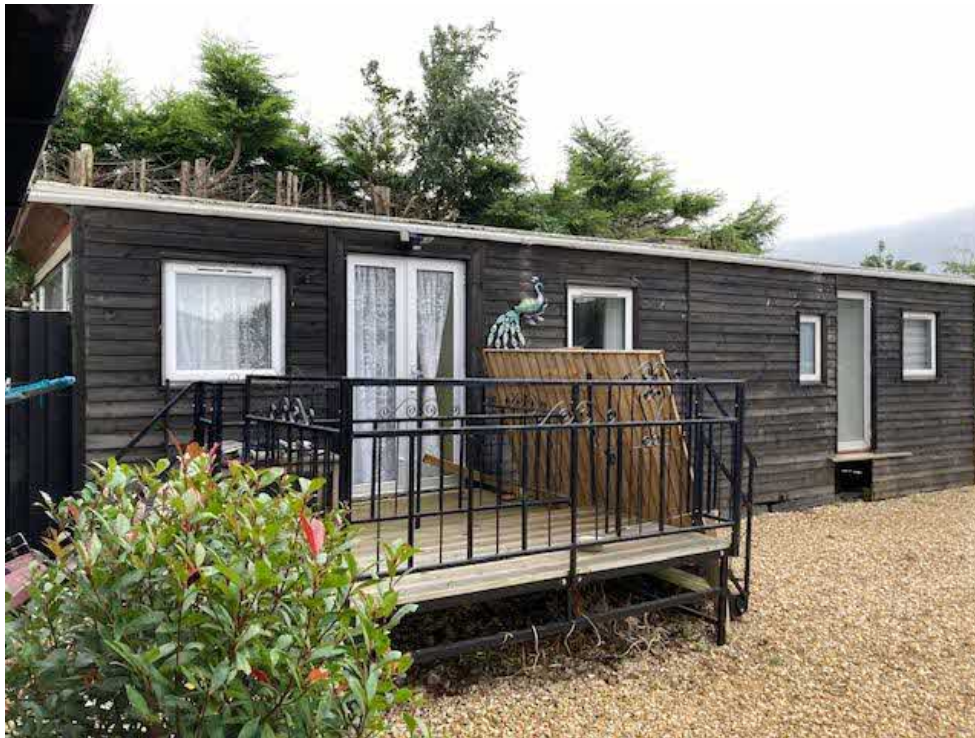
24. The front north east facing elevation of the front amenity cabin building.

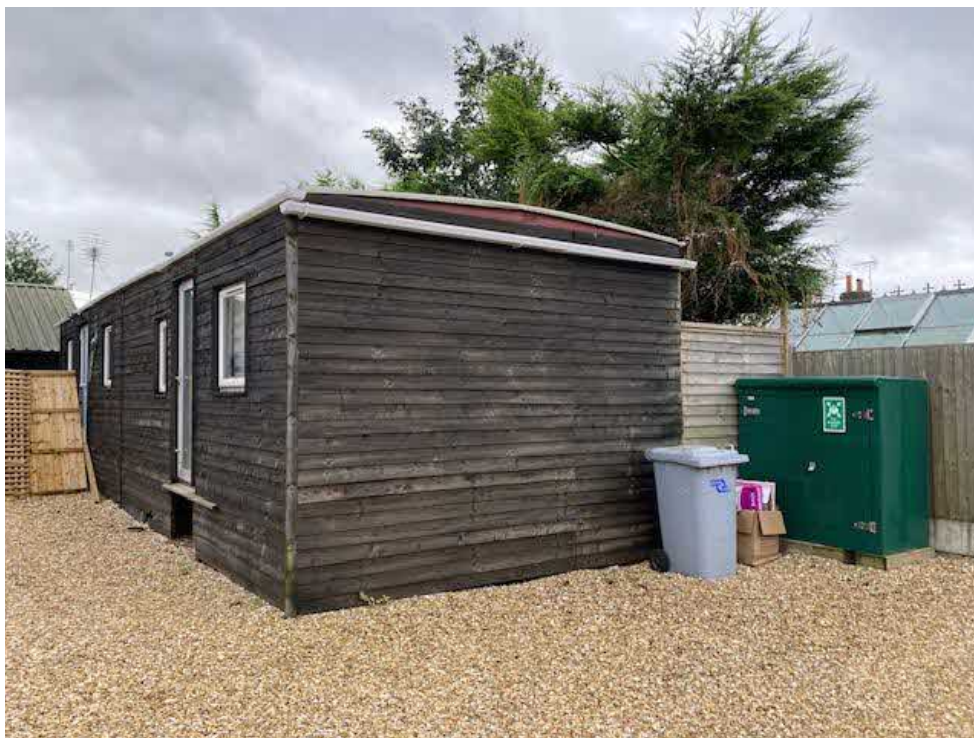
25. The north west end of the cabin amenity building and rear timber fence.

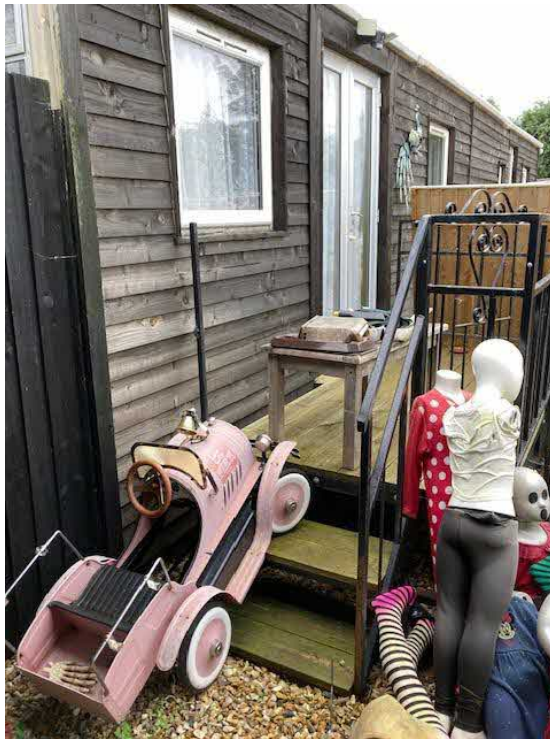
26. The metal and timber raised front deck with steps.

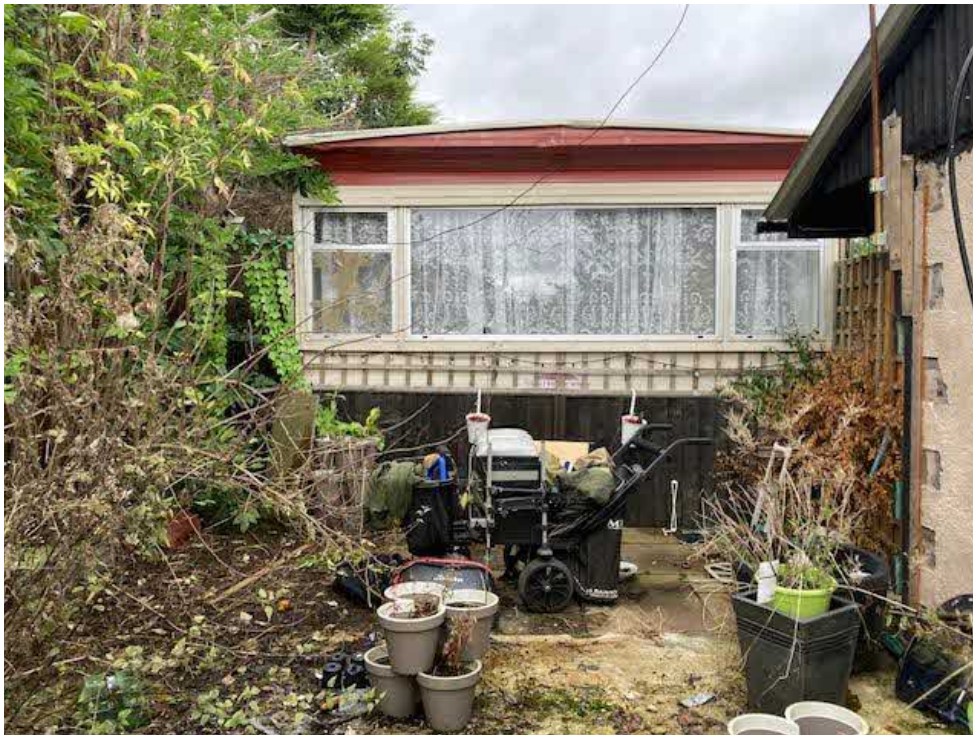
27. The large window in the south east end of the amenity cabin building.

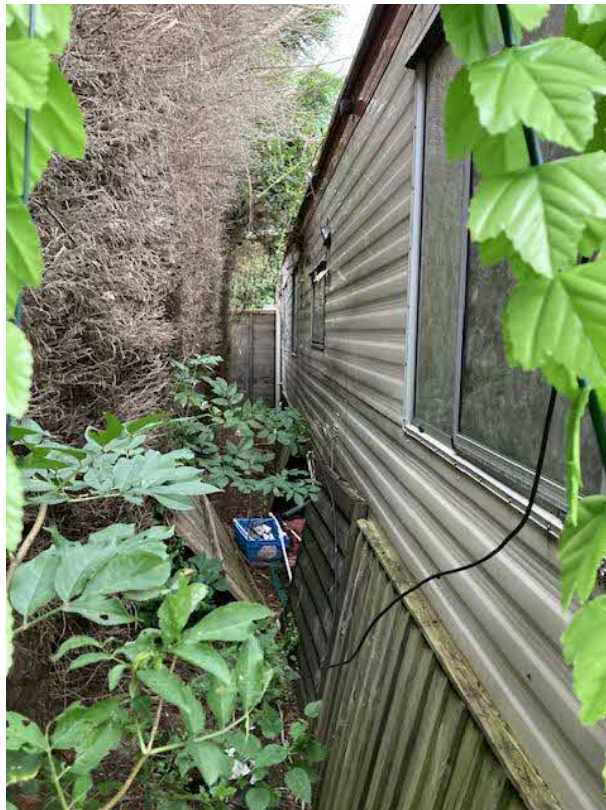
28. Looking west along the rear elevation of the cabin building.

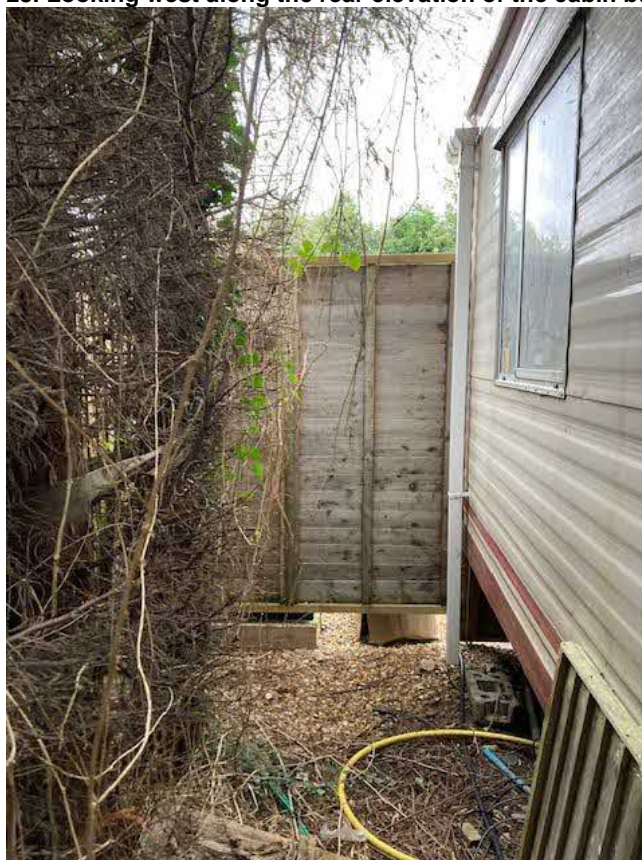
29. The rear west corner of the cabin building and west end fence.

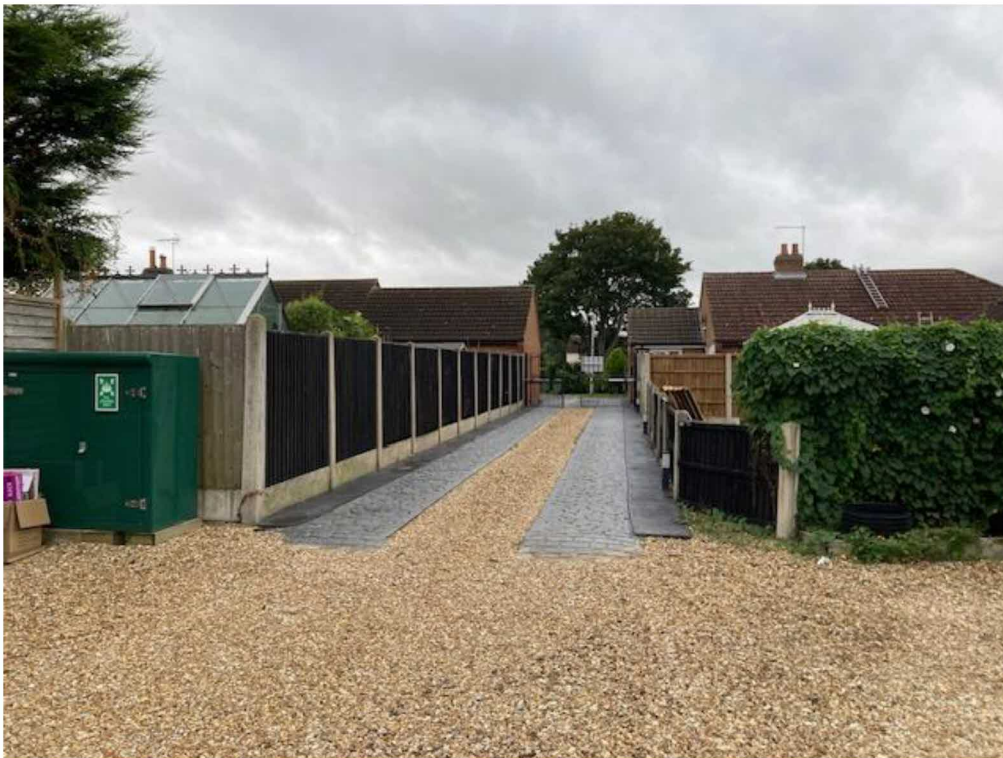
30. Looking north west along the entrance drive from the gravel car parking area.

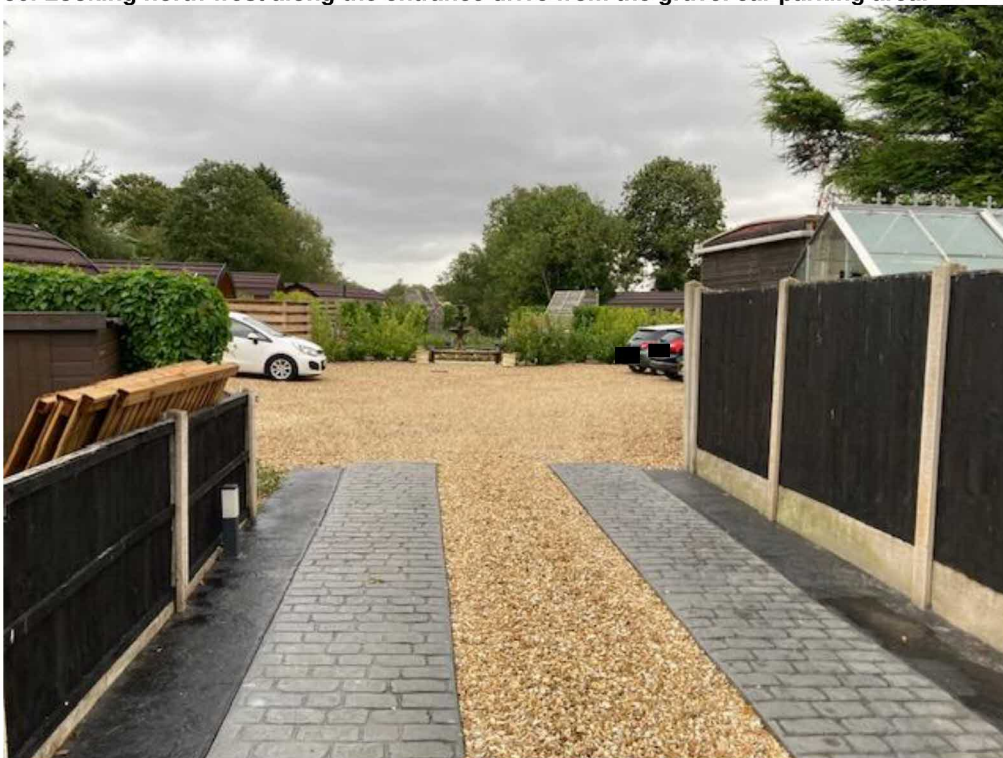
31. The south east end of the entrance drive onto the gravel car parking area.
