Design & Access Statement

Reedland Farmhouse, Holland Road, Little Clacton, CO16 9RX

To repoint Snug Fireplace and fit a replacement woodburning stove.
To repoint Living Room Fireplace and refit existing stove.

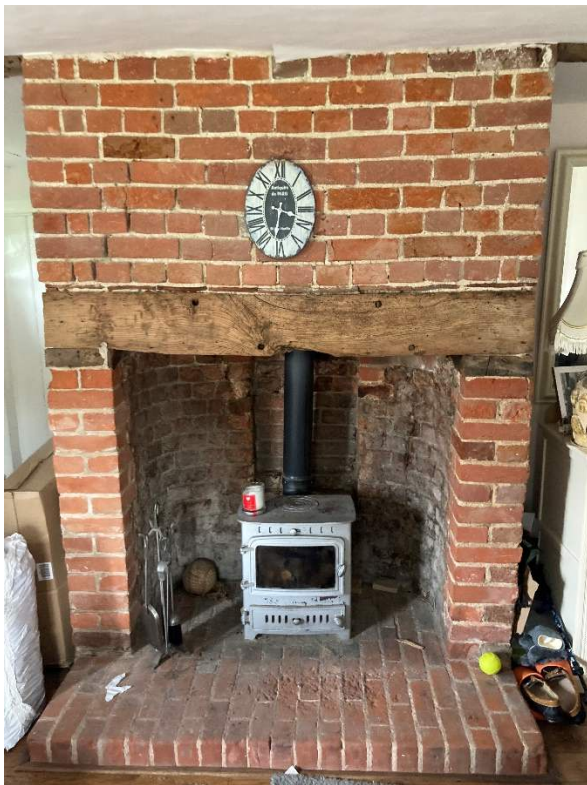
Snug Inglenook is fitted with a woodburning stove and has a curved chamber and brick hearth.

It is proposed to repoint both inglenooks – chambers and chimney breasts – using a traditional lime mortar. Any replacement bricks will either be reclaimed soft red Imperial or reclaimed soft clay Tudor bricks in sympathy with existing and will be sourced at time of the work being carried out to ensure a good blend with existing.

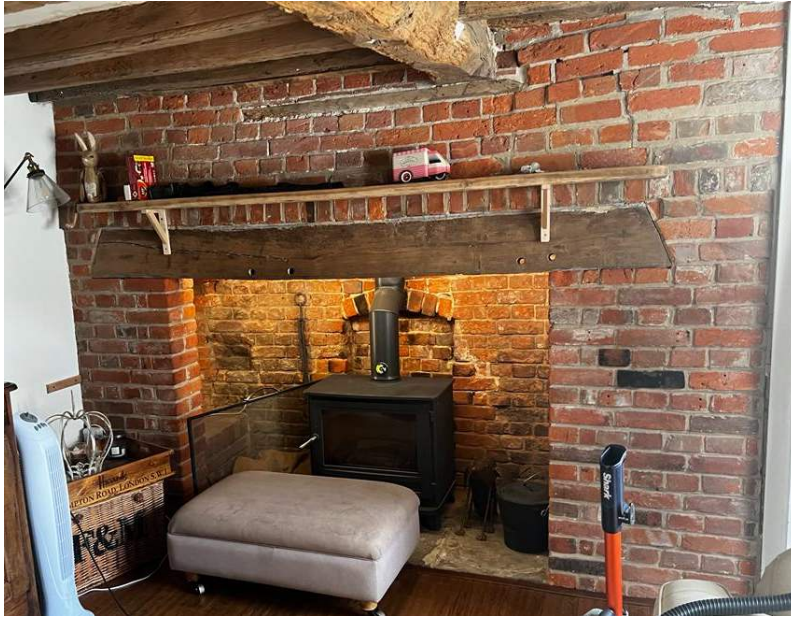
Living Room Inglenook is fitted with a woodburning stove and has a square back, plastered inner panels, and a brick hearth.

There are plastered panels on the inside walls of the Living Room inglenook chamber – modern plaster is not designed to withstand the heat from a woodburning stove and is cracking and crumbling. We propose to remove the modern plaster and replace with a traditional lime render in these two sections, which will move with the heat and protect the brickwork below.

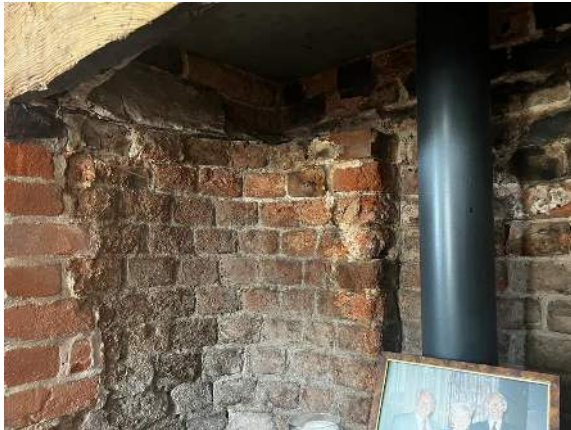
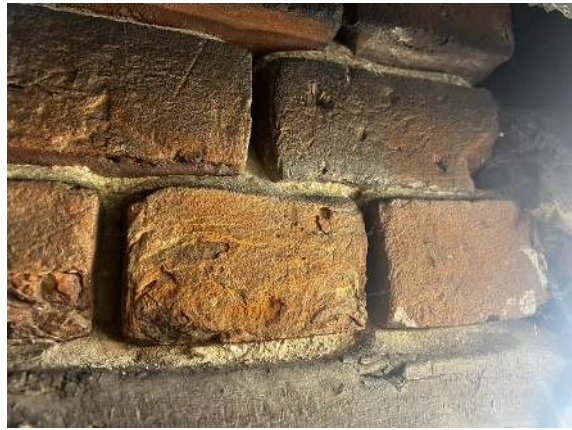
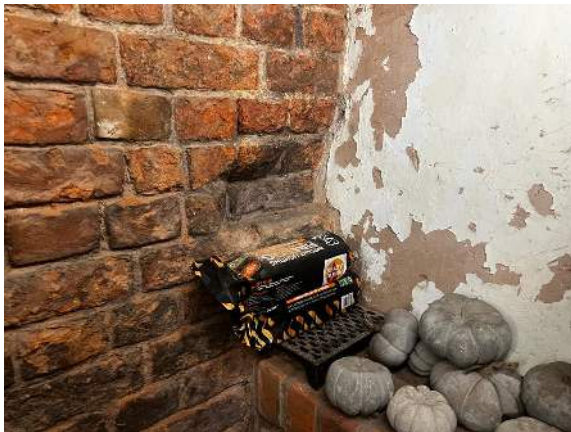
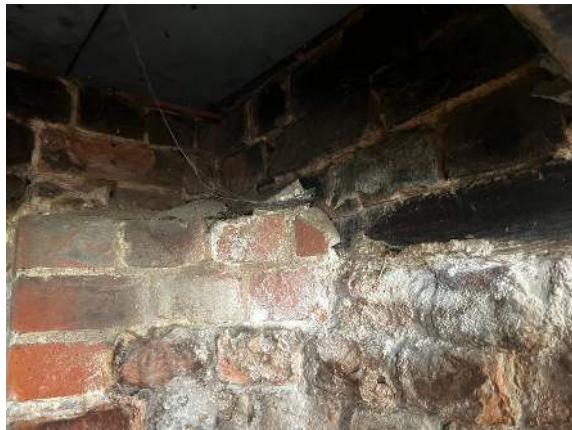
Snug

Currently both fireplaces are pointed using modern cement mortars. This is not malleable and does not allow the bricks to move and breathe. There is evidence of efflorescence and cracking – a traditional lime mortar will assist with both of these issues and prevent the bricks from deteriorating further.

Both fireplaces have poor pointing/ areas of concern. Please see close-up photos below –
