## CRAIG HAMILTON ARCHITECTS

### THE OLD RECTORY, WITHINGTON

#### APPLICATION FOR PLANNING PERMISSION AND LISTED BUILDING CONSENT FOR SECONDARY GLAZING AND MINOR INTERIOR & EXTERIOR ALTERATIONS

#### DESIGN AND ACCESS STATEMENT

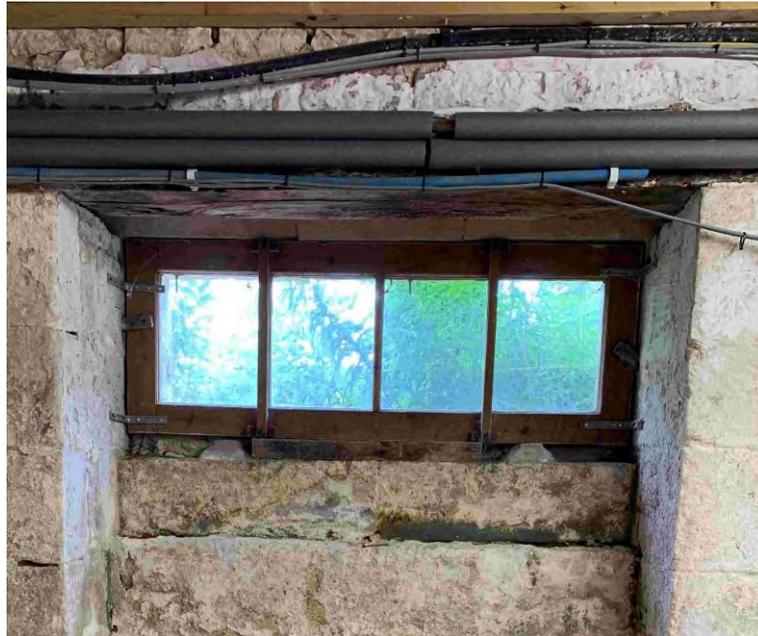
basement. The walls around the windows require some making good and stabilising locally. The windows are held in place with metal straps and the existing installation is not robust.

Above: Existing Basement Window

5.5 The Basement area is used for the mechanical and electrical installations for the house and is utilitarian in nature. The windows are very low on the façade at garden level, and are consequently not visually prominent (see cover photograph). It is proposed that these windows are replaced with double-glazed architectural bronze casements with a Heritage profile. The outer panes would be 4mm kiln-distorted glass which will retain the historic appearance.

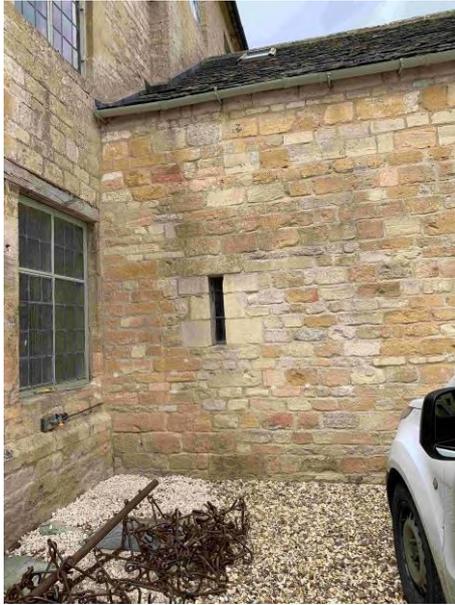
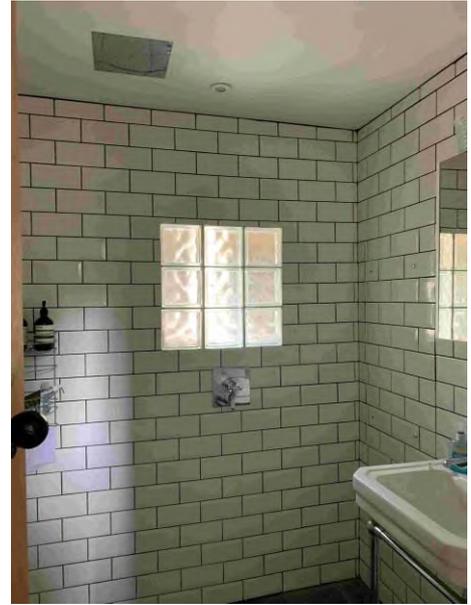
interior as it sits within a wet room. It is very small and does not provide any ventilation to the room. The proposal is to enlarge the window in width and fit it with an opening casement.

Above Left: Cottage Bathroom window WG13 as existing – exterior view

Above Right: Cottage Bathroom window WG13 as existing – interior view

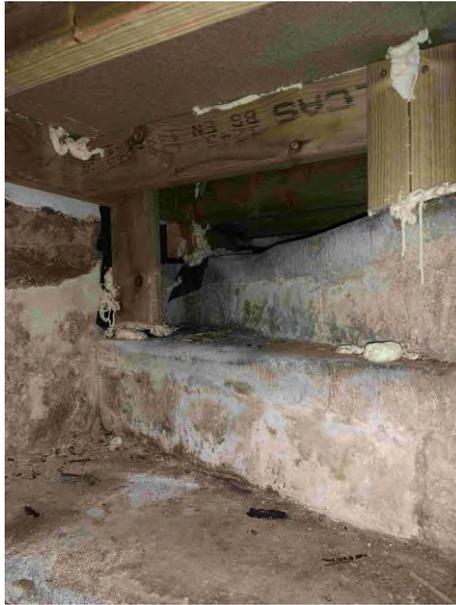
There is evidence of both wet and dry rot in the modern timbers which support the Snug floor.

Above: View of existing spiral stair and the timber support for the chipboard floor to the Snug.

5.34 It is proposed that the supporting structure is omitted and replaced with timber joists on joist hangers. The basement walls and floors are damp, and the timber needs to be kept away from those damp surfaces. The joist hangers would provide the required isolation, and would also be easily reversible should the staircase be opened up again in the future. The space at Basement level would also be easier to access with the timber posts removed.

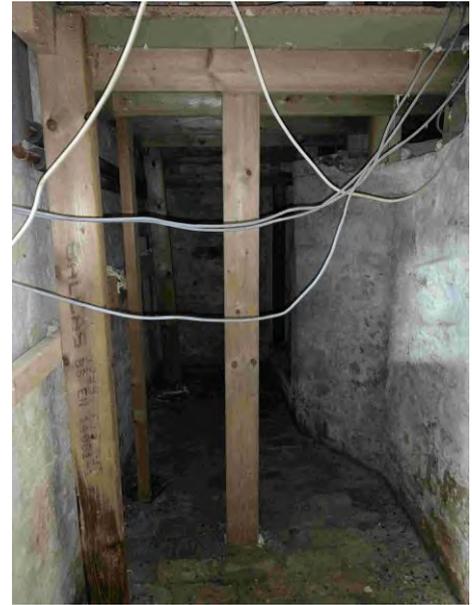
Above: View of timber supports to the chipboard floor to the Snug above.

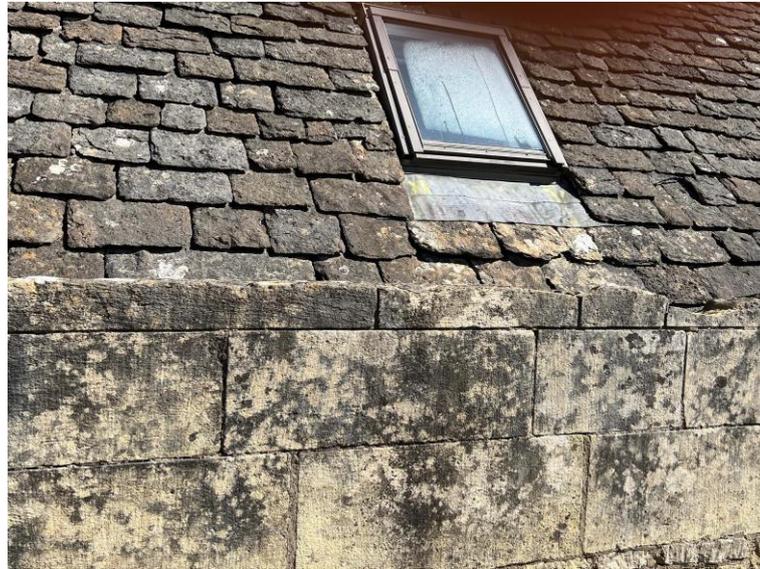
The existing copings to the east and west parapet gutters are in very poor condition with spalling stone falling into the gutters. The copings are set flush with the external wall surface so there is no drip to throw water away from the façade. This leads to black staining on the stone at the tops of the walls. At the gable ends the copings have drips either side of the wall surface.

Above: Detail view of copings to east wing. Black staining is visible on the façade as well as erosion to the copings.

It can be noted that the top 2 ashlar courses as shown in photo 5.48, though unmolested by weathering, are starting to loose their joints due to water ingress from above and no doubt freeze/thaw process that is slowly decaying the lime mortar jointing to these stones. There is no doubt that with the copings in their current situation, further deterioration of the parapet walls will continue. There are a couple of areas where these ashlar courses are being dislodged by water ingress and freeze/thaw cycles.

I agree with the DAS report articles 5.47 - 5.53 and in conclusion I propose that these copings be replaced with a selected bed of either Clipsham limestone or Cadeby limestone and by means of understanding the term of "selected bed", I refer to the fact that the appropriate beds out of the quarry must be chosen to achieve the optimum selection of stone in regard to its impervious nature, as not all the beds in either quarry will perform to the optimum as required here for copings.

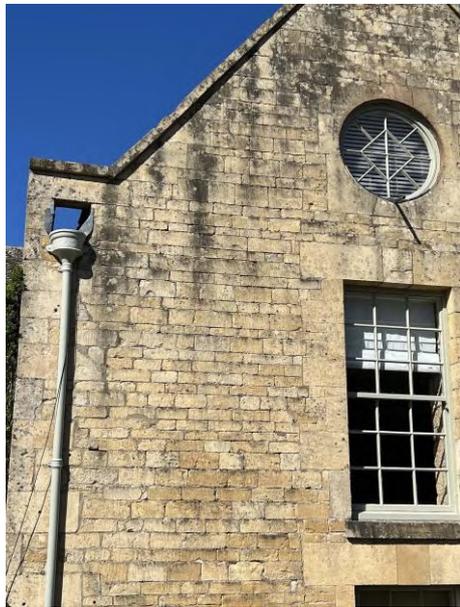
Above: View of east wing gable. The overhang on the gable copings is visible. There is black staining to the stone façade where pointing has come away between the copings.

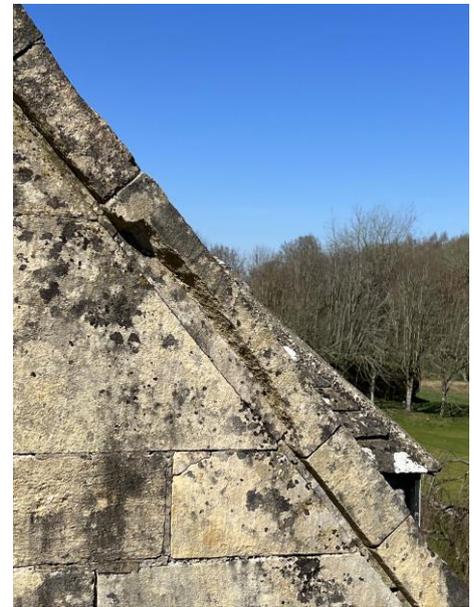
Above: Detail View of the east wing gable copings. Damaged copings require replacement and the wall and copings need repointing with natural hydraulic lime mortar..

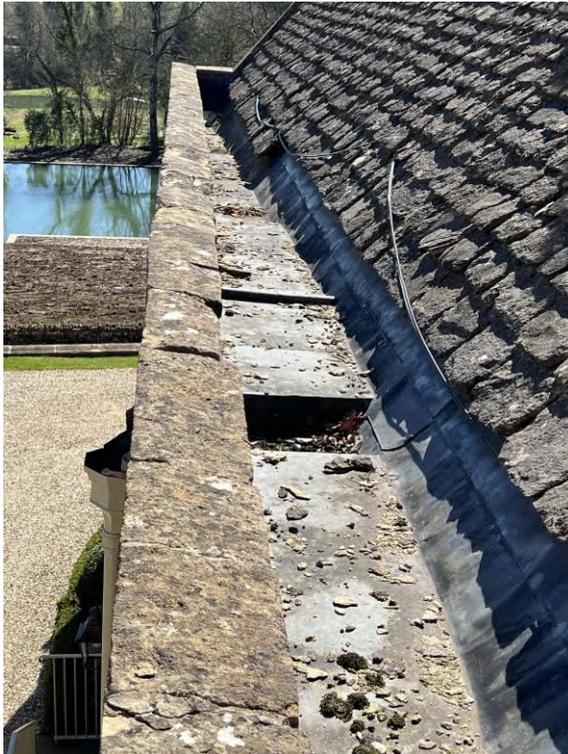
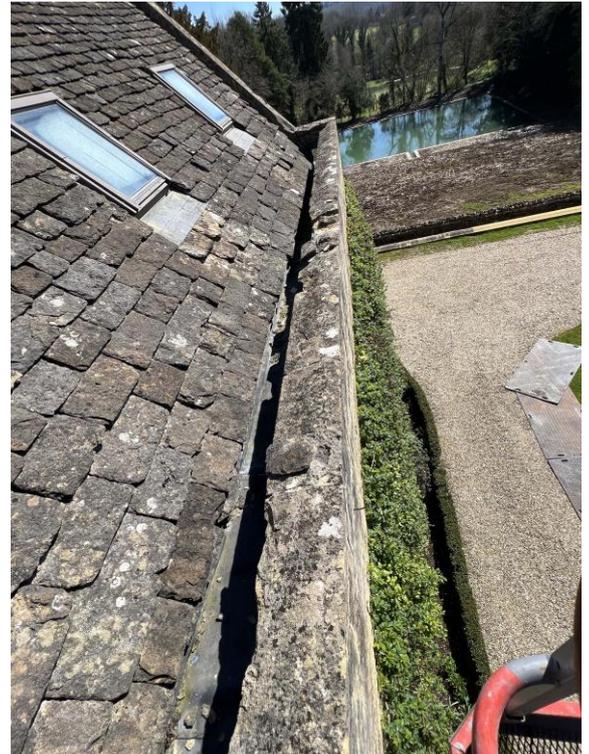
View looking south down west wing gutter

View looking south down east wing valley gutter

been consulted. He has indicated that the fabric supporting the sole of the gutters will be wet or damp due to the inadequate drip heights.

5.60 The configuration of the gutters would be considerably improved by replacing the existing lead with a higher lead code. The longer pieces of lead would allow for fewer drips, which would be increased in size to meet current guidelines. This would help keep the gutter sole dry and improve the building's longevity.

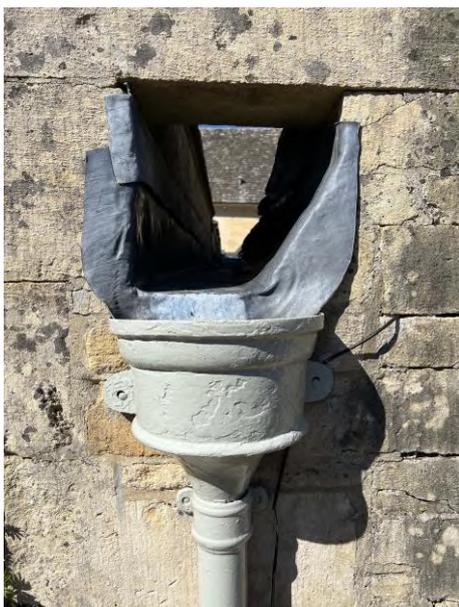
5.65 Hoppers and gutters look undersized – for example the hoppers serving the east and west lead parapet gutters are undersized. It has been noted by Justin Ayton that the hoppers are not of any historical merit.

View looking down east wing lead parapet gutter with its hopper in the foreground. The hopper is very undersized in relation to the size of the outlet.

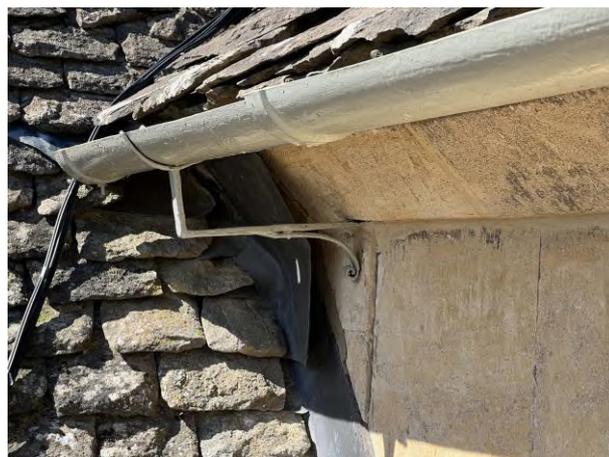
Above: existing half round gutter on the north range. The gutter is supported on delicate brackets, however over time the gutter falls have become misaligned – in this section the gutter is falling away from the downpipe. The capacity of the gutter is also insufficient to cope with water draining from the roof surface area.

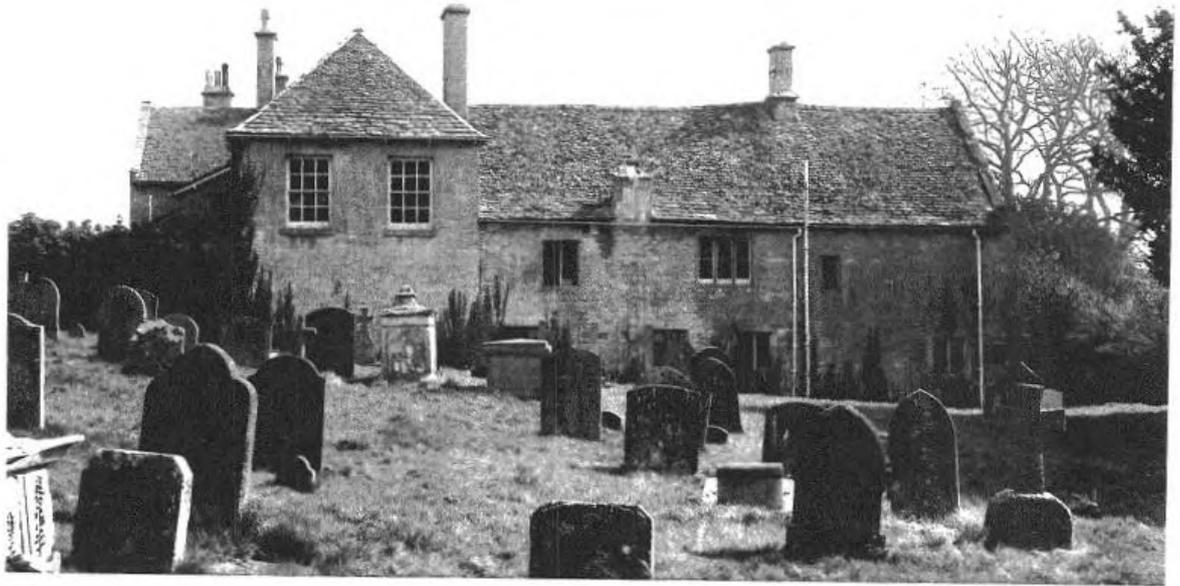
5.67 The eaves running along the west elevation of the west wing have no gutters, allowing water to soak the stone walls below. As the prevailing wind is from the west, this will be a common occurrence.

Above: Photograph of the house taken in the 1970's. The photograph indicates that there was historically a gutter and downpipes running along this façade, prior to the work carried out in the 1990's.

- 5.69 A painted cast-iron gutter on traditional metal brackets is therefore proposed to be reinstated to this elevation.
- 5.70 Enhancements to the existing rainwater system would be carried out sympathetically to the listed building. Rainwater goods will all be of a traditional pattern in painted cast iron. Painted cast iron gutters will be supported on traditional metal rise and fall brackets. Hoppers will be cast from traditional patterns in painted cast iron.

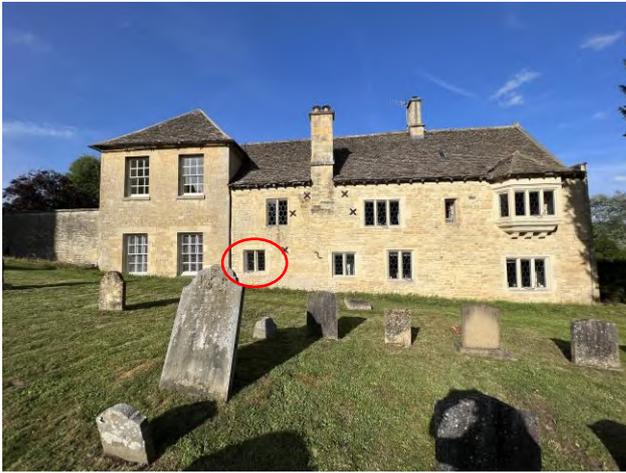
Above: West wing – west elevation as existing. The red circle indicates the affected window (WG31).

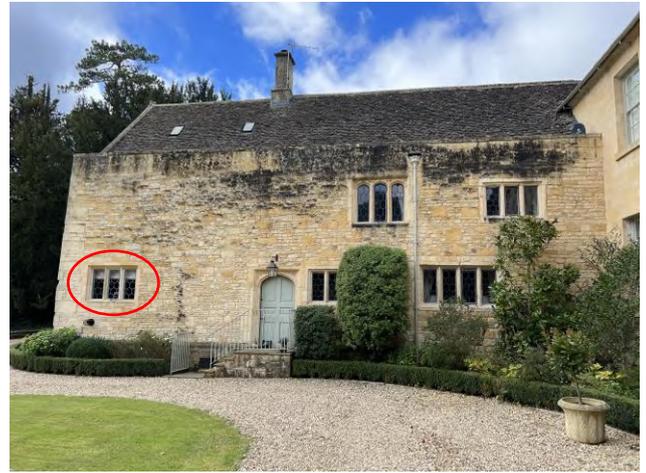
Above: West wing – east elevation as existing. The red circle indicates the affected window (WG26).

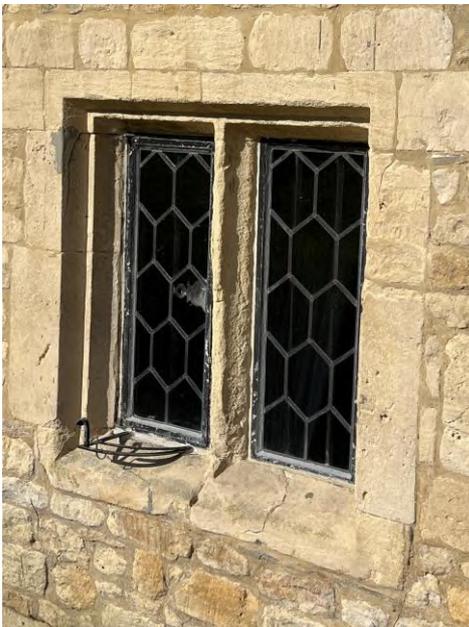
Above: Window WG31 detail. The central mullion has eroded significantly, and it is proposed that this is carefully replaced.

During my site inspection and noted that these mullions were in quite a decayed state and are rapidly heading towards failure.

It is relevant that there are 2 issues concerning ongoing failure of these mullions the first being water ingress into the building, and the second being more serious that these mullions do act as a structural support of the lintel above and therefore the facade above. Therefore it can be understood that replacement of these mullions is necessary, not just for aesthetic reasons, but importantly for the wellbeing of the building.

5.75 The exterior of the mullion would be carefully dressed back to the plane of the glazing, by hand using traditional methods (mullet and chisel), and then a new section of mullion would be carefully pinned and dowelled to the outside face of the existing mullion. This would ensure as much historic fabric is retained as possible, and that it is protected for the future.

Ketton would initially propose only replacing the external section of the mullion and such would be hand dressed away to the line of the frame whilst the lintel above was temporarily supported. It can be noted that hopefully such an approach would be able to be carried out in a manner that leaves the window frame in place.

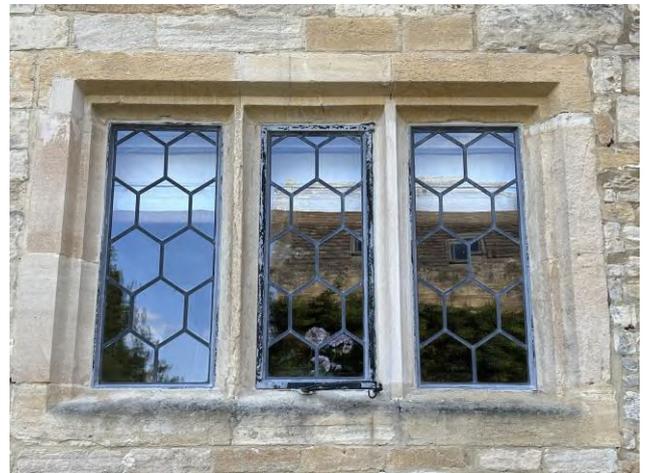
Above: Window WG26 detail. The left-hand mullion is significantly eroded, and it is proposed that this is carefully partially replaced. The right-hand mullion has already been replaced.
