ARBORICULTURAL IMPACT ASSESSMENT REPORT  
BS 5837:2012 'Trees in relation to design, demolition and construction. Recommendations'

Debden Village Hall, Mill Rd, Saffron Walden CB11 3LE

**DATE: 7 October 2019**

**OUR REF: SHA 944**

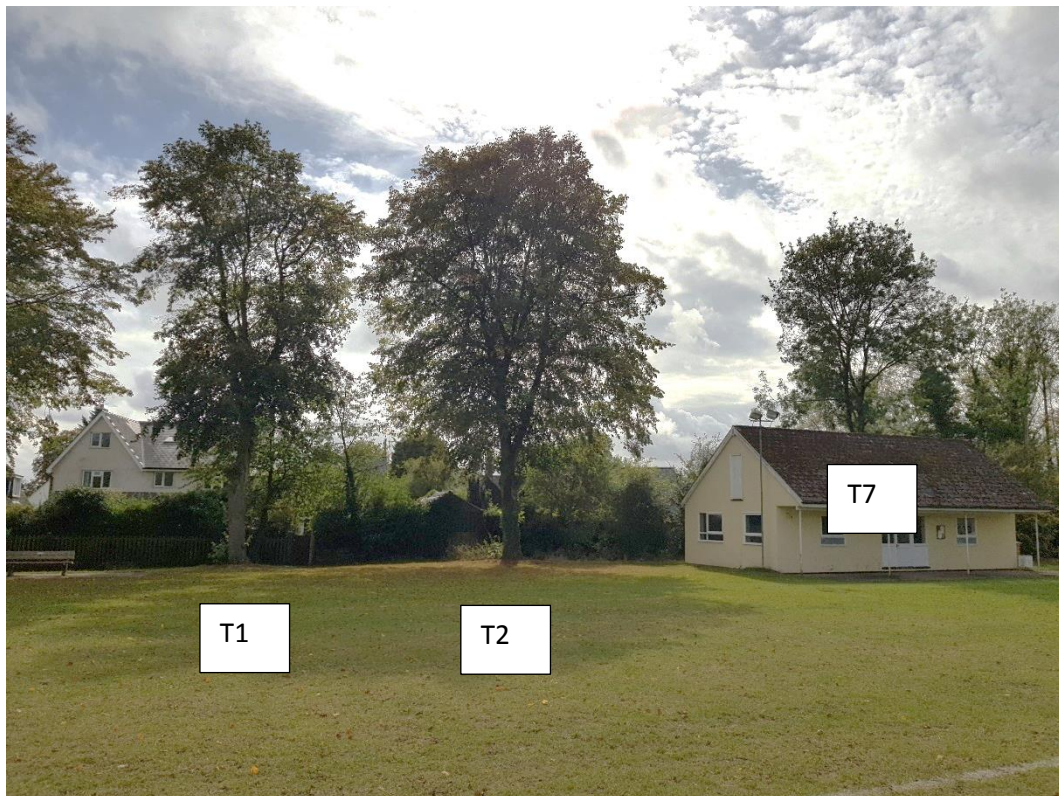
- 6.4. *Comments on specific trees and the arboricultural impact:* Trees to the immediate north and south-east of the proposal: T1 lime (category B under the BS – moderate value), T2 lime (category A under the BS – high value) and T21 lime (category C under the BS – low value). The two lime trees are the western trees of a line of important trees along the southern boundary of the recreation ground, which are a strong landscape feature. These two trees are in a good form and condition, with T2 being large tree with a better form. T21 is a semi-mature lime tree with a slight lean south and tight compression forks between main stems at 2m. See photo 10 on page 14.

*Photo 1 of T1, T2 and T7 looking south*

The building is within 11% of the root protection area of T1, and 4m at its closest point. The actual rooting area will be explored under arboricultural supervision to establish the depth, extent and size of any roots in the proposed footprint of the building. This will be done by a hand dug trial trench. The results of this will be reported to the Landscape Officer at Uttlesford District Council and be used to inform foundation design. It will also assist in calculating the amount of pruning required to compensate for any root pruning. Ideally some roots will continue under the building. The down pipes will be directed towards the tree and there will be no excavations for new services along the southern boundary. A draft method statement for the installation of the foundation is found at appendix 6, and the area to which this applies is shown by a thick yellow line (see plan 1 extract below).

At the time of writing it is presumed that the tree will be pruned approximately 2m (a crown reduction), as detailed in the tree surgery schedule at appendix 4.

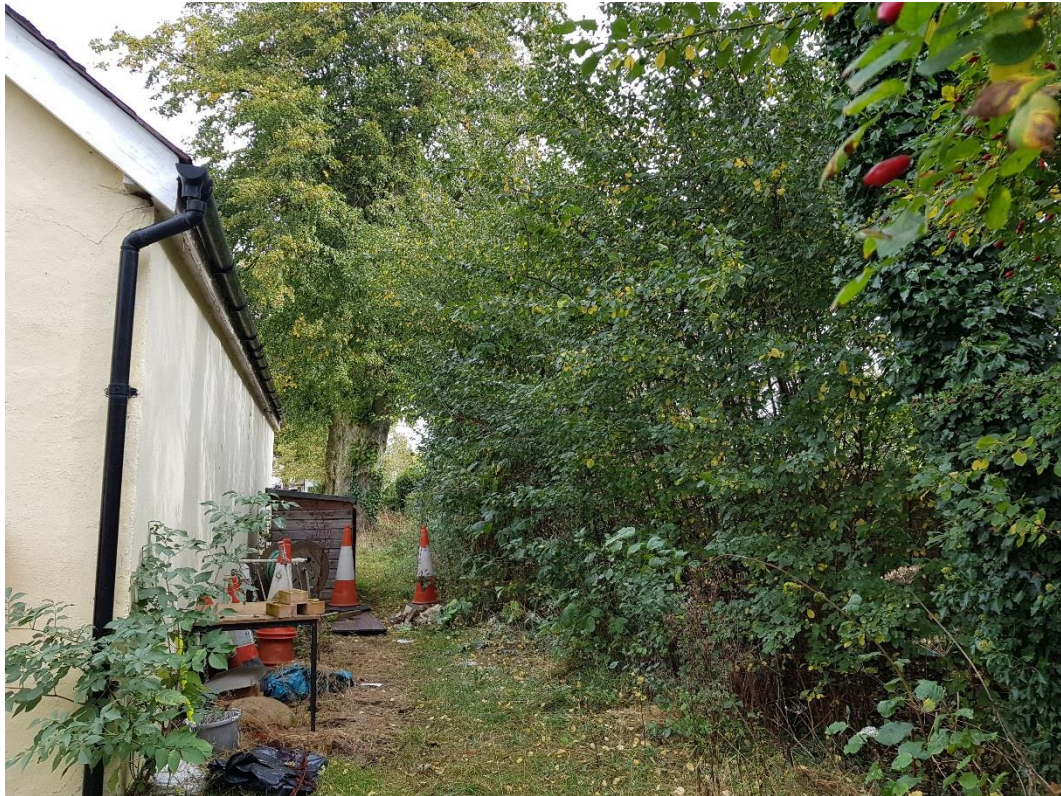
*Photo 2 of G6 and T3 – T5 looking east, with T2 in the background. The vegetation is on a steep ditch*

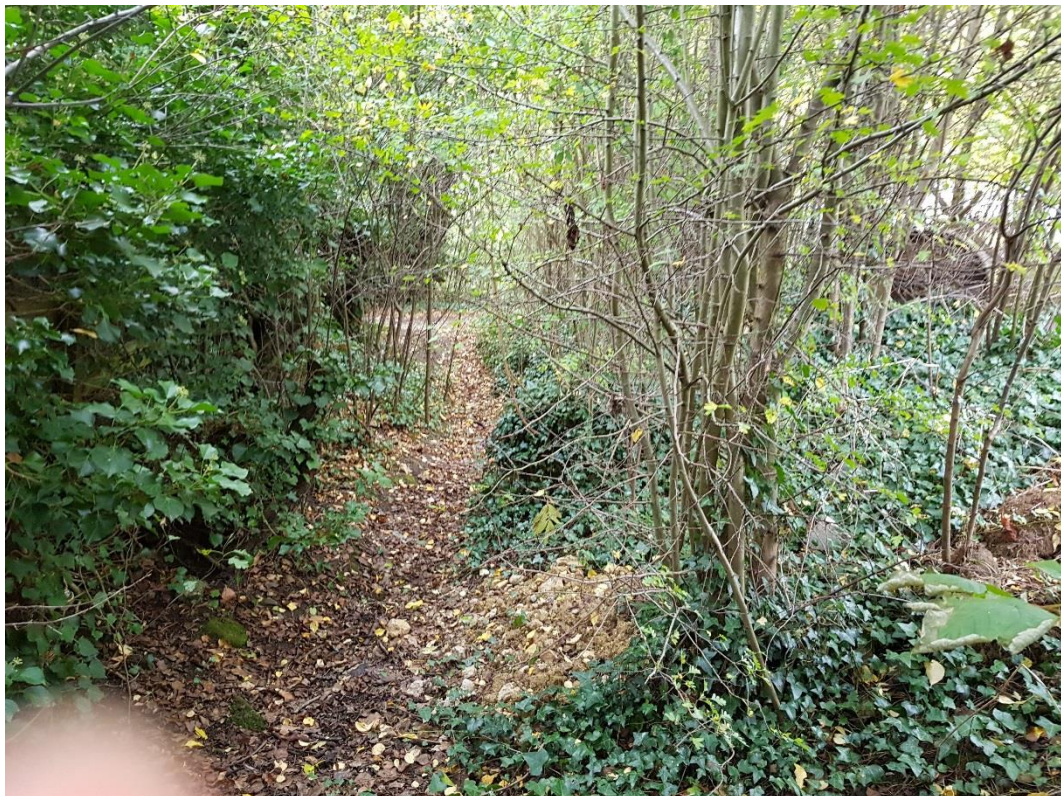
*Photo 3 a general view of the character of the ditch with G6 on the left hand side. Looking west.*

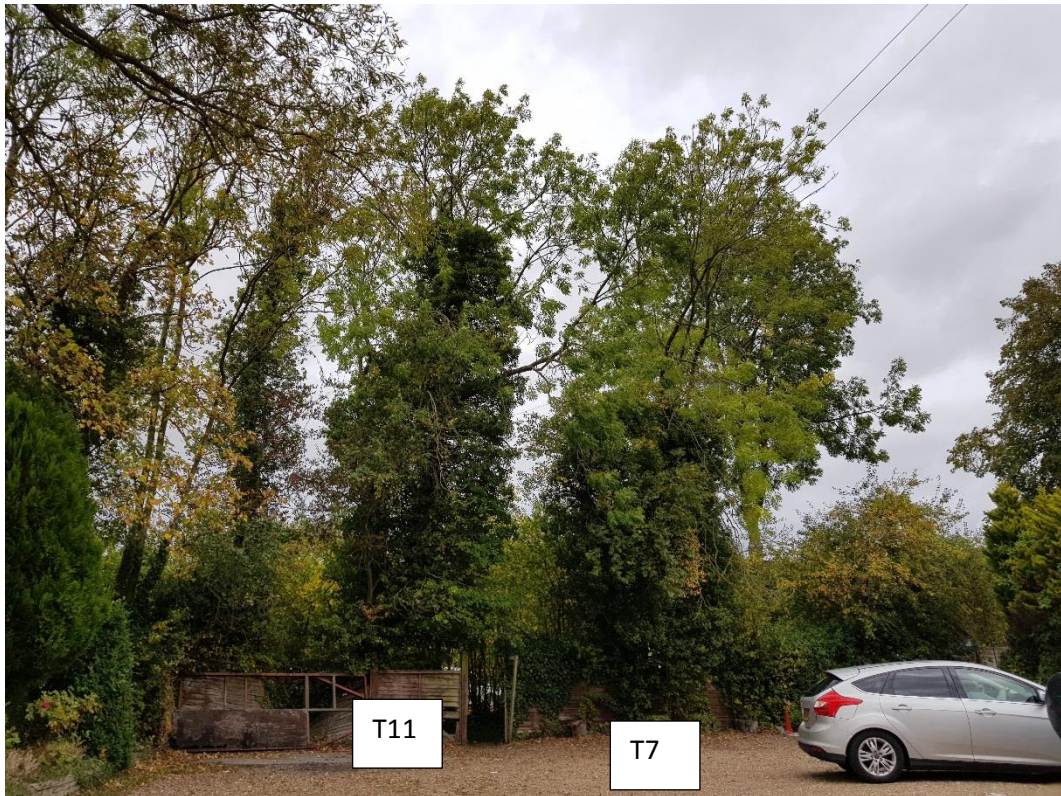
The prominent trees are ash (T7 and T11) which are in a reasonable form and condition, and G12 which contains a mix of reasonable sycamore and low quality ash which are likely to be in decline (most likely to do ash dieback). Straddling a ditch are groups of mixed thorn, damson and elder which form a dense native screen and wildlife corridor. None of the trees are managed, but form an attractive semi-natural thicket.

*Photo 4 of T7 and T11 looking north from neighbouring property*

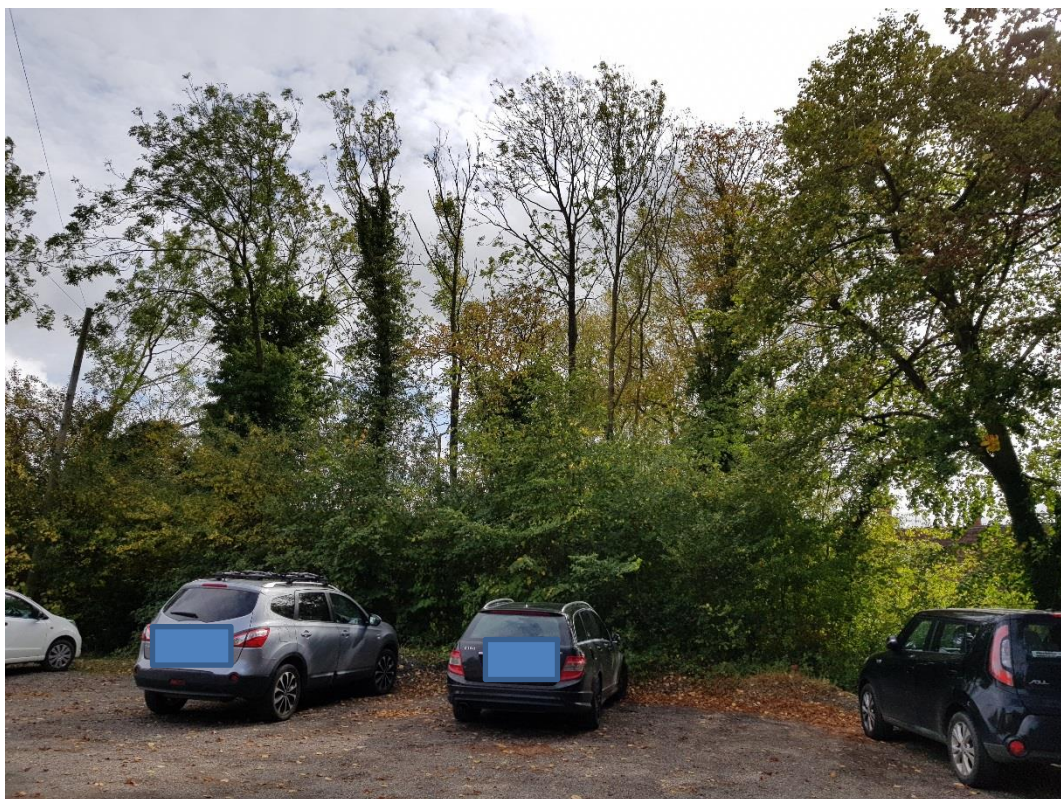
*Photo 5 of G12 ash and sycamore, with G13 in the fore ground. Note how the ash are tall, spindly and appear to be in decline. Looking south.*

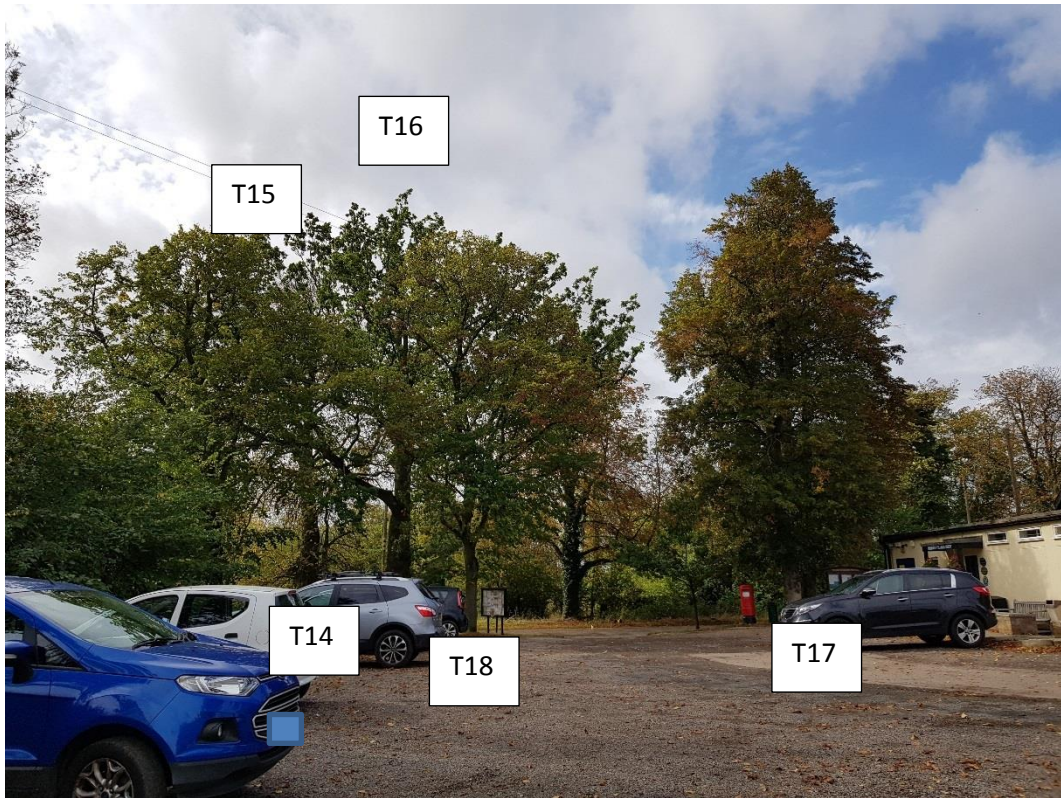
This is a strategically important group providing a high level of amenity to Mill Road. The trees are prominent and in reasonable form and condition. Whilst outside of the immediate area for the application, they were surveyed for completeness. There are no works required to facilitate construction, but there are minor works recommended for safety reasons. The only urgent work is removal of large dead branches in the lime tree (SHA T17) which might fall next to the Village Shop. The attractive horse chestnut (SHA T19) has a steeply ascending form with a tight union between the stems (photo 9). This means that the stems may not be strongly attached to each other. I recommend that a tree surgeon carries out a climbing inspection to probe where the stems join the main trunk to check for decay, and reports this to the arboricultural consultant. If found to be weak, there are tree management options, such as pruning or bracing, available, but it is likely that no management would be required as this is the natural form of the tree. Other recommendations are found in the tree surgery schedule.

*Photo 6 of T14, T15, T16, T17 and T18 looking west*

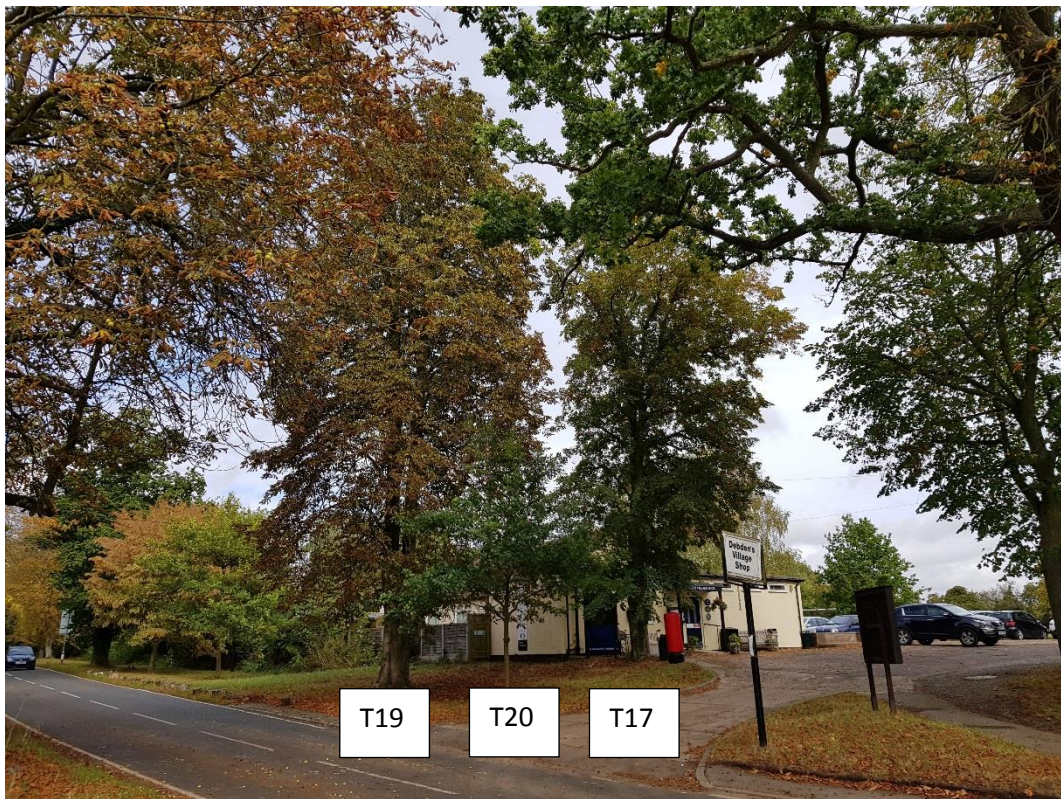
*Photo 7 of T18 - T20 looking north-east*

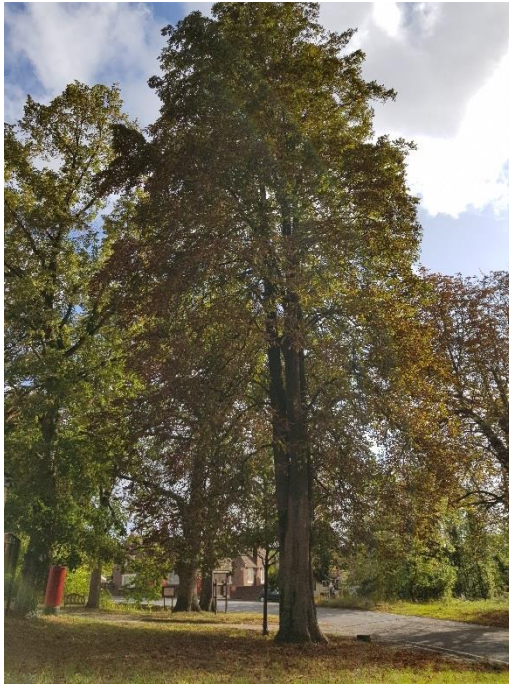
*Photo 8 of T19 long view looking south*

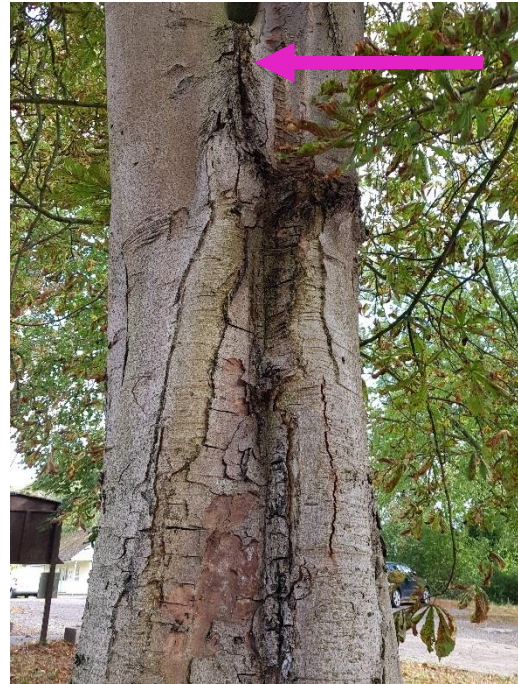
*Photo 9 of T19 tight fork. A climbing inspection is recommended to probe the union, with a view of bracing or reducing the crown.*

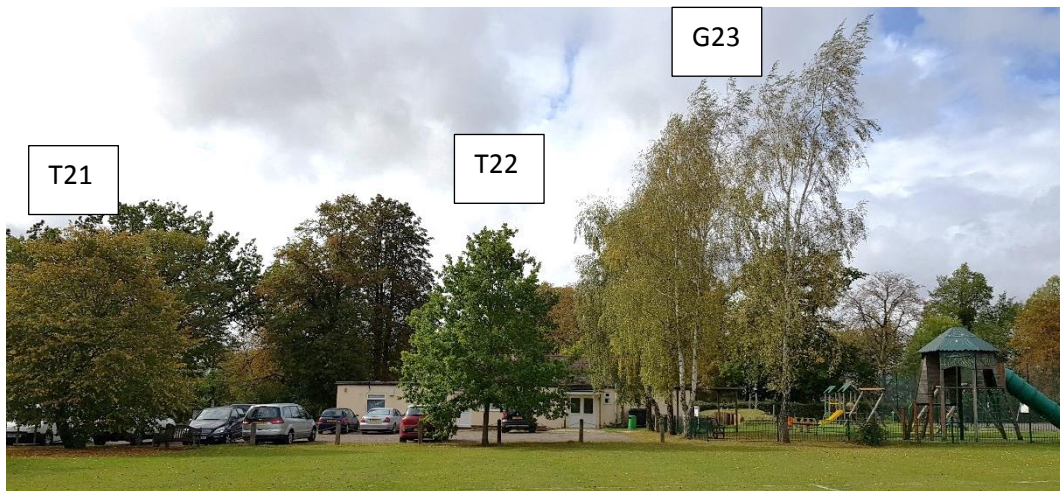
The oak tree has good form and potential to make a fine amenity tree. Ideally it should be crown lifted to achieve 5m clearance over the car park, but this is not essential at this stage, or in connection with the proposal. The silver birch forms an attractive group providing softening and screening between the car park and play area and are in reasonable form and condition.

*Photo 10 of T21 lime, T22 oak and G23 silver birch, looking west*

T21 will be removed to facilitate construction. There is room for a replacement tree to its immediate north, and I recommend a different species than lime to build resilience in the landscape. Field maple or hornbeam and suitable native species for this location.

- 8.7. That there is a replacement tree for T21 of a native species, and ideally not another lime, birch, ash or oak. Field maple or hornbeam would be suitable.
