## DESIGN, ACCESS & HERITAGE STATEMENT

Statutory Address 1: LODGE AT ENTRANCE TO MELDON PARK

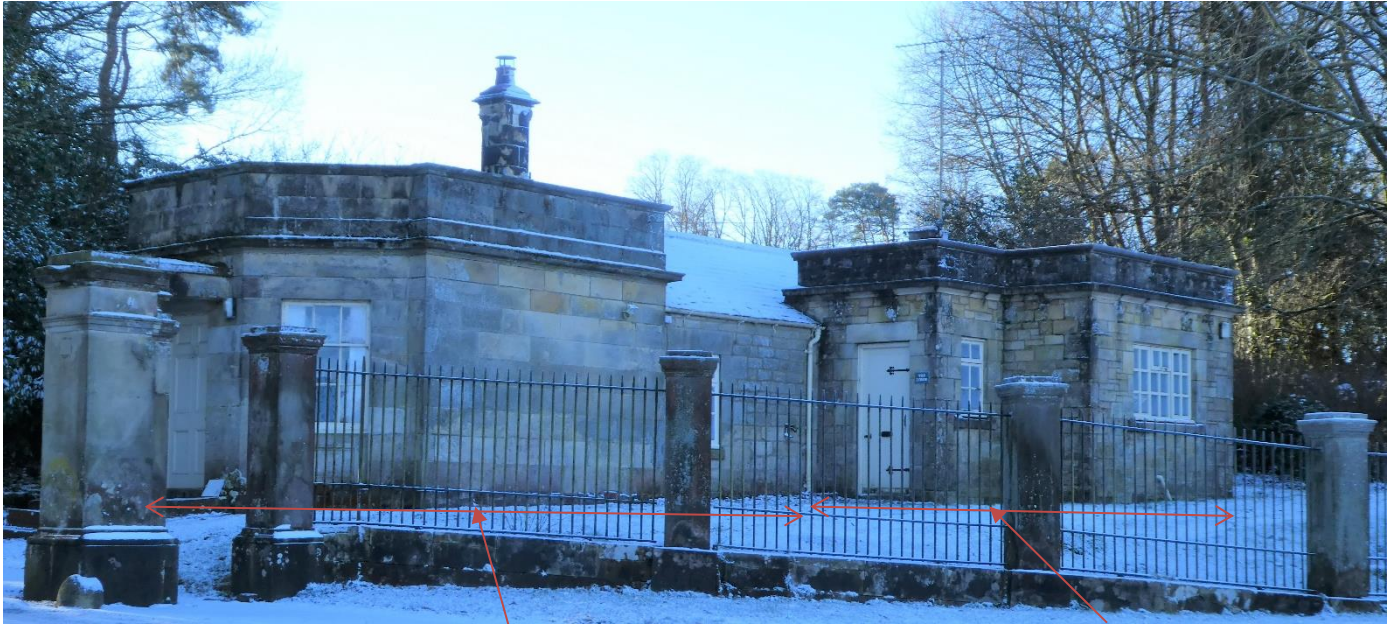
NORTH ELEVATION, gateway on the left. Original building

Later extension.

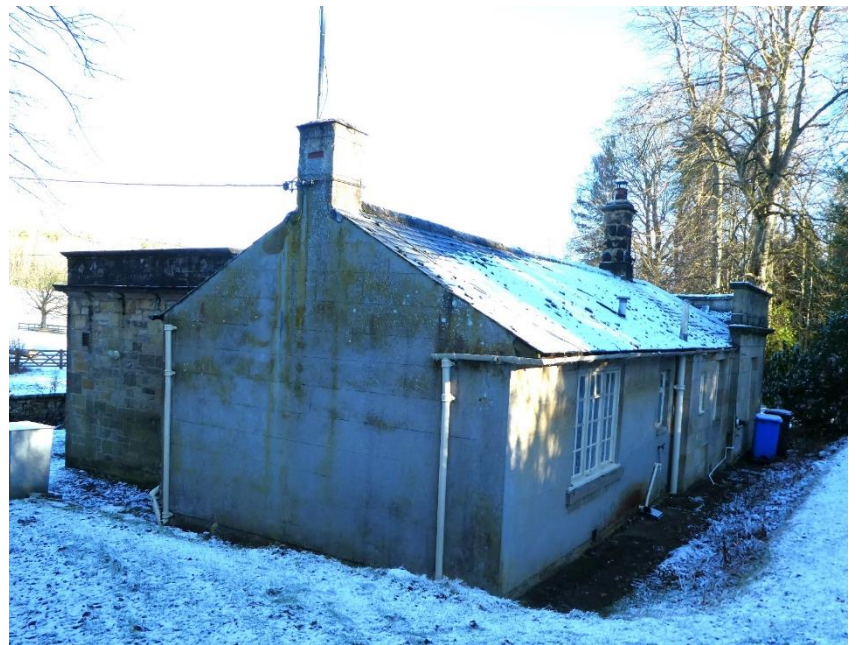
WEST ELEVATION, from South West. Existing Kitchen to left, existing Bedroom to right, all part of the later extension.

- 8. **The Later Extension** did not benefit from the same quality of design and construction; this is a mundane extension of negligible heritage asset, and it will be interesting to find out from the drawings held by the RIBA to what extent was Edwin Lutyens involved.

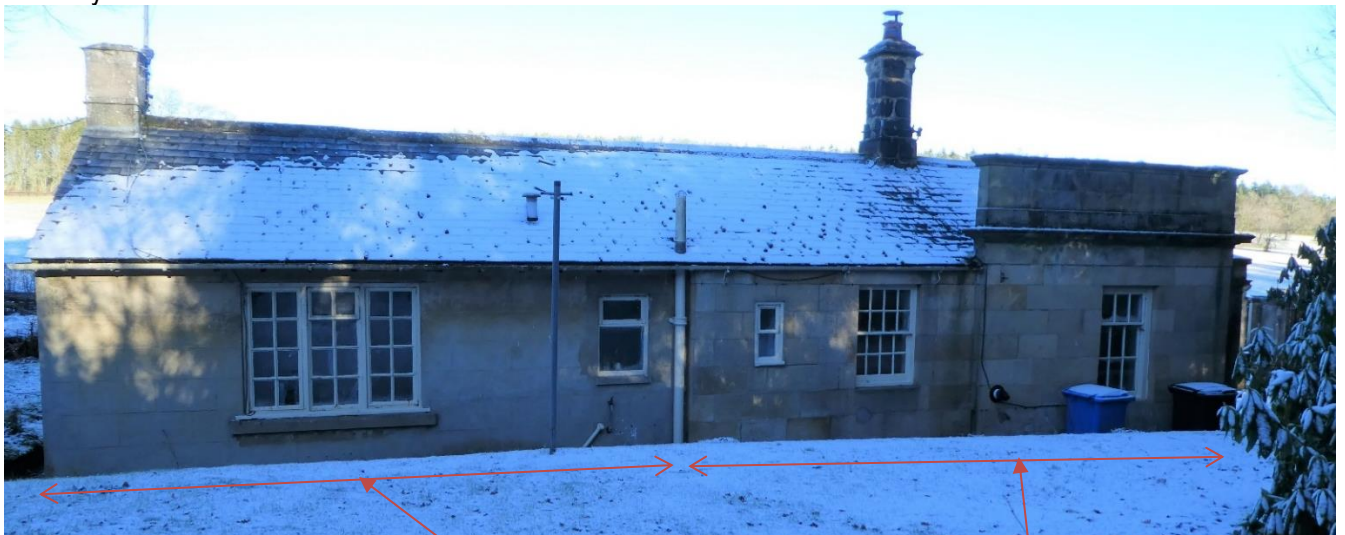
SOUTH ELEVATION. Existing Bedroom and Bathroom, all part of the Later Extension. Bedroom 2, Liv Room: the original building
