**Tree Survey, Arboricultural Impact Assessment
Preliminary Arboricultural Method Statement & Tree Protection Plan
In Accordance with BS 5837:2012**

Proj. No 10498	2 School House, Straight Road, Battisford, Stowmarket, IP14 2HR		
Client:		James Bailey Planning Ltd	
Date of Report:	30/10/2023	Revision:	Original

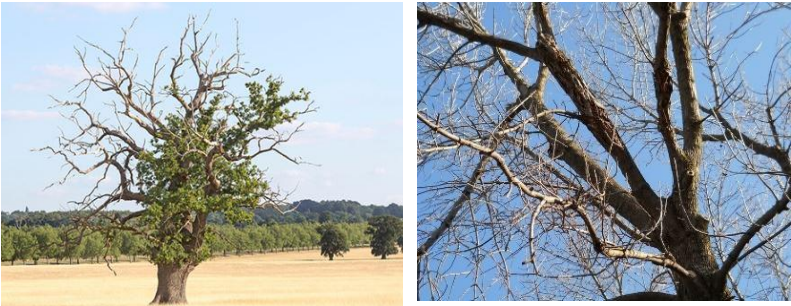
Name: Deadwood	
Symptoms/damage type and cause:	This relates to dead branches in the crown of the tree. In the majority of cases, this is caused by the natural ageing process of the tree or shading due to its close proximity to neighbouring trees. However, in some situations, it may be related to fungal, bacterial or viral infection.
Consequence:	Depending upon the location and mass of dead wood removal of the affected tissue may be necessary to prevent harm to persons or property as the wood will become unstable as it decays and in some circumstances is likely to fall from the tree with little or no warning.
Control:	Detailed monitoring should be undertaken on those trees showing signs of excessive deadwood production to identify the underlying cause.
Species affected:	Most tree species.
Images:

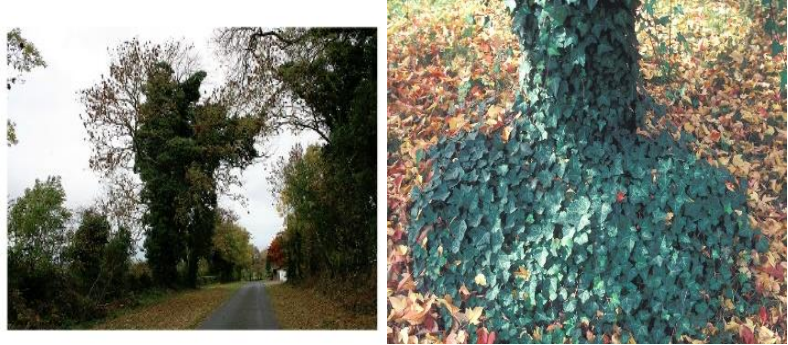
Name: <i>Hedera helix</i> (Ivy)	
Symptoms/damage type and cause:	Ivy may grow to varying degrees on all areas of a tree from the base to the upper crown. It is possible that in doing so it will out-compete the host tree for available light thereby suppressing the host.
Consequence:	This is generally only harmful to the tree on already unhealthy specimens which may be constricted by large ivy stems around the trunk or may have their top growth suppressed by a mass of flowering shoots in the crown. Ivy can also mask potentially dangerous faults on a tree.
Control:	Ivy should only be removed if absolutely necessary because it provides abundant cover to wildlife and then by severing twice close to the ground and removing a length of stem thereby causing the gradual dying away of the aerial parts of the plant providing extended benefit to wildlife whilst relieving the pressure on the tree.
Species affected:	Most trees can be affected.
