Appendix 1

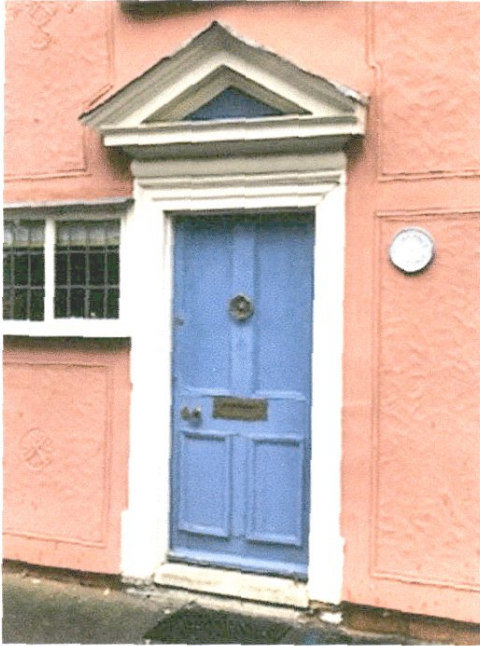
Timber front door beyond repair. To be replaced on a like for like basis in timber reusing all existing door furniture.

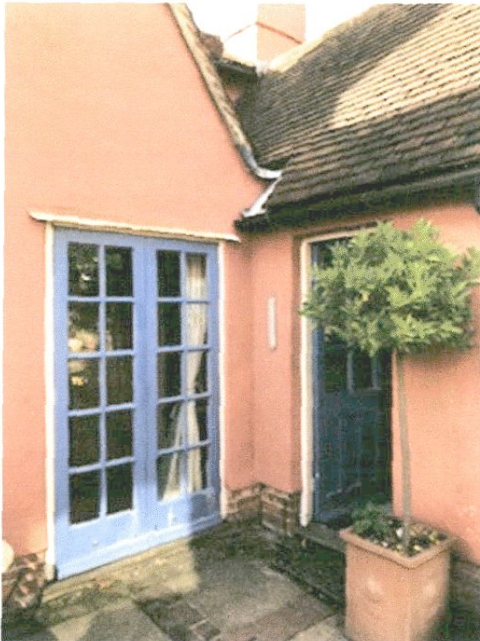
Proposed pitched roof veranda over backdoor and French doors in area shown. Oak framed, single oak post at outer corner, glass roof, lead flashings. Lead box gutter to replace existing plastic gutter above backdoor discharging to cast collector and downpipe replacing existing plastic items
