Arboricultural Impact Assessment

Wind Willow House,
Hyams Lann,
Holbrook

OAS 23-308-AR01

November 2023

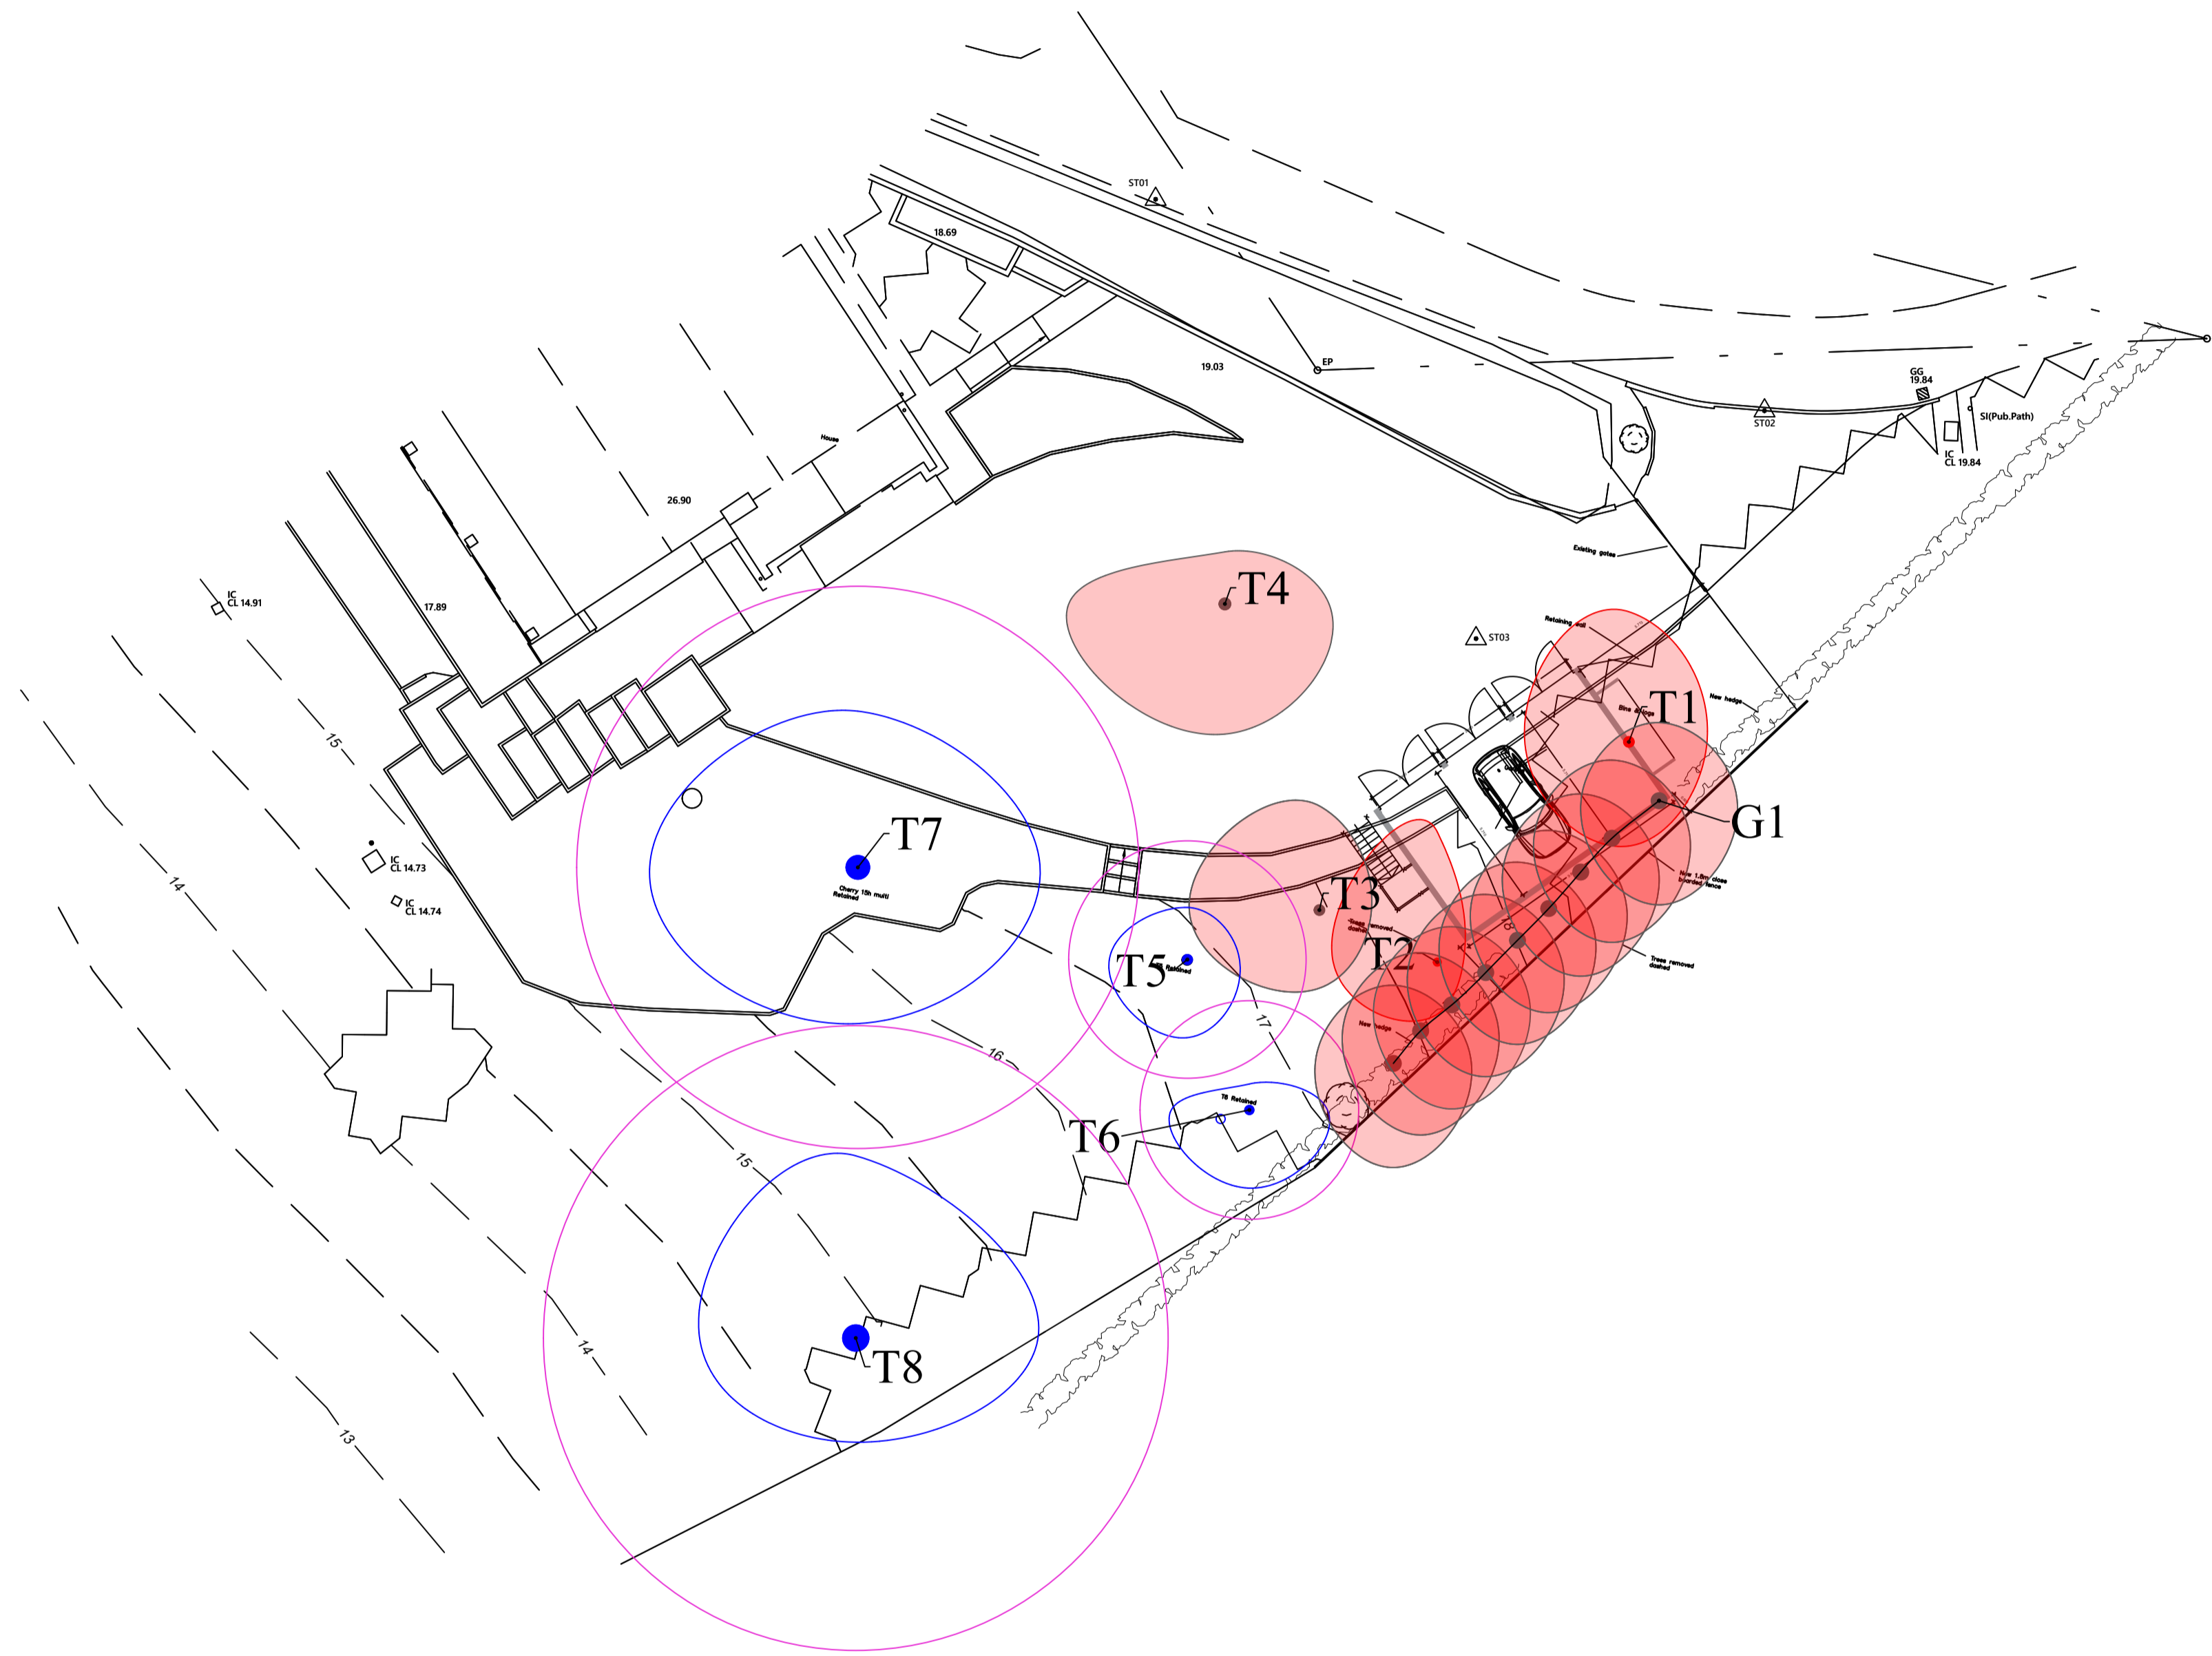
CLIENT c/o TMA		DWG. TITLE Tree Layout Plan	
SITE: Wind Willow House, Hyams Ln, Holbrook			
DRAWN BY SPM	CHECKED BY SPM	SCALE 1:200 @A1	DATE Oct 2023
DWG NO. OAS 23-308-TS03	REV.

3.1.2 The proposal will see the removal of T1- T4 and G1 to accommodate the cart lodge and reconfigure the driveway. T1 and T2 are both in decline, cat U, and their removal is recommended regardless of any proposal. T3, T4 and G1 are all of low quality and their removal will have no significant impact on the site arboricultural value. Replacement planting of a native hedge is to be accommodated.
