Home Farm, West Raynham

- **Heritage Statement**

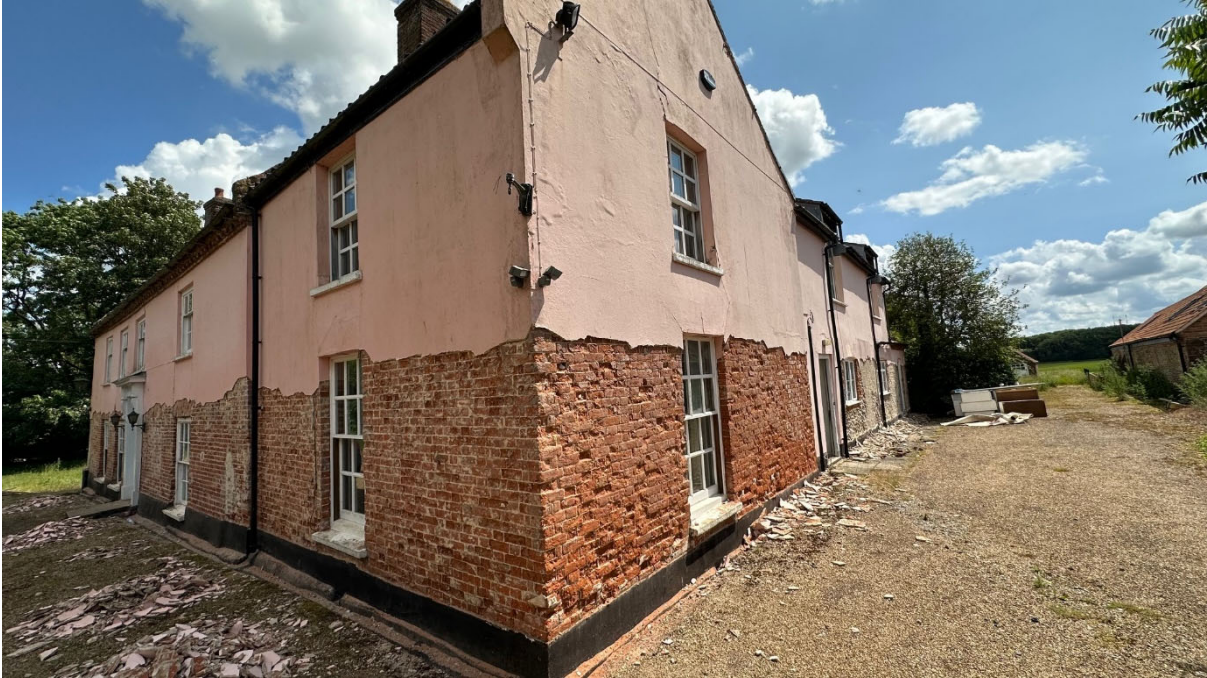
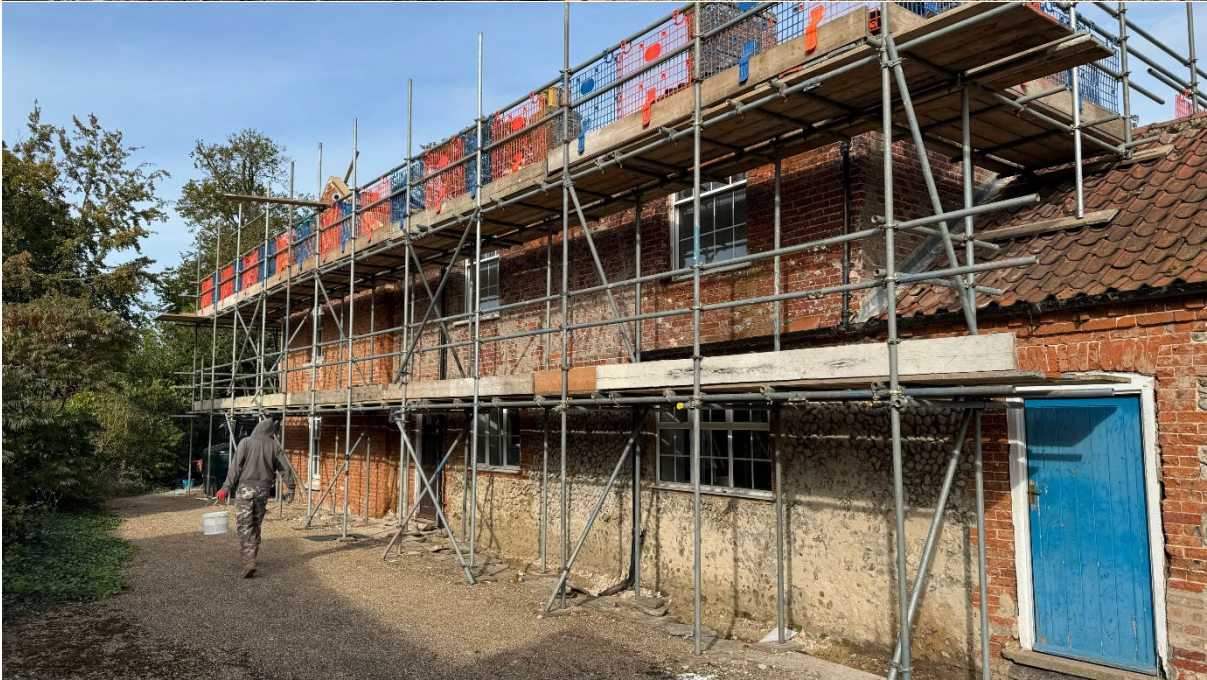
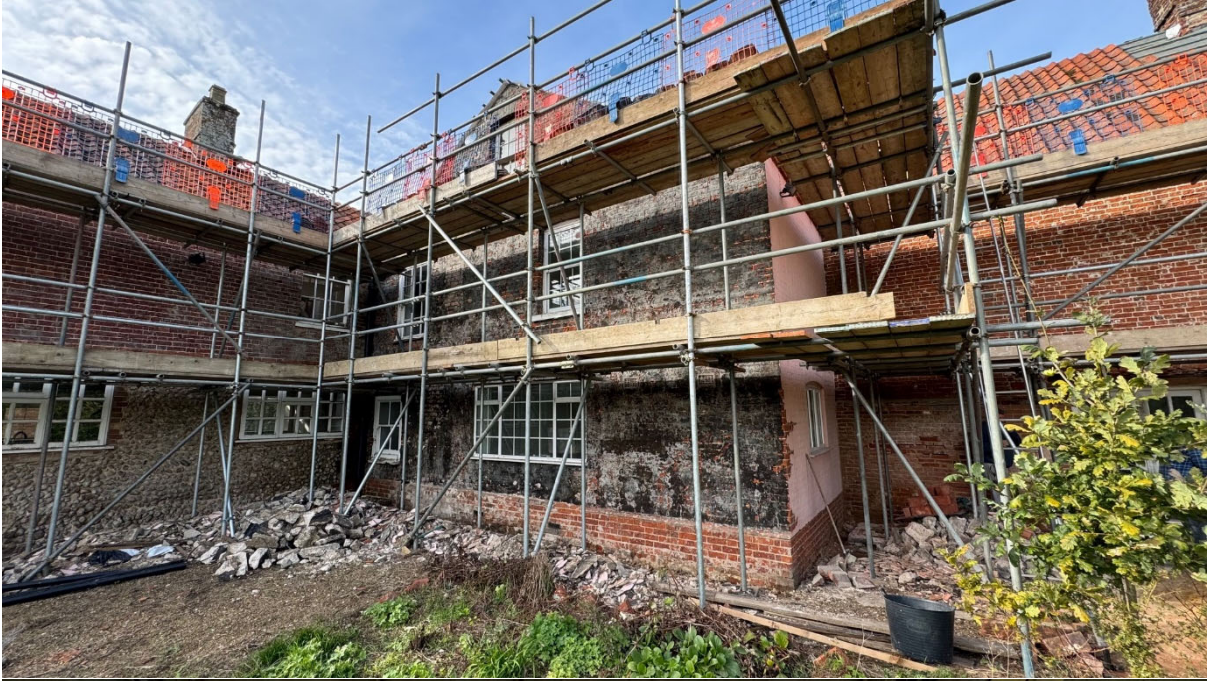
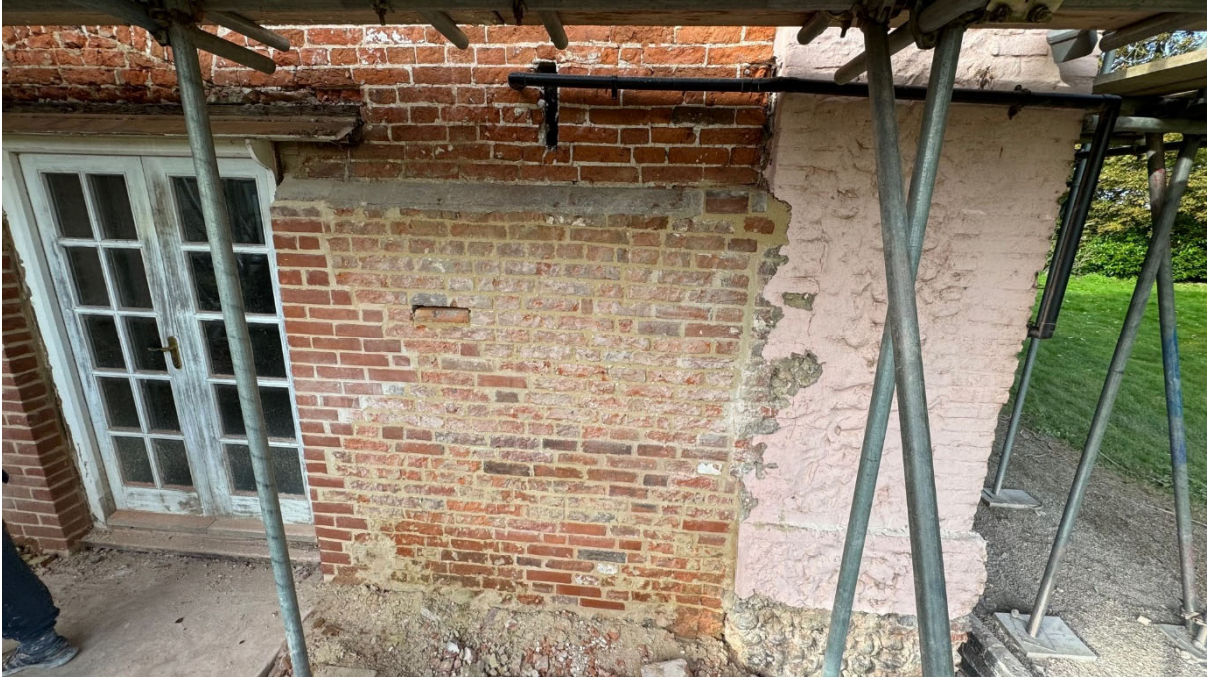
All the render has now been removed from the building and has revealed the wonderful Norfolk red brick underneath along with brick and flint to two elevations. We propose to carry out some repair works to some areas of poor brick, re-render the lower section of the front elevation in a lime render as these had sat wet for decades due to cement render. On the more recent (C20th) extension a bitumen paint was used underneath the cement render and this needs to be taken off as it is stopping the bricks from breathing and we propose to paint these two walls with a neutral colour (off white).

The chimney stack on the gable end needs to be taken down and rebuilt as it is leaning and in danger of collapsing either into the house or falling out.

The windows that are in bad condition, metal or UPVC we propose to replace with wooden sash with glazing bars as elsewhere in the house.

It would be beneficial to the building to allow it to breathe again to leave the brickwork exposed. In discussion with Chris Young we will keep a watching brief on the bricks and any damp internally and if necessary we will might need to consider rendering the whole in the future in a lime render if the bricks are not able to repel the weather.
