Ampney Park – Pump Houses, Stone Wall and Trees

Preliminary Bat Roost
Assessment

April 2023

Client: Simon Murray-Jones
Architects Ltd
Report Ref: SEB2428_05
Author:
Kate Hayward MCIEEM
www.seasonsecology.co.uk

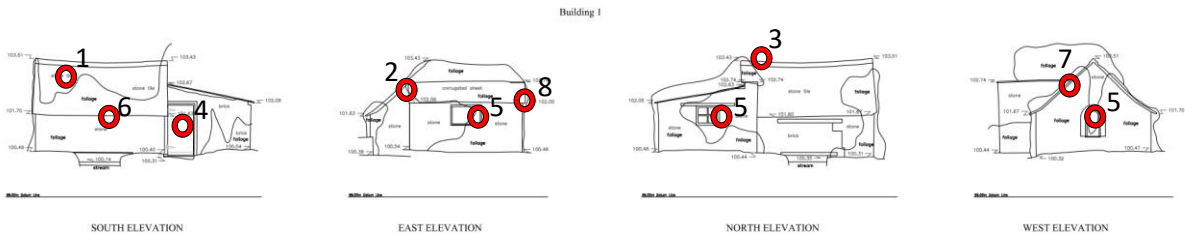
- 4.2.4 Building B1 is constructed of a combination of brick and Cotswold stone. The south and west elevations are directly adjacent to Ampney Brook. The west end has a pitched roof constructed of flat stone tiles of varying sizes, and the east end has a lean-to corrugated asbestos roof. There are timber-framed windows on the north, east and west elevations. There is a timber-framed door on the south elevation.
- 4.2.5 The roof tiles are in very poor condition with several raised, missing and misplaced tiles evident (Target Note 1, Annex 1). The walls have several gaps, particularly at the roofline, notably there is a hole in the wall near the roofline on the east elevation (Target Note 2, Annex 1). Both roof sections are partially collapsed where a mature ash tree has fallen onto the roof (Target Note

3, Annex 1). The timber-framed door on the south elevation is permanently left open (Target Note 4, Annex 1). The windows on the north, east and west elevations have no glass (Target Note 5, Annex 1).

- 4.2.7 The internal walls of B1 are in poor condition with numerous crevices evident, particularly near the roofline (Target Note 6, Annex 1). The lime mortar beneath the roof tiles is in very poor condition with numerous gaps present (Target Note 7, Annex 1). The broken windows and partially collapsed roof allow an influx of daylight into the interior, however darker areas are present internally. One bird's nest was located in the north-east corner of the building at the time of survey (Target Note 8, Annex 1).

- 4.2.8 Building B1 is assessed as *Low* suitability to roosting bats. Whilst there are access points into the interior identified, including the partially collapsed roofs, windows with no glass and open doorway, and external features (raised, missing and misplaced roof tiles and gaps at the roof line), the building is suitable to support low numbers and individual bats within these features, and is also suitable as a night roost with internal wooden beams for perching. However, it is generally unsuitable to support large numbers of bats or significant roosts.

- 1: Raised, missing and misplaced roof tiles.
- 2: Hole in the wall near the roofline.
- 3: Ash tree fallen on roof, the corrugated asbestos roof and stone tiled roof are both partially collapsed.
- 4: Timber frame door which is permanently left open.
- 5: Windows missing windowpanes.
- 6: Internal walls have numerous crevices.
- 7: Lime mortar beneath tiles in poor condition with numerous gaps.
- 8: Bird's nest

- Pump Houses – One bat survey should be undertaken of the Pump Houses, between May and September, to determine the presence of bat roosts, the status of any roosts found, and the numbers and species of bats. The surveys will inform the approach to works, including additional surveys, licensing requirements and mitigation and compensation measures.

- 6.4.1 Renovation of the Pump Houses could result in the loss of potential roosting and nesting features for bats and birds. During re-roofing of the Pump Houses, several stone tiles should be left with gaps beneath, to maintain opportunities for roosting bats. A larger opening could be left in each of the Pump Houses to maintain potential accesses for roosting bats and nesting birds, on completion of the works.
- 6.4.2 The wider estate offers opportunity to enhance roosting and nesting opportunities for bats and birds, with the provision of a range of bat and bird boxes on suitable trees across the estate.

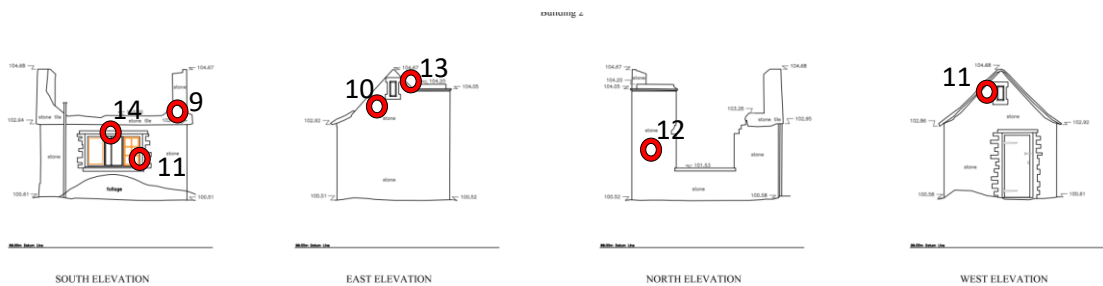
- 4.2.11 The stonework walls of the building are in good condition. The remaining roof tiles above the south elevation have a low number of gaps near the roofline (Target Note 9, Annex 1). There is a hole in the wall on the east elevation at the roofline (Target Note 10, Annex 1). There is a hole within the beam above the door on the north elevation which appears to lead into a small cavity within the doorframe. The timber-framed windows are without glass (Target Note 11, Annex 1).

- 4.2.12 Internally the stonework walls are in good condition, with a very low number of gaps (Target Note 12, Annex 1). There is a wide gap under the lead flashing on the east elevation (Target Note 13, Annex 1). There is a long narrow gap across the entire top window frame on the south elevation (Target Note 14, Annex 1).

- 4.2.13 The internal area of B2 is well-lit due to the missing roof and windows on the north, east and south elevations.
- 4.2.14 Building B2 is assessed as *Low* suitability to roosting bats. Whilst there are external and internal cracks in stonework, a hole in a beam and gap in the top of one window frame, the absence of a roof creates exposed and well-lit conditions, suitable for low numbers or individual bats to roost. The building is unsuitable to support large numbers of bats or significant roosts.

- 9: Low number of gaps near the roofline.
- 10: Hole in the wall at the roofline.
- 11: Timber-framed windows, no glass.
- 12: Internally there is a low number of gaps in the stonework.
- 13: Wide gap under the lead flashing.
- 14: Long narrow gap across the top of the window fame.

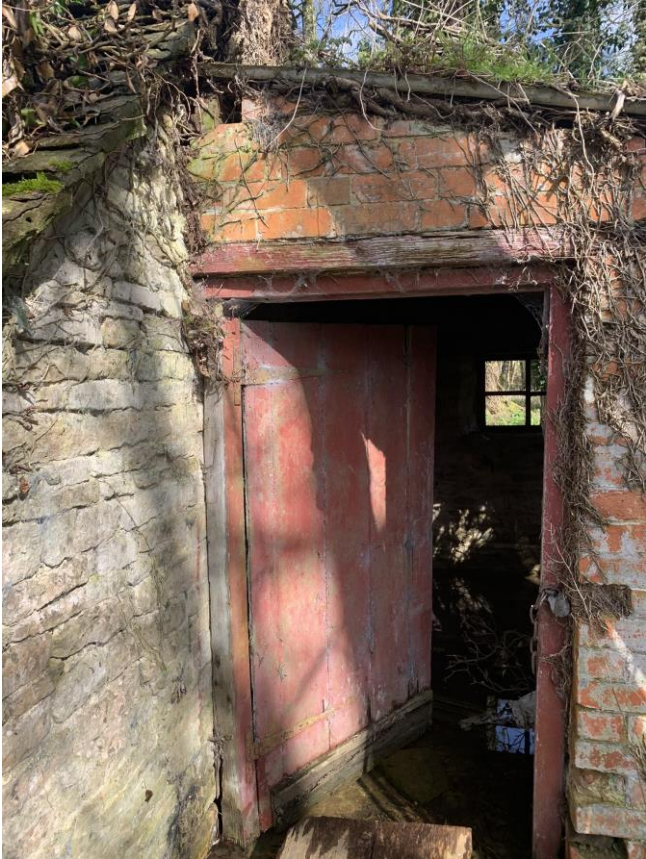
Photograph 3. Open door on the south elevation of Building B1.

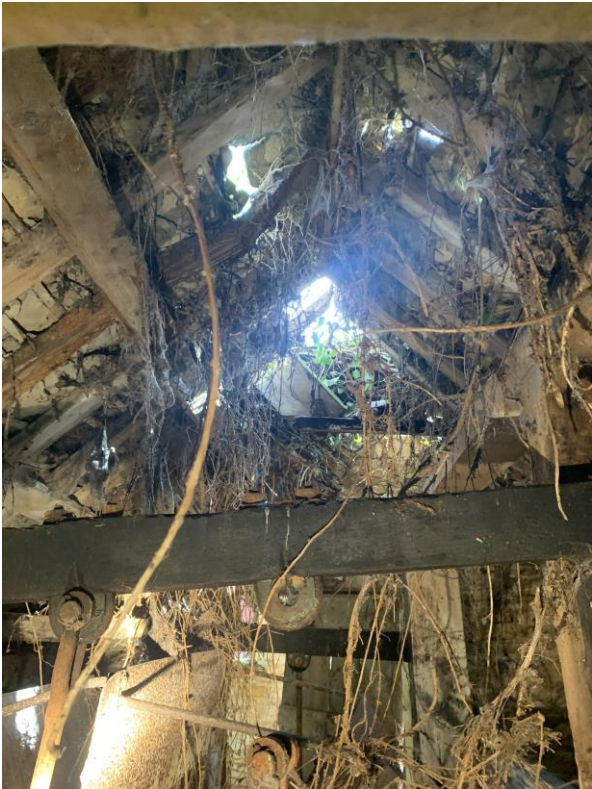
Photograph 7. The inside of Building B1, showing the hole in the roof caused by the collapsed ash tree.

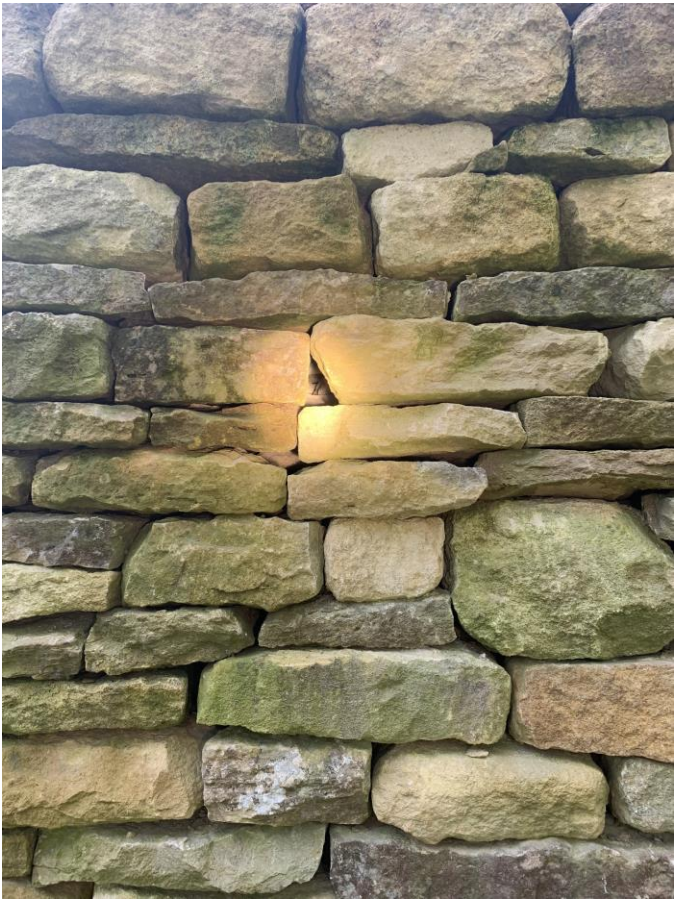
- 4.2.16 There are dry-stone walls across the estate, including the section to be removed, which is relatively newly constructed (within the last few years). This section is approximately 3m to 3.5m in height. Numerous crevices, including deeper crevices are evident between the stones on both the north and south elevations of the wall.
- 4.2.17 The stone wall is assessed as *Moderate* suitability to roosting bats owing to the presence of deeper crevices within the wall.
- 4.2.18 No evidence of roosting bats or nesting birds was found in the stone wall during the survey.

- 5.1.2 The stone wall is assessed as *Moderate* suitability to roosting bats, with crevices, including deeper crevices identified.
- 5.1.3 Three trees are assessed as *Low* suitability to roosting bats (two ash and one pine) and one tree (a sycamore) is assessed as *Moderate* suitability to roosting bats.

Photograph 12. Crevices within the Stone Wall.

- Stone Wall – Two bat surveys should be undertaken of the stone wall, between May and September, to determine the presence of bat roosts, the status of any roosts found, and the numbers and species of bats. The surveys will inform the approach to works, including additional surveys, licensing requirements and mitigation and compensation measures.

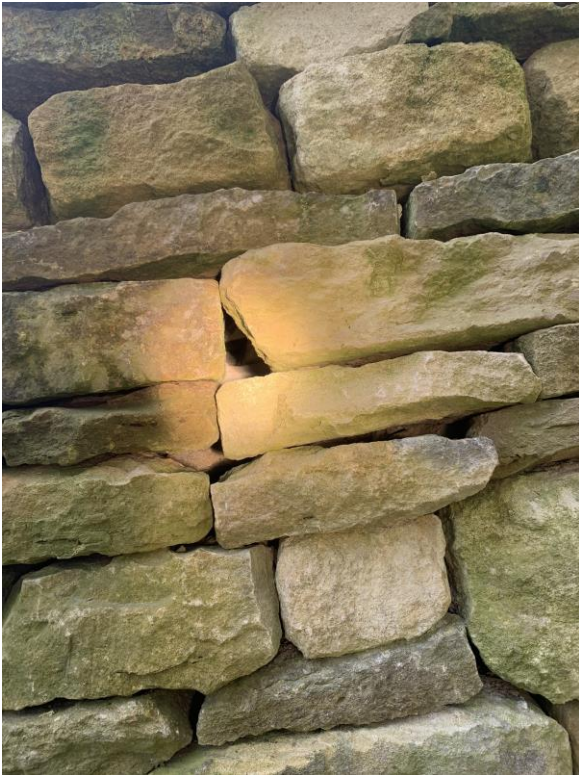
Photograph 13. A deeper crevice in the Stone Wall.

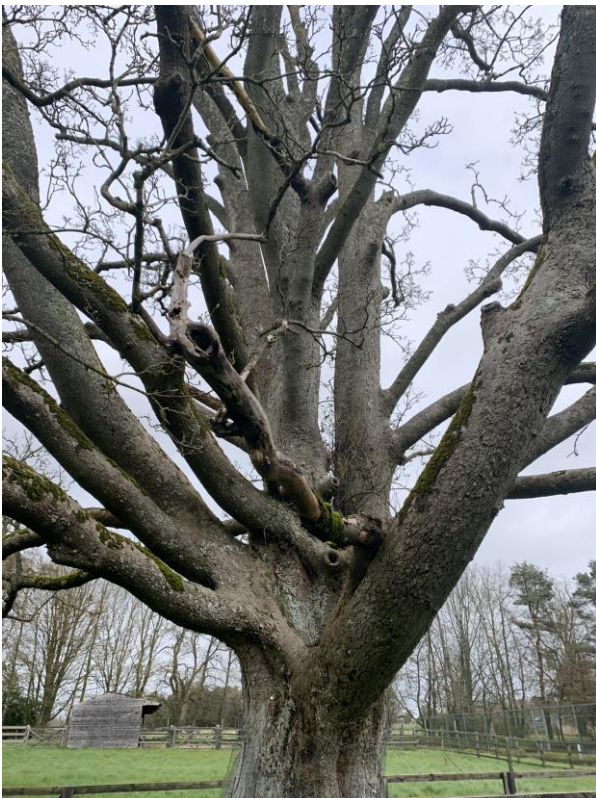
4.2.21 Referring to Table 1, 37 of the 41 trees surveyed were assessed as *Negligible* suitability to roosting bats. Three trees were assessed as *Low* suitability to roosting bats, two ash (T 2352 and T 977c) and one pine (T 2317), and one tree was assessed as *Moderate* suitability to roosting bats, a mature sycamore (T 2386).

Photograph 14. Tree 2386, a sycamore assessed as *Moderate* suitability to roosting bats. Visible features include rot holes and cracked, loose bark.

- Trees – A Climb and Inspect survey should be undertaken of trees T 977c, T 2317, T 2352 and T 2386, by a suitably Licensed Bat Ecologist and Qualified Tree Climber, to inspect the roosting features identified on each tree with the aid of an endoscope. The survey will aim to identify any bat roosts present, and any requirement for further surveys to inform the approach to works, licensing requirements and mitigation and compensation measures.

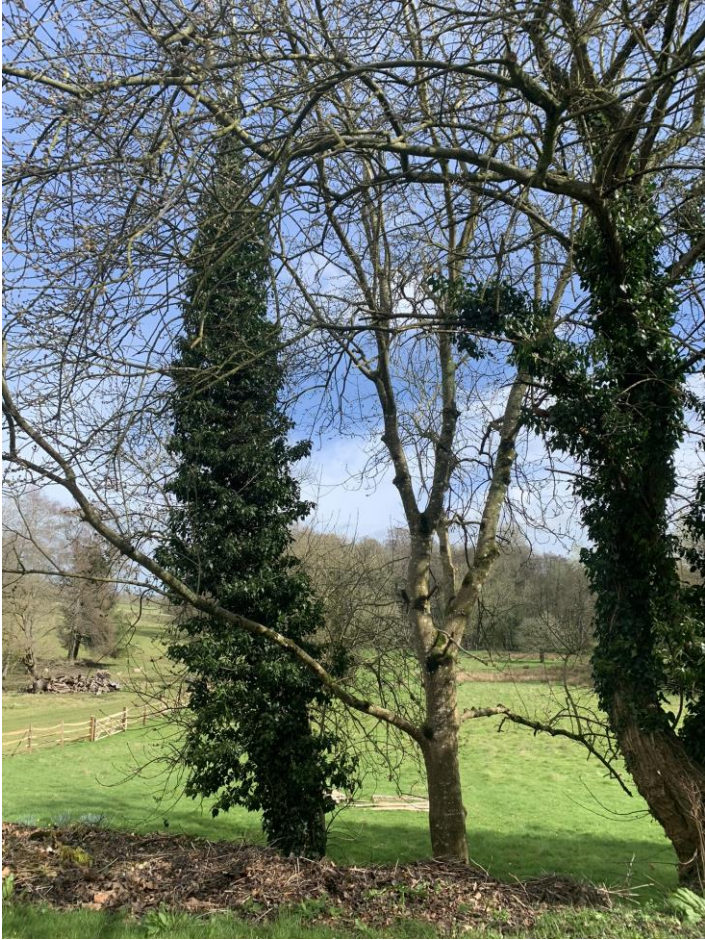
Photograph 15. Trees 977a, 977b and 977. The tree on the left is T 977c, an ash tree assessed as *Low* suitability to roosting bats.
