# Ampney Park

## Preliminary Bat Roost Assessment and Survey

April 2021

Client: Simon Morray-Jones  
Architects Ltd  
Report Ref: SEB2429\_01  
Author:  
Kate Hayward MCIEEM  
[www.seasonsecology.co.uk](http://www.seasonsecology.co.uk)

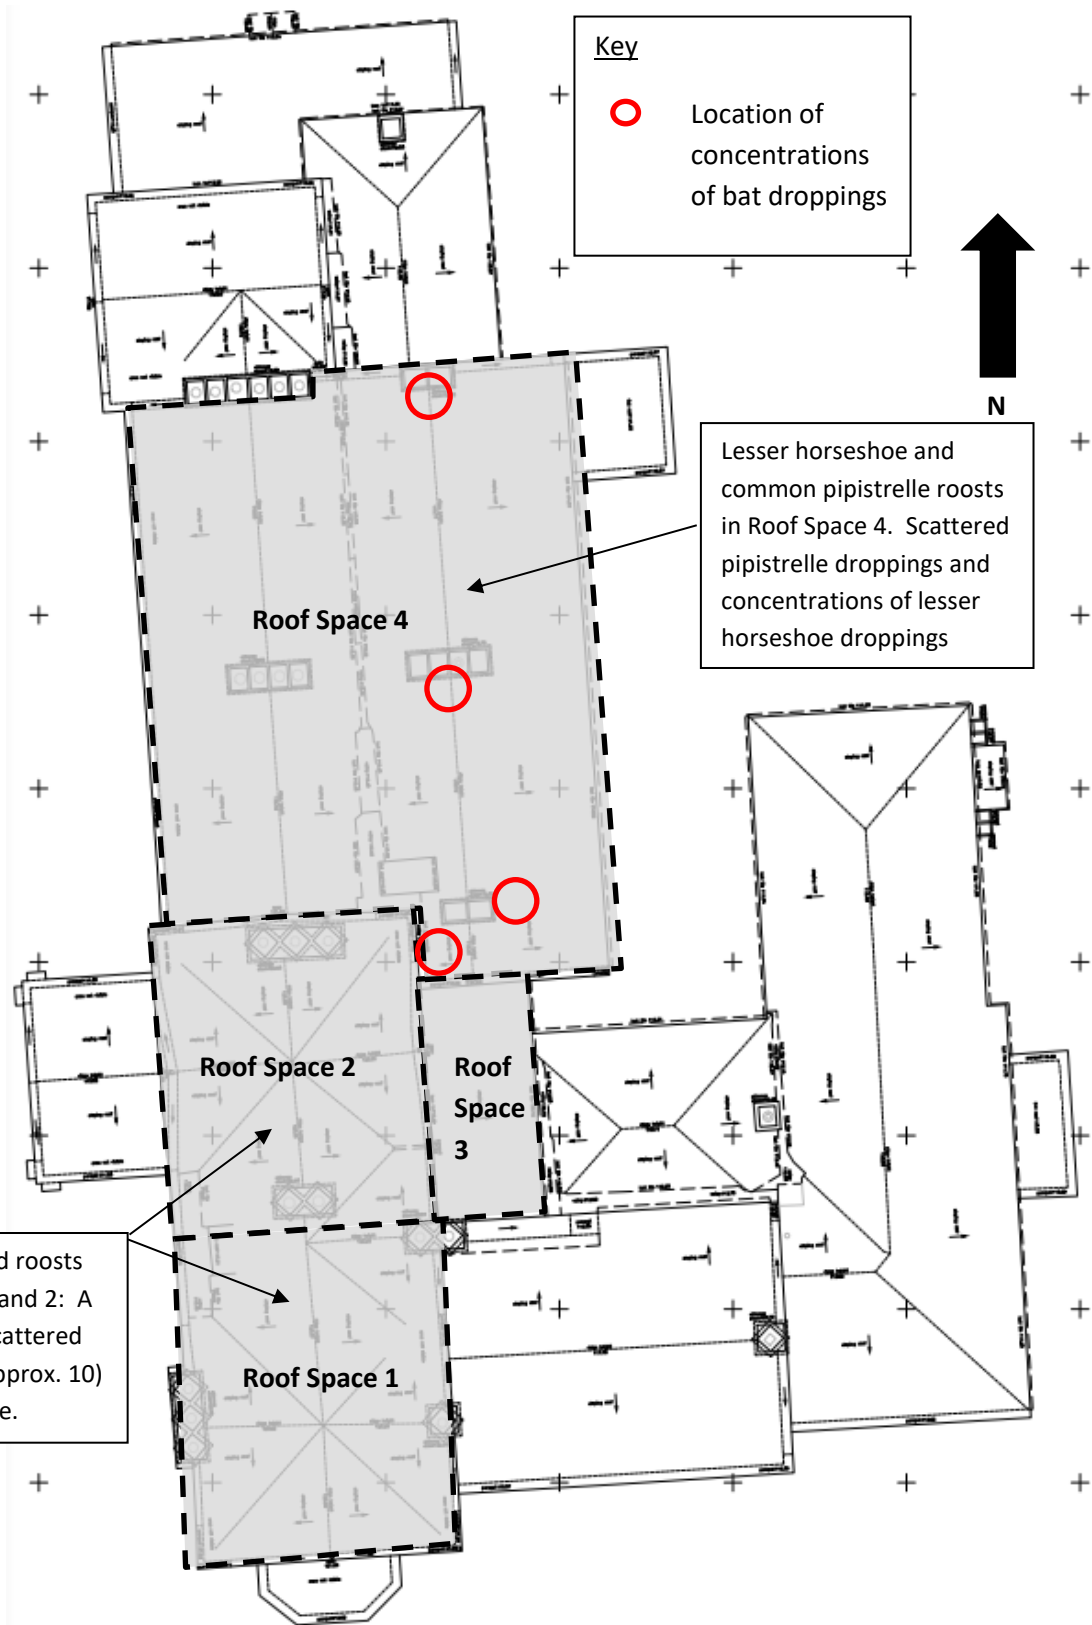
## Annex 2: Main House Roof Layout and Survey Results (April 2021)

- 4.2.7 The roof spaces are dark and undisturbed. They have traditional Bitumen-type liners and wooden roof supports.
- 4.2.8 *Roof spaces 1 and 2*, both accessed from the second floor of the South Wing, are approximately 1.7m high to the apex, and 8m width and length. They are cluttered and contain water tanks. Evidence of bats was found in both roof spaces in the form of a low number of scattered bat droppings.

- 4.2.10 *Roof space 4* is accessed off the first floor of the North Wing and is located beneath the M-shaped, slate-tiled roof and occupies both sides of the valley. Only the eastern half of the roof space was accessed, to the east of the valley, due to the small gap between the two spaces. This eastern half of the roof space is approximately 2.5m high to the apex, 6m in width and 15m in length. There is a door at the southern end, which opens out onto the lead valley roof. Evidence of bats was found in the form of bat droppings, located in four distinct piles near to the chimneys, as well as scattered bat droppings throughout, numbering several hundred (refer to Photograph 3, Annex 4).

Roof Space 4, North Wing – Lesser horseshoe and common pipistrelle

- 5.1.1 The Main House is the subject of internal layout alterations and re-roofing and repairs to external areas, including stonework and roofs.
- 5.1.2 Internal works include a new roof light to the en suite bathroom to Bedroom 3, which will impact Roof Space 4, the location of a lesser horseshoe roost and common pipistrelle roost. This will modify the roosts, with a minor reduction in area, and will create disturbance during the works. Roof repairs may also be required to this section of the roof.

- 5.1.3 Internal works include removing the ceiling in the en suite bathroom to Bedroom 9 and roof upgrade, which will impact Roof Space 2, the location of a brown long-eared roost. This will damage, disturb and result in the loss of this roost.

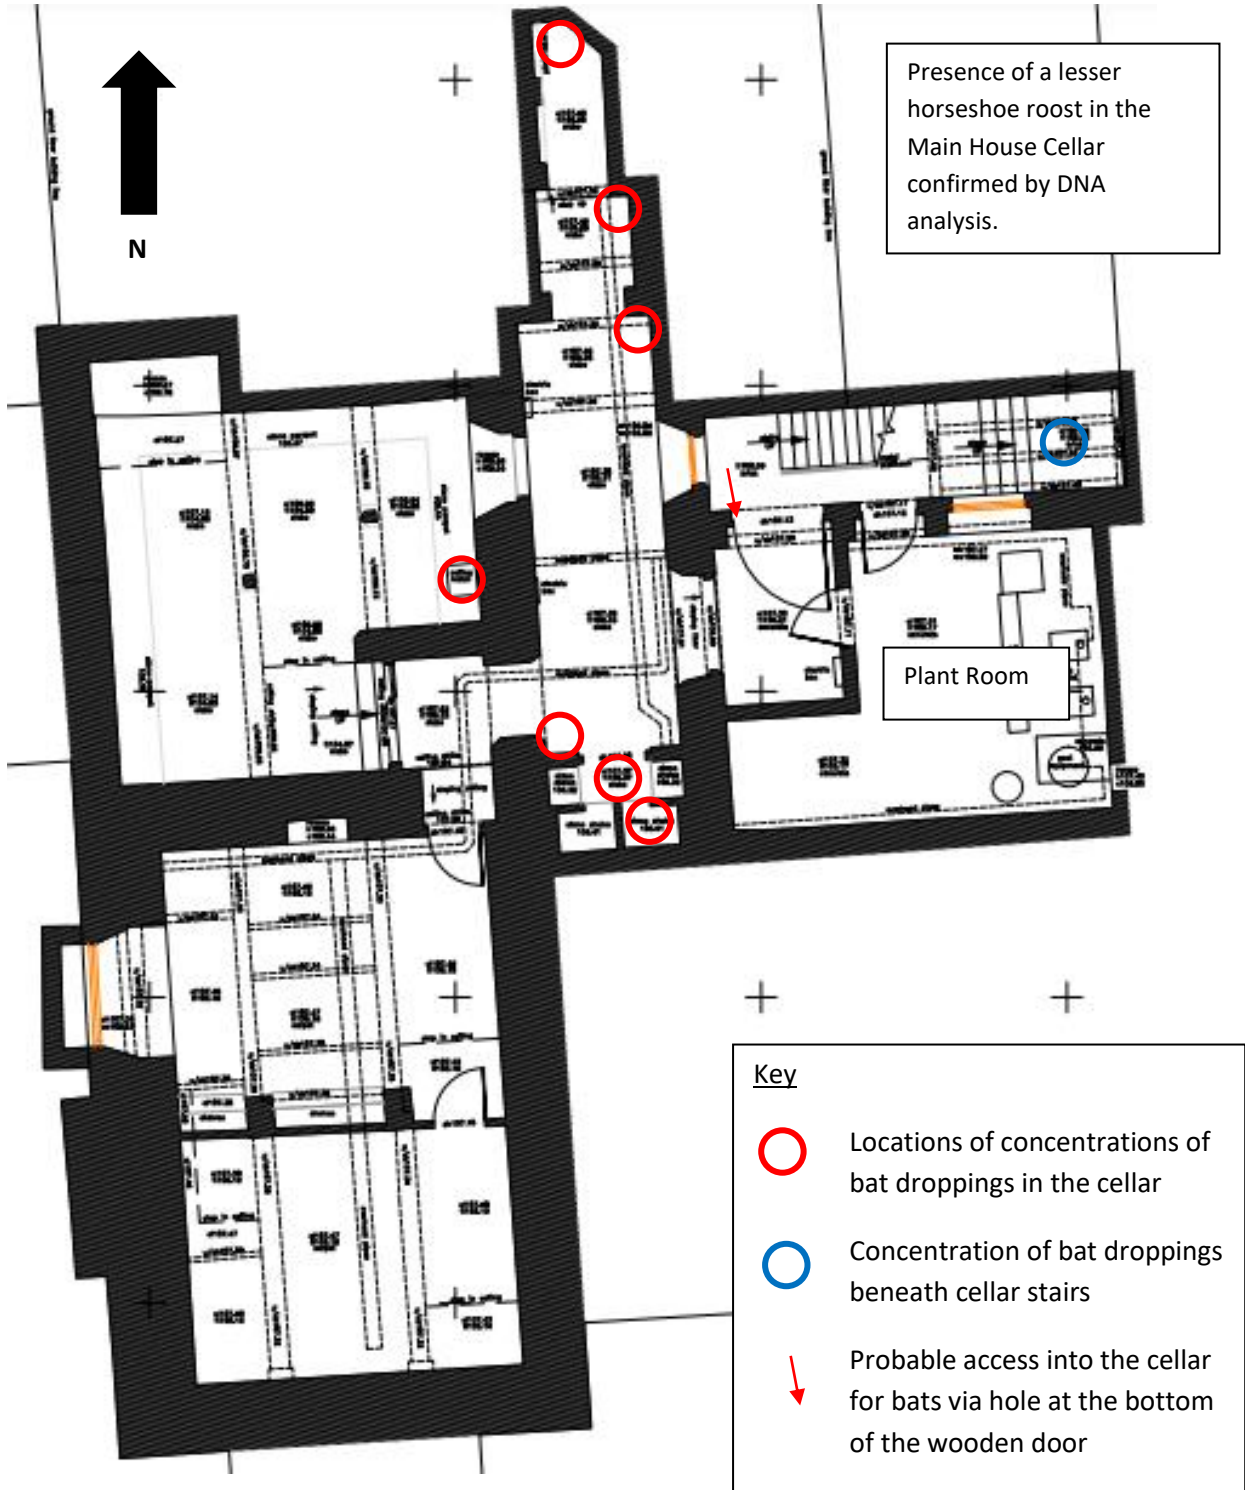
### Annex 3: Main House Cellar Layout and Survey Results (April 2021)

- 4.2.14 Seven distinct piles of bat droppings were identified within the cellar rooms (shown on the cellar plan at Annex 3 and Photograph 5, Annex 4). Bat droppings were also found beneath the stairs leading down to the cellar (Photograph 6, Annex 4). The piles of droppings number between approximately 30 and 100. No bats were present in the cellar at the time of the survey.

Cellar – Lesser horseshoe

<u>Cellar</u> Large cellar comprising several rooms, including plant room	Confirmed presence of lesser horseshoe roost: Several concentrated piles of bat droppings (30 to 100 droppings each) confirmed by DNA analysis

- 5.1.4 Upgrading of the heating system throughout the Main House, with the plant room located in the cellar, will impact on the lesser horseshoe roost recorded in the cellar and under the stairs leading down to the cellar, through disturbance during the works. Removal of asbestos cladding around some of the heating pipes leading through the cellar will also disturb roosting bats.

- 5.1.9 **Occasional access to the plant room in the cellar is required for maintenance purposes. It is recommended that the door between the plant room and the rest of the cellar is blocked off to prevent access to areas where lesser horseshoe bat is roosting.**

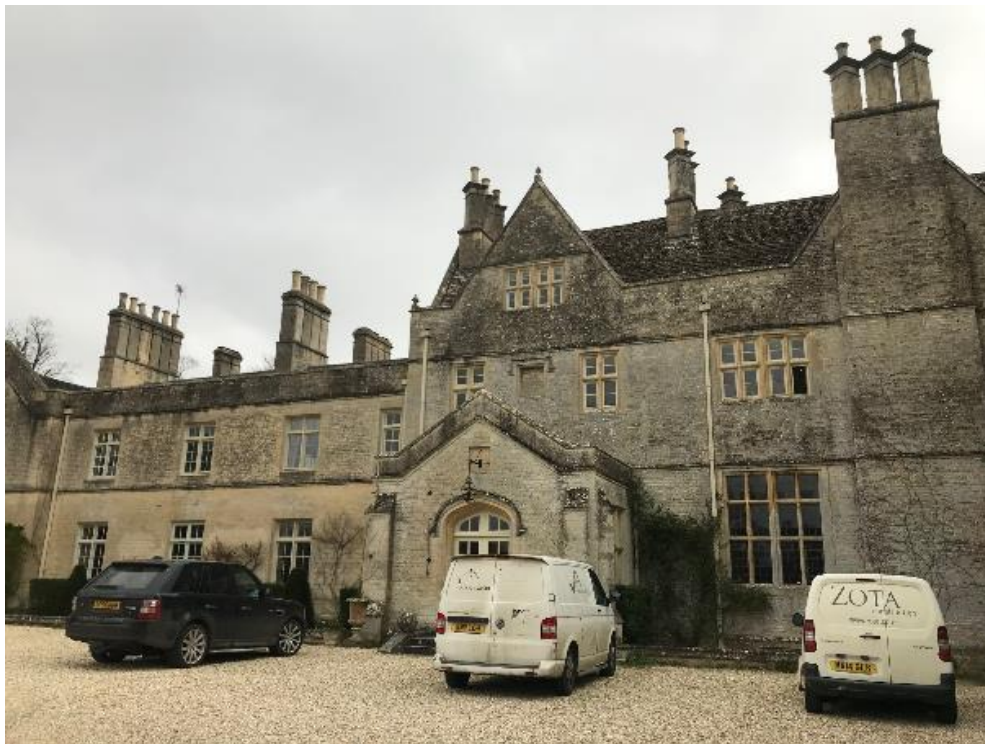
- 4.2.2 The Main House is a large period property, constructed of Cotswold stone with slate and stone-tiled gabled roofs and multiple chimneys (refer to Photographs 1 and 2, Annex 4). There is a North Wing and a South Wing. The two-storey North Wing has an M-shaped, slate-tiled roof. The three-storey South Wing has a gabled, stone-tiled roof with a slate-tiled roof to the two-storey element attached to the east (rear) elevation. There are single-storey sections attached to the north elevation (North Wing) and east elevation (South Wing), all constructed of Cotswold stone with slate-tiled roofs with shallow pitches.

- 4.2.4 The slate tiles on the North Wing roofs have few gaps evident and there are few gaps in stonework evident on the external walls. The north aspect of the North Wing has several gaps in coping stones and stonework near the roofline.

- 4.2.5 The stone tiles on the South Wing roof feature several gaps beneath and there are a number of gaps in the stonework on the external walls, mainly on the east and west aspects.

Photograph 1. The front (west) aspect of the Main House, showing the two-storey North Wing and three-storey South Wing.

- 5.1.5 External repairs to roofs, re-roofing and repairs to stonework could impact on any bats if using these features for roosting.
- 5.1.6 To further assess use of the Main House by roosting bats, and to provide further information on the roosts known to be present, including numbers, access points and roost types, it is recommended that three bat surveys are undertaken. The bat surveys should be a combination of dusk emergence and dawn re-entry surveys and carried out between June and August. Five surveyors will be required to adequately cover all aspects of the building, including the cellar entrance.**

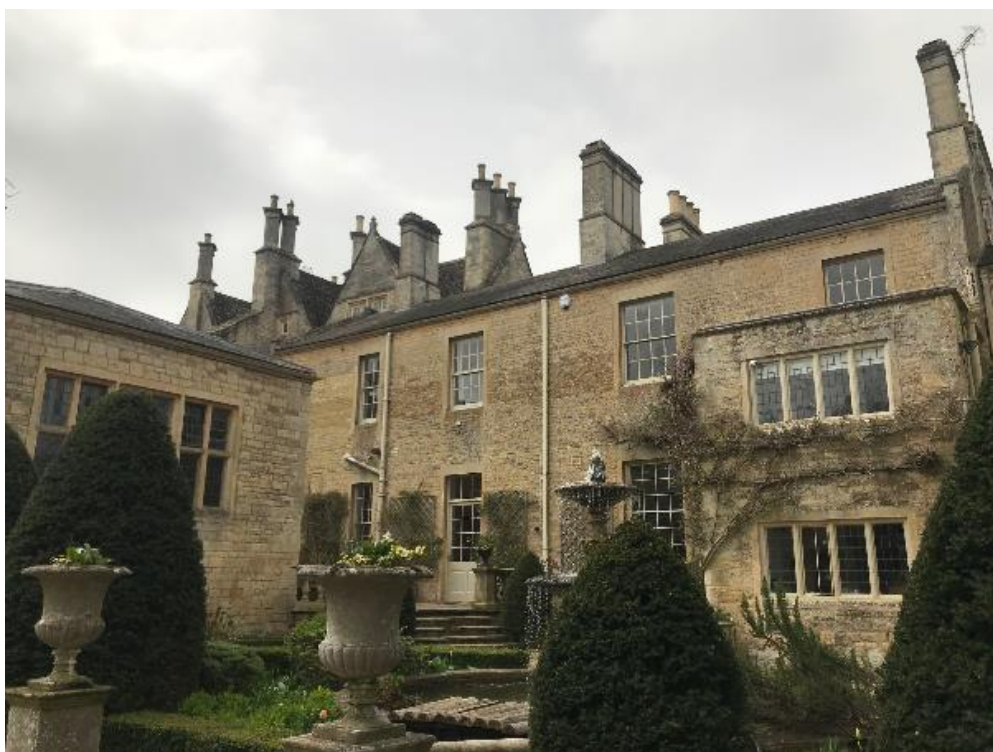
Photograph 2. The rear (east) aspect of the Main House.

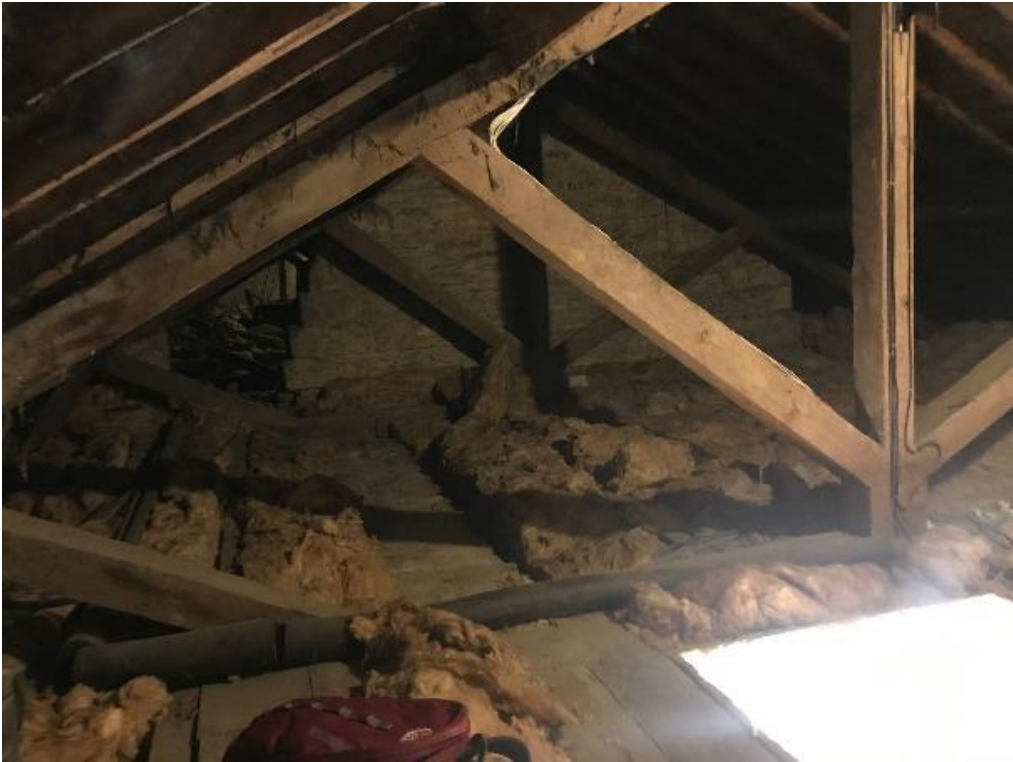
Photograph 3. Part of Roof Space 4 of the Main House (North Wing). Confirmed lesser horseshoe and common pipistrelle roosts.

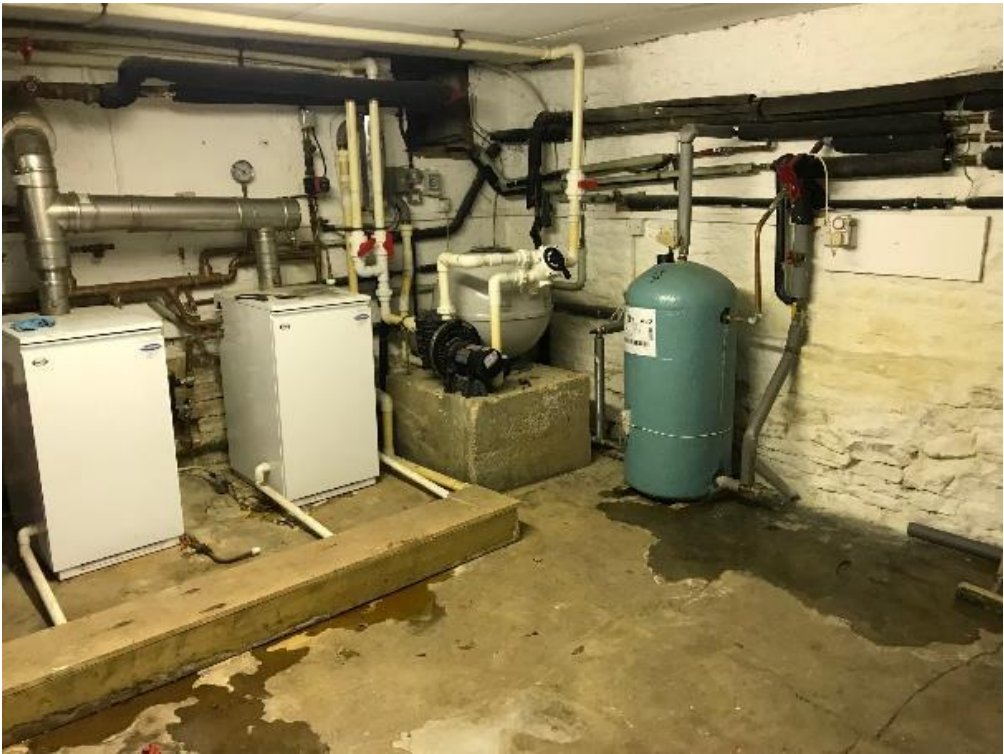
- 4.2.12 The plant room contains the heating system for the Main House (refer to Photograph 4, Annex 4). It has a warm and stable environment but is heavily disturbed from noise and vibration from machinery. It is well-lit from one window opening onto the stairwell. No evidence of bats was found in the plant room.

Photograph 4. View of the Main House Cellar, Plant Room.

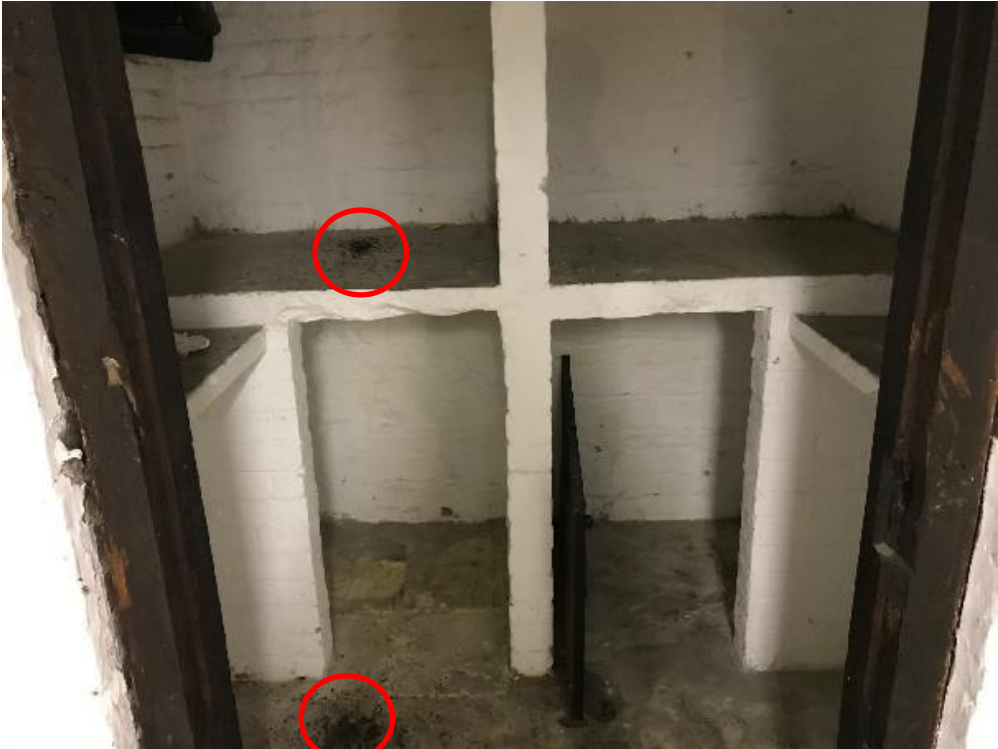
Photograph 5. Main House Cellar showing concentrations of lesser horseshoe bat droppings (circled).

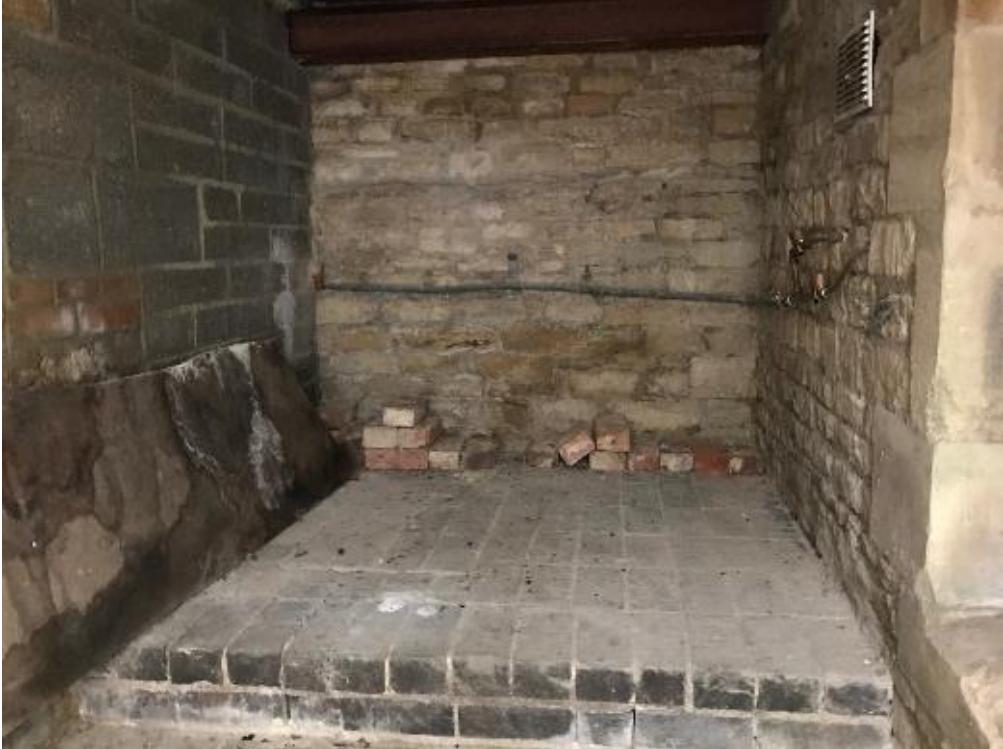
Photograph 6. Area below the Cellar stairs with lesser horseshoe droppings.

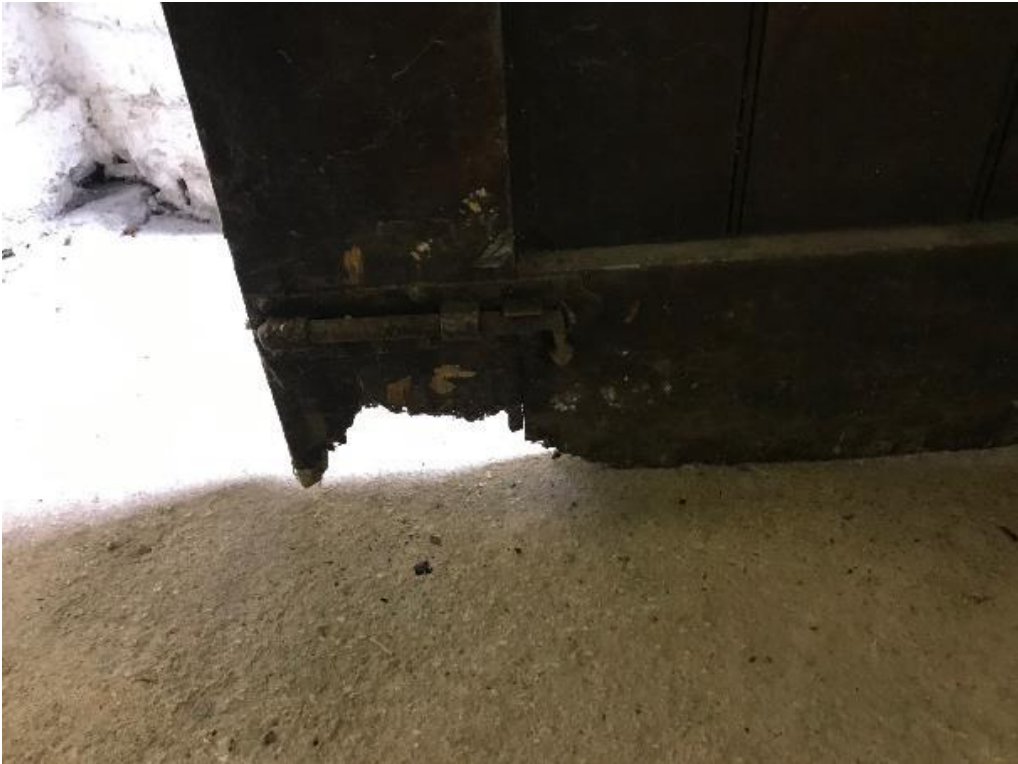
Photograph 7. Probable access point for lesser horseshoe at base of the Cellar door.

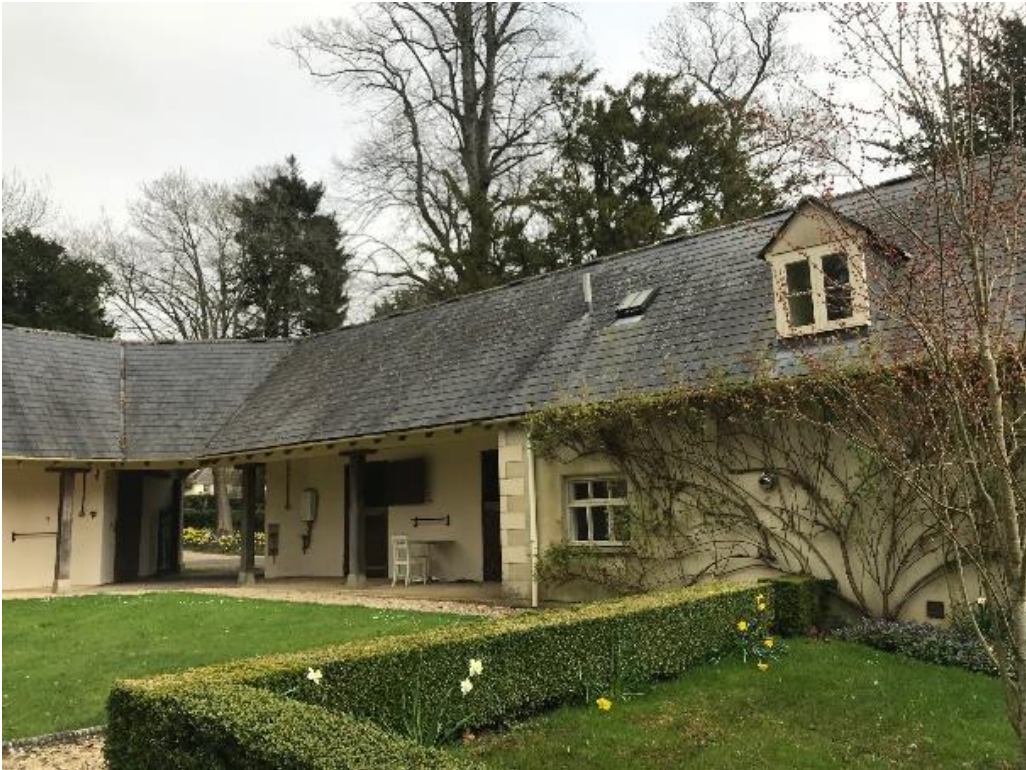
- 4.2.16 The Stables and Grooms Flat is an L-shaped building, with rendered external stone walls and a pitched slate-tiled roof. The Grooms Flat is at the southern end and has a dormer window and a roof light on the west aspect of the roof and two dormer windows on the east aspect of the roof. A car port is located beneath the first floor of the Grooms Flat on the east aspect (refer to Photographs 8 and 9, Annex 4).
- 4.2.17 The rendering of the walls is in good condition with no gaps or cracks presents and the slate tiles are flush and in good condition with no gaps evident. Gaps are present underneath the ridge tiles at equal spacings along the ridge.

Photograph 8. The west aspect of the Stables and Grooms Flat.

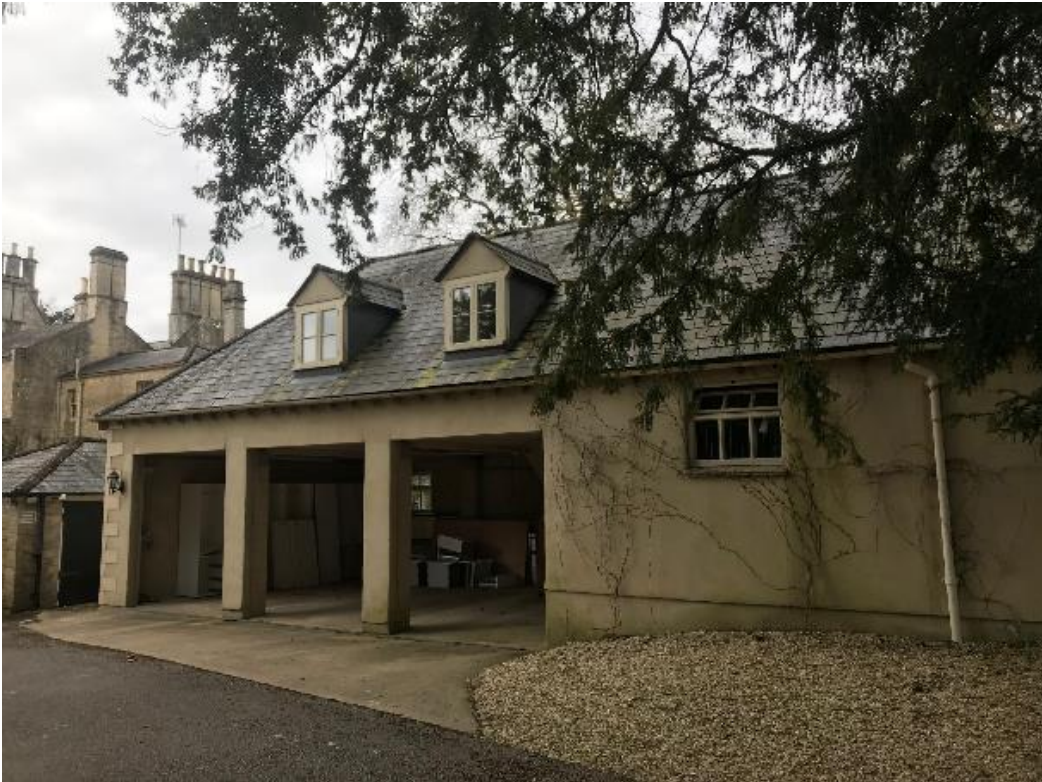
Photograph 9. The east aspect of the Stables and Grooms Flat showing the car port below the flat.

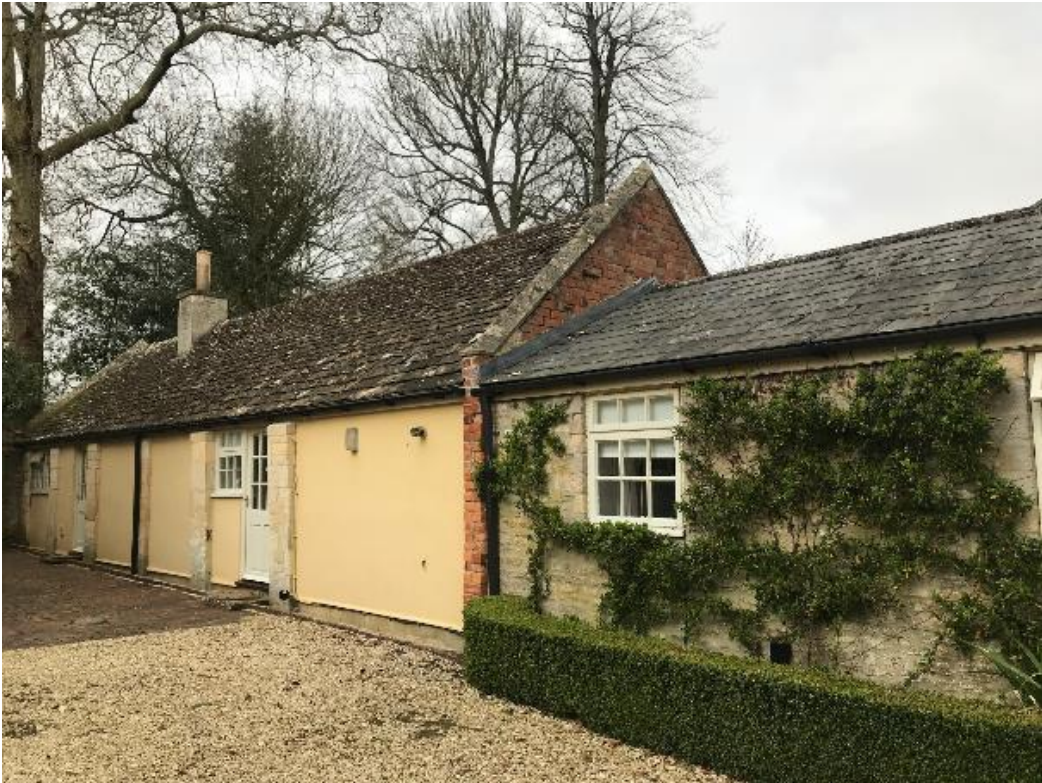
- 4.2.19 The Stable Cottage is a single-storey building, formed of two sections. The western section is has rendered stone walls and a gabled stone-tiled roof. The eastern end has stone walls with a gabled, slate-tiled roof (refer to Photograph 10, Annex 4).
- 4.2.20 There are several gaps evident under stone tiles on the western section. The slate tiles on the eastern section are in good condition and appear tight and well-sealed.

Photograph 10. The south aspect of the Stable Cottage. The area beneath the slate-tiled section contains a roof space. The stone tiles have occasional gaps beneath.

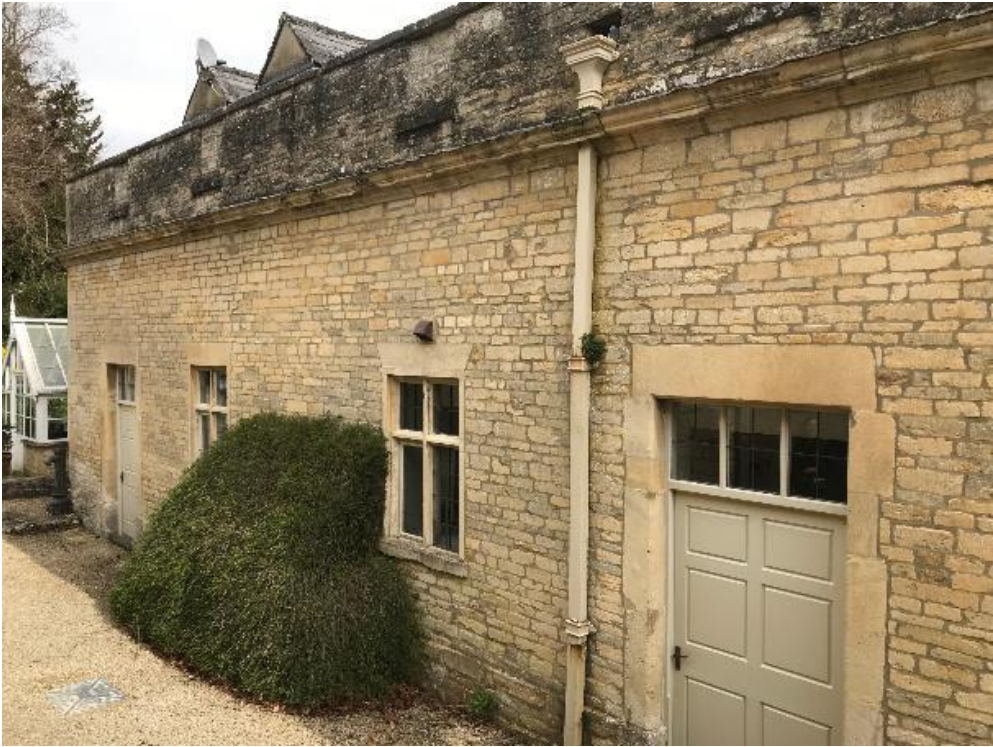
- 4.2.23 The Stone Barn is a two-storey building constructed of Cotswold stone, with stone parapets and a pitched, slate-tiled roof with dormers on the west and east aspects (refer to Photograph 11, Annex 4). The stonework is in good condition with no obvious gaps or cracks. Much of the roof could not be seen from ground level due to the parapets obstructing views, but where slate tiles were visible, these appear in good condition with gaps evident.

Photograph 11. The west aspect of the Stone Barn.

- 5.2.4 Stone Barn – This building will undergo internal alterations and roof repair/re-roofing. It is assessed as *Low* suitability to roosting bats. Therefore, **one dawn re-entry survey is recommended**. A re-entry survey of this building is preferable as there is limited views of the roof structure and bats returning to their roosts at dawn tend to exhibit swarming behaviour, which is often easier to observe.

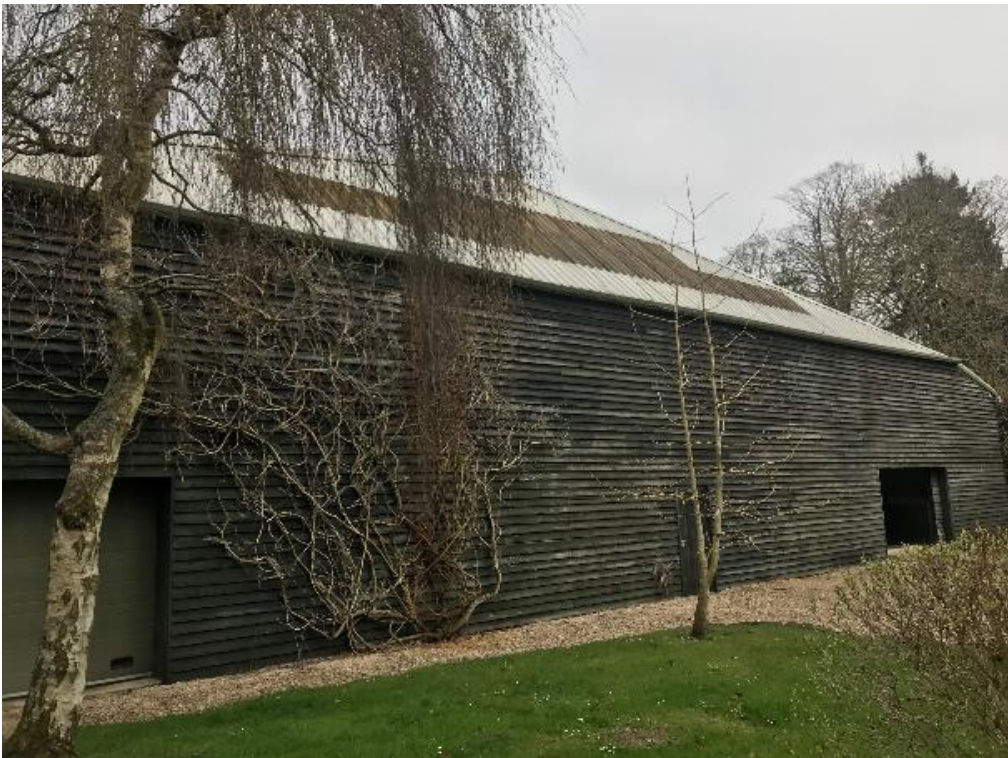
- 4.2.25 The Indoor Horse Arena is a large, steel-framed, wooden-clad structure with a corrugated metal roof (refer to Photograph 12, Annex 4). There are numerous gaps behind the wooden cladding on all aspects. Attached to the building's western elevation is a lean-to structure, also wooden-clad with windows on the east aspect. On the building's eastern elevation is an open-sided machinery store/car port. There is one large metal door on the south aspect, which provides access into the internal area of the arena.

Photograph 12. The Indoor Horse Arena.

- 5.2.5 Indoor Horse Arena – This building will be demolished. It is assessed as *Low* suitability to roosting bats. Therefore, **one dusk emergence or dawn re-entry survey is recommended**.

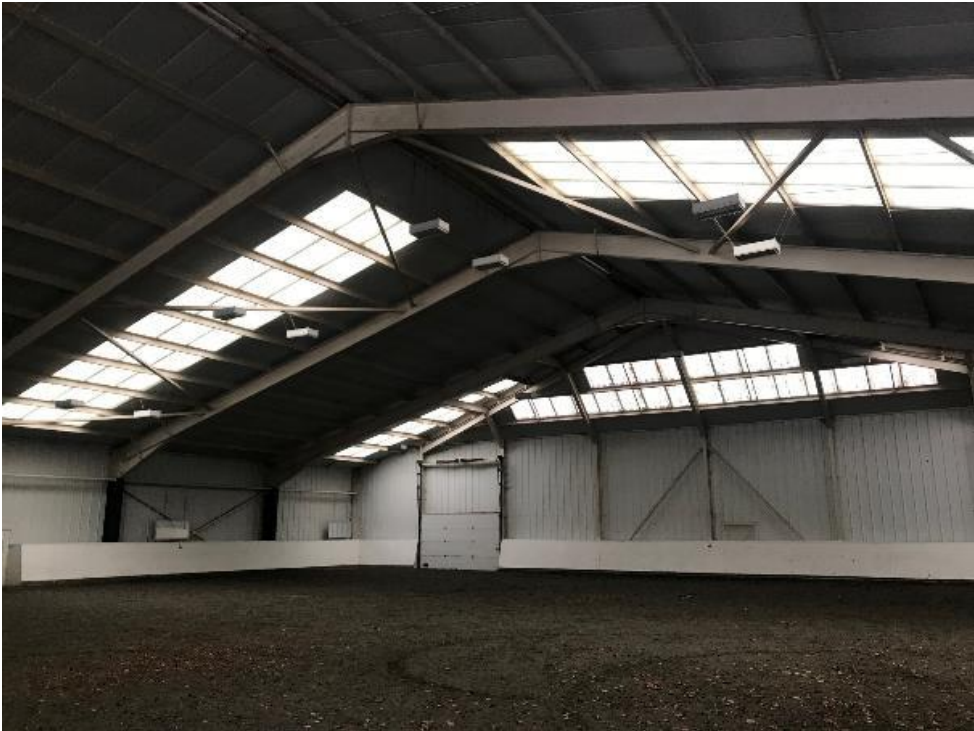
- 4.2.26 Internally, the arena is entirely open to the metal roof and the steel frame is visible (refer to Photograph 13, Annex 4). There are no enclosed spaces and no visible crevices. The interior is well-lit owing to sections of clear corrugated roof panels. One bird's nest was noted to be present on an internal beam.

Photograph 13. The interior of the Indoor Horse Arena.

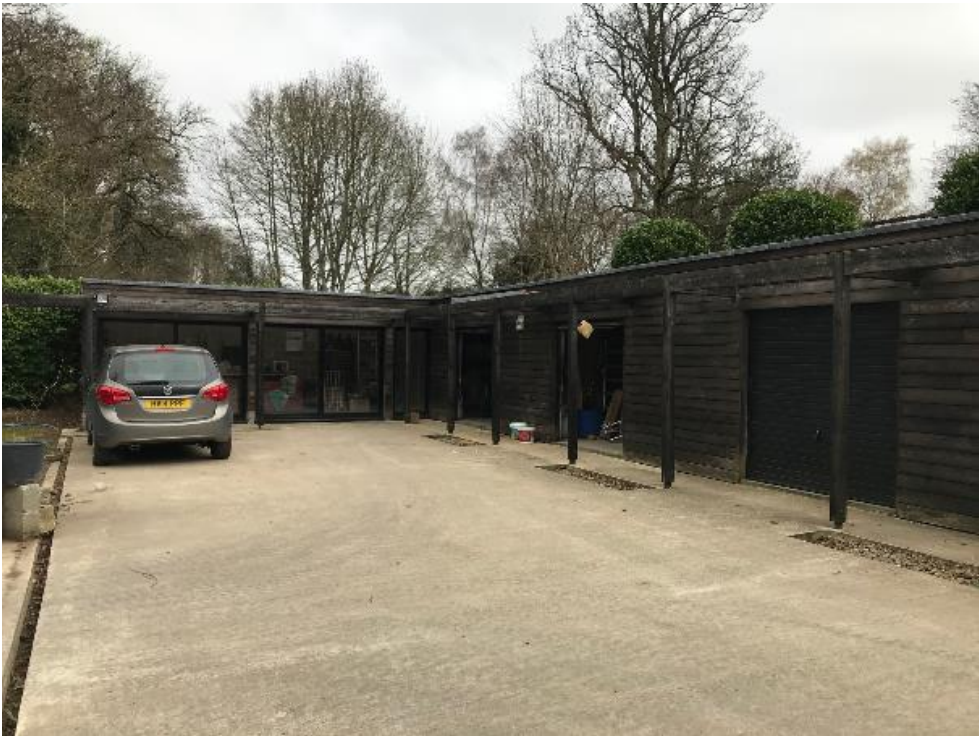
- 4.2.27 The Grounds Building is a modern, single-storey, L-shape building, located within the wider grounds of the estate away from the Main House and other ancillary buildings. It constructed of blockwork walls with wooden cladding and a flat, lead-lined, gravel roof (refer to Photograph 14, Annex 4). Two large windows are present on the east aspect and three large metal garage doors are located on the south aspect. The external wood cladding and lead-lining of the roof are tight and well-sealed.
- 4.2.28 The internal area was not accessed, but there is no enclosed roof space, all areas being living accommodation/storage.

Photograph 14. The Grounds Building.

- 5.2.6 Grounds Building – This building will be converted/modified or replaced to create a ceremony space. This building is assessed as *Negligible* suitability to roosting bats. No further surveys are recommended.
