Ampney Park

Water Vole and Otter Survey

May 2022

Client: Simon Morray-Jones Report Ref: SEB2428_04 Author: Kate Hayward MCIEEM www.seasonsecology.co.uk

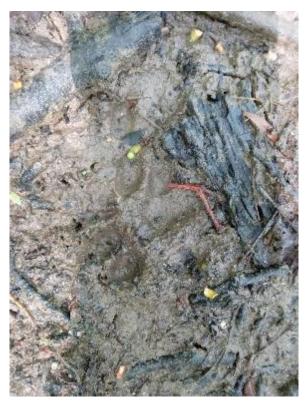
- 4.2.1 The survey area offers natural habitats for otter such as tree roots, which provide shelter and the Ampney Brook, Lake 1 and Lake 2 are known to support fish populations, providing foraging opportunities for otter. Recent signs of otter were recorded during the survey; otter prints within the mud where the eastern channel in Section C of the Ampney Brook has dried up and otter spraint in three separate locations within the south-east of the grounds.

1. Otter prints in mud along the north section of the eastern channel at Section C (Target Note 1).

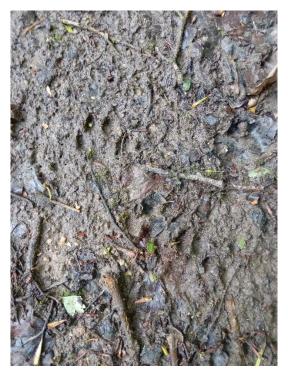
2. Further otter prints in mud along the north section of the eastern channel of Section C (Target Note 1).

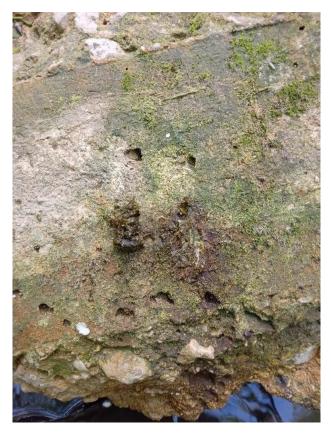
3. Otter spraint on a rock at the southern end of the eastern channel of Section C (Target Note 2).

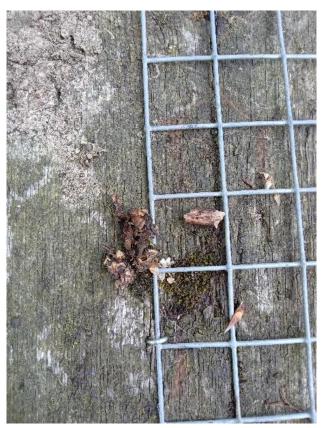
4. Otter spraint on the wooden bridge at Lake 1 (Target Note 2).
