Appendix A - Tree Schedule

Redhorn Close Poole

drawing title
TREE SURVEY PLAN

11047-T-01

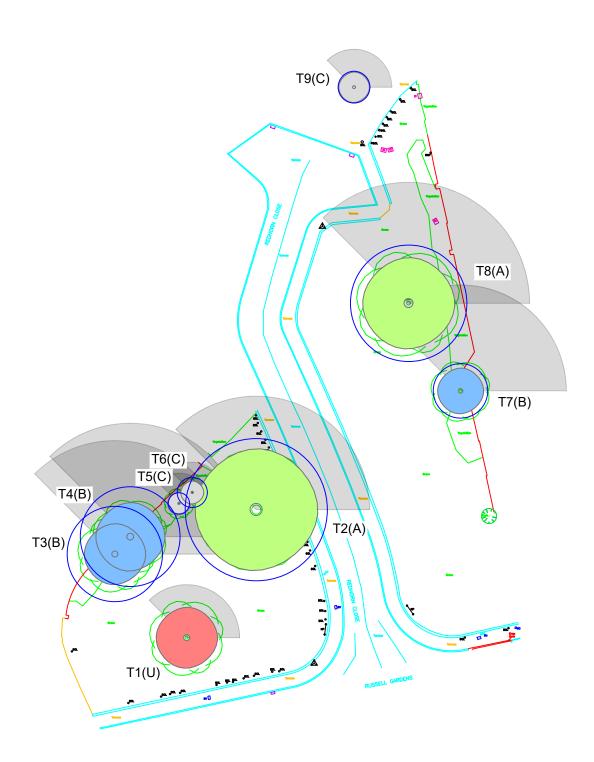
Tree No	Species	Height	Stem Dia.	Crown Radius	Age Class	Overall Condition	Structural Condition	RPA	RPA Radius	BS5837 Cat		
INDIVII	INDIVIDUAL TREES											
T1	Wild Cherry Prunus avium	7	upto 420	4	М	P/D	Two major stem cavities present on the main stem The first at 300mm about ground level 450 high and 400mm wide with heartwood exposed and associated decay present. The second at 1.7m high extending to 3.5m appears to be a included union which has decayed resulting in major decay at the union which tracks upwards on the inside of both of the stems. Canopy is 90% dead with several branches containing a small number of leaves. Recommend removal.	N/A	N/A	U		
Т2	London Plane Platanus x hispanica	15	upto 780	8	М	F	Minor dead wood evident in the crown (<75mm) Pruning wounds noted Prominent specimen located within green space. Main stem has a 10 degree lean to the east towards side road. The western canopy has lost a major branch leaving a large dent in the shape of the canopy. Some dead branches are present directly above the area of damage. Canopy height of 0.5m on southern and western aspects and 1.2m over the footpath.	275	9.4	A (i)

Т3	Leyland Cypress Cupressocyparis leylandii	15	upto 400 340	4	М	F	Located along the northern site boundary c.300m south of brick wall. Interlocking canopies with T4 Crown lifted to a height of 5m Twin stemmed from 1m	125	6.3	B (ii)		
T4	Leyland Cypress Cupressocyparis leylandii	15	upto 550	4.5	М	F	Located along the northern site boundary c.300m south of brick wall. Interlocking canopies with T3 Crown lifted to a height of 2m Stem divides at 1.8m into 4 stems of equal diameter of 250mm.	137	6.6	B (ii)		
T5	Cotoneaster Cotoneaster frigidus	4	upto 100 70	1.5	EM	Р	Specimen located along northern boundary c.1.2m south of brick wall. Specimen has a number of poor pruning wounds and a sparse poorly formed canopy.	7	1.5	C (ii)

Tree No	Species	Height	Stem Dia.	Crown Radius	Age Class	Overall Condition	Structural Condition		RPA Radius	BS5837 Cat
Т6	Cotoneaster Cotoneaster frigidus	4	upto 120 110	1.5	EM	Р	Specimen located along northern boundary c.1.2m south of brick wall. Specimen has a number of poor pruning wounds and a sparse poorly formed canopy.	12	2.0	C (ii)
Т7	Silver Birch Betula pendula	14	upto 300	3	М	F	Pruning wounds noted Typical form specimen situated 0.5m west of brick wall. Pendula branches hang to 1.2m above ground level.	41	3.6	B (ii)
Т8	Hornbeam Carpinus betulus	16	upto 640	6	М	G	Minor dead wood evident in the crown (<75mm) Pruning wounds noted Prominent specimen located within green space Canopy height of 2m Multi-leadered form from 2.2m Dense canopy. Rope swing and basic tree house has been installed within the tree. The swing has lead to an area of compacted grass less ground on the south eastern aspect of the tree with some bark damage to the main stem.	185	7.7	A (i)

Т9	Hawthorn Crataegus monogyna	5	upto 150 70 40	2	EM	F	Situated with grassed area between two footpaths. Three stemmed from ground level Unremarkable specimen.	13	2.0	C (ii)
