**MEETING HALL, COLES GARDEN,
KILMERSDON, SOMESSET**

PROTECTED SPECIES SURVEY

Final Report

16th October 2023

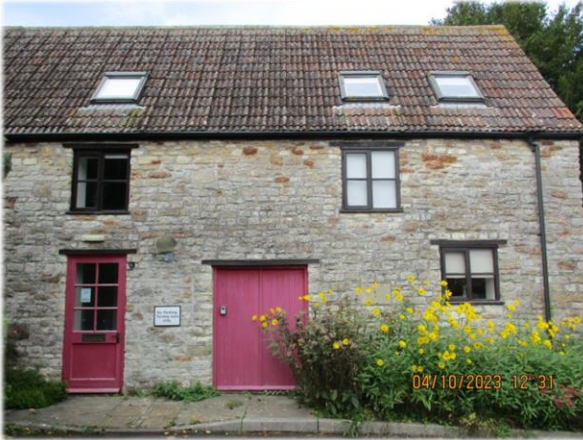
Front, southeast-facing building elevation (left) with one missing roof tile to immediate right of roof window (right)

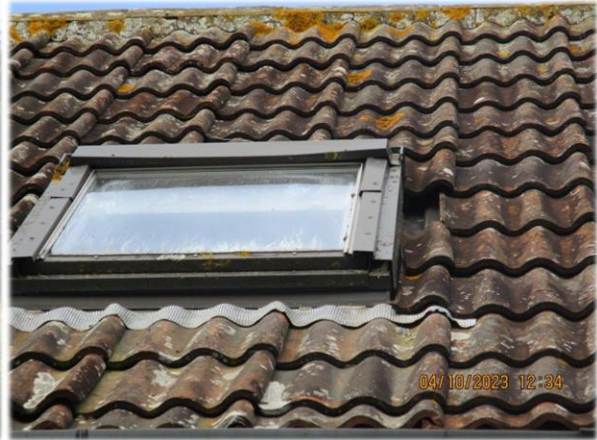
There is one missing roof tile adjacent to the northern-most roof window, which leaves a gap under the remaining roof tile above it. However, this gap was inspected and was classed as being sub-optimal for supporting bats as it was large/open and will be draughty.

The building is generally totally unsuitable for supporting roosting bats as there are no optimal external gaps and no internal gaps/hidden voids (or access into the building interior) that bats could potentially exploit. The external gaps under the narrow barge boards are unsuitable for roosting bat being very small/shallow (<2" deep) and exposed/in shade but were nevertheless fully inspected for signs of bats. The single gap associated with the missing tile is sub-optimal for roosting bats being large/open but was visually inspected for signs of bats.

No specific mitigation for the protection of bats is necessary for this proposed development. However, for replacement of the missing roof tile the following precautionary action should be implemented to ensure complete protection of bats:

- ❖ Preferably replace the roof tile between September and April inclusive (i.e. not within May-August to avoid the main summer period for bats).
- ❖ If the roof tile is replaced during May to August then a precautionary Reasonable Avoidance Method Statement (RAMS) should be defined and issued to the contractor, which is likely to include a pre-inspection by a Natural England licenced bat handler to ensure no bats are present.

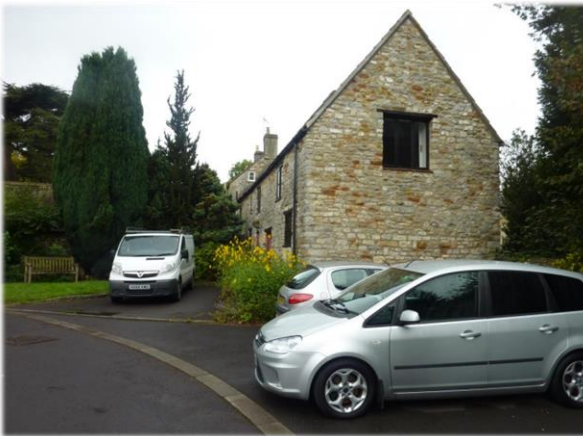
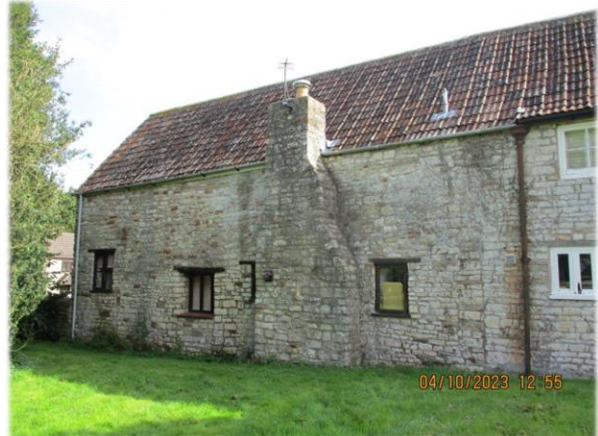
Side, northeast-facing gable end elevation and immediate surrounding land (left) and rear, northwest-facing elevation (right)

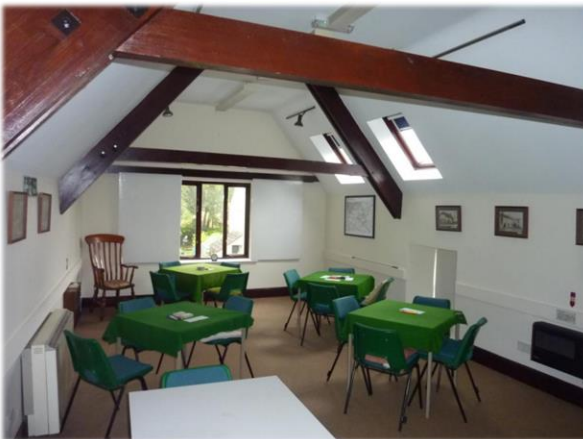
The interior of the building is completely sealed with all areas used by people for meetings or for associated facilities such as kitchen or toilets. The upper room has a vaulted ceiling and there is no enclosed roof / attic space. There are no opportunities for bats or other wildlife associated with the building interior.

First floor interior (left) and mown grass to rear of building in Church cemetery (right)
