**INTERNAL  
ALTERATIONS, NOS. 55-  
57 HAILGATE, HOWDEN**

**HERITAGE STATEMENT**

December 2021

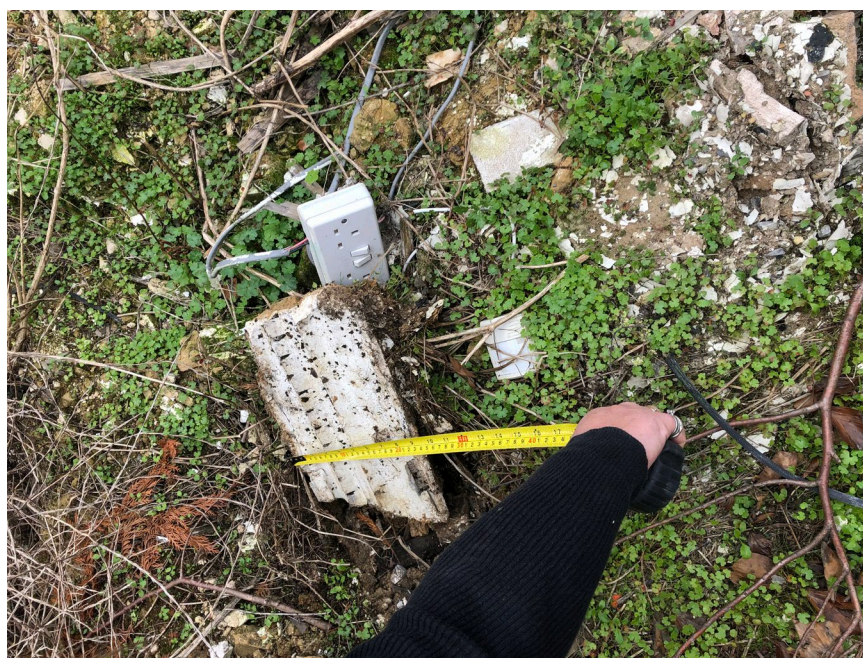
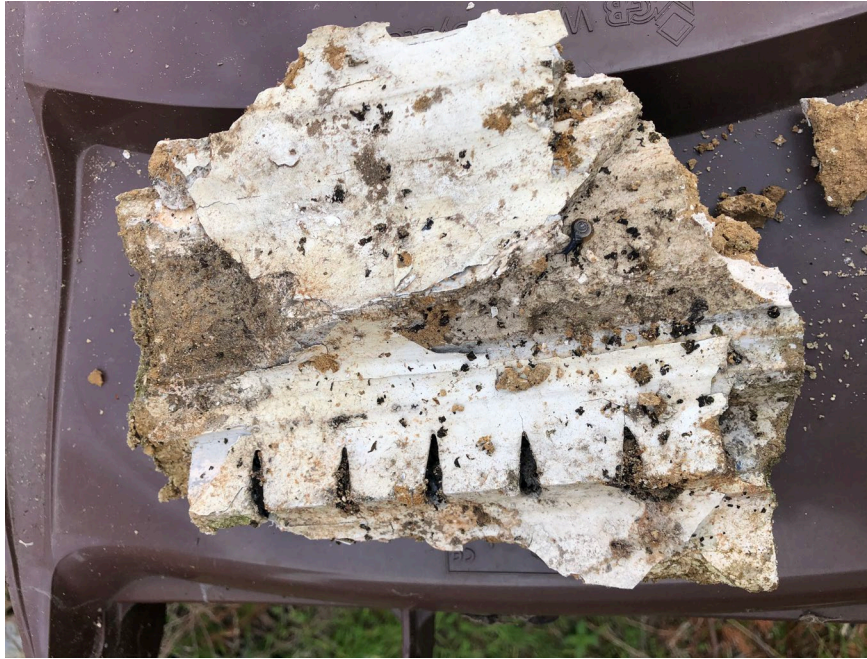
Photo 5: Cornice fragment retrieved from spoil heap

Photo 6: Fragment of cornice found in spoilheap

Removal of cornice	<p>Reinstate cornice as detailed on SK008 which reflect the fragments of cornice recovered from site and photographic evidence (Photo 5 and 6).</p>	<p>Whilst there has been harm to significance of the listed building due to loss of historic fabric, this will be mitigated by reinstatement of plaster cornice with matching detail.</p>
<i>Room 1.2</i>		
Removal of lath and plaster ceiling	<p>The historic fabric has been removed and it is proposed to provide and install new fireline plasterboard to comply with building regulations (lath and</p>	<p>The lath and plaster ceilings have limited significance, making a limited aesthetic contribution to the listed building.</p>

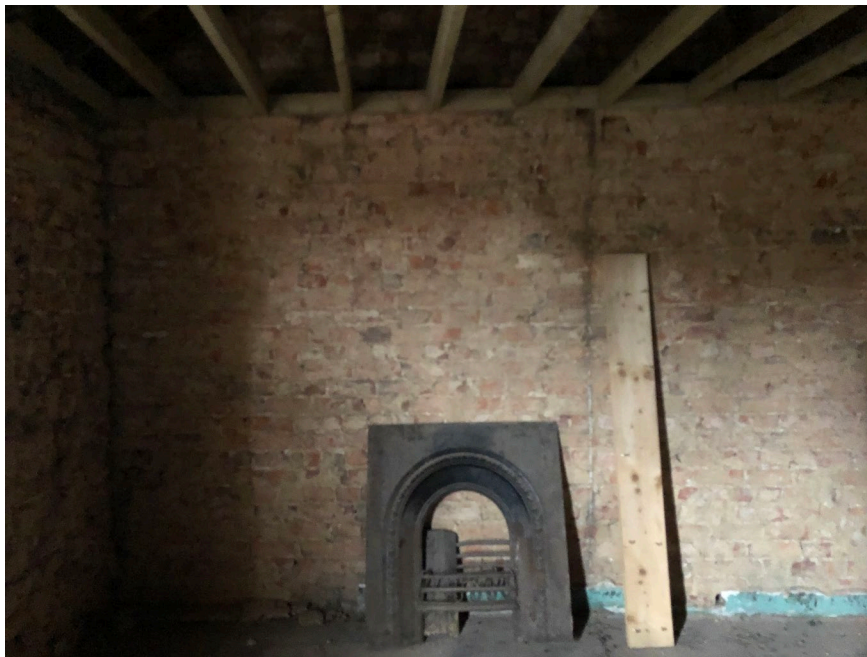
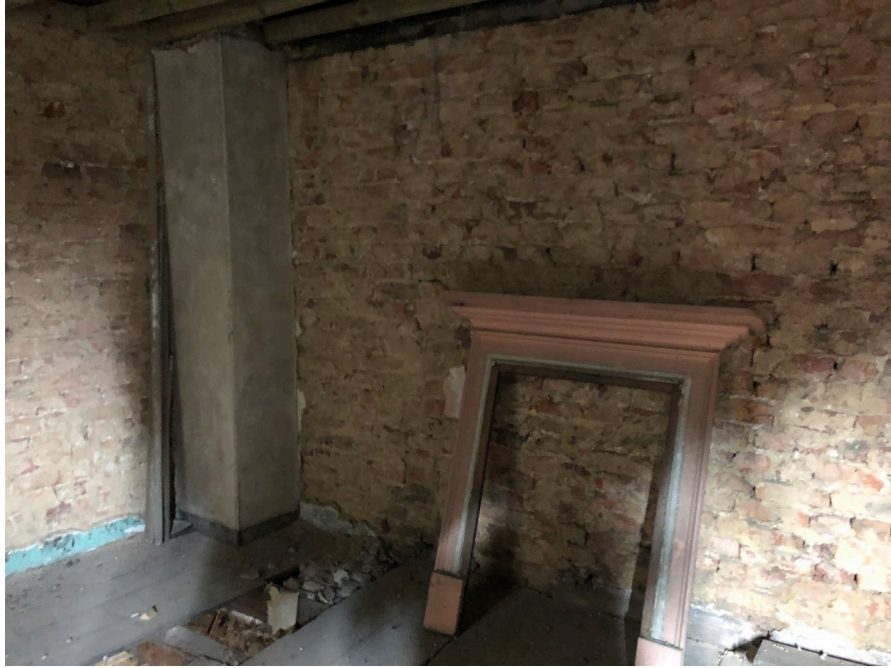
Photo 7: Fire grate in storage

Photo 8: Fire surround in storage

Removal of fireplace	Reinstate fireplace as approved plans (Photos 7 and 8)	<p>The fireplace is still on site and will be re-fitted.</p> <p>There will be no impact on significance, as this is reinstatement of an historic feature.</p>
Removal of lath and plaster ceiling	The historic fabric has been removed and it is proposed to provide and install new fireline plasterboard to comply with building regulations.	The lath and plaster ceilings have limited significance, making a limited aesthetic contribution to the listed building.

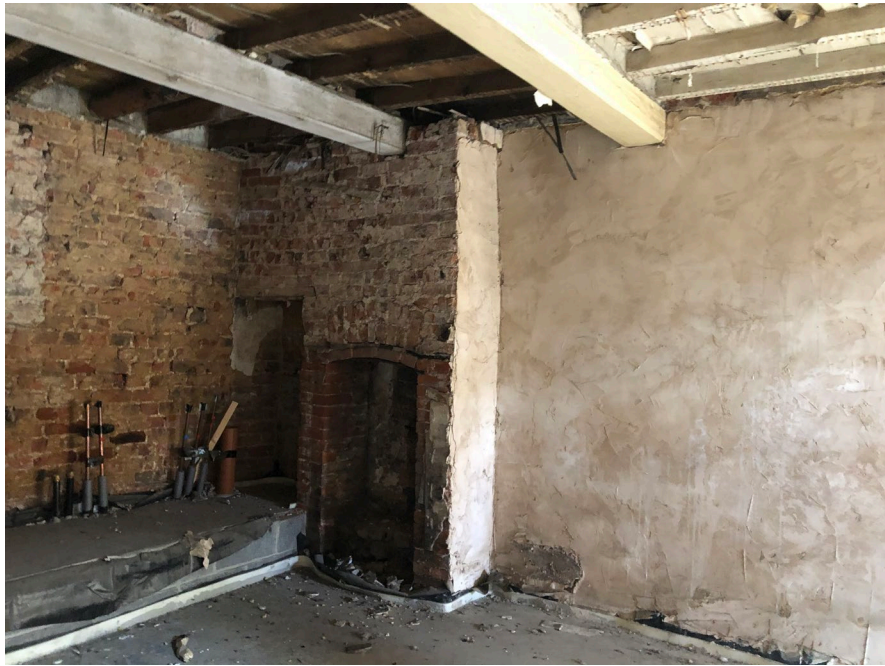
Photo 9: Chimney breast to be retained

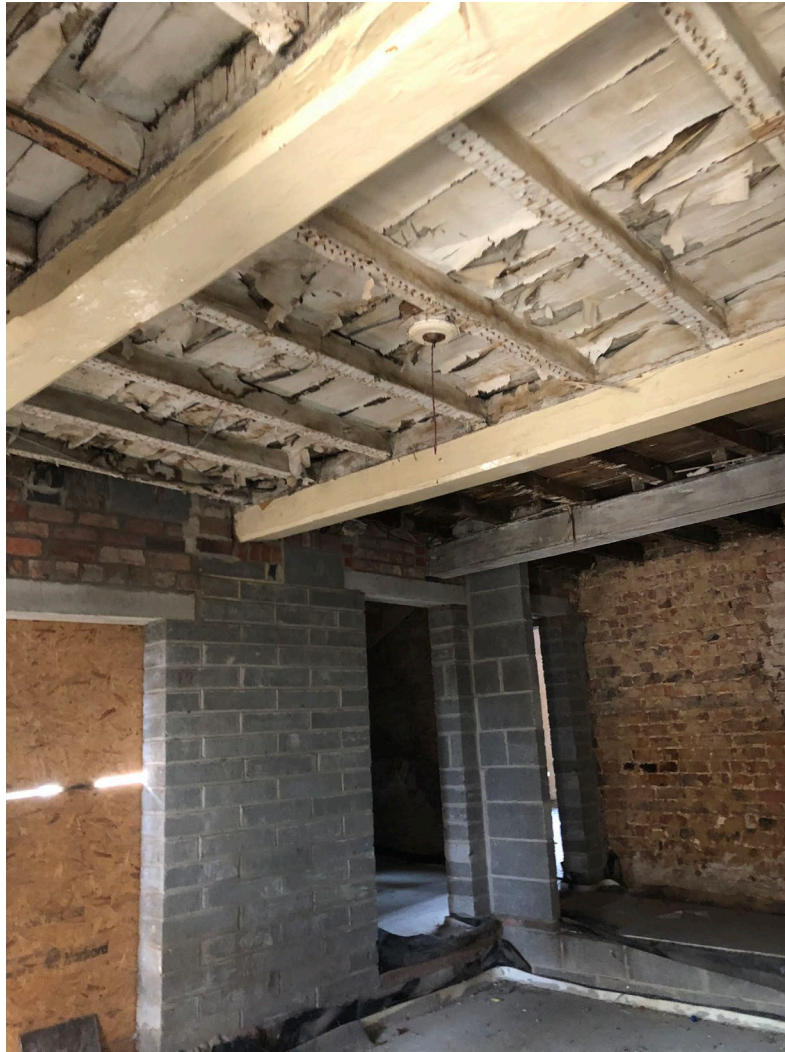
Photo 10: Painted underside of first floor

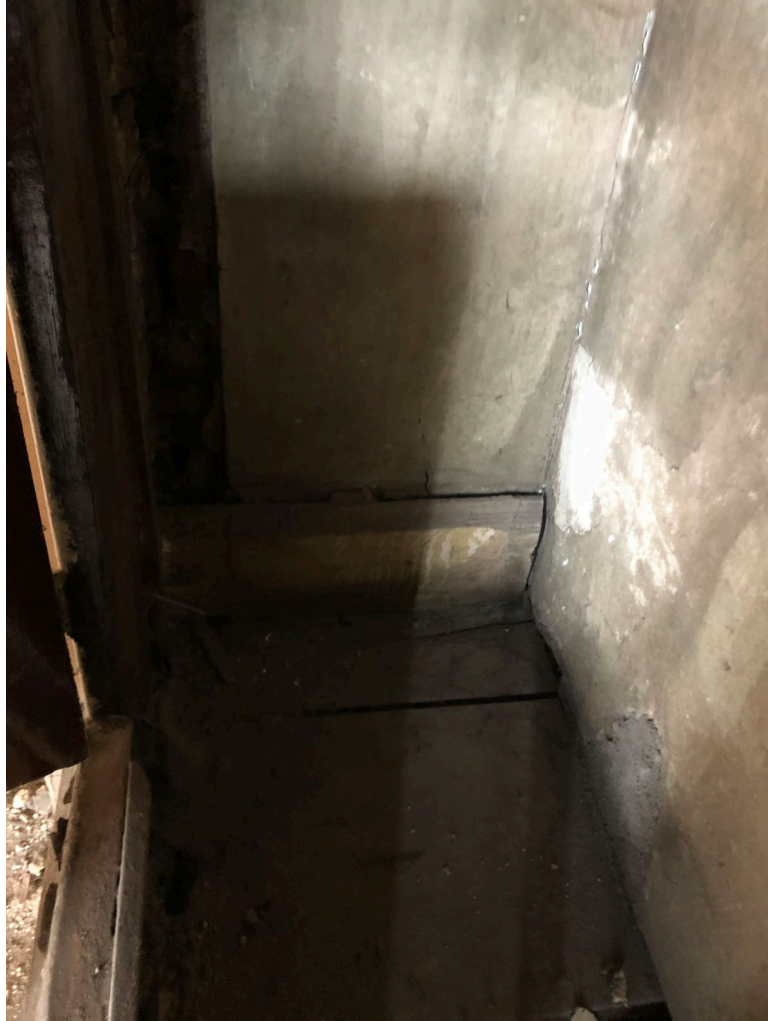
Photo 11: Surviving skirting on first floor

<i>Room 1.1</i>		
Removal of skirtings, architraves and doors	<p>Skirtings to be reinstated as original (Photo 11).</p> <p>Existing door has been removed from site. Proposed new door, and architraves (of fire door FD30) to be provided in the same style as the original ground floor doors (6 panel), as details on</p>	<p>Whilst there has been some harm to the significance of the listed building, due to the loss of historic fabric, this is mitigated by the reinstatement of matching skirtings, architraves and door.</p>

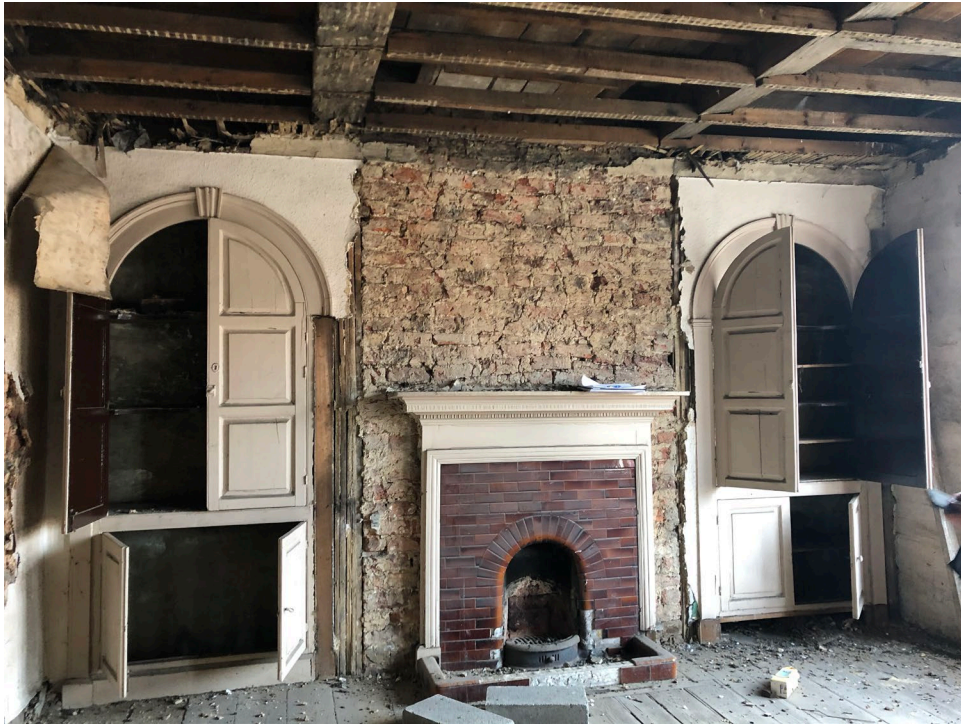
Photo 12: Surviving cupboards on first floor

<p>MAC SK001 and SK004.</p> <p>The cupboards to either side of the chimney breast remain in situ and it is proposed to repair/replace any damaged/missing detail (Photo 12).</p>	
Removal of lath and plaster ceiling	<p>The historic fabric has been removed and it is proposed to provide and install new fireline plasterboard to comply with building regulations (lath and plaster would not comply)</p>	<p>The lath and plaster ceilings have limited significance, making a limited aesthetic contribution to the listed building.</p> <p>Due to both the difficulty in achieving the necessary fire resistance with lath and plaster ceilings and the associated cost, the proposal is to line the ceiling with fireline board with a plaster skim.</p> <p>As noted below, the plaster cornice will be reinstated around the perimeter of the room, which will restore the visual appearance of the room.</p> <p>It should be noted that the 2017 application allowed for the provision of new plasterboard ceilings on the second floor.</p>
