3 St Thomas Court WN8 ONE.

Supporting evidence on the continued maintenance of the building.

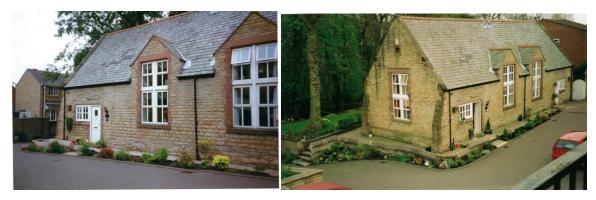
The front door now (2023)

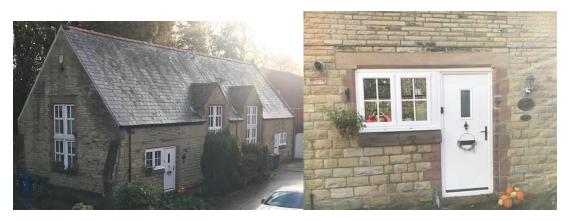
The new front door and window, installed in 2023.

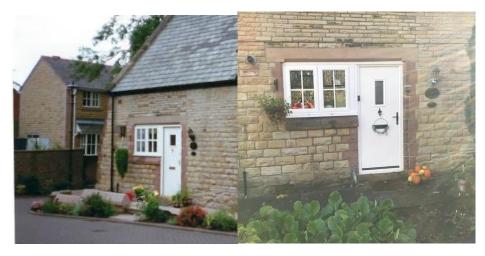
The door and window 1999 and 2023 side by side

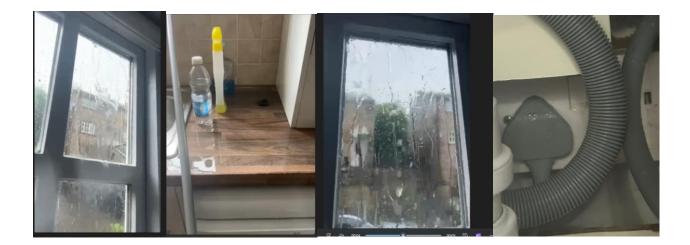
The issues that led to the door and window needing emergency attention

The severe storms in June 2023 really hit this elevation of the house. They were a freak of nature and will probably never be repeated. For the kitchen window in 3 St Thomas Court this completely failed and as you can see from the photographs water was streaming into the building

The double-glazed window failed, and the kitchen was flooded.

The occupant of the house at the time suffered an electrical shock.

- 1. Electrical failure an insurance claim was filed, and an emergency electrician was called to make safe and to give instructions as to how to fix the issue.
- 2. On their advice we also called the builder Peter Finch of Croftland Building Services (07932058661). Peter and his team have completed work on this property many times over the last 10 years. They know the building intimately. Their diagnosis was that the window needed replacing as soon as possible.

- 3. This also meant that there needed to be a new front door as they are all one piece. It is not possible to change just the window. As a side issue the front door was also in a poor state of repair, despite always being maintained with Dulux Weathershield Paint it was very warped and sticking in the frame.

- 4. On advice and consultation, it was decided to install upvc window and doors.
 - a. This was the quickest option; these windows were available to be custom made in the style from when the building was converted in 3 weeks as opposed to a minimum of 8- 12 weeks for wood. It was of utmost importance that we kept the same style of front door and window design that was used in the original conversion. This meant that the window and door would have to be made specially for this property.

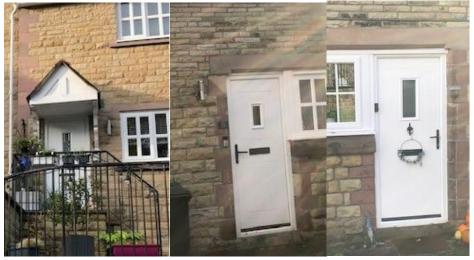
This is the only original front door No 4 St. Thomas Court. This is the style of the doors when the houses were converted and built.
