# Contaminated Land Phase One Desk Study for Whalleys Farm, Preston Road, Charnock Richard, PR7 5HR.

January 2021

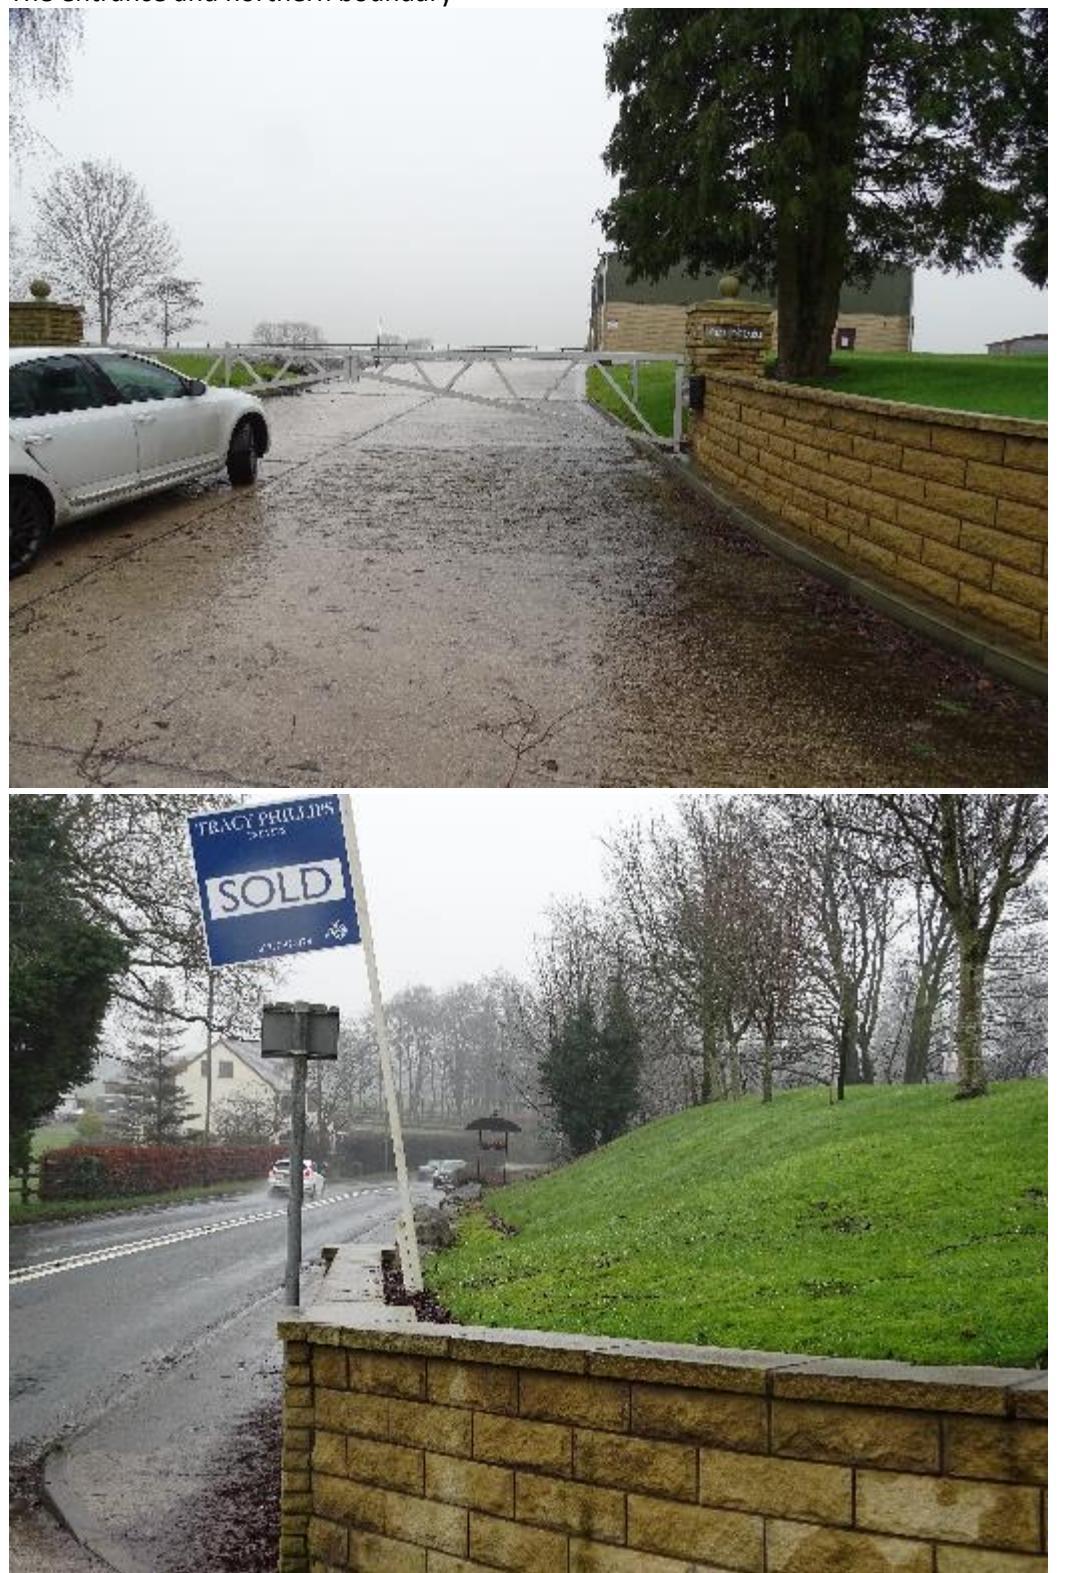
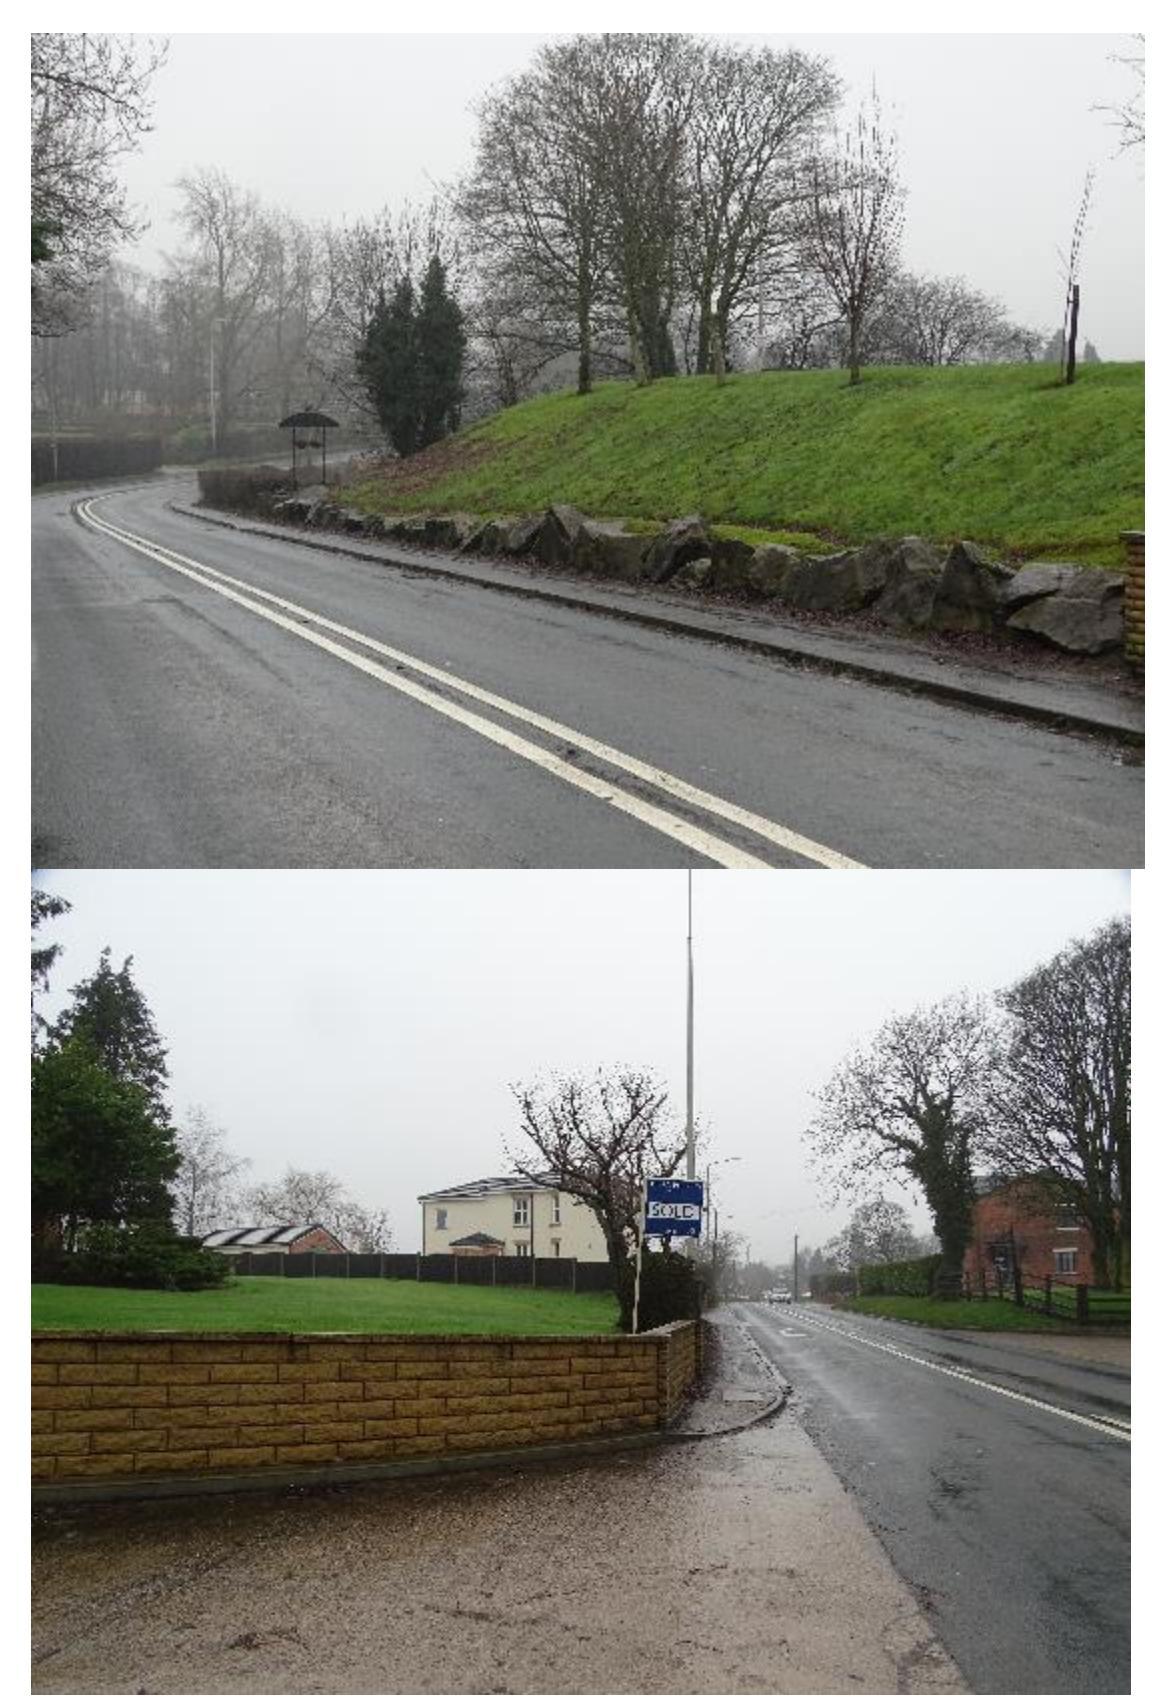
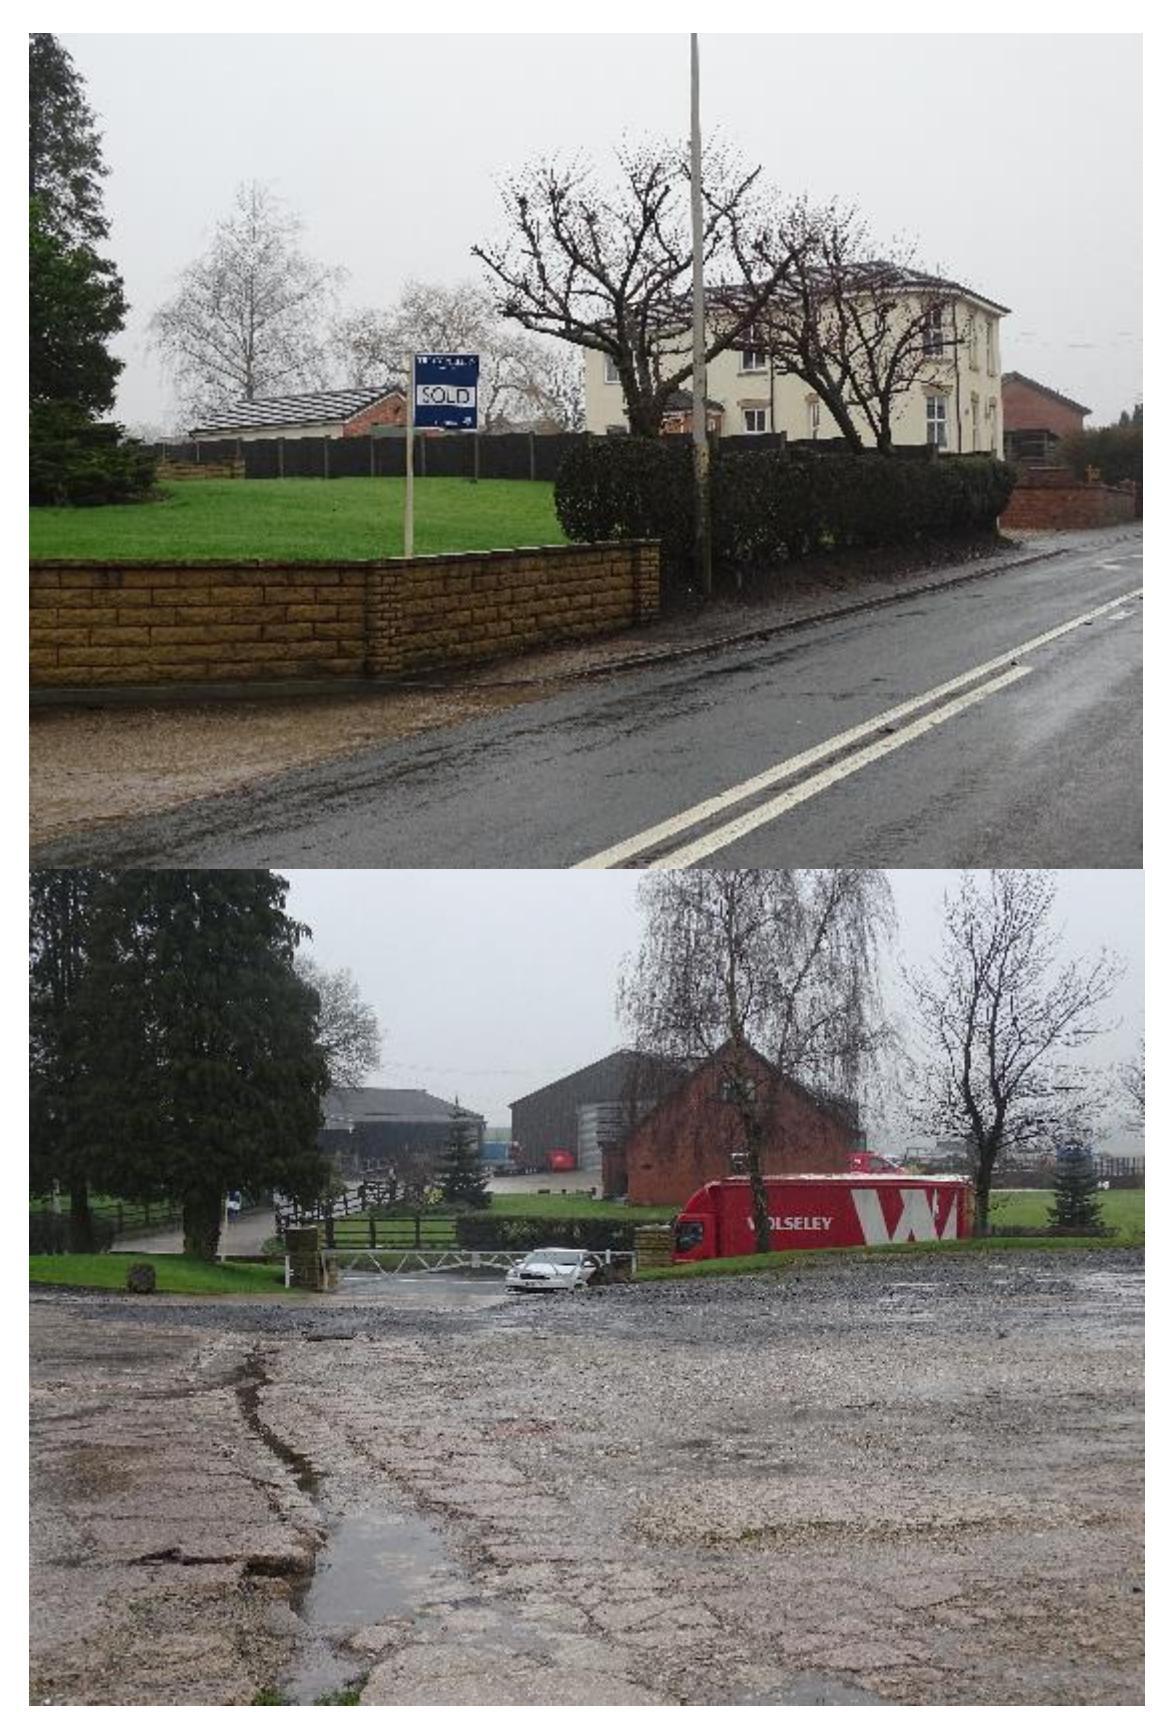
The entrance and northern boundary

The site is accessed from the main road to the north of the site, by a concrete drive. It is significantly higher than the road and surrounding land to the east but roughly the same level as the fields to the south and the property to the west.

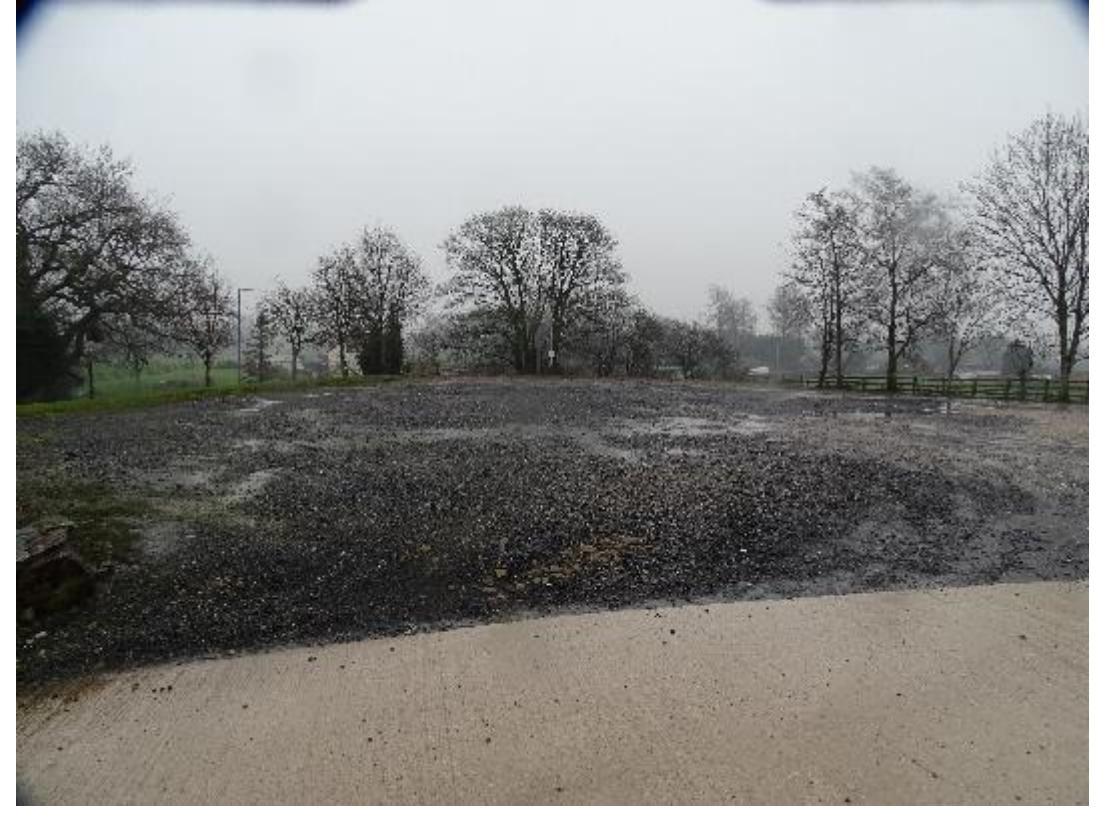
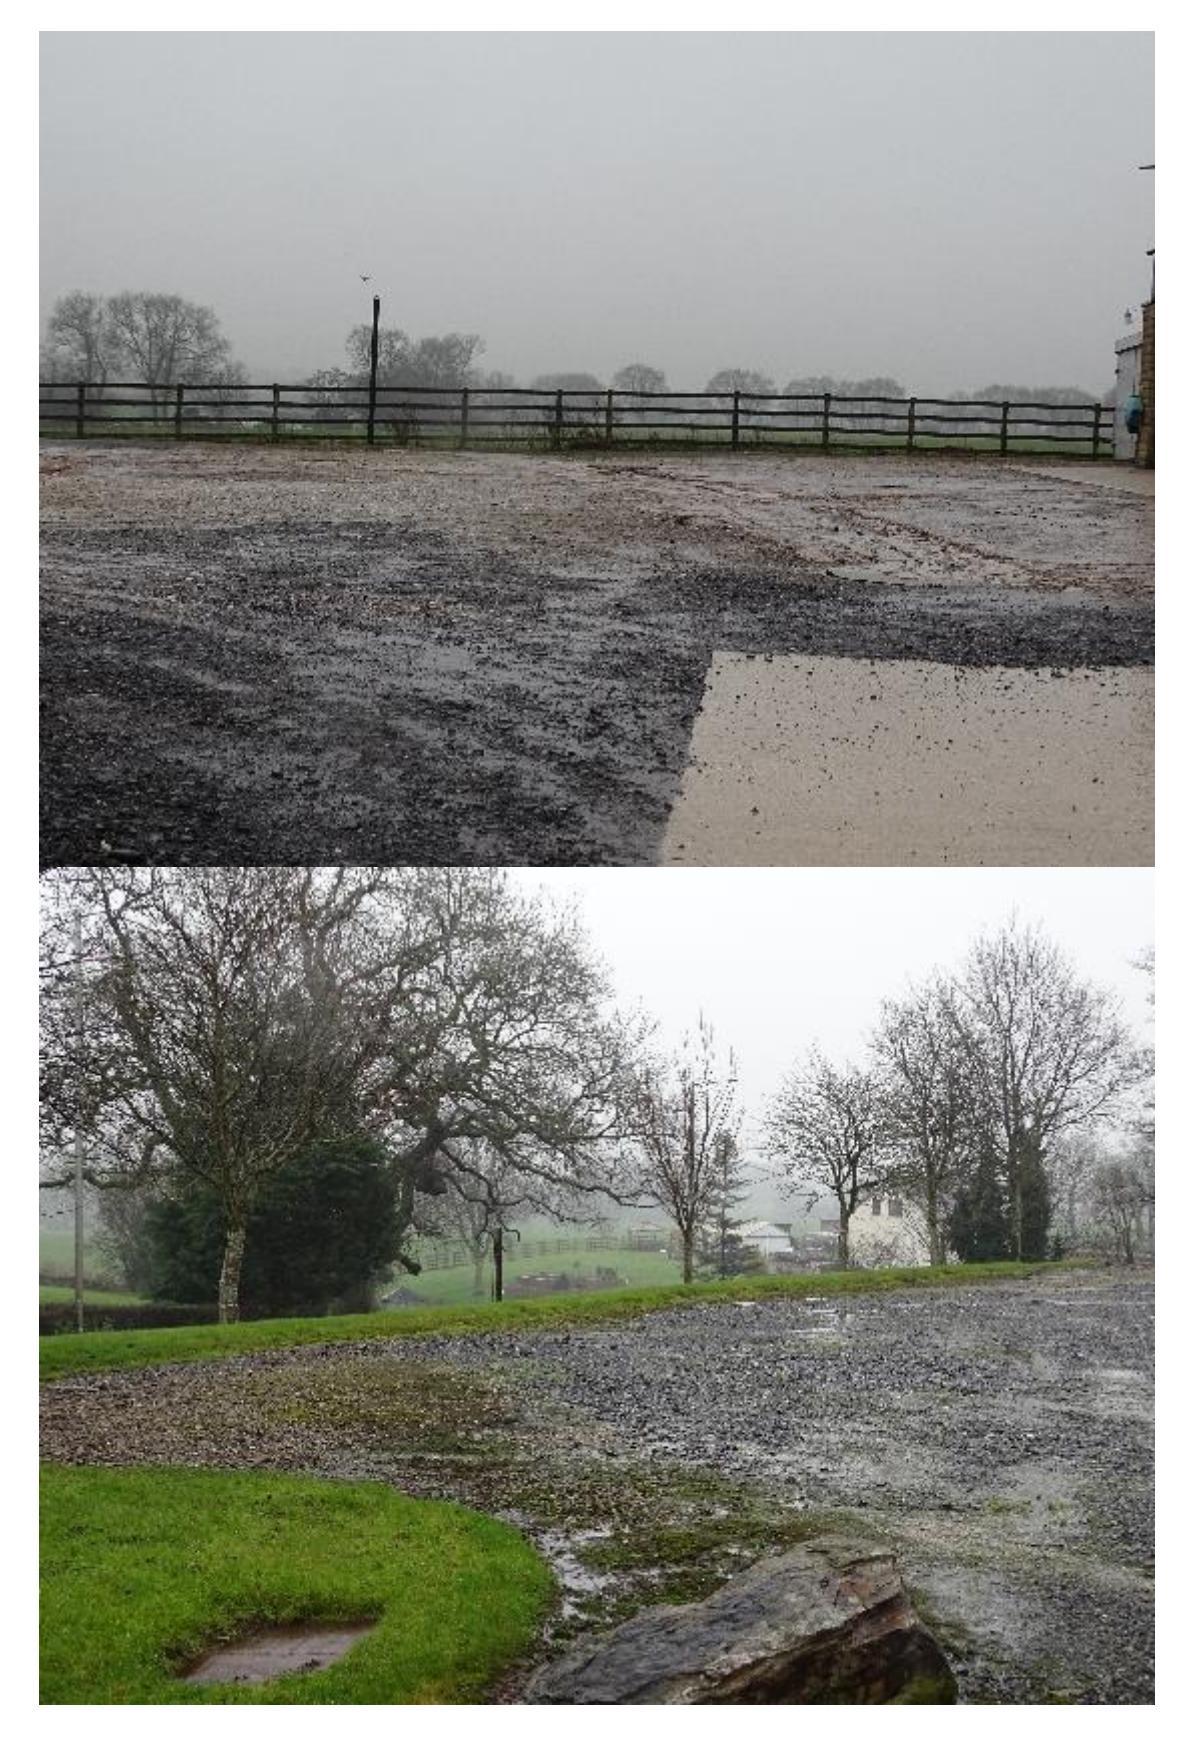
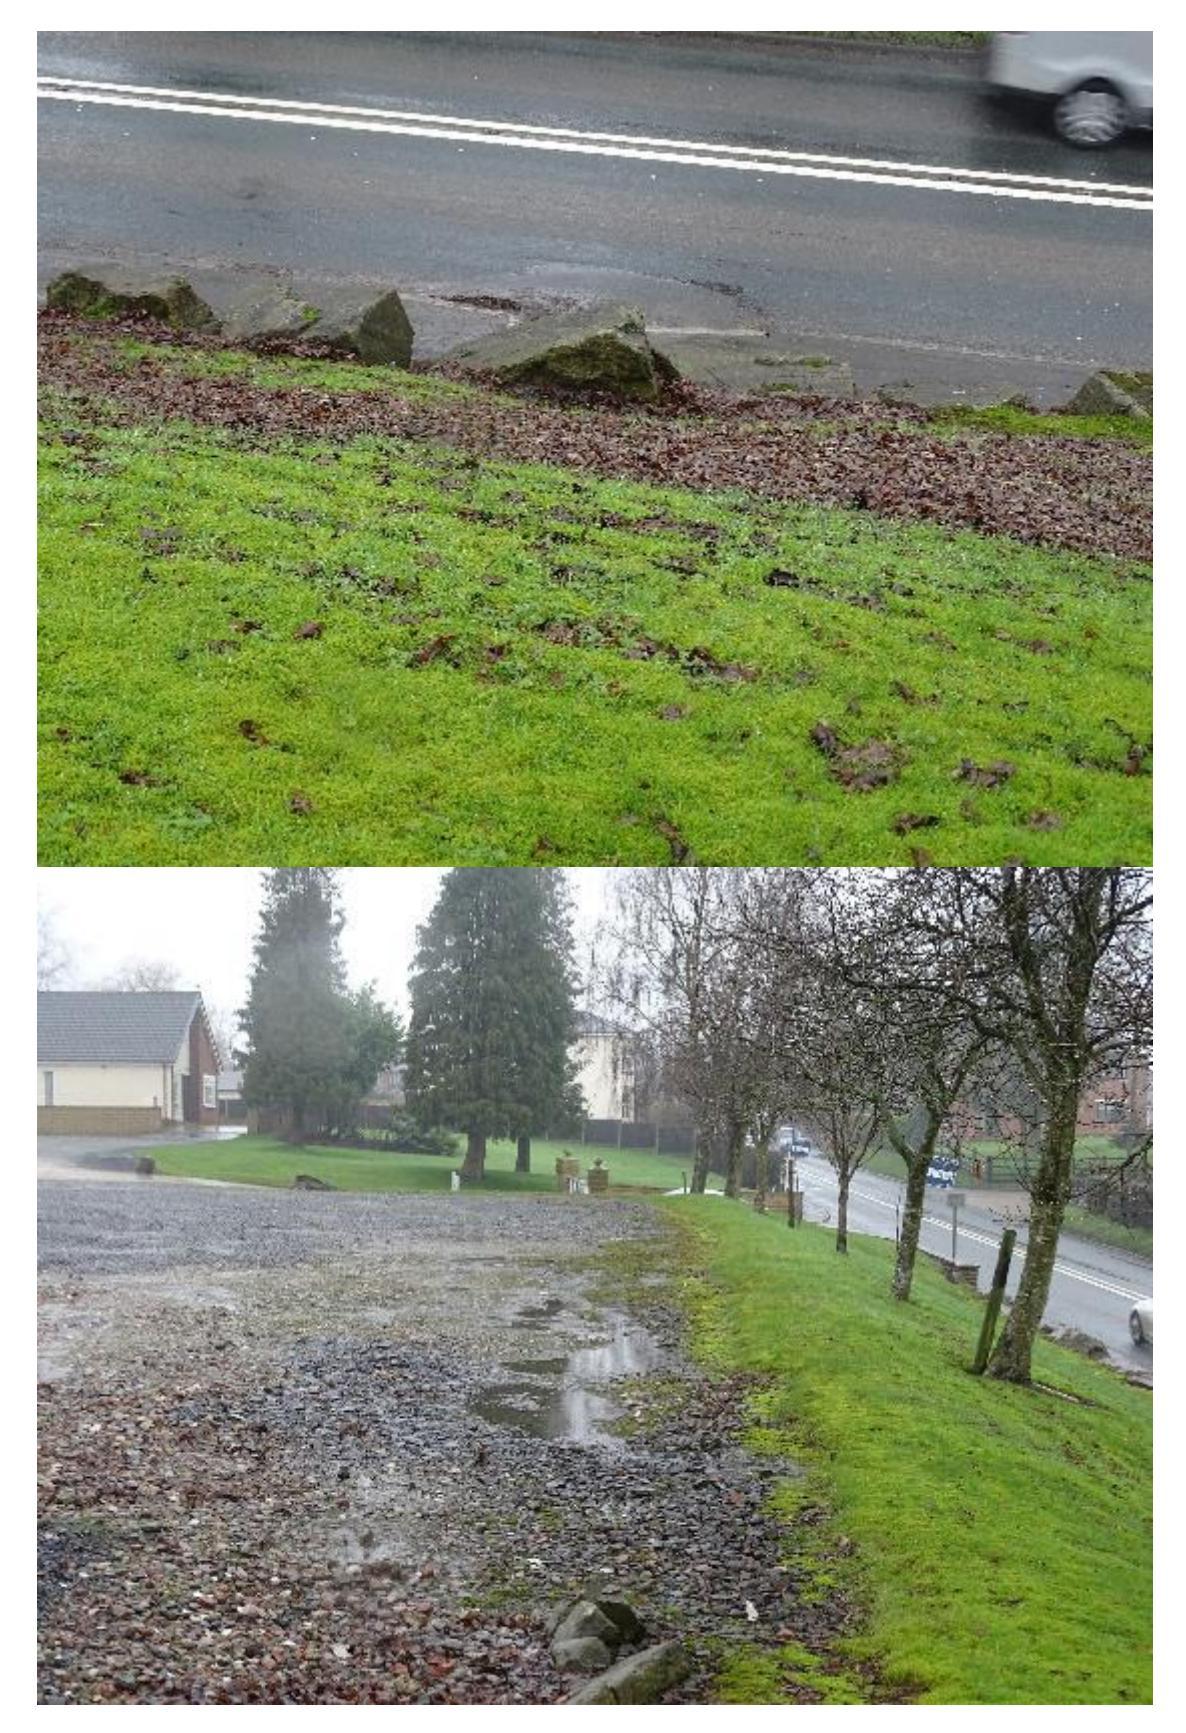
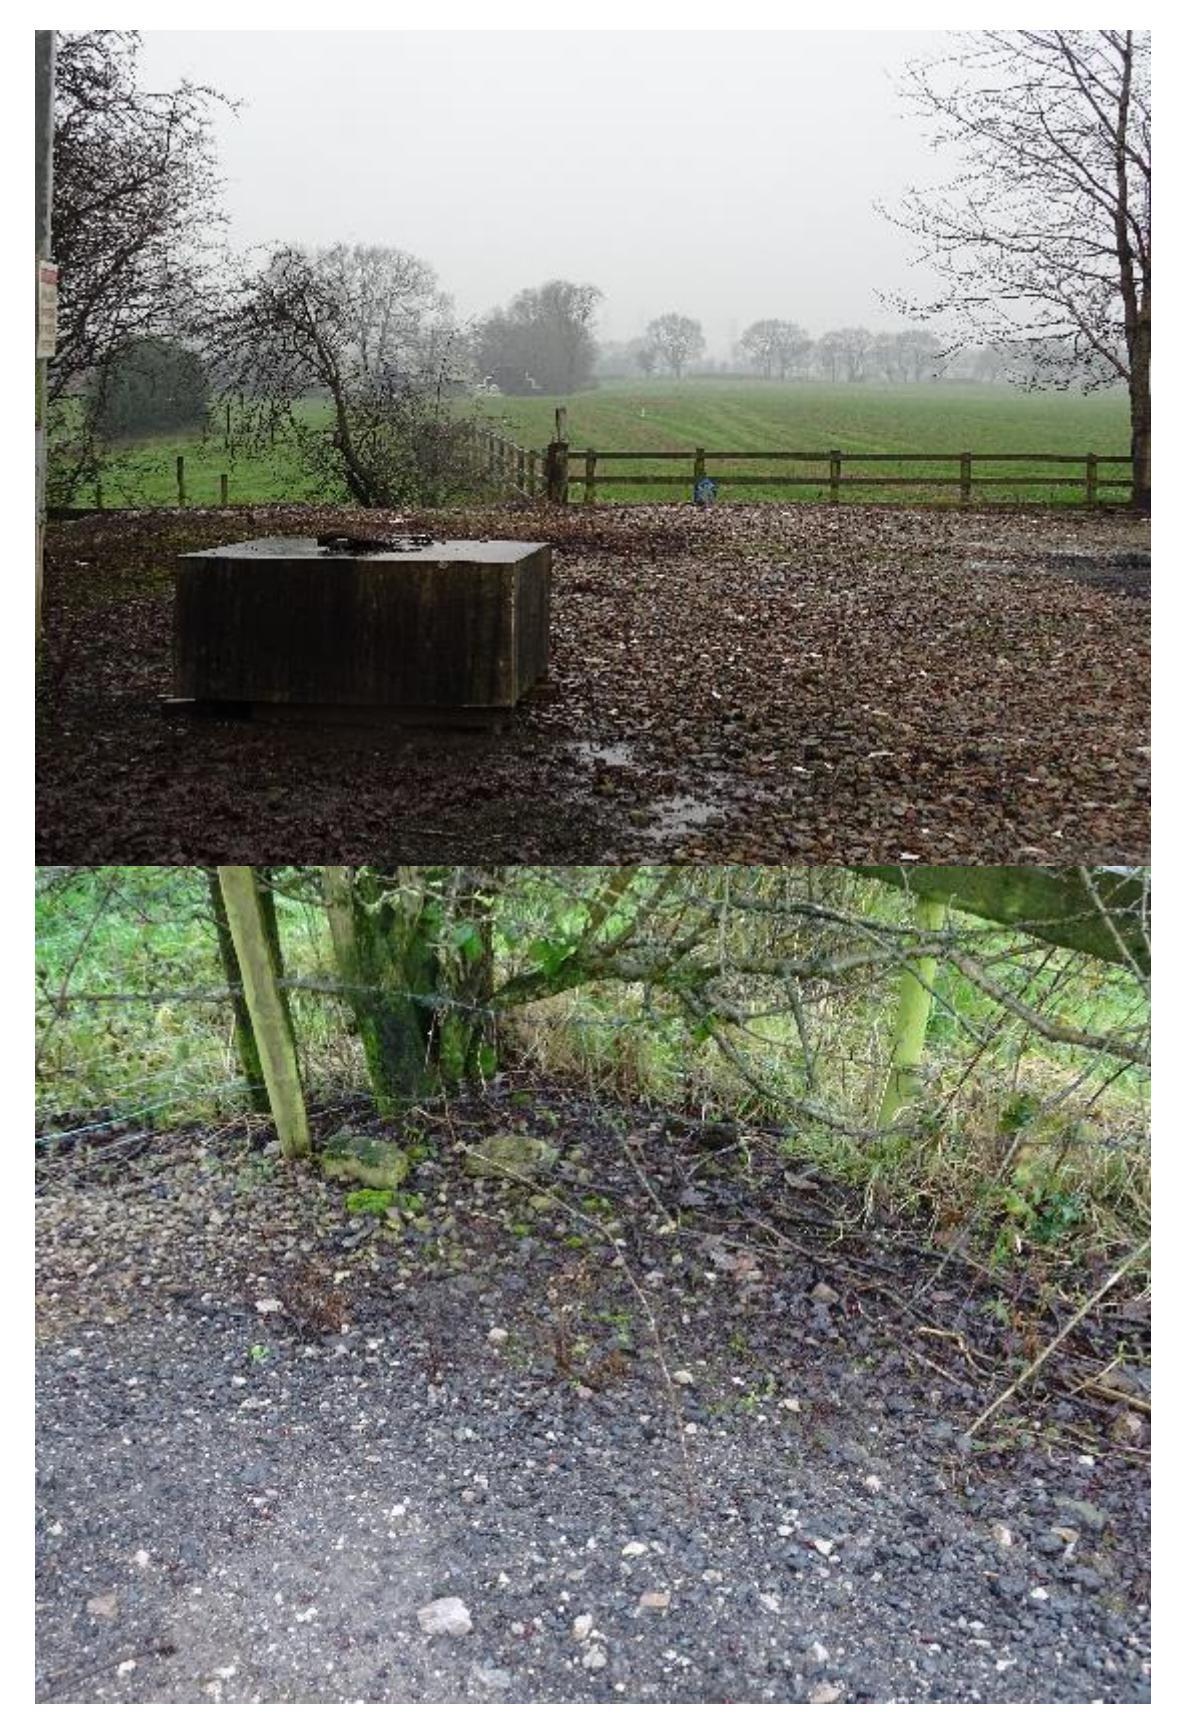
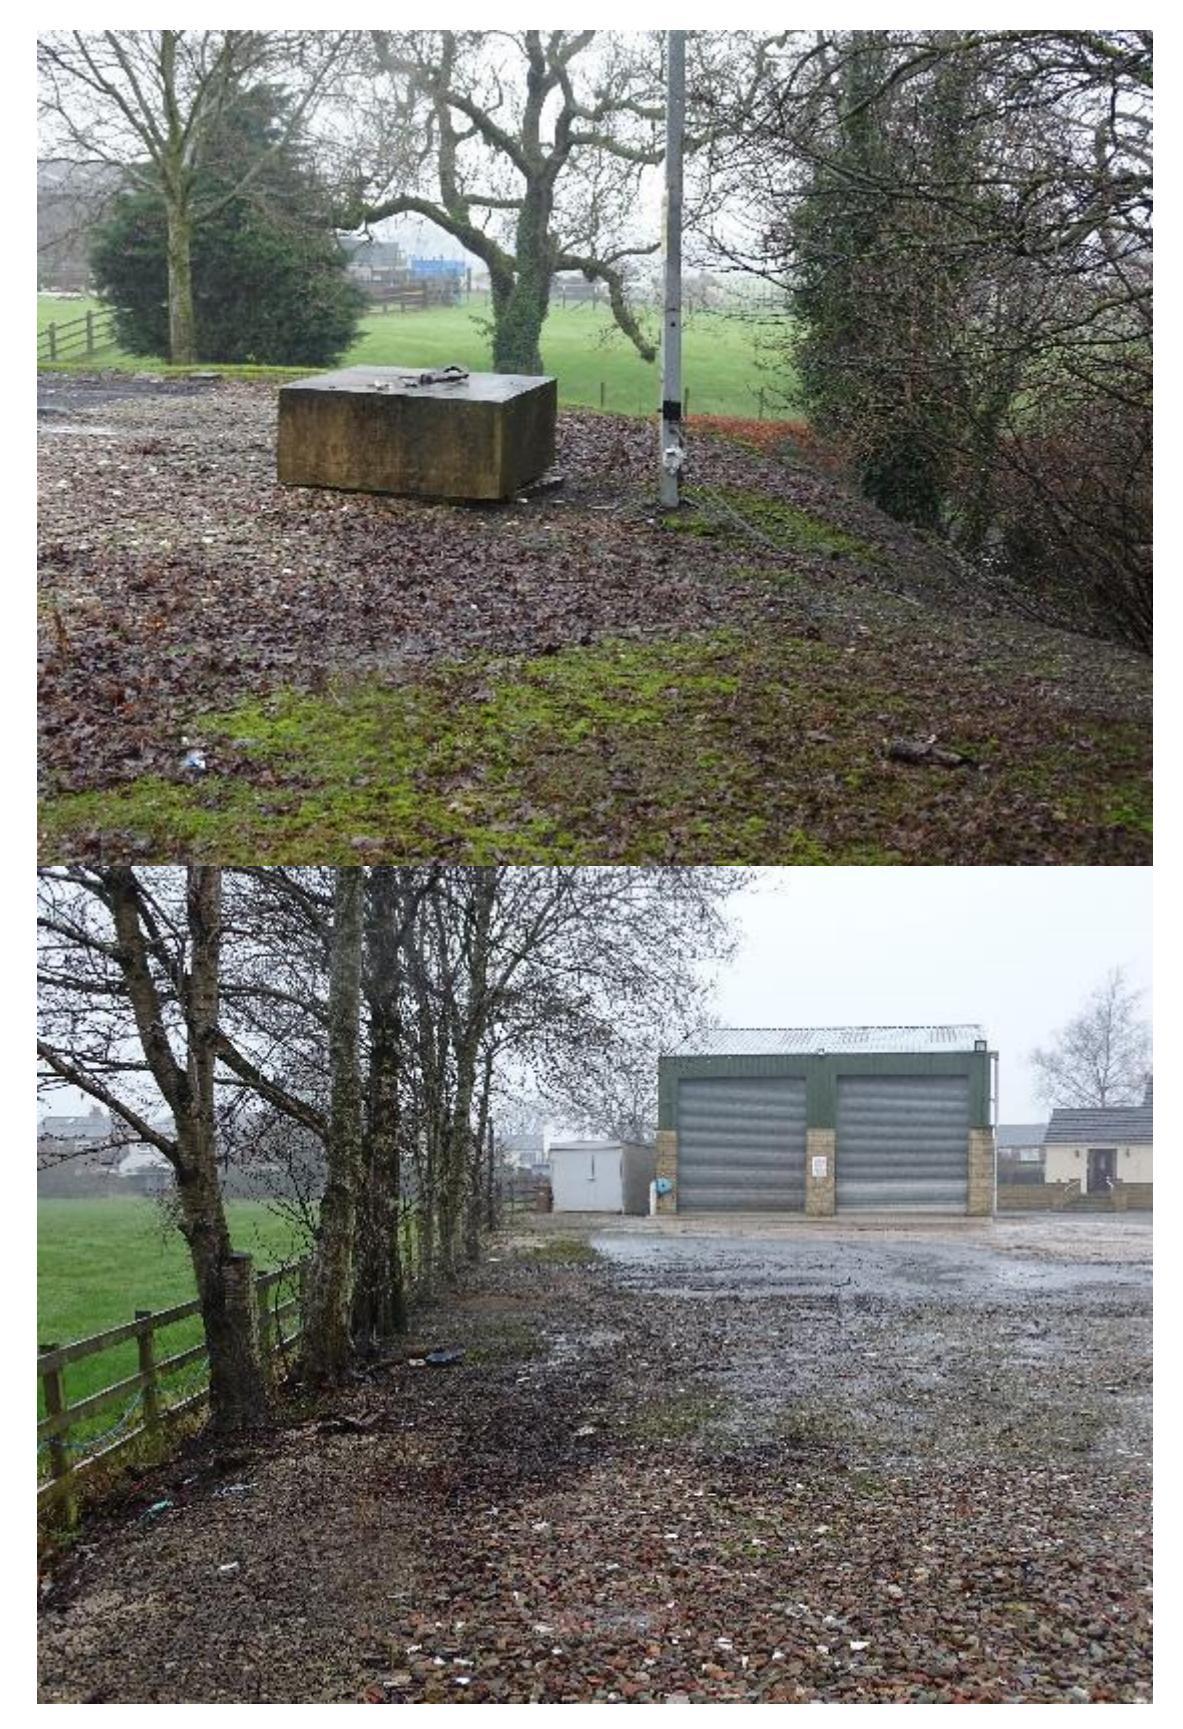
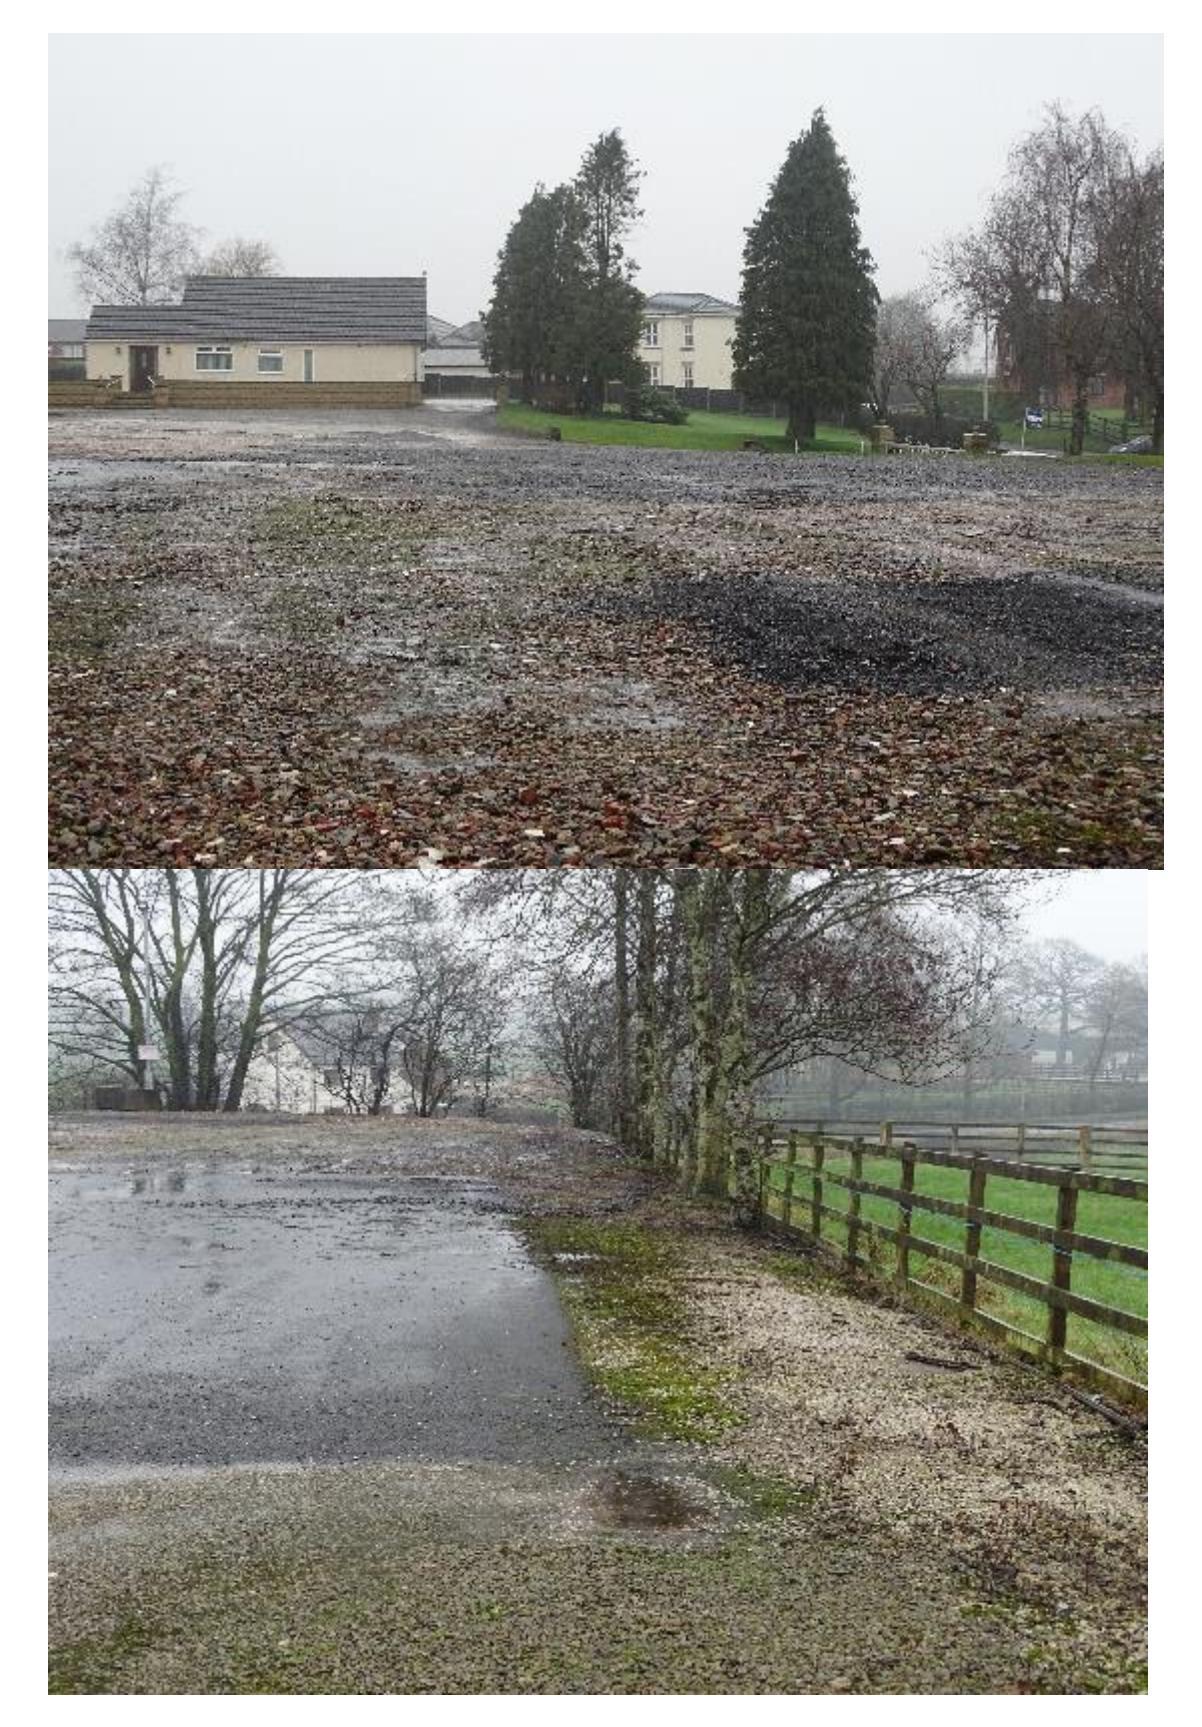
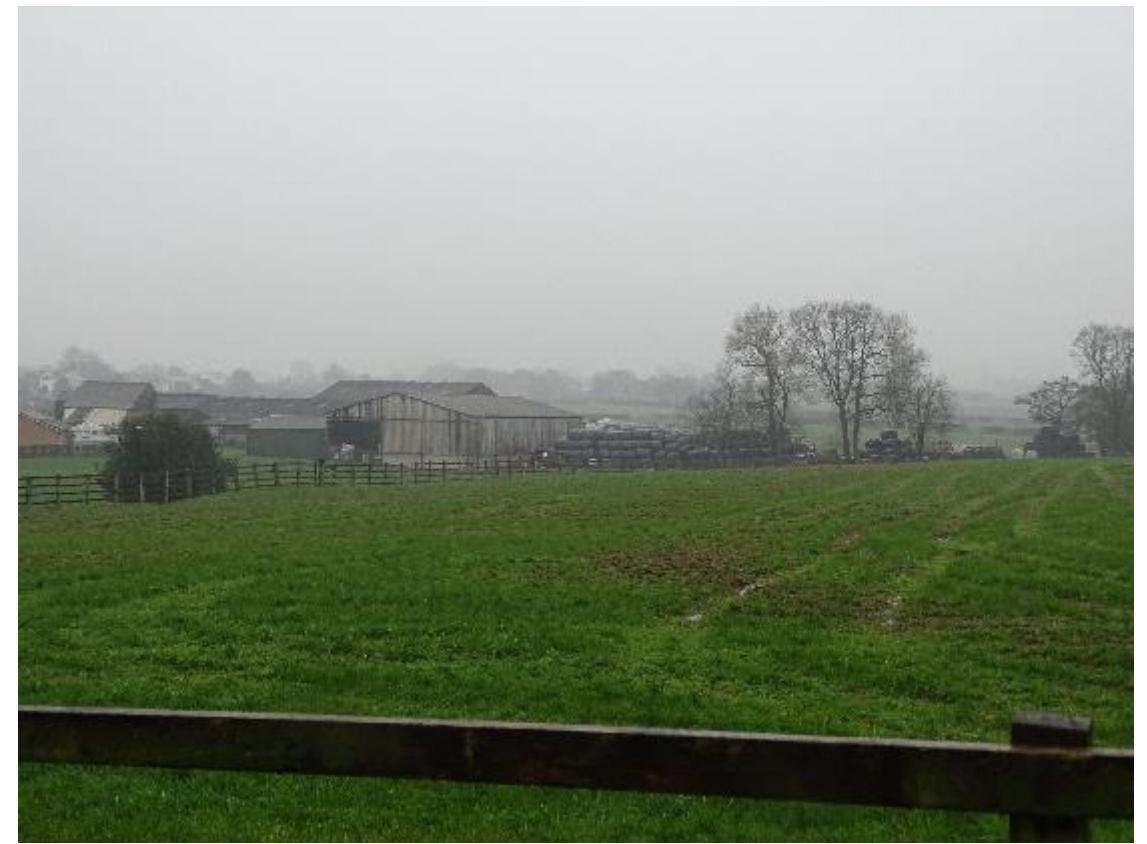
The eastern section of the site, looking along the northern, eastern and southern boundary

The site has been historically redeveloped and currently contains a commercial unit replacing former units on site. To the east of the site the land has been raised to make the site level. There is therefore the potential for contamination on site within the made ground or from the former industrial units, this could potentially include heavy metals, and petroleum hydrocarbons from fuel and oils and maintenance to machinery on site or Polyaromatic hydrocarbons within the made ground.

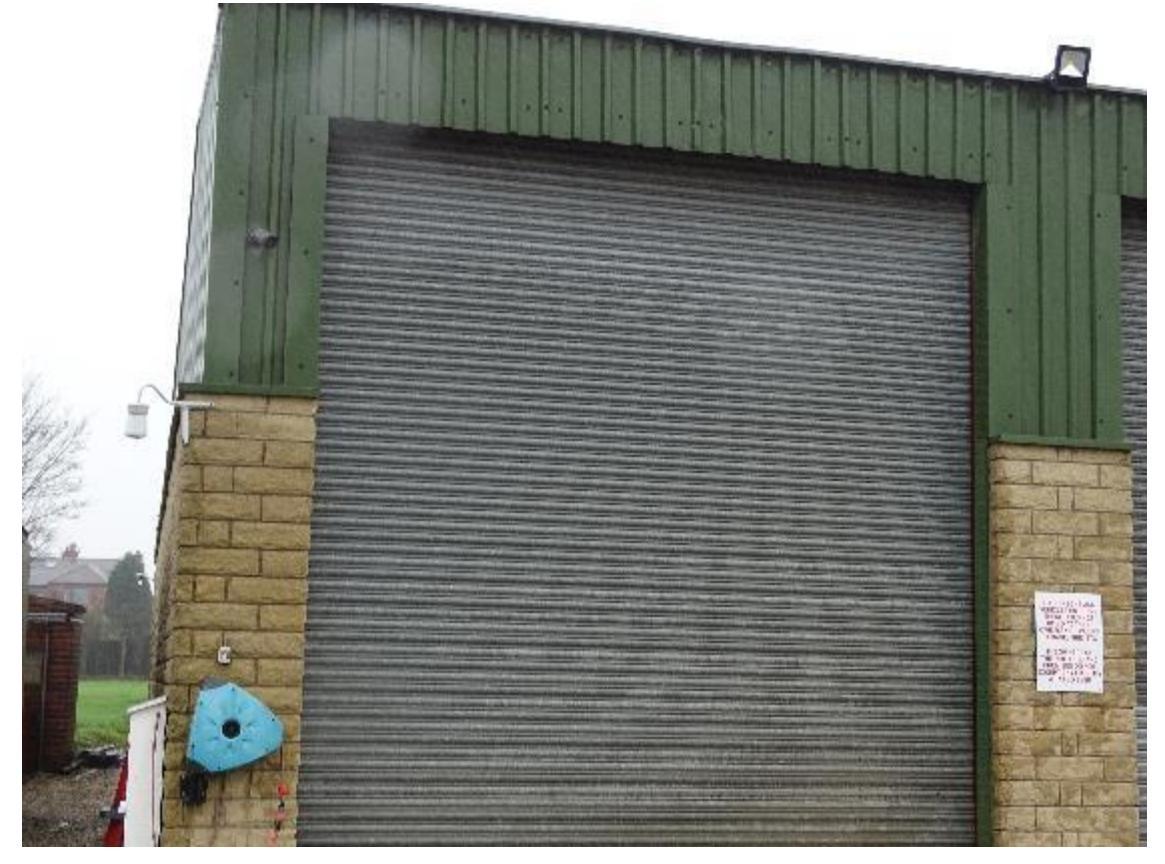
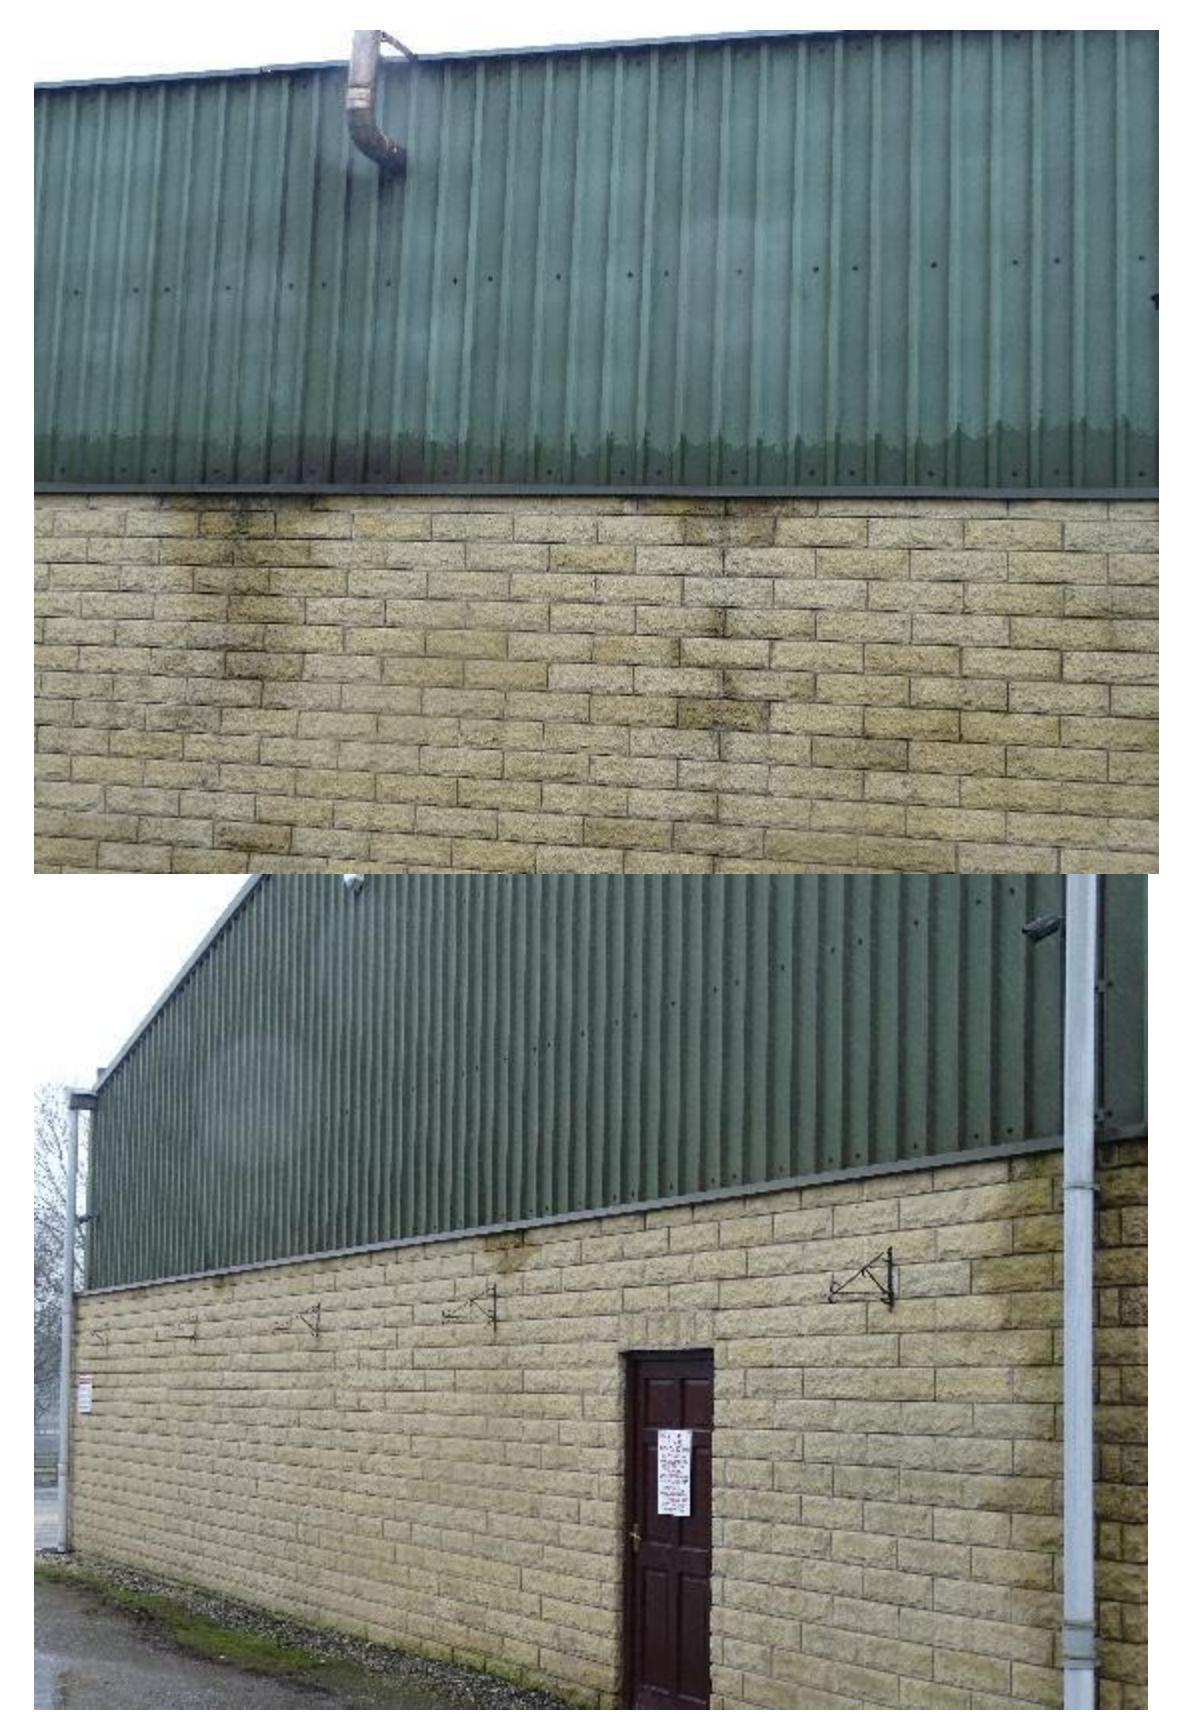
The commercial unit

From the access drive a large commercial unit is located in front of the access along the southern boundary. Constructed from a metal frame with stone and metl walls and roof. To the rear south of this building is a metal container and behind that a wooden dog house/run.
