# Contaminated Land Phase One Desk Study for Whalleys Farm, Preston Road, Charnock Richard, PR7 5HR.

January 2021

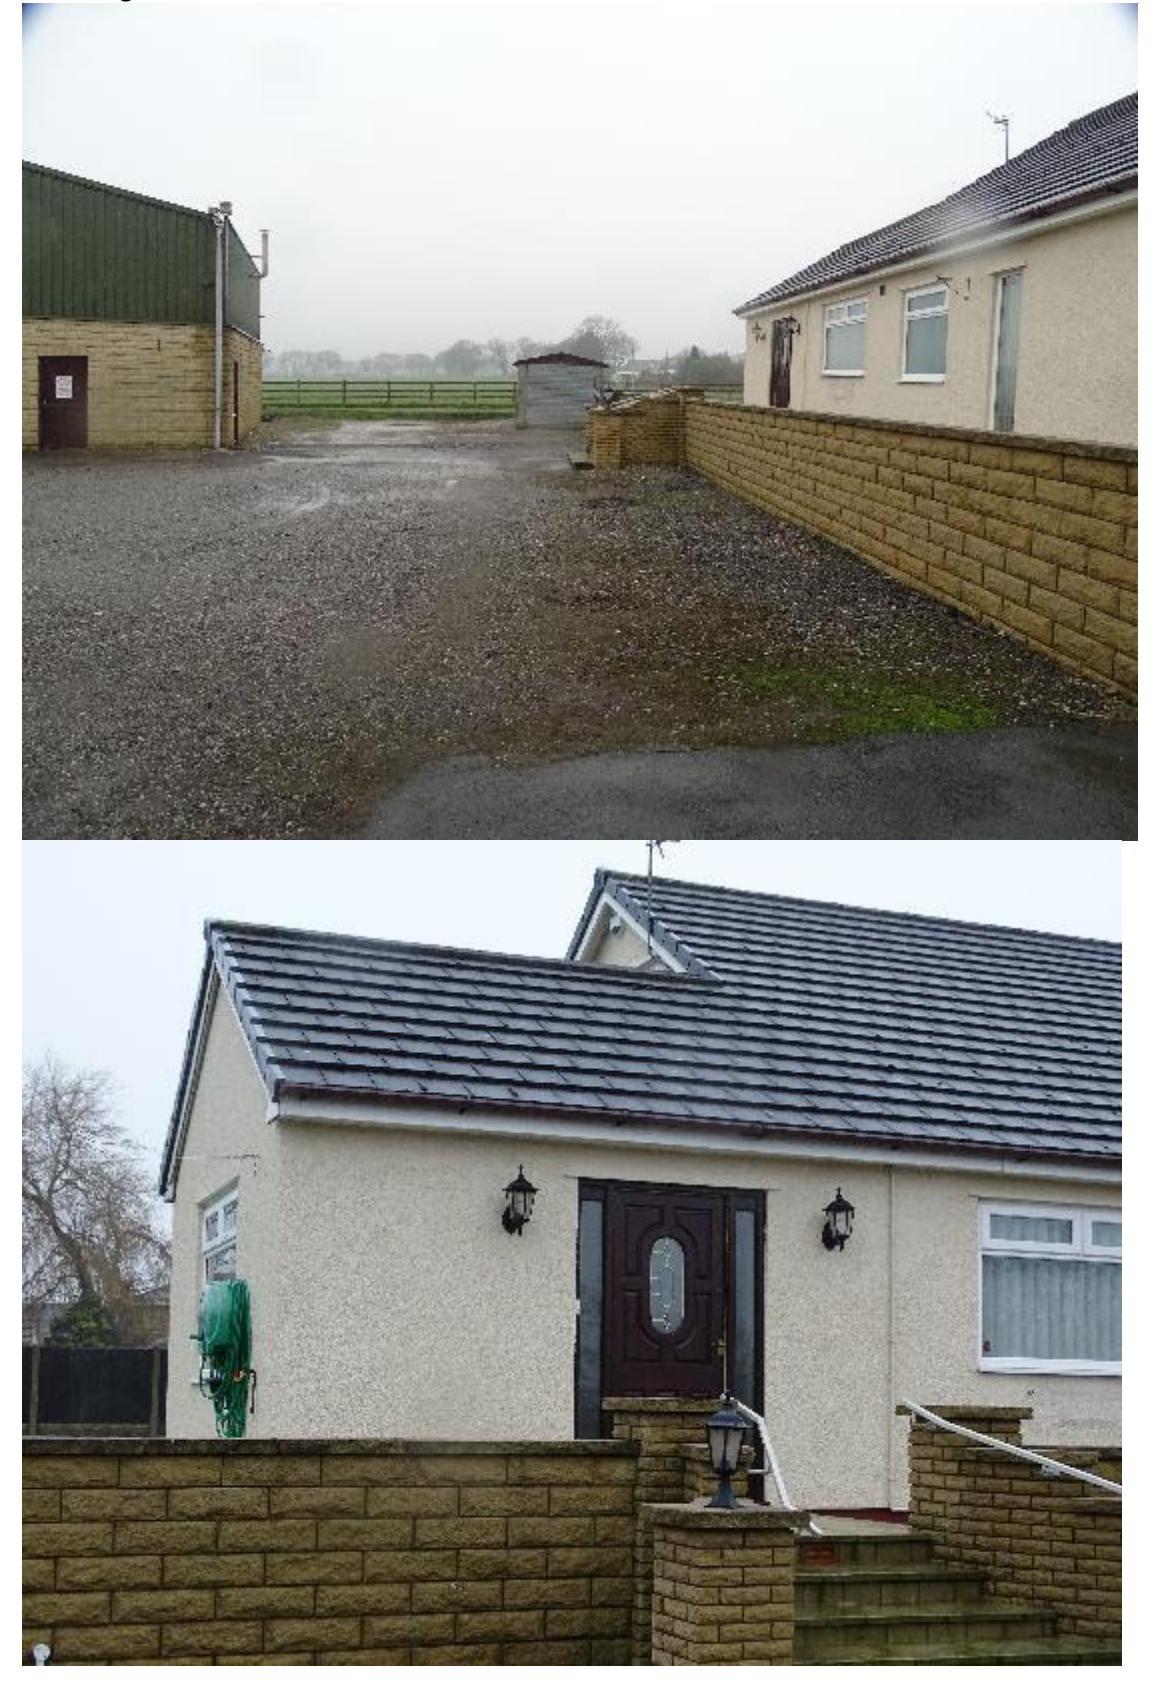
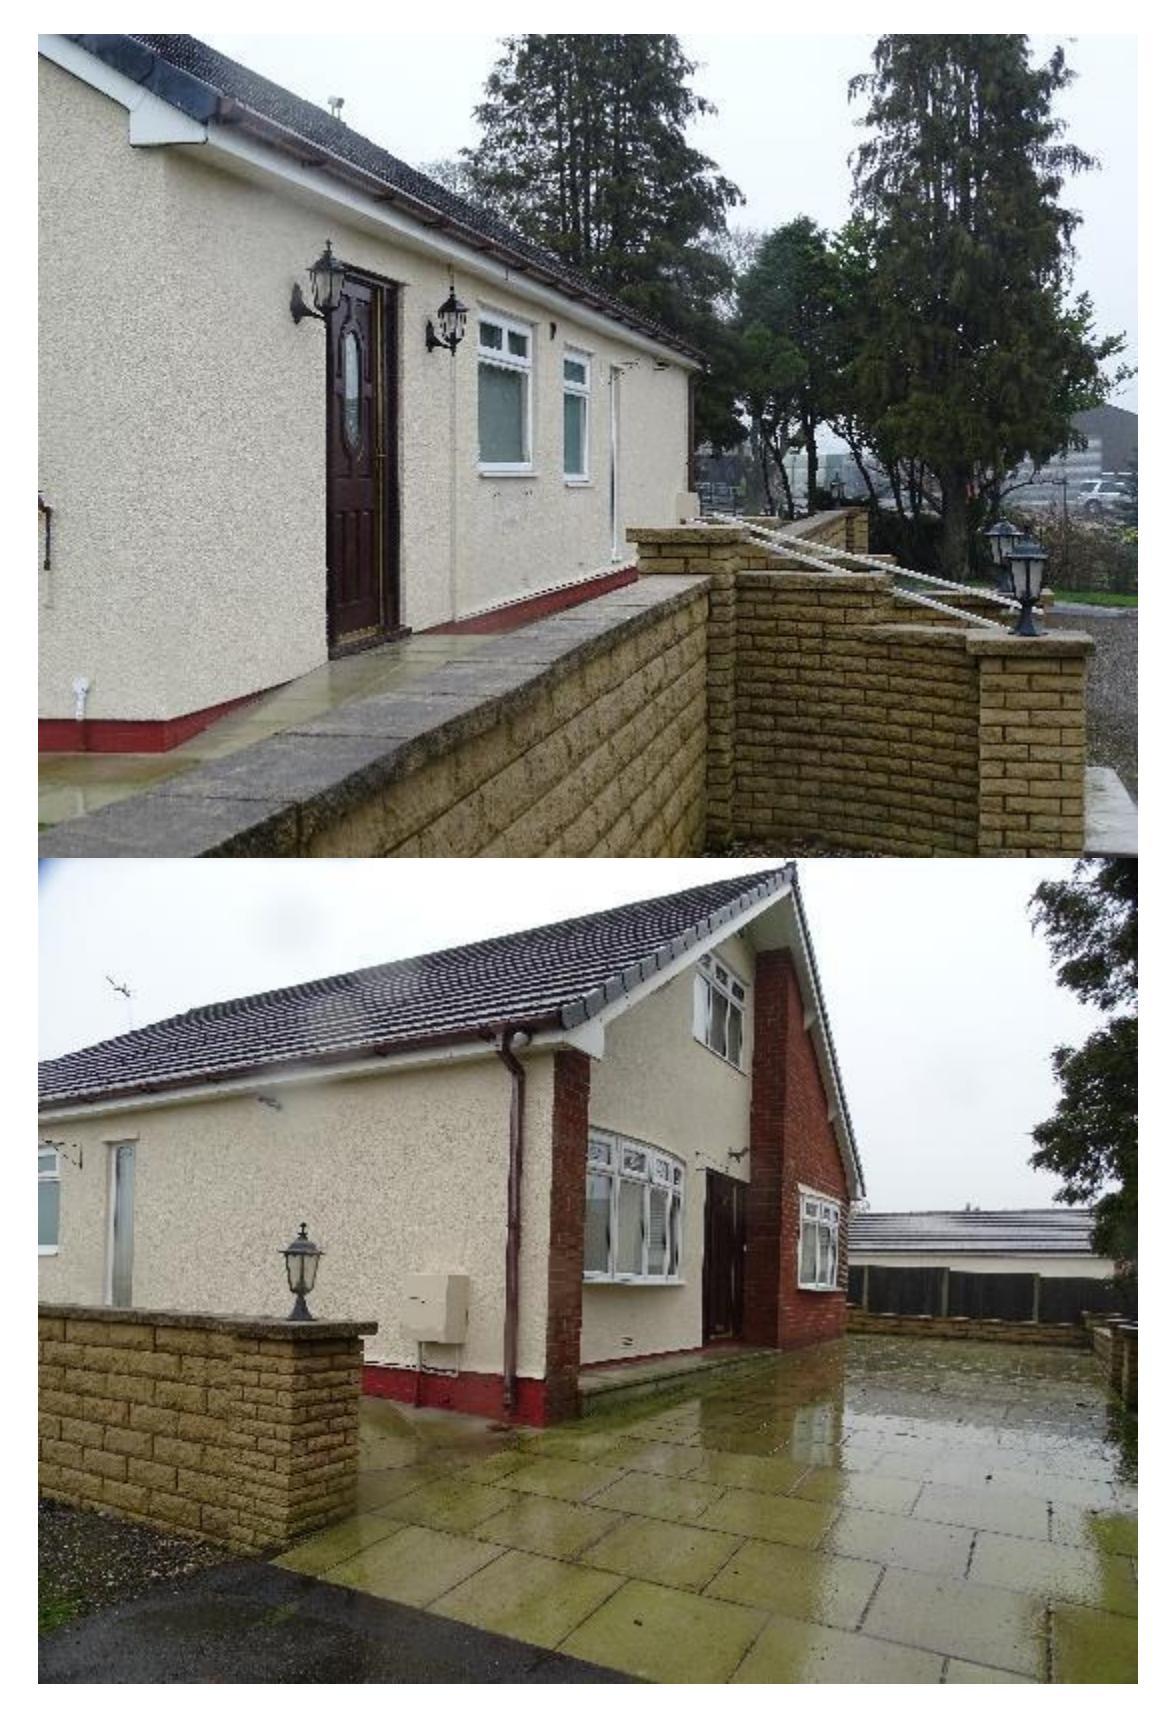
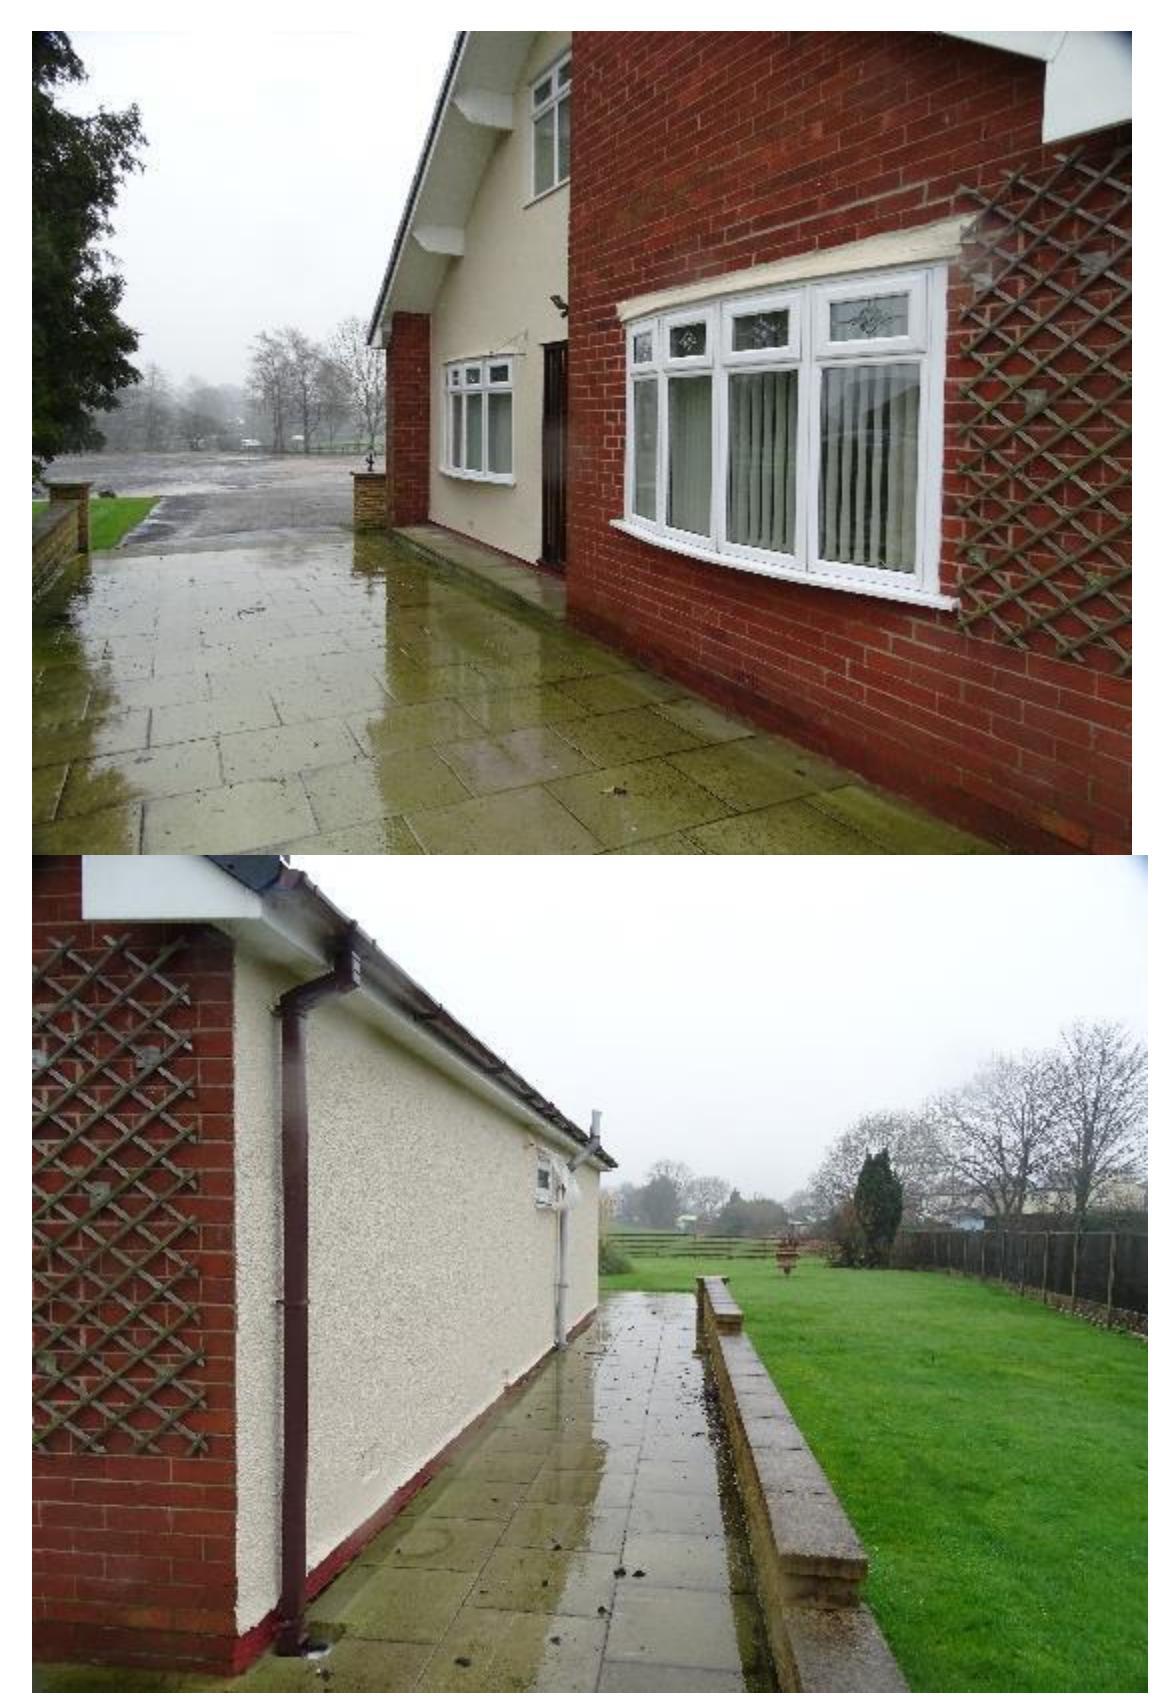
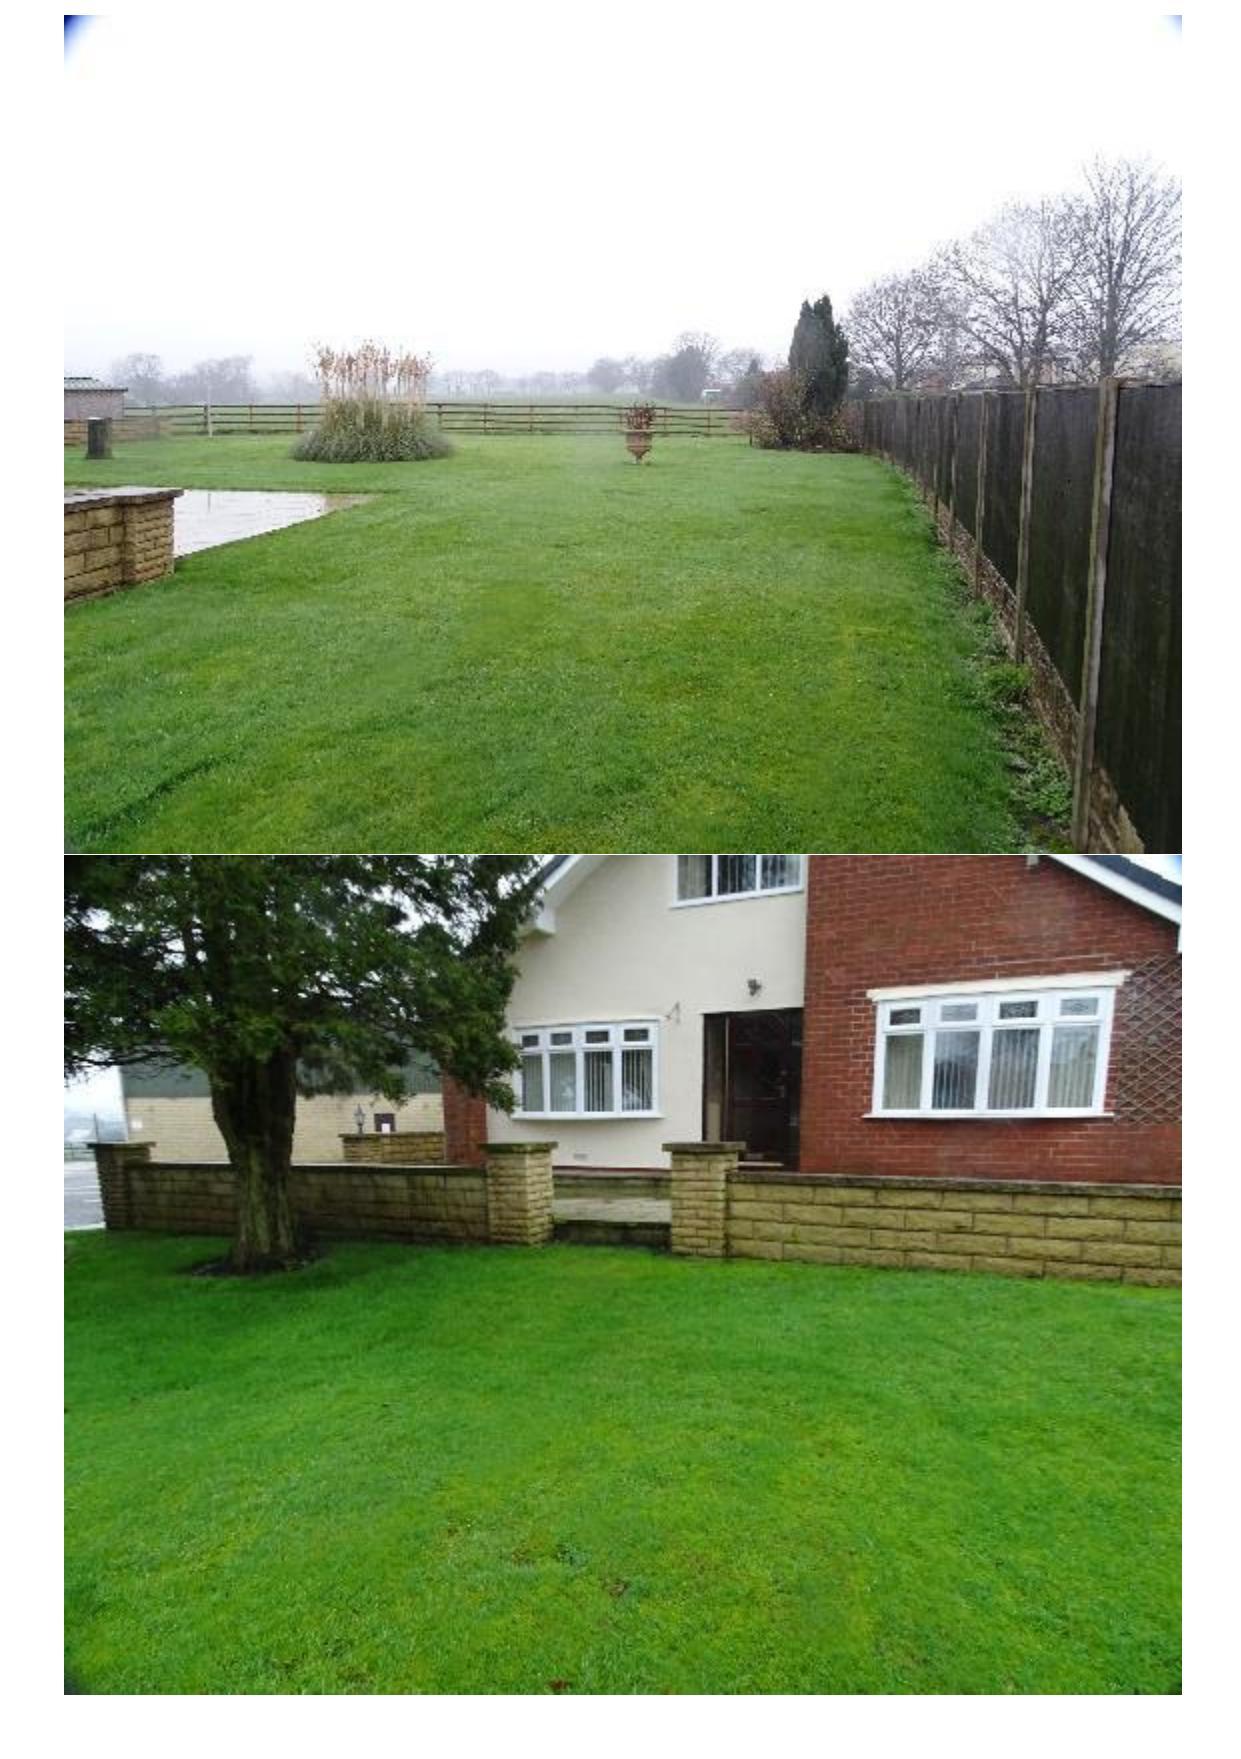
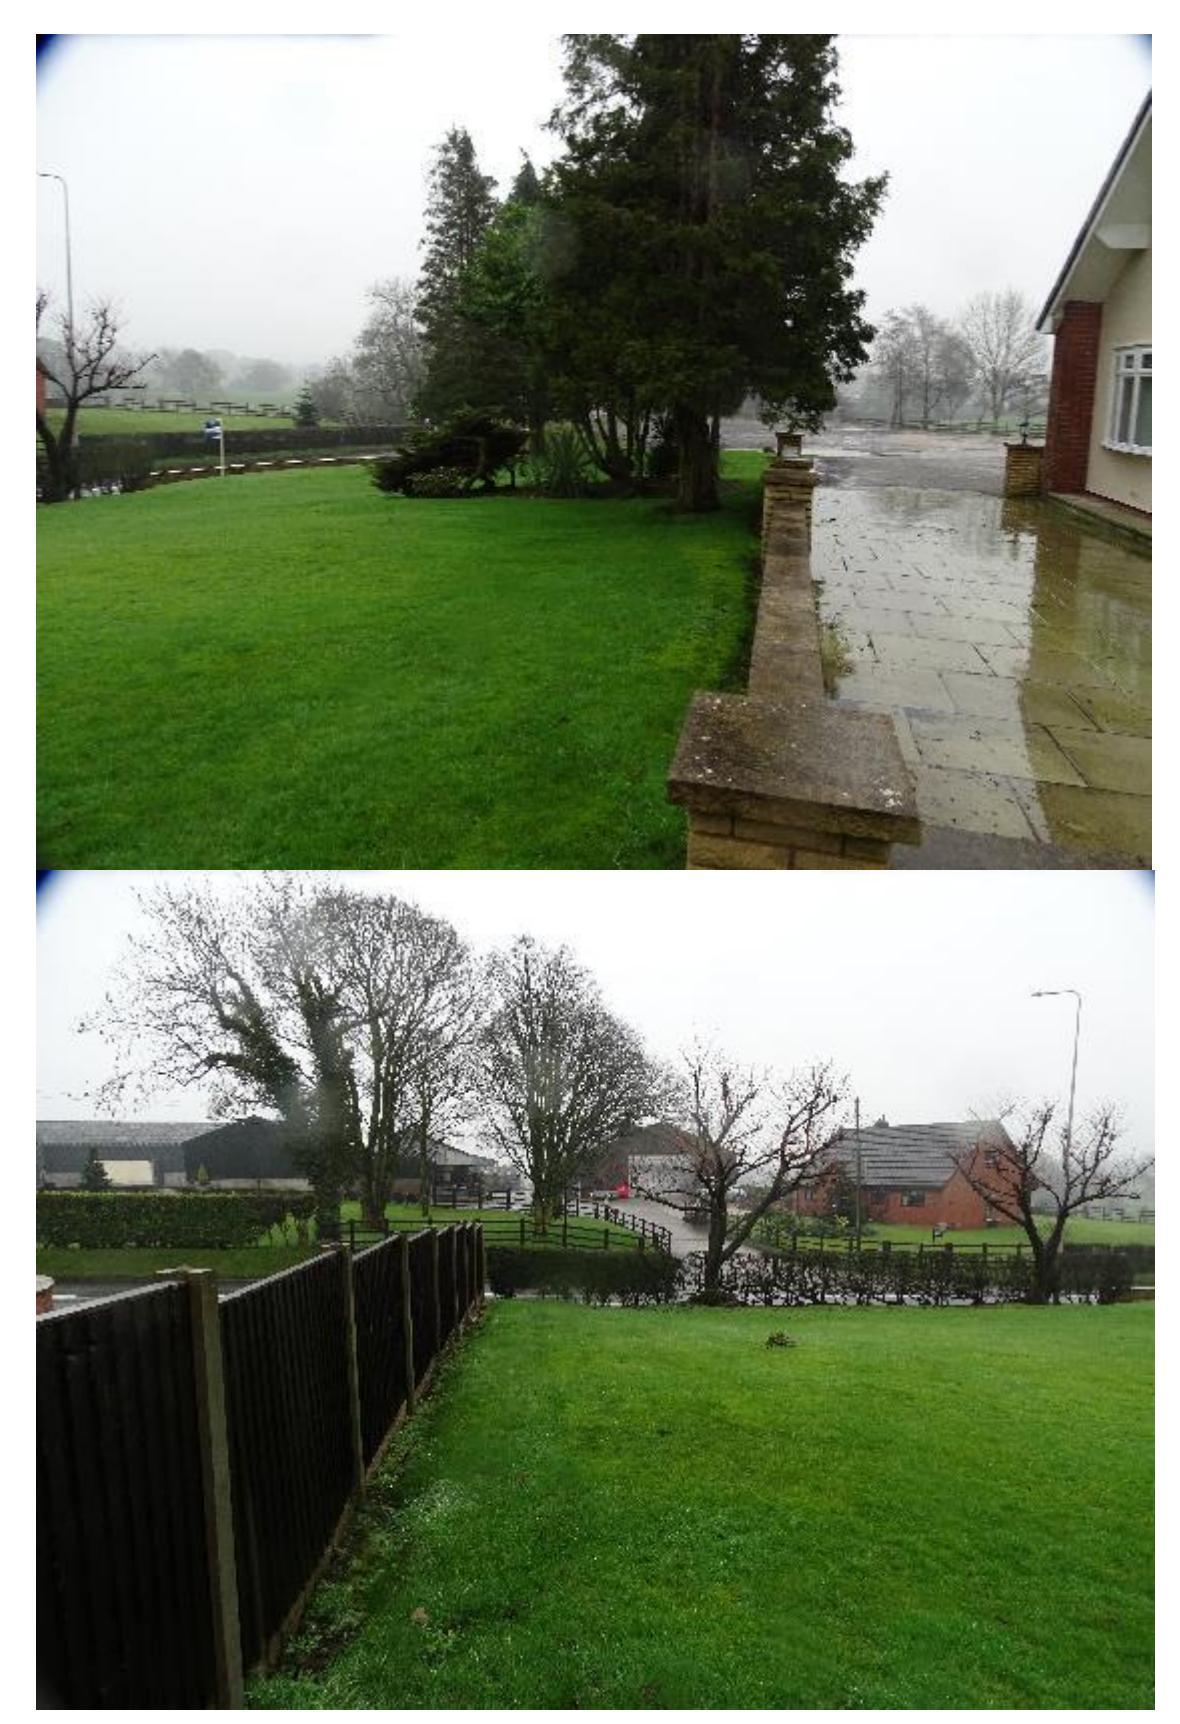
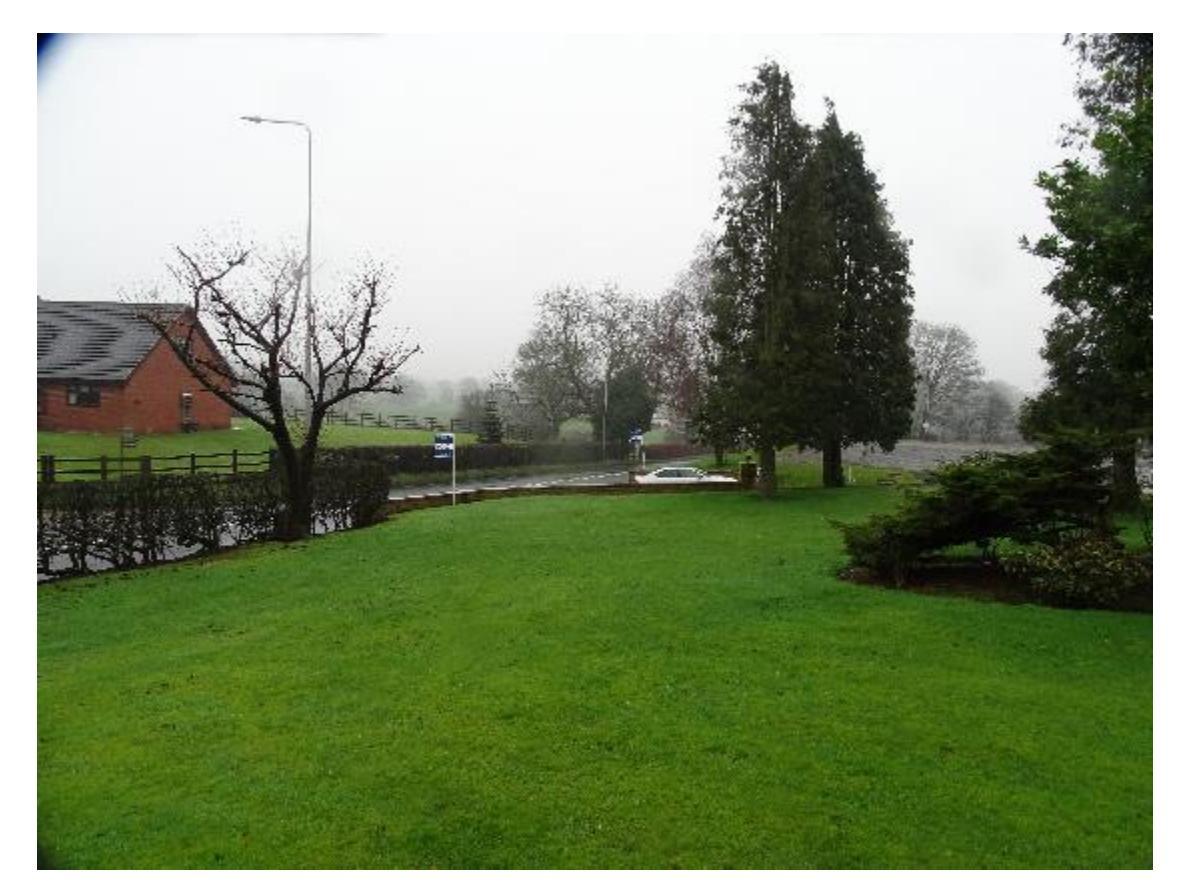
The bungalow and lawns

To the west a lawn at the front of the site, a bungalow to the centre along the western boundary and another lawn to the rear of this. At the side of the lawn and located between the lawn and the commercial unit is a domestic garage with constructed from concrete panels and a metal roof. The bungalow is a brick built rendered building and is elevated from the reast of the site.
