**TREE SURVEY & CONSTRAINTS PLAN
IN ACCORDANCE WITH BS 5837:2012**

Proj. No 10399	Rose Cottage, Middlewood Green, Stowmarket, IP14 5HB
Client:	PJT Design
Date of Report:	25/07/2023

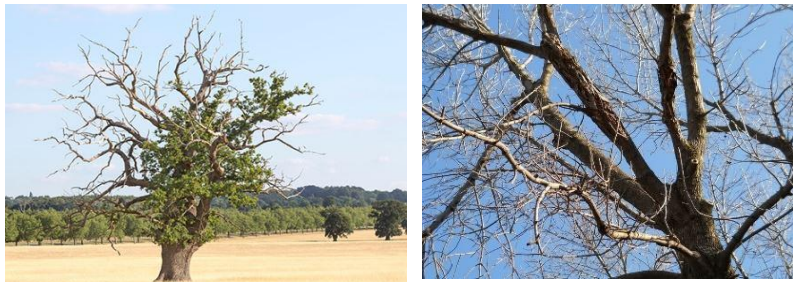
Name: Deadwood	
Symptoms/damage type and cause:	This relates to dead branches in the crown of the tree. In the majority of cases, this is caused by the natural ageing process of the tree or shading due to its close proximity to neighbouring trees. However, in some situations, it may be related to fungal, bacterial or viral infection.
Consequence:	Depending upon the location and mass of dead wood removal of the affected tissue may be necessary to prevent harm to persons or property as the wood will become unstable as it decays and in some circumstances is likely to fall from the tree with little or no warning.
Control:	Detailed monitoring should be undertaken on those trees showing signs of excessive deadwood production to identify the underlying cause.
Species affected:	Most tree species.
Images:

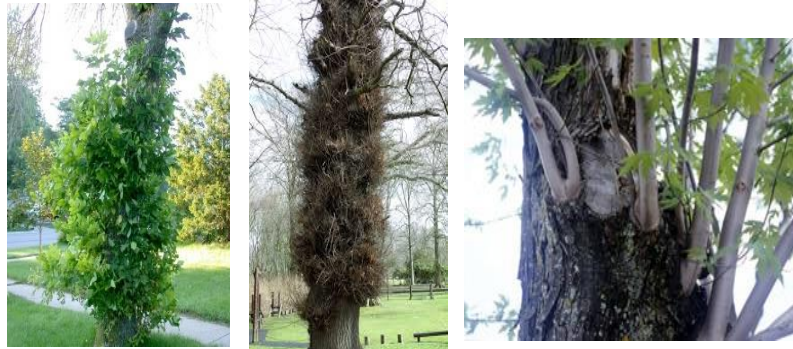
Name: Epicormic growth	
Symptoms/damage type and cause:	This is the production of numerous shoots on the main stem and branches of the tree. They are produced by the bursting into life of otherwise dormant buds. It is commonly associated with elevated levels of stress on the tree.
Consequence:	Whilst epicormic growth is usually symptomatic of an issue elsewhere within the tree, heavy proliferation can cause the trees resources to become depleted or may mask significant structural weaknesses within the framework of the tree.
Control:	Pruning off epicormic growth may be necessary to improve the visual amenity of the tree or prevent the development of a hazard or obstruction. No direct means of prevention are available other than therapeutic measures to alleviate stresses on the tree.
Species affected:	Most tree species, including European Lime, Willow species, Sweet Chestnut, and Silver Maple.
Images:

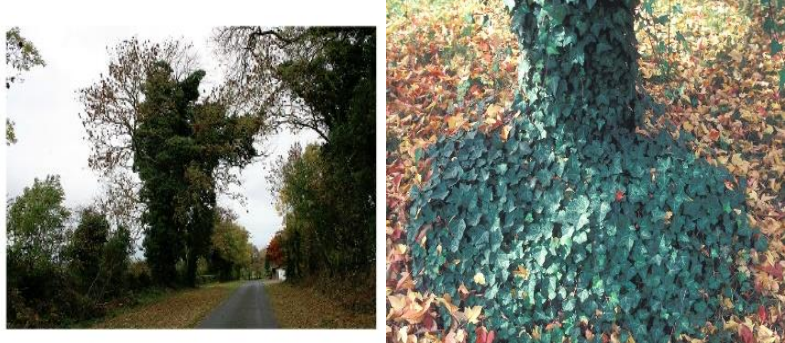
Name: <i>Hedera helix</i> (Ivy)	
Symptoms/damage type and cause:	Ivy may grow to varying degrees on all areas of a tree from the base to the upper crown. It is possible that in doing so it will out-compete the host tree for available light thereby suppressing the host.
Consequence:	This is generally only harmful to the tree on already unhealthy specimens which may be constricted by large ivy stems around the trunk or may have their top growth suppressed by a mass of flowering shoots in the crown. Ivy can also mask potentially dangerous faults on a tree.
Control:	Ivy should only be removed if absolutely necessary because it provides abundant cover to wildlife and then by severing twice close to the ground and removing a length of stem thereby causing the gradual dying away of the aerial parts of the plant providing extended benefit to wildlife whilst relieving the pressure on the tree.
Species affected:	Most trees can be affected.
